The State of Stream Restoration in the North Carolina Piedmont: An Assessment of Instream
Structure Durability and Stream Bank Erosion

by
Kimberly Mae Spangler Hamlin

A thesis submitted to the Graduate Faculty of
North Carolina State University
in partial fulfillment of the
requirements for the degree of
Master of Science

2011

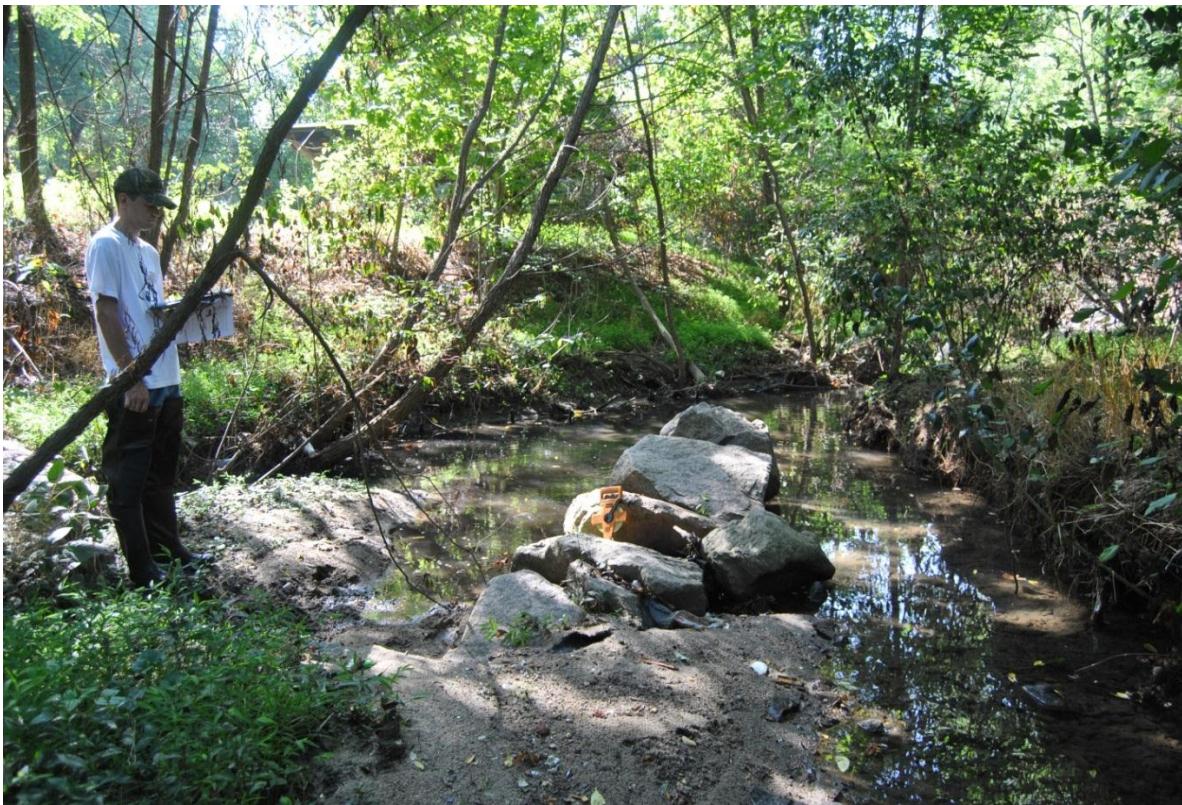
Of all the hard engineered structures, rock cross vanes suffered the highest occurrences of damage in this study. The half-life for rock cross vanes was 6.5 years. There were problems with arm and sill failure due to insufficient backfill and improper alignment. Rock cross vanes also experienced erosion directly downstream of the arms either due to side cutting of water or flow expansion out of the vane. This was preventing the establishment of woody vegetation in some cases. Miller and Kochel (2010) reported similar results with rock cross vanes experiencing the most instances of damage among the structures they surveyed. Rock cross vanes are complex structures involving many footer and arm boulders. Correctly sizing boulders and properly backfilling the vane are important in decreasing spaces in the structure where water can pipe

Figure B1 – Rock Cross Vane Damage. The channel has migrated to the right side of the structure allowing sediment to fill in the scour pool and cover the left arm.

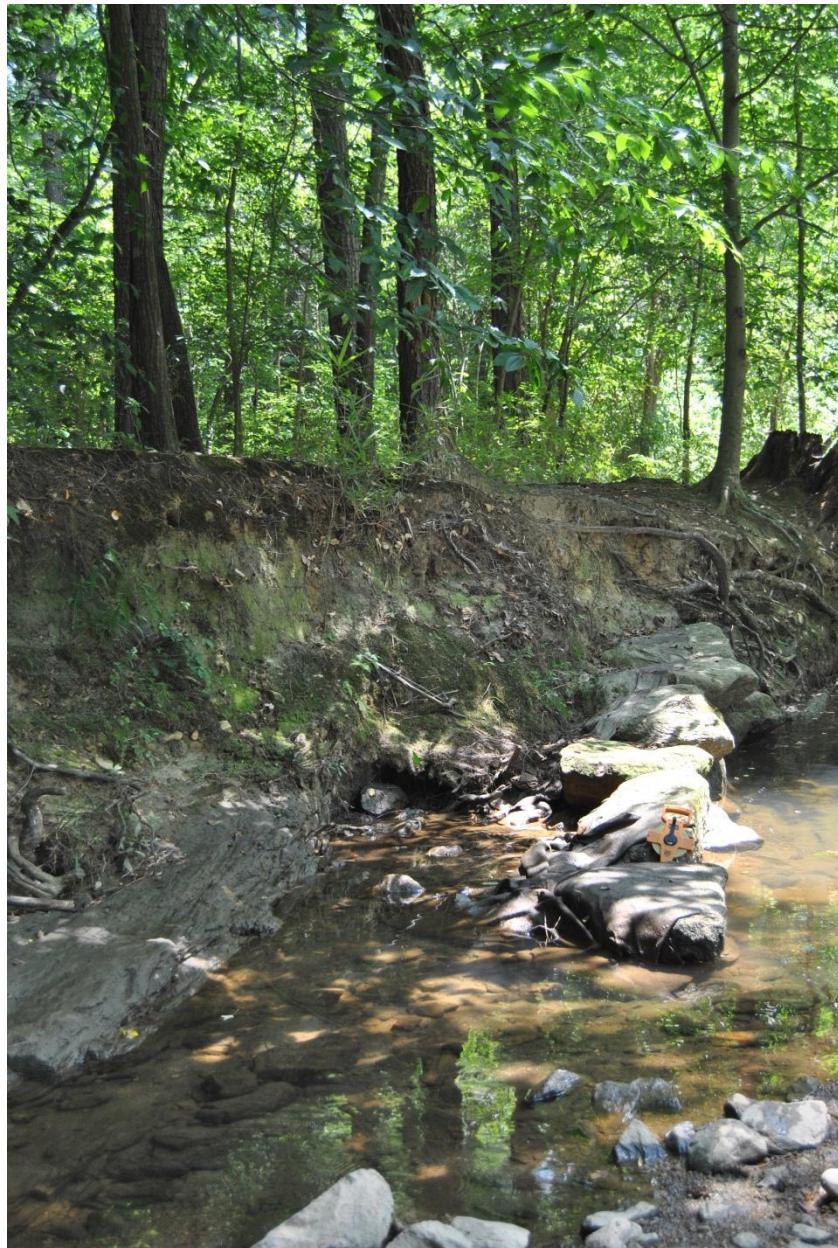
Single arm vanes were the third most durable structures. The scores passed the threshold value at age ten and the half-life for single arm vanes was 10.9 years. Problems resulted from erosion behind boulders which compromised stability. This was either due to improper alignment of the vane or insufficient backfill which allowed water to move behind the arm and dislodge boulders. Occasionally, the arm vanes were too steep which resulted in undercutting of the footer boulders. Erosion occurred once the boulders were washed away from the bank. Although not as complicated or expensive to install and repair as rock cross vanes, careful placement and sizing of boulders is still important to the success of these vanes.

Figure B2 – Single Arm Vane Damage. The left side of the stream has eroded down to bedrock behind the single arm vane. The backfill material has been washed out, and many of the arm boulders have shifted.

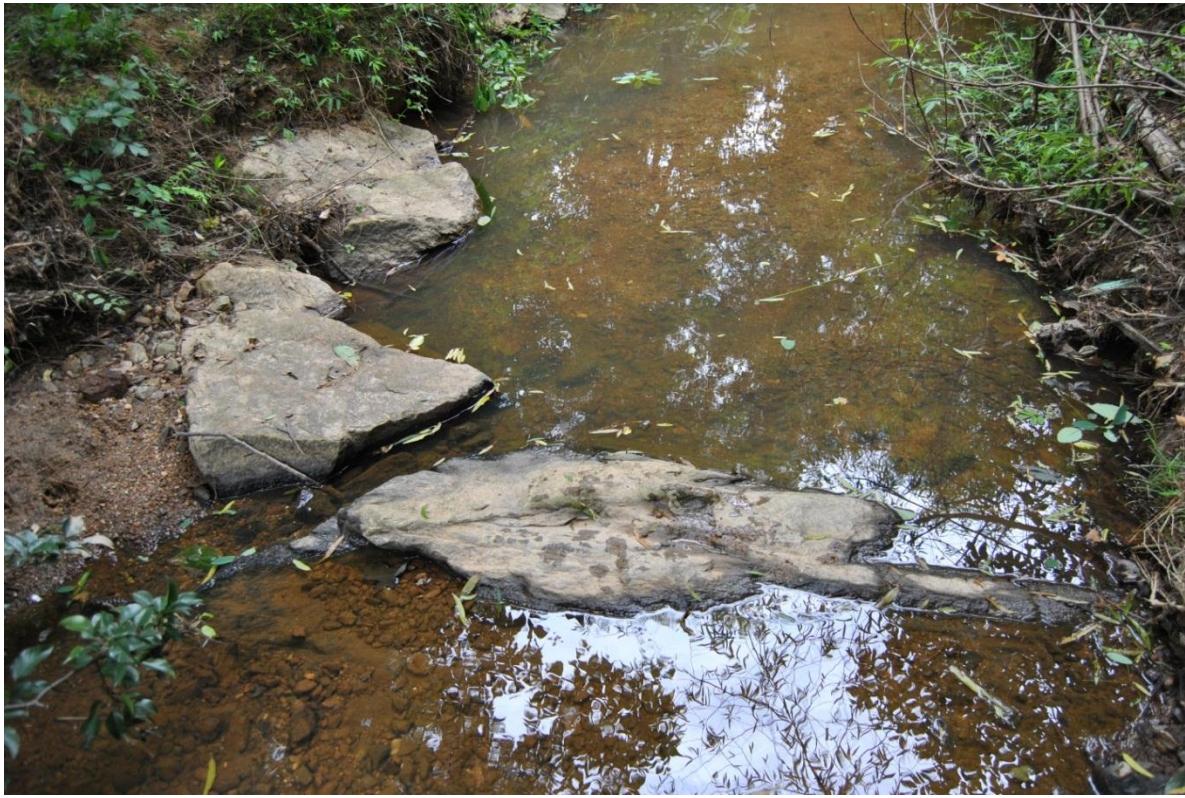
J-hook vanes were more durable than single arm vanes, and surpassed the threshold value after nine years and had a half-life of 15.6 years. Problems and causes for j-hook vane failures were similar to those for single arm vanes. In addition, j-hook vanes experienced problems with scour pool development when arm boulders fell into the pool.

Figure B3 – J-hook Vane Damage. Sediment has deposited behind first arm boulder, and there is minor erosion of the left bank at the end of the structure.

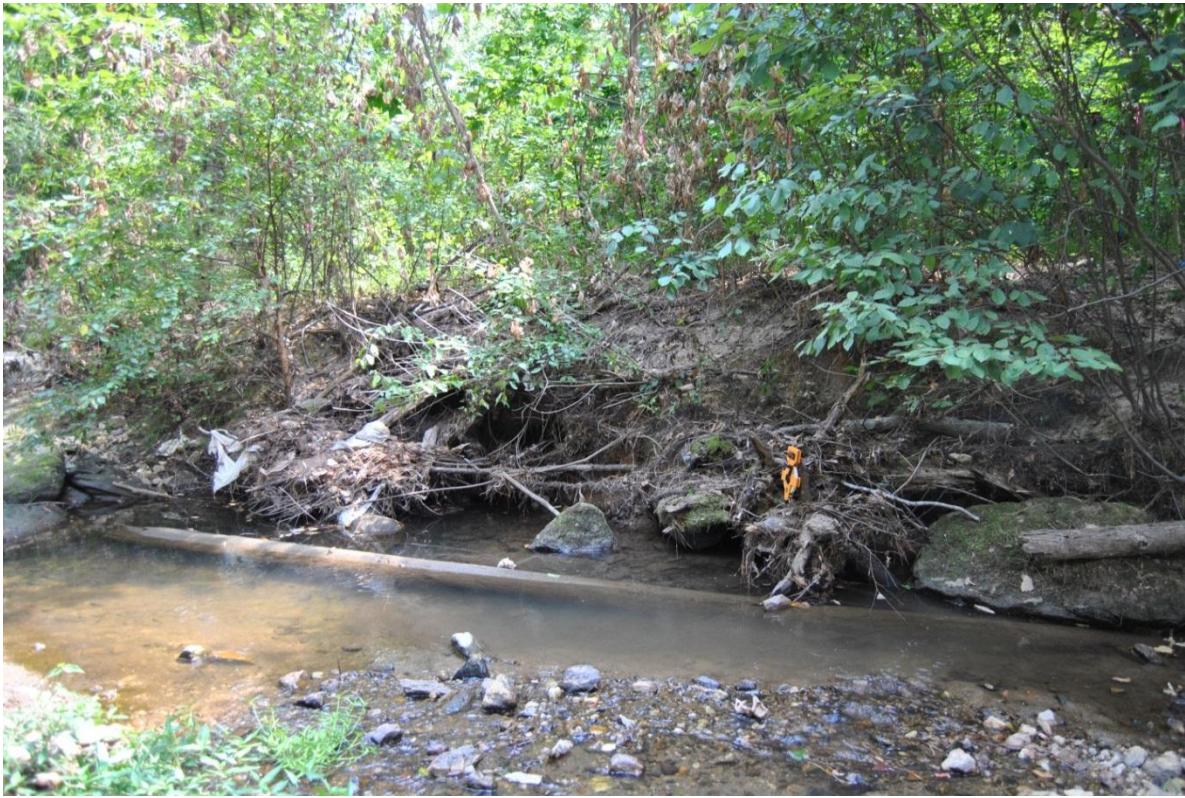
Rootwad revetments reached the threshold value six years after construction, but held constant up to year ten. The half-life for rootwads was 4.9 years. Rootwads were also highly impacted according to Miller and Kochel (2010). Most problems resulted from bank erosion behind the root ball leading to shifting of the rootwad or footer boulders. Rootwad protection is only needed until woody vegetation becomes established; however, when parts of the structure fail, vegetation has a difficult time growing on the eroding bank. Other problems included the rootwad being installed too high from base flow exposing the majority of the rootwad to air.

The continued exposure of the moist root ball to air lead to faster decay of the root ball. This coupled with lack of vegetation reduced the stability of the structure.

Figure B4 – Rootwad Revetment Damage. Severe erosion occurred below and behind the root ball. The footer log has been exposed.
