MILLER, ANTHONY D. Repair of Impact-Damaged Prestressed Concrete Bridge Girders Using Carbon Fiber Reinforced Polymer (CFRP) Materials. (Under the direction of Dr. Sami Rizkalla).

**REPAIR OF IMPACT-DAMAGED PRESTRESSED
CONCRETE BRIDGE GIRDERS USING CARBON FIBER
REINFORCED POLYMER (CFRP) MATERIALS**

A thesis submitted to the Graduate Faculty of
North Carolina State University
in partial fulfillment of the requirements for
the Degree of Master of Science

2006

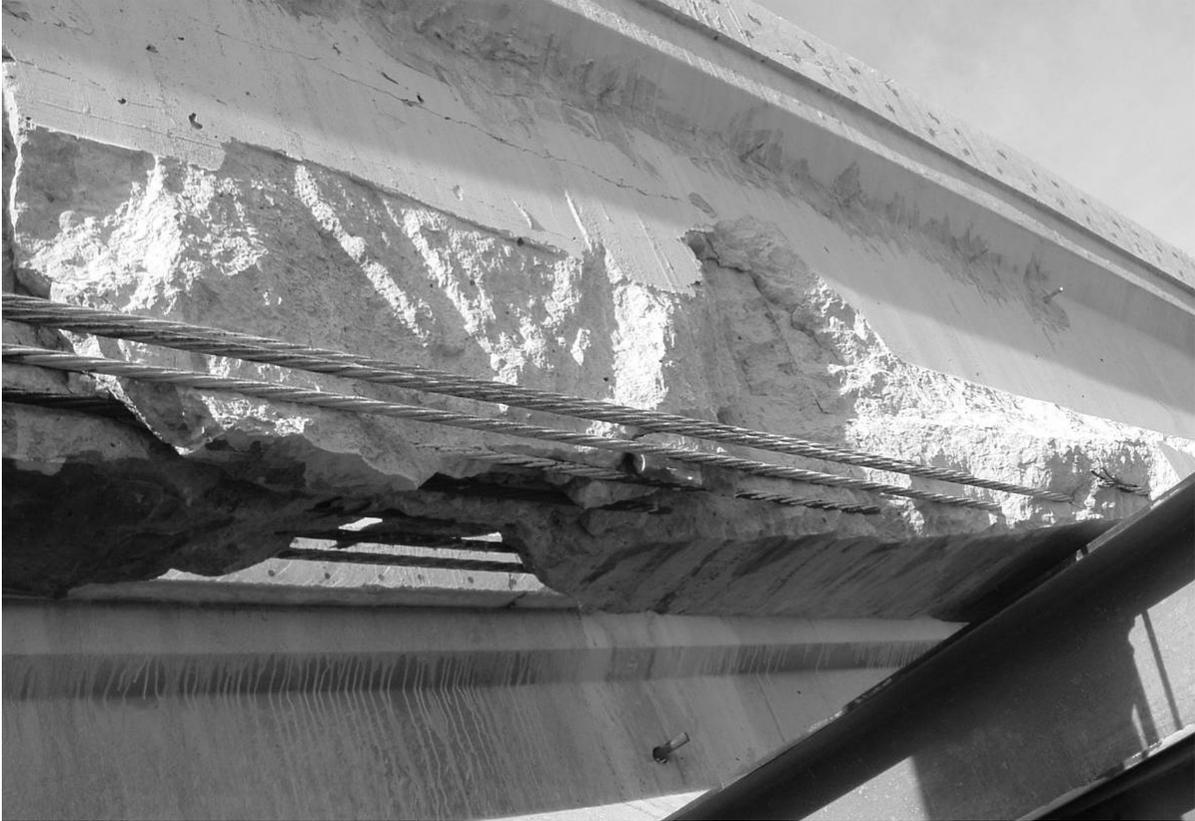
AASHTO1 was the first girder tested in this research project. The test girder was an AASHTO Type II girder prestressed with sixteen 0.5 in (12.7 mm) – 7 wire 270 ksi (1862 MPa) straight prestressing strands, as shown in Figure 3.3. The total length of the tested girder was 54.84 ft (16.71 m) with a center-to-center support span of 53.34 ft (16.26 m). The girder after impact damage from an overheight vehicle is shown in Figure 3.4. The cross section and elevation of AASHTO1 are shown in Figure 3.3. The loss of concrete section extended a length of 11.9 ft (3.63 m) on the front side and 6.0 ft (1.83 m) on the back side with an approximate volume of damaged concrete equal to 4.8 ft³ (0.1 m³). In addition to the loss of concrete, one prestressing strand on the bottom layer was ruptured on the front side, resulting in a 6.3 percent loss of prestressing force. The full 7 ft (2.13 m) composite bridge deck was not part of the test specimen since it was cut through in order to remove the damaged girder from the bridge superstructure. The average width of the composite deck of the test girder was 14.9 in (388 mm), ranging from 16.9 in (430 mm) to 13.9 in (353 mm). Several transverse cuts were located along the length of the composite deck. These cuts, originating during the cutting of the cast in place diaphragms, were approximately 0.4 in (10 mm) in width.

Figure 3.4 AASHTO1 at NCDOT yard after impact damage

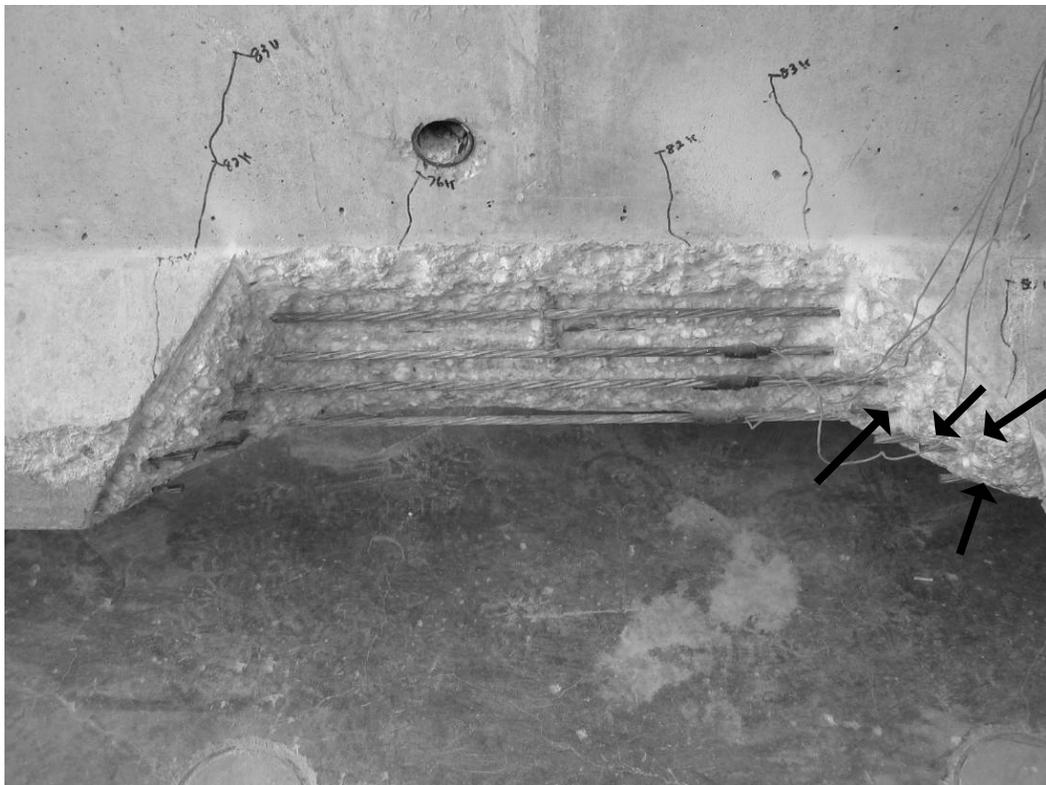
As previously mentioned in Section 3.1, AASHTO2 was received by the researchers undamaged, except for several transverse cuts approximately 0.4 in (10 mm) wide in the composite deck after the removal of the diaphragms. In order to simulate impact damage, a large portion of the tension flange of the girder was removed (Figure 3.6), and four prestressing strands were ruptured (Figure 3.7), corresponding to a reduction in prestressing force of 14.3 percent. The length of the damage was extended to a total of 2.0 ft (0.61 m) on either side of midspan on the front side of the girder only. Approximately 2.2 ft³ (0.06 m³) of concrete was removed, as shown in Figure 3.7.

Figure 3.7 Simulated damage of AASHTO2 girder

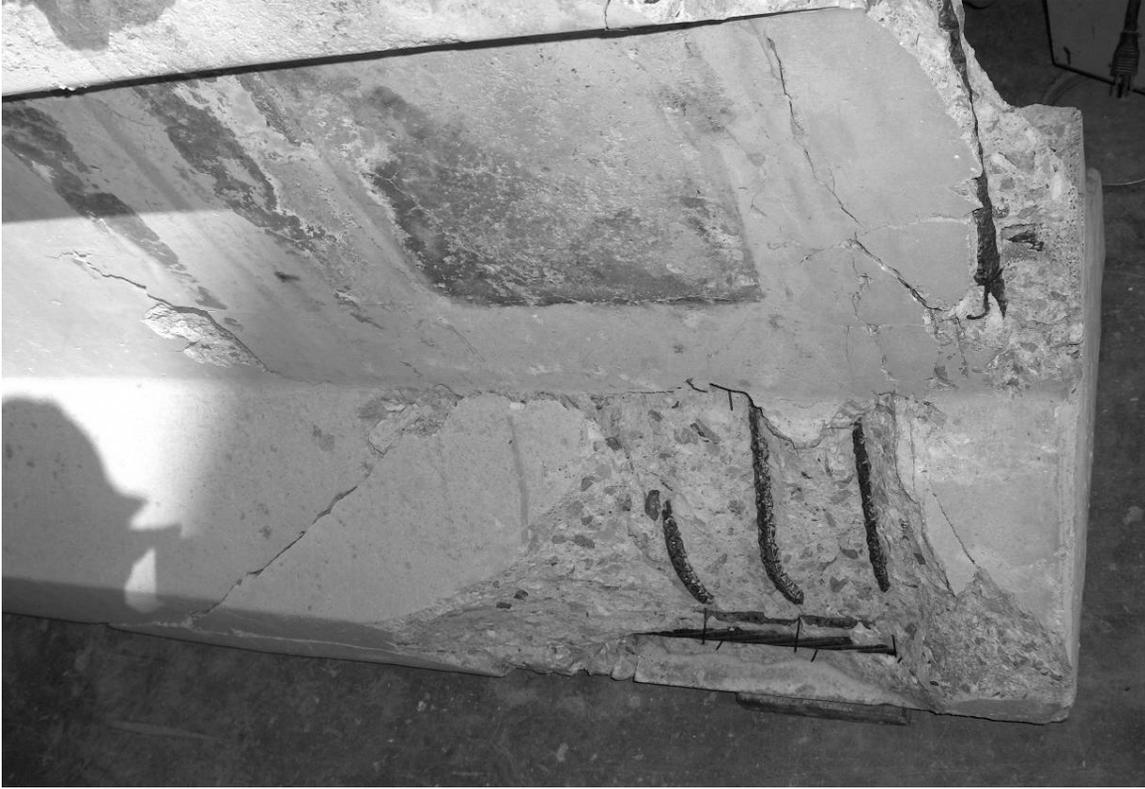
Figure 3.8 Damage to right support of AASHTO3 caused during transportation of girder

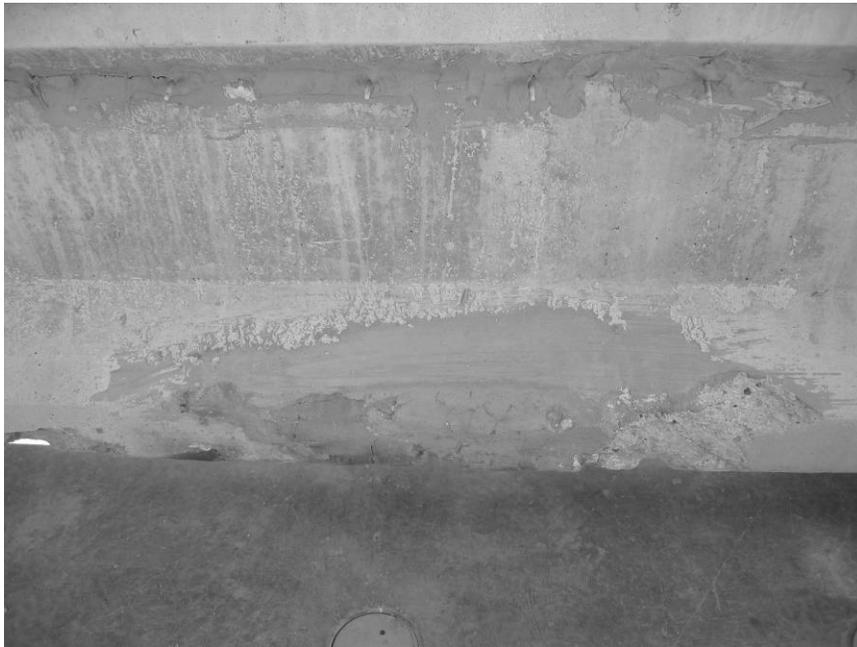
AASHTO3 had been impacted several times prior to being removed from the bridge. Figure 3.10 shows one section where an earlier concrete repair had been performed along with epoxy injection of the cracks caused by vehicular impacts. In order to simulate impact damage to this girder, a large portion of the tension flange was removed, similar to girder AASHTO2, and three prestressing strands were ruptured (Figure 3.11), corresponding to a reduction in prestressing force of 18.8 percent. The length of the damage was 2.0 ft (0.61 m) to the left of midspan and approximately 5.0 ft (1.52 m) to the right on the front side only. It was intended for the damage to be symmetrical about midspan, but the presence of earlier repairs made it difficult to cut as planned. A total of approximately 2.4 ft³ (0.07 m³) of concrete was removed, as shown in Figure 3.11.

Figure 3.10 AASHTO3 defects after arriving at the testing facility

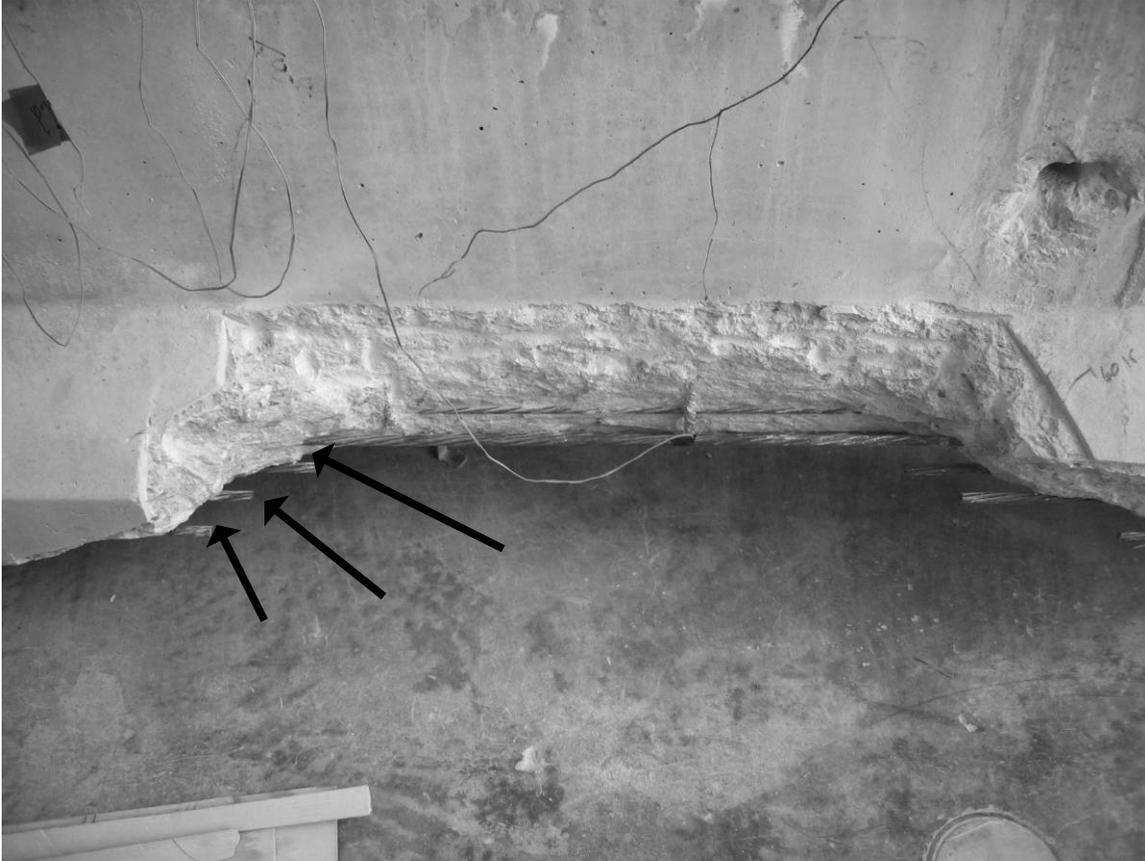
Figure 3.11 Simulated damage of AASHTO3 girder

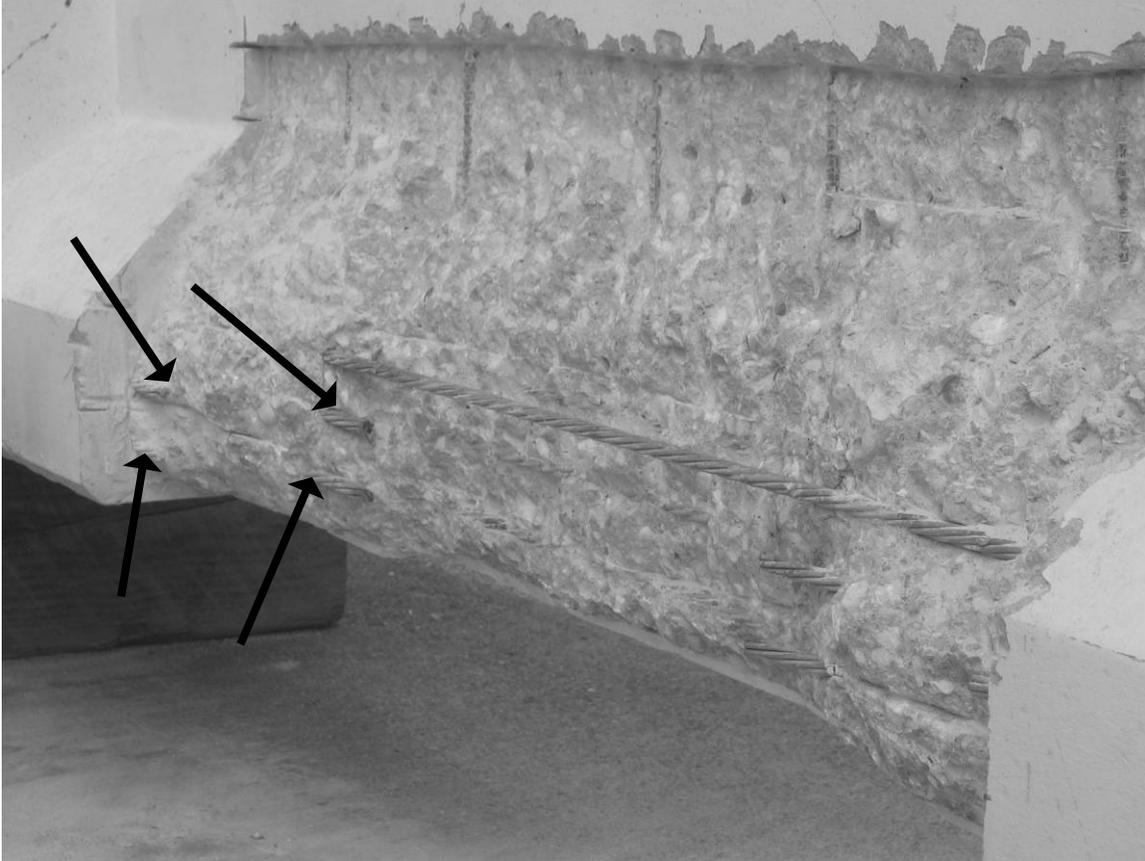
In order to simulate impact damage, a large portion of the tension flange of the girder was removed, and four prestressing strands were ruptured (Figure 3.16), corresponding to a reduction in prestressing force of 14.3 percent. The length of the damage began 1 ft (305 mm) past the face of the left support and extended 4 ft (1.22 m) to the right. A total of approximately 1.5 ft³ (0.04 m³) of concrete was removed, as shown in Figure 3.16.

Figure 3.16 AASHTO2R after completion of simulated damage

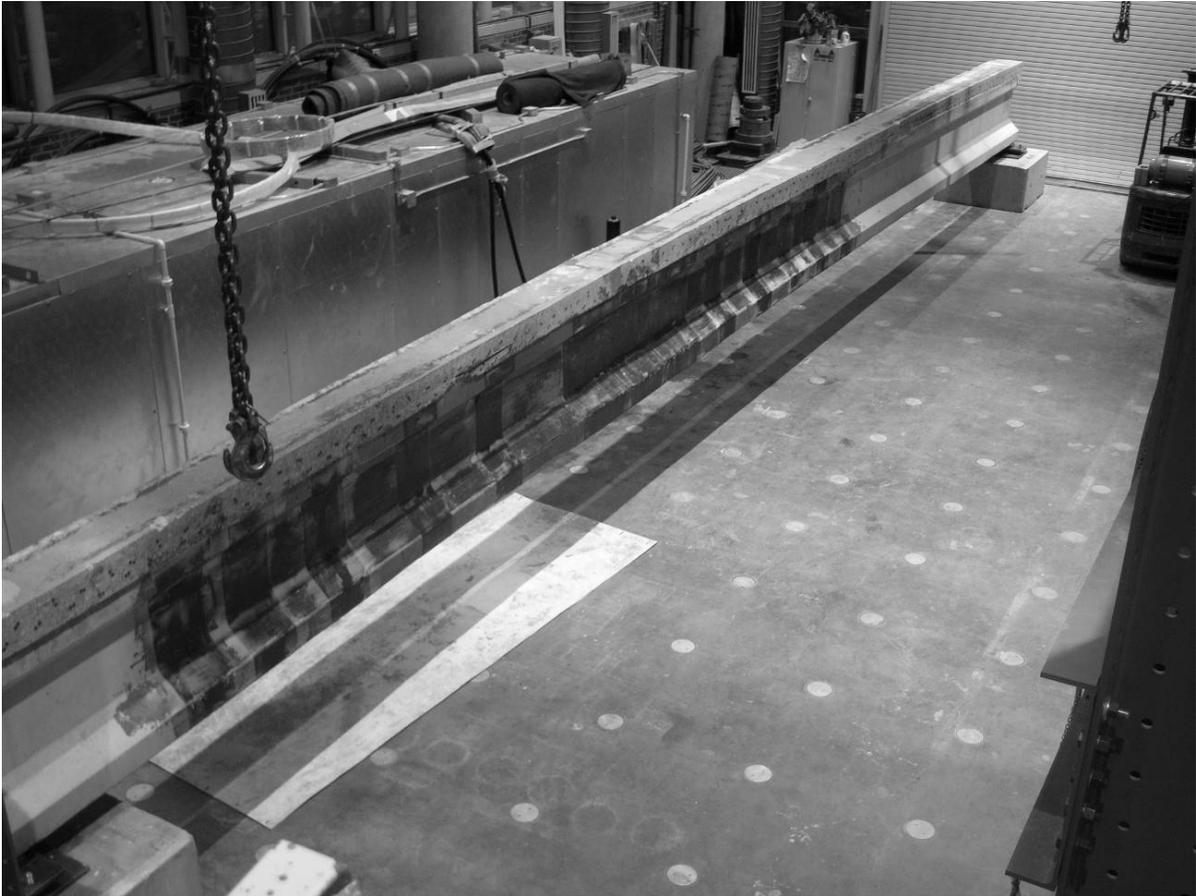
Figure 3.23 CFRP repaired AASHTO1 girder

The completed installation of the CFRP system for AASHTO1 is shown in Figure 3.23.

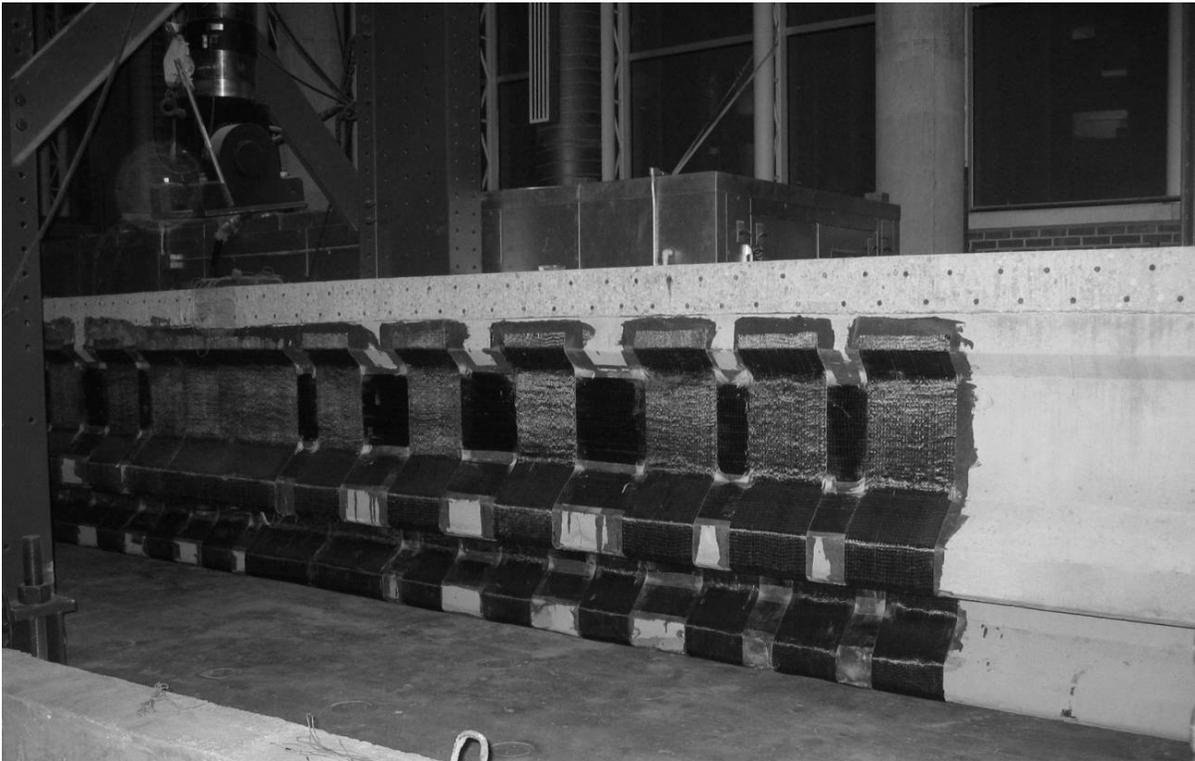
Figure 3.24 CFRP repaired AASHTO2 girder

The completed installation of the CFRP system for AASHTO2 is shown in Figure 3.24.

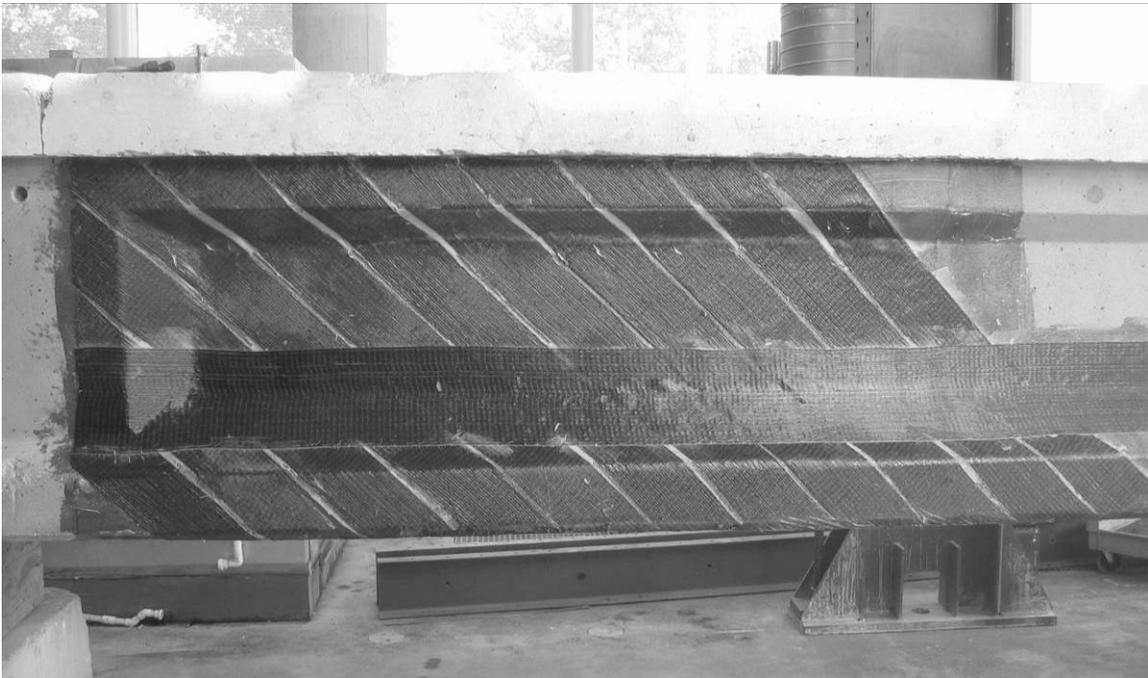
Figure 3.26 CFRP repaired AASHTO2R girder

The completed installation of the CFRP repair system for AASHTO2R is shown in Figure 3.26.

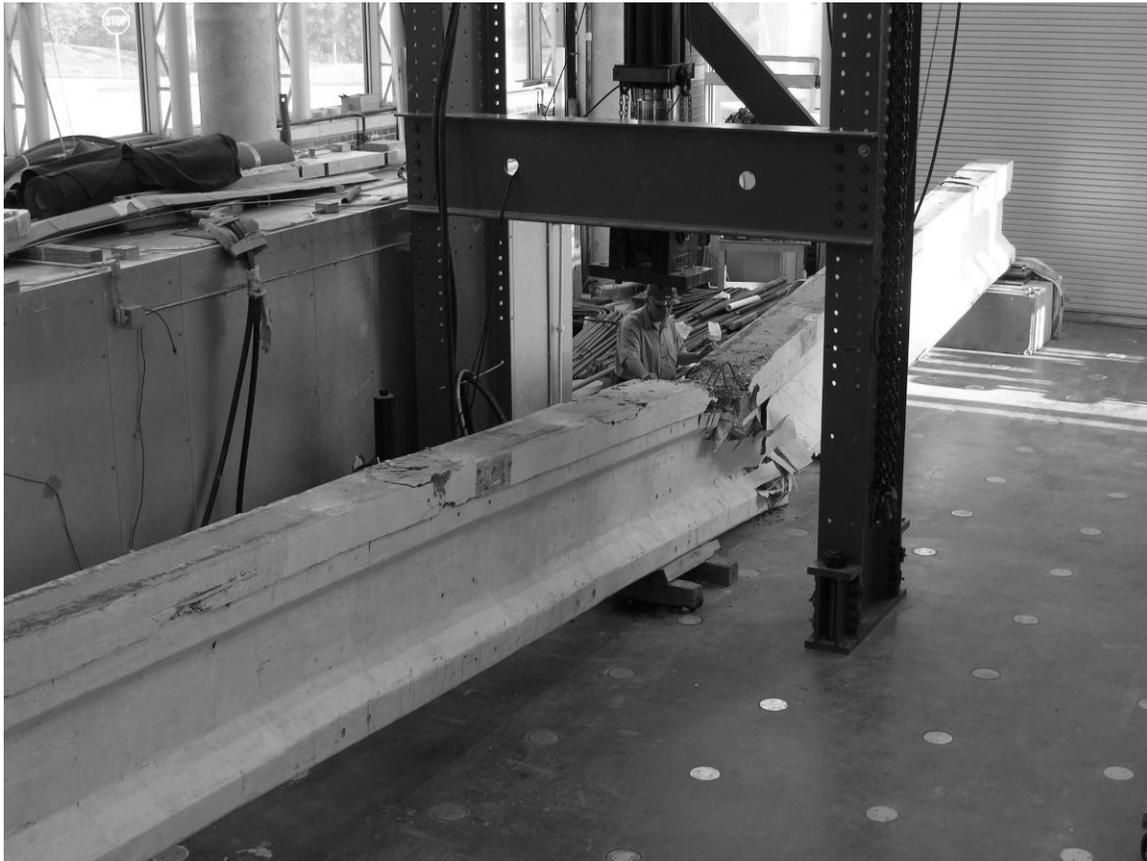
(147 mm). After the maximum load was achieved, a sudden drop of 2.0 k (8.9 kN) occurred. The load rate was then increased to 0.2 in/min (5.1 mm/min) until at a displacement of 6.17 in (157 mm) a large flexural-shear crack suddenly extended from the right termination point of the longitudinal CFRP to the concrete crushing zone near the loading plate. This flexural-shear crack caused catastrophic failure, as shown in Figure 3.38. Complete test results are presented in Chapter 4.

Figure 3.38 AASHTO1 girder after failure

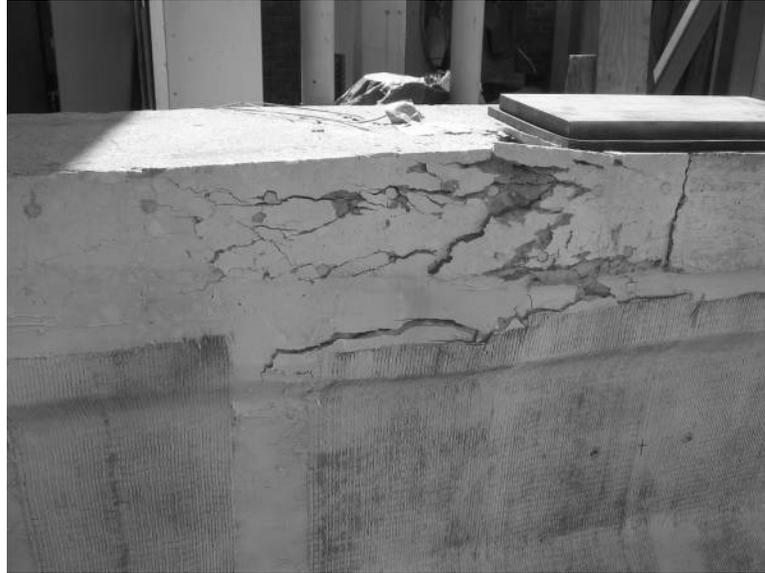
concrete crushing occurred at the left edge of the loading plate on the side with the simulated damaged at a load of 125 k (556 kN). Loading continued until the girder noticeably shifted approximately 1.0 in (25.4 mm) out-of-plane towards the damaged side. The maximum load achieved was 135 k (601 kN) with a midspan deflection of 4.77 in (121 mm). The concrete crushing failure is shown in Figure 3.39. Complete test results are presented in Chapter 4.

Figure 3.39 AASHTO2 girder localized concrete crushing

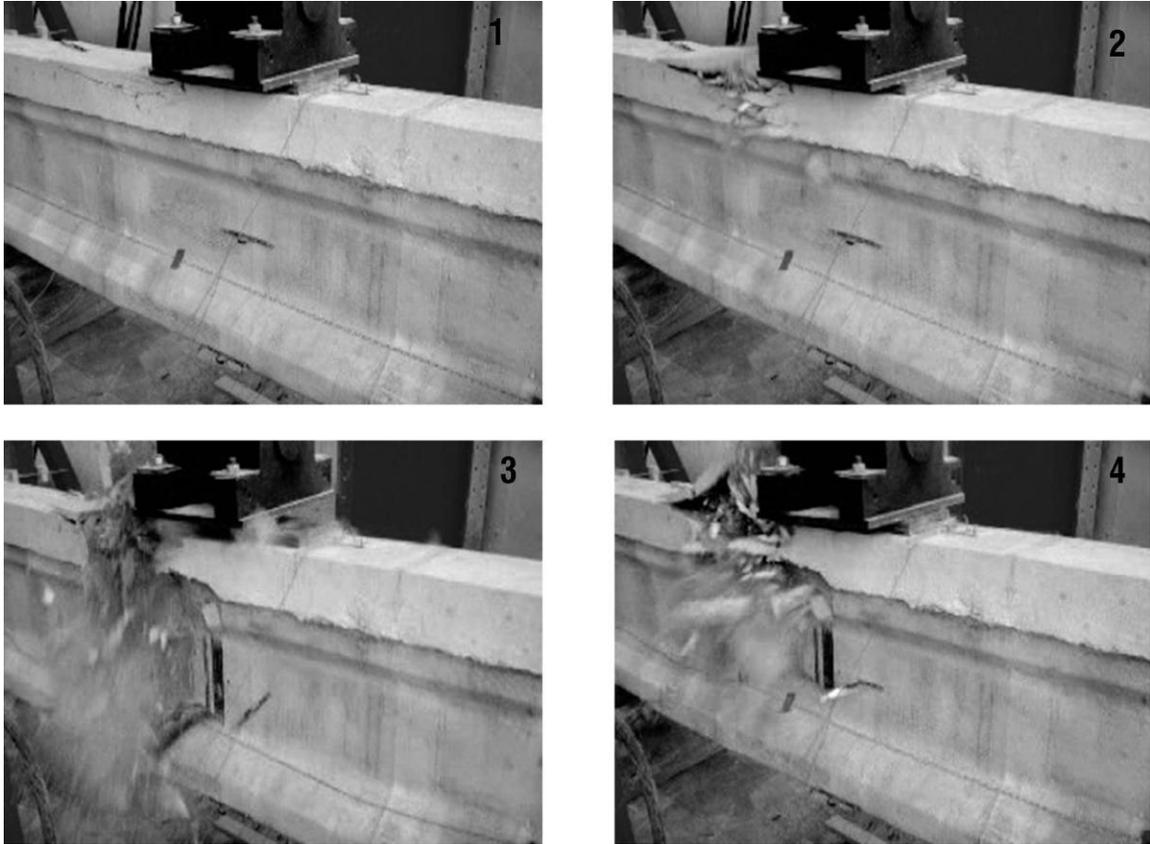
The final static test of AASHTO3 was performed monotonically to failure in two cycles at a load rate of 0.1 in/min (2.5 mm/min). The first visible crack appeared between two CFRP U-wraps just to the right of the fully encapsulated area; at a load of 65.0 k (289 kN). The first cycle continued to load the specimen to 84.3 k (375 kN) where cracking was heard beneath the CFRP but was not visible. The girder was unloaded and reloaded to a maximum load of 145.5 k (647 kN) and a midspan deflection of 5.41 in (137 mm). Failure of the girder was caused by crushing of the concrete beneath the left side of the load plate at 144.7 k (644 kN), followed later by catastrophic failure as a flexural crack extended into the deck, splitting the member in two. Figure 3.40 shows the progressive failure of the AASHTO3 girder, and Figure 3.41 shows catastrophic failure of AASHTO3.

Figure 3.40 Progressive failure of AASHTO3 girder

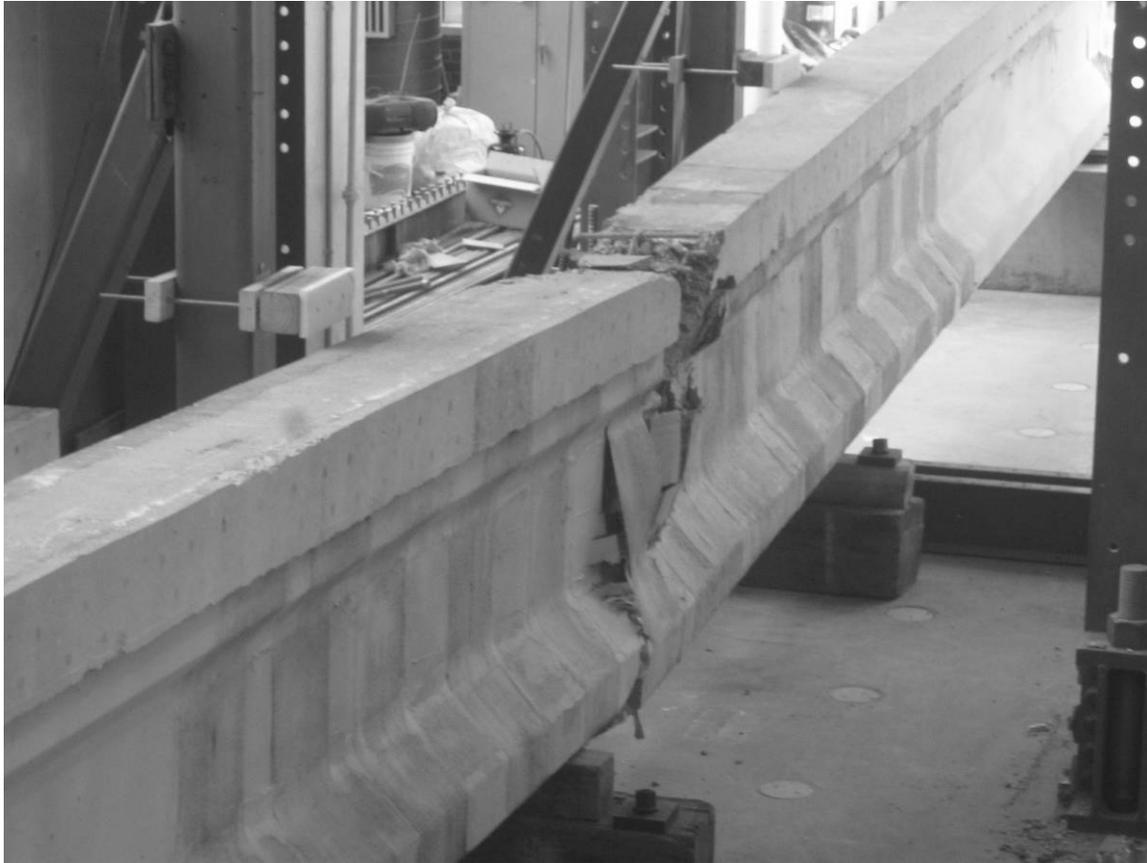
Figure 3.41 AASHTO3girder after failure

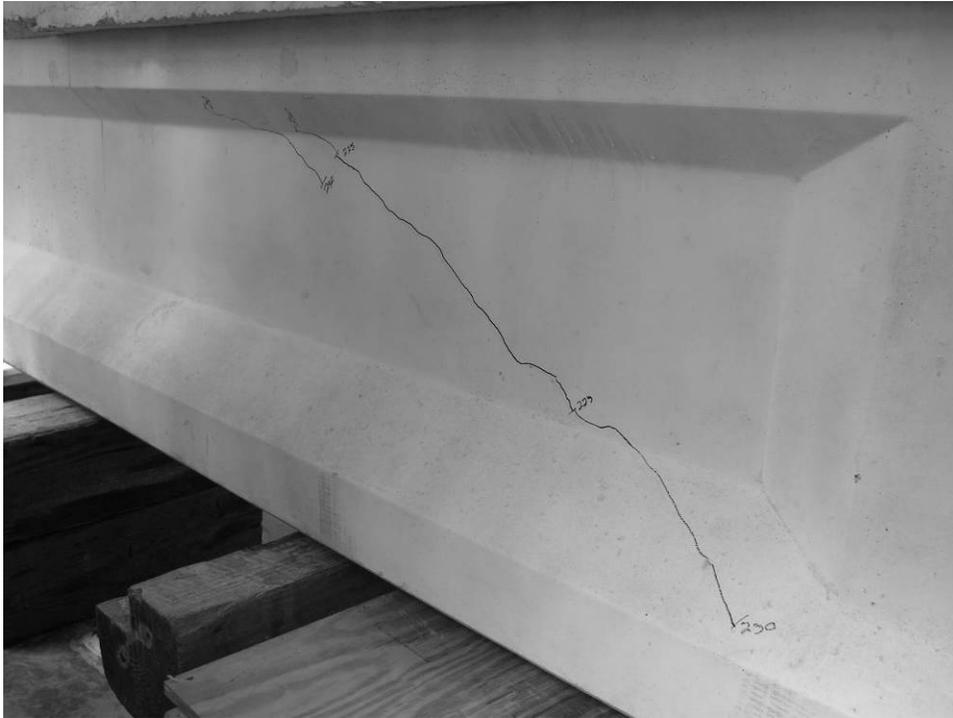
in Figure 3.42, while the catastrophic web shear failure is shown in Figure 3.43. Complete test results are presented in Chapter 4.

Figure 3.42 Initial shear cracks in AASHTO2C girder (back side)

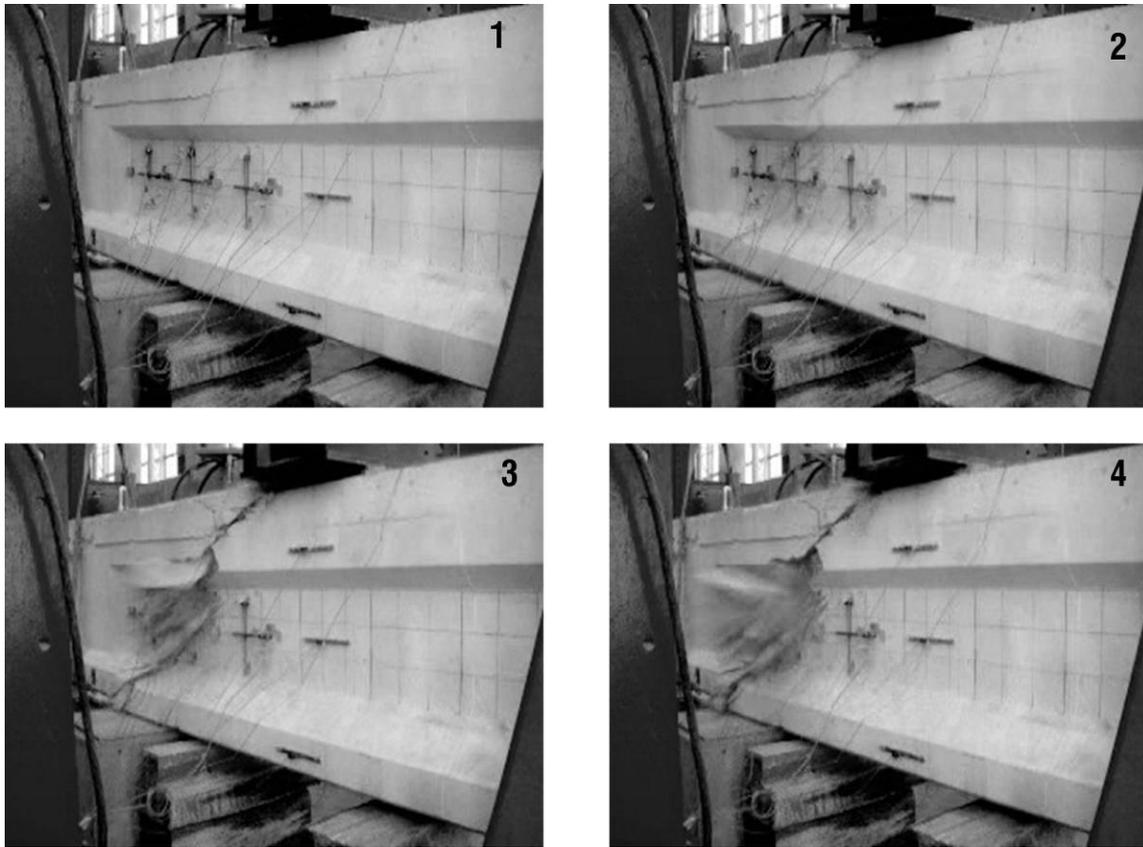
Figure 3.43 Progressive failure of AASHTO2C girder (front side)

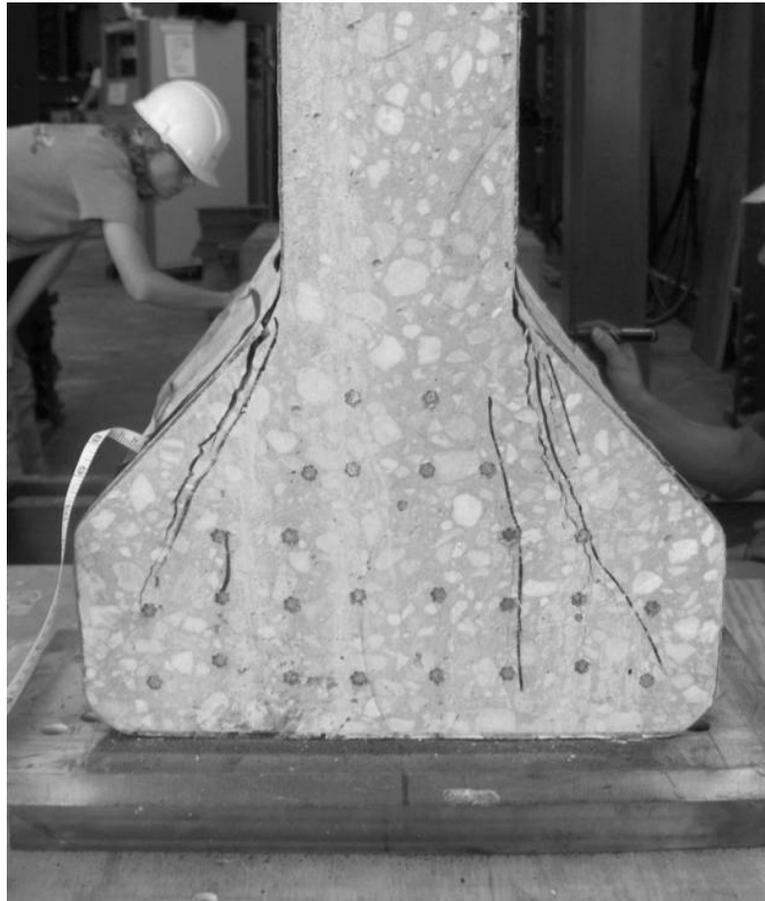
propagating through the right, undamaged, side of the specimen from the load point to the support. Plate end debonding at the right termination point of the bottom longitudinal CFRP also occurred in this same region. The flexural-shear failure is shown in Figure 3.45. It should be noted that the transverse CFRP sheets that are visibly debonded were not part of the shear study, but were left over from the flexural repair of the specimen. Complete test results are presented in Chapter 4.

Figure 3.44 Failure in transfer zone of girder AASHTO2R

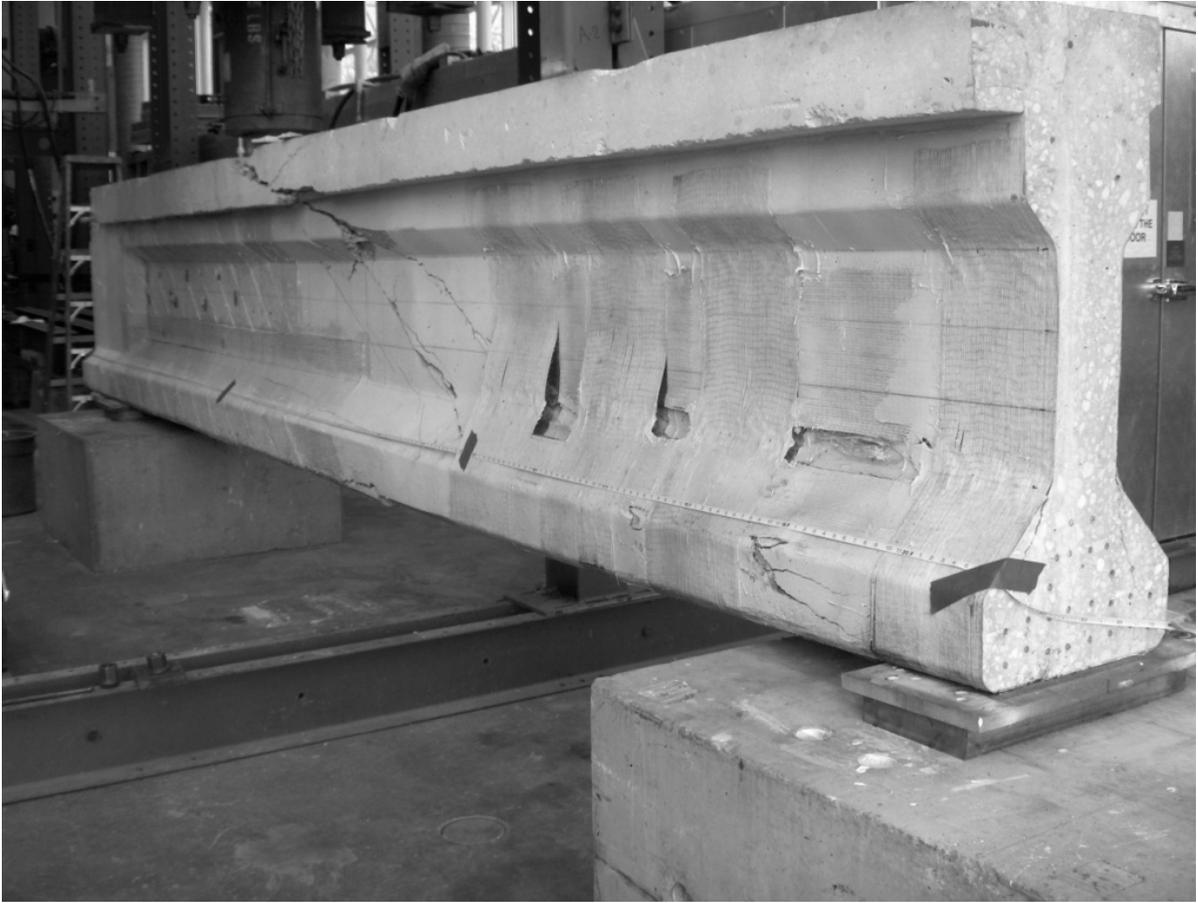
Figure 3.45 Failure of AASHTO2R girder (front side)
