Fatigue and Failure Behaviour of a Mechanically Loaded Ferritic Pipe Bend in High Temperature Water With Elevated Oxygen Content

K. KUSSMAUL, H. DIEM, D. UHLMANN
University of Stuttgart, Stuttgart, FRG

The trial delineated relates to cracks with an axial orientation at a pipe bend of DN 425 nominal width.

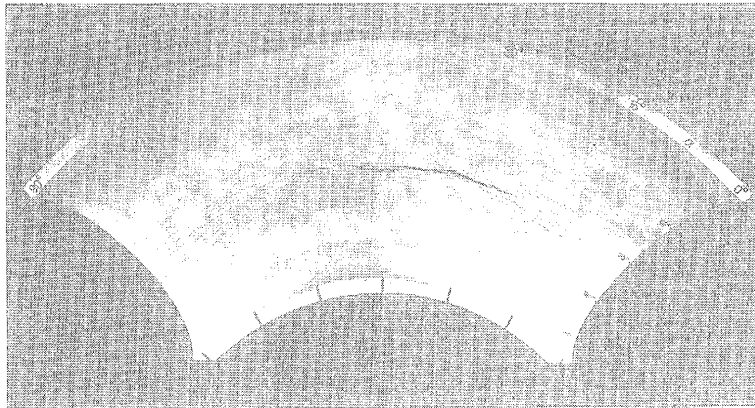
Following the termination of the experiment, the pipe bend damaged by a longitudinal through-crack at the bend half-shell 0° - 90° - 180° , Figure 4, was cut off and subjected to metallographic and fractographic examination at MPA Stuttgart. An examination of the bend inner surface using magnetic particle showed pronounced crack fields on both flanks. The macroscopic crack length at the leak point was 235 mm on the external side, and approx. 640 mm on the inner side. Transverse microsections from the bend flank yielded 103 to 298 single cracks with an assumed threshold of evaluation of $a = 0,1$ mm, Figure 5.

Fig. 4: Multiple crack field, Bend shell 0° - 90° - 180°

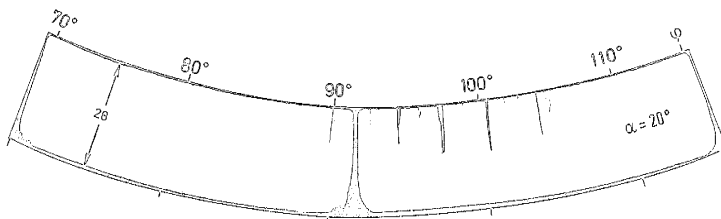
Fig. 5: Multiple crack field at position $\alpha=20^{\circ}$
