THE FAILURE ROOT CAUSE ANALYSIS OF RECIRCULATING SENSING LINE IN TAIWAN CHINSHAN NUCLEAR POWER PLANT

K. Ting

Atomic Energy Council, Taipei, Taiwan, R.O.C. and Institute of Nuclear Energy Research, Lung-Tan, Taiwan, R.O.C.

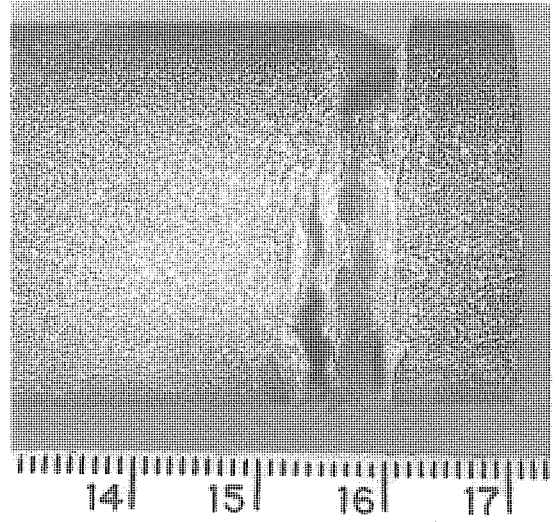
All the recirculating lines including risers were replaced by the new pipe material to prevent the stress corrosion cracking during 1989. But the sensing lines were still unchanged. For Unit 2, the increased leakage flow was detected in March 1991. A circumferential through-wall-crack between the matrix and

the weld of N2E sensing line was found by the penetrant test after the shutdown, as shown in Fig.4.

- (1) The reactor had been shutdown before the leakage occurred.
- (2) The failed sensing line was U-type line.
- (3) The crack location was the supported points of vertical bending near the weldolet.

Fig.4 Crack in N2E sensing line

(i) The opening of F017 valve must be larger than 15% and two pumps of RHR system will be operated during shutdown period.

(ii) The PT examinations must be conducted during the outage period.

The spherical valve F017 can be replaced to the drag valve.

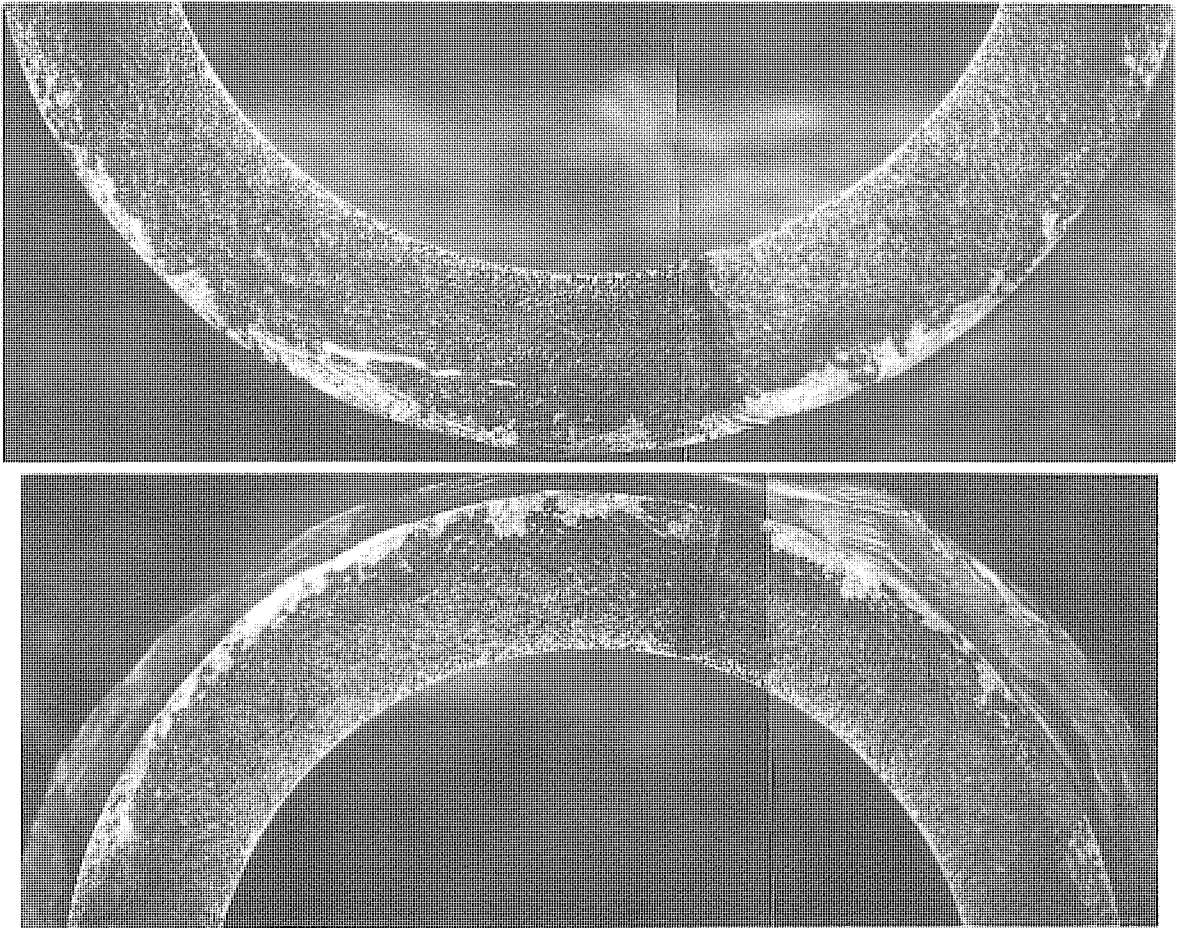
The fractographic examinations of failed sensing line had been conducted[1]. Fig.5 shows the cross section of the fracture surface and there was no evidence of the plastic deformation to be found. Fig.6 displays the SEM examinations at the localization of the fracture surface. The slip line was discovered near the outer surface which the crack was initiated by the over-stress loading. As following, the fatigue striation was also observed due to high cycle fatigue. Based on the fractographic examinations of failed sensing line, the phenomena can be concluded as following:

- (1) The locations of failure were always at the bottom of the fracture cross section near the weldolet. In that region, there existed a notch effect to induce the stress concentration.
- (2) The fracture process could be divided into two steps:
 - (i) the crack was initiated by the high-rate loading,
 - (ii) the crack was then propagated by the high-cycle fatigue.
- (3) The material properties are still unchanged during the welding process.

Fig.5 Fracture surface of N2E sensing line

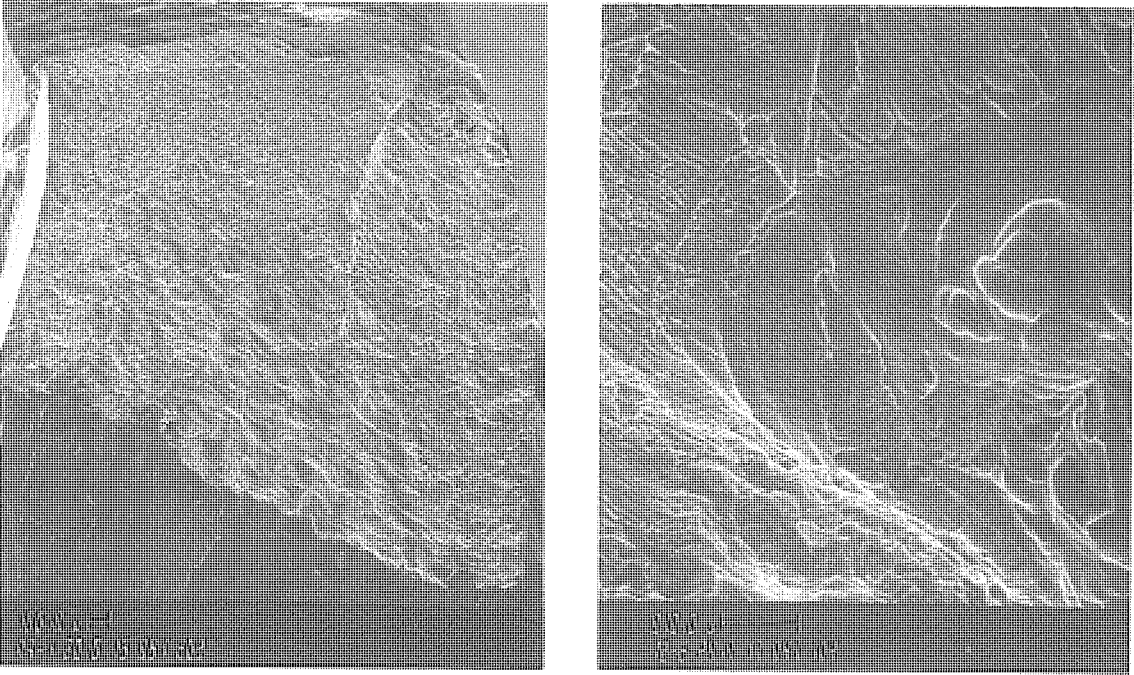
Fig.6 SEM examinations of N2E sensing line

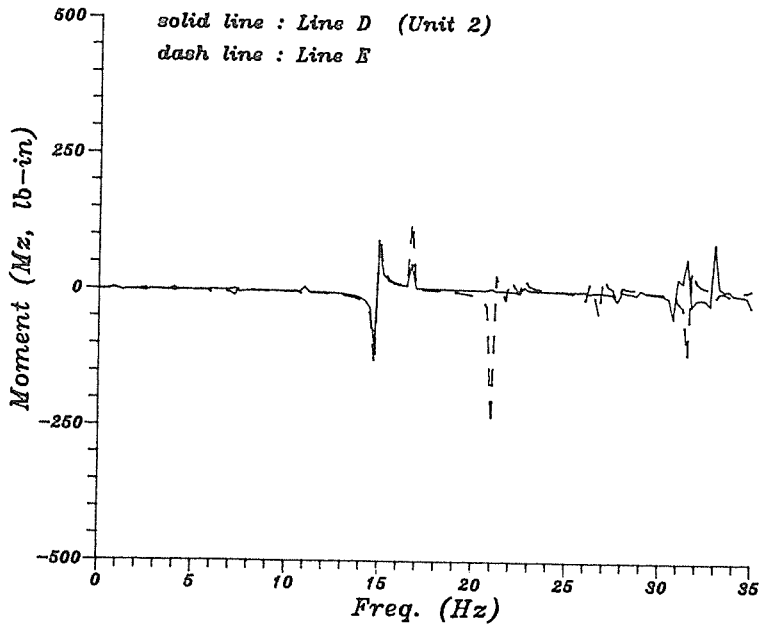
The ANSYS finite element package[3] is also employed in this root cause analysis to realize the dynamic response of the sensing line. The harmonic motions including various frequencies are applied to the risers. Fig.7 shows the vertical bending moments of N2D and N2E sensing lines versus the various frequencies. Both of two sensing lines have the peak response at 17Hz which can be excited by the pump operation of RHR system. The response of N2E sensing line is higher than that of N2D sensing line. Therefore, the N2E sensing line failed other than of N2D one. Fig.8 displays the response of N2C sensing line. There is no 17N Hz frequencies which can be excited by the RHR pump. Thus, the reason why only the N2E sensing line failed is proven. In Fig.7, the other one peak response is also found at 21Hz which can be excited by the operation of the recirculating pump during the normal operation (1200 rpm \sim 1300 rpm, i.e. 20 \sim 22 Hz). This vibration will induce the crack growth of high cycle fatigue.

Fig.7 Vertical moments versus frequencies for N2D and N2E sensing lines
