Cladding Breaches in a Fast Reactor Mixed-Oxide Fuel Assembly

U.P. Nayak, P.J. Levine, A. Boltax

Summary

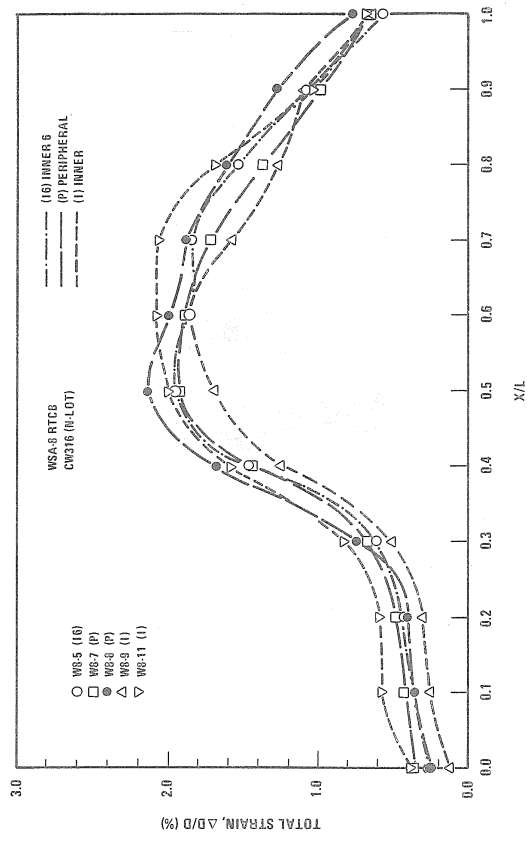
Diametral strain profiles are illustrated in Figures 2 and 3 for the AISI 316 and titanium-modified AISI 316 claddings, respectively. The AISI 316-clad fuel pins showed a single peak in the strain profile, $\sim 2\% \Delta D/D$, slightly above the core midplane. The strain profile was not affected by the RTCB operation. The titanium-modified AISI 316-clad fuel pins showed a low temperature peak, $\sim 2\% \Delta D/D$ at an X/L of 0.2 to 0.4, and a high temperature peak at an X/L of 0.9. Prior to RTCB operation, only the interior fuel pins, which operated at a slightly higher temperature than the peripheral pins, exhibited a small second peak. After the RTCB operation most of the pins showed the second peak, the magnitude being approximately proportional to the temperature. The two breached pins showed much larger hot end diametral strains.

FIGURE 2. Diametral Strain Profiles of MSA-8 RTCB Fuel Pins with AISI Type 316 (N-Lot) Cladding

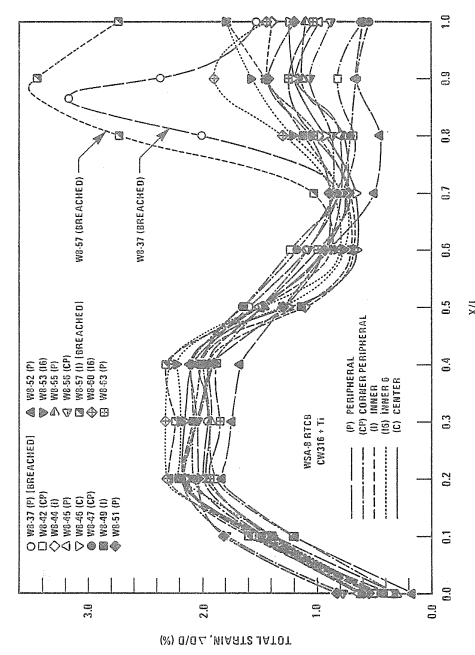
Comparison of the cladding strain behavior of the 316 and titanium-modified 316 (Figures 2, 3 and 4) indicates a greater sensitivity of the modified alloy to the cladding temperature increase during RTCB operation. This sensitivity is believed to be related to the differences in composition of the two alloys, particularly the titanium and silicon as shown in Table 2. The breached pins exhibited the greatest dimensional instability which is consistent with the conclusion that they experienced a local hot spot.

FIGURE 3. Diametral Strain Profiles of MSA-8 RTCB Fuel Pins with Titanium-Modified AISI Type 316 Cladding

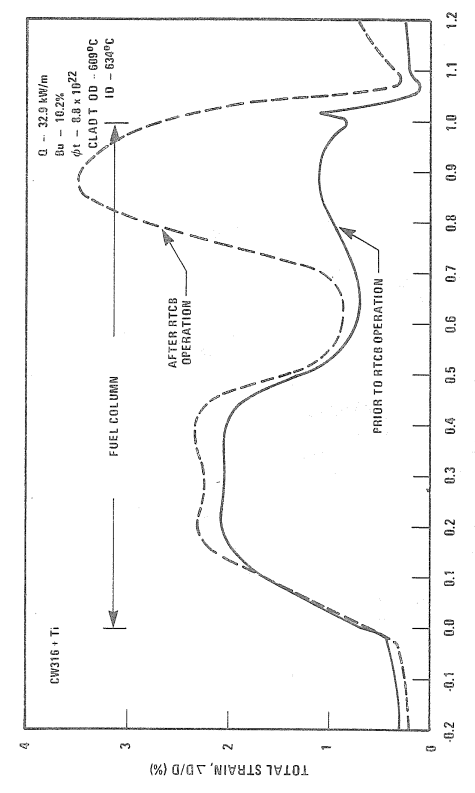
A comparison of the post-breach and interim diametral strain profiles of pin W8-57, illustrated in Figure 4, revealed that the peak strain at the hot end increased from 1.1% $\Delta D/D$ at the interim to 3.6% $\Delta D/D$ after the RTCB operation. The additional strain occurred in 239 effective full power hours. A similar comparison for a comparable AISI 316-clad pin showed little change in diametral strain.

FIGURE 4. Diametral Strain Profiles of Pin W8-57

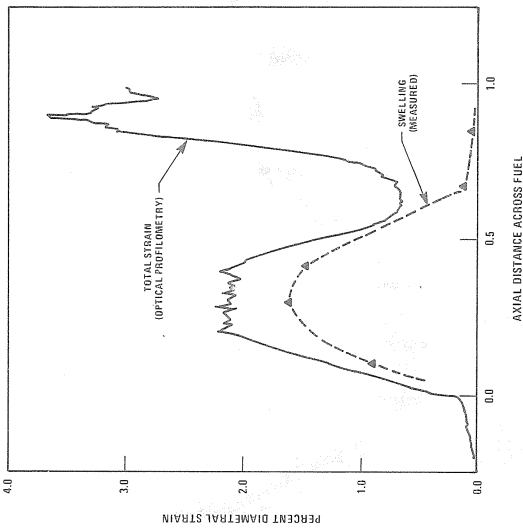
Peak swelling of 4.9% $\Delta V/V_0$ at an X/L of 0.3 was determined from immersion density measurements on the W8-57 pin. In the breached region, the measured swelling was less than 0.25% $\Delta V/V_0$, indicating that the large strain was not caused by enhanced swelling of the

cladding. Comparative total strain and swelling profiles for pin W8-57 are illustrated in Figure 5.

FIGURE 5. Total and Swelling Strains of Pin W8-57

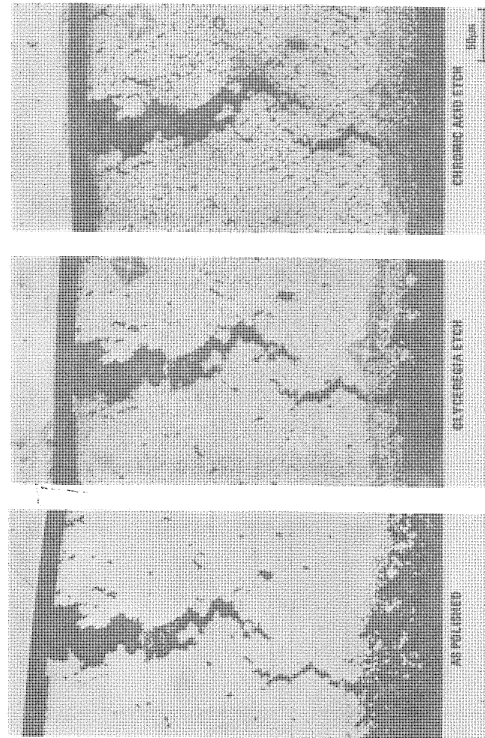
Microstructural examination of fuel and cladding indicated that breach occurred ~40 mm below the top of the fuel column in pins W8-37 and -57. The breaches had the characteristics of a high-temperature creep rupture. Figure 6 shows a transverse cross section at the breach region of pin W8-57. The as-polished and etched cladding structures are illustrated in Figure 7. The as-polished cladding shows the breach and associated creep voids. The etched structures showed a considerable amount of second phase precipitation, indicating that high temperatures were experienced during operation. Cladding structures diametrically opposite the breach showed less second phase precipitation, indicating lower temperatures than the breach region during irradiation. Figure 8 shows cladding structures at two different azimuthal orientations in the same axial section of pin W8-37.

The cladding structures did not show any evidence of recrystallization. Microhardness values near the breach ranged from 200 to 212 DPH compared to values of 260 DPH in a diametrically opposite region. Cladding thickness measurements on transverse sections revealed localized thinning, ~20% of the original thickness, in the vicinity of the breaches.

FIGURE 7. Cladding Structure at the Breach in Pin W8-57

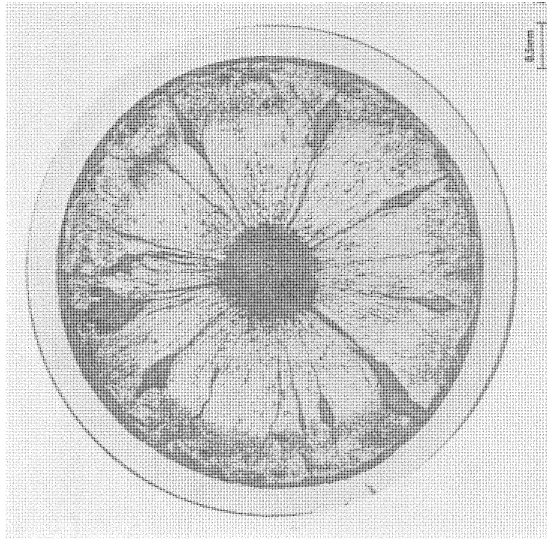
FIGURE 6. Transverse Section From Pin W8-57 at the Breached Region (X/L=0.89)

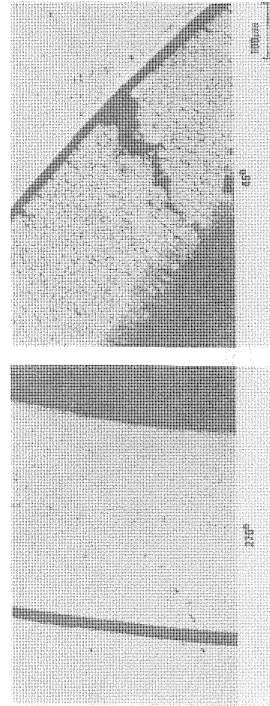
FIGURE 8. Cladding Structures at Breached Section in Pin W8-37 (Chromic Acid Etch)
