## Safety Review on Recent Steam Generator Tube Failure in Korea and Lessons Learned

Youn Won Park and Jin Ho Lee  
Korea Institute of Nuclear Safety, Taejon, Korea

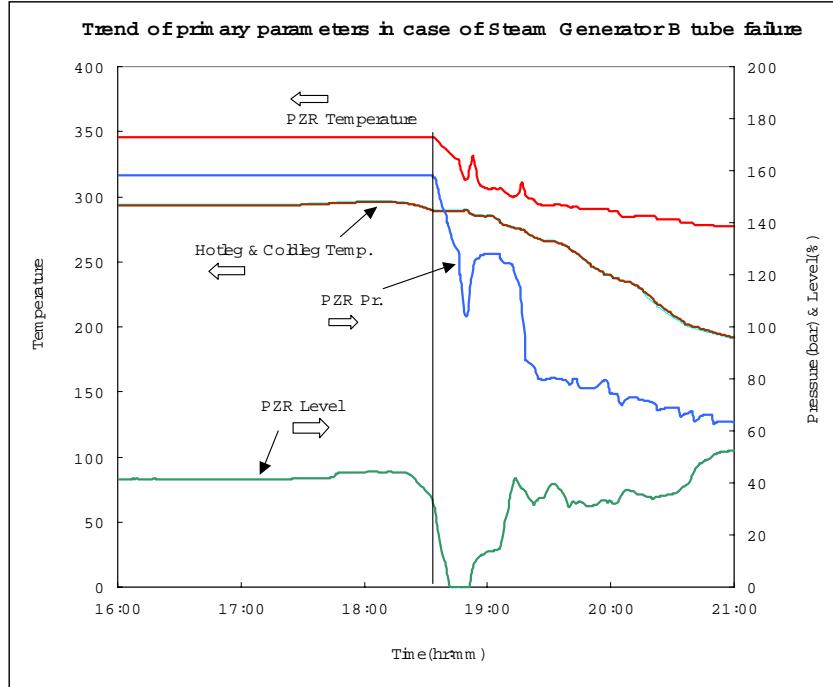
The Fig. 1 shows trends of principal parameters of primary system, such as pressurizer level, primary pressure and temperature. At about 7 hours, the shut down cooling system (residual heat removal system) was in service and finally at 13:25 hours on April 6, the reactor arrived at cold shutdown condition of reactor coolant system temperature of 99°C and pressurizer pressure of 27kg/cm<sup>2</sup>. As shown in Fig. 1 and 2, there was no significant excursion in primary to secondary pressure.

Fig. 1 Principal parameters of reactor coolant system of the Ulchin unit 4 during steam generator tube failure event of April 5, 2002.

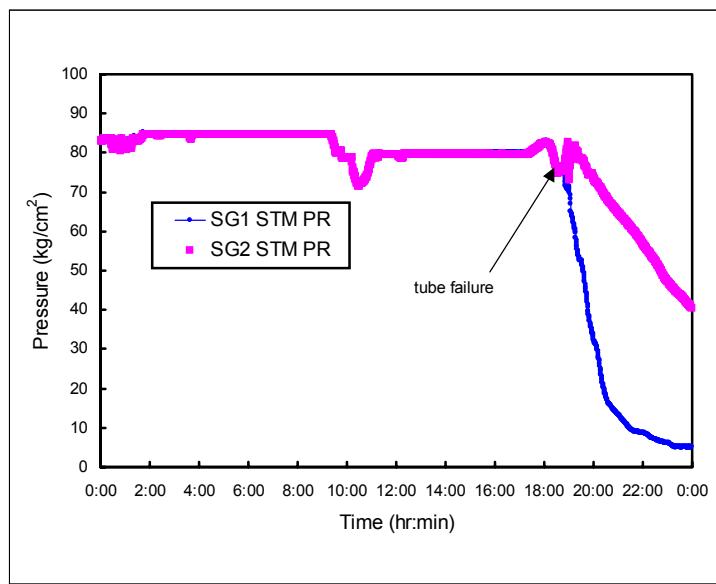
Fig. 2 Steam generator secondary side pressure during Ulchin Unit 4 steam generator tube failure event of April 5, 2002.

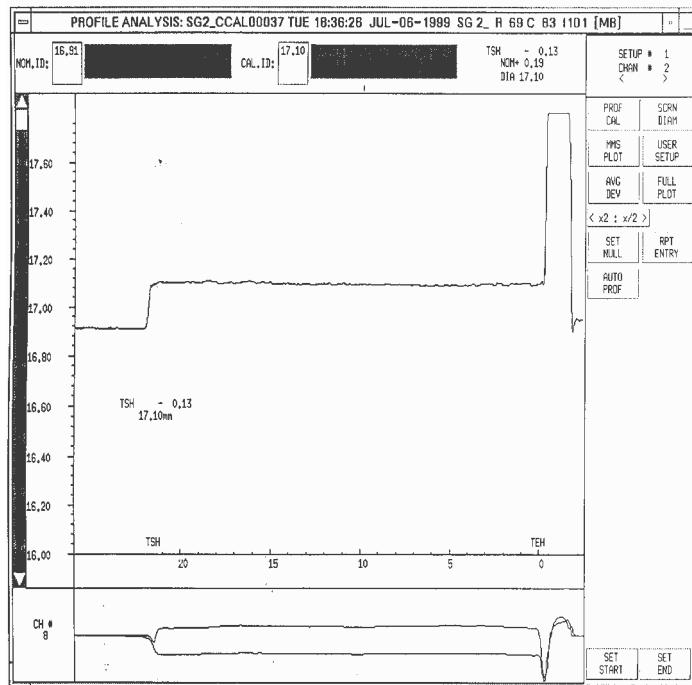
(a) Profilometry of sane tube

Fig. 4 Profilometry of sane tube and failed tube

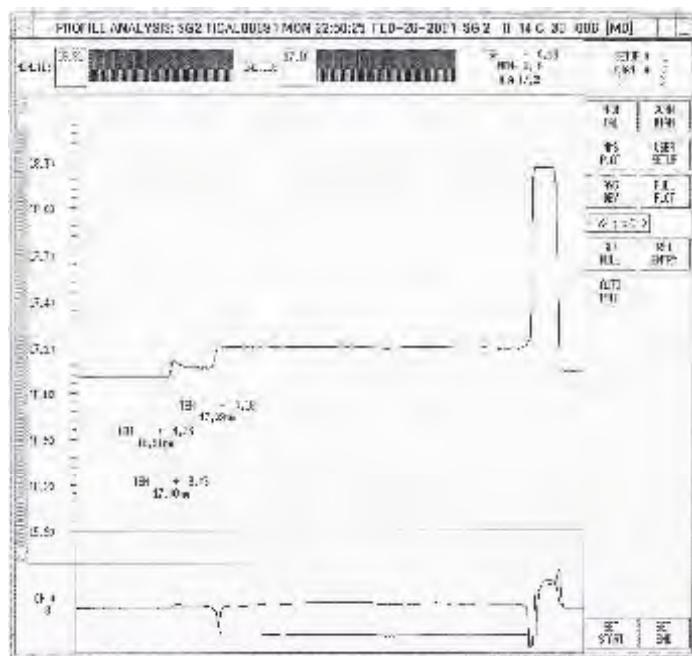
In order to investigate whether the failure is tube specific problem or generic one, the KHNTP performed extensive inspections on all the tubes of UCN 4 steam generator and found that the characteristics of the failed tube were pertaining to the longitudinal SCC cracks initially developed in bulge section. The KHNTP also found that such characteristics could be identified in the profile of failed tube which had an intermediate overexpansion as shown in Fig. 4 (b). The failed tube was removed from the B steam generator for detailed examination. The interim conclusion from examination on the removed tube is that the stress corrosion cracking begins to develop at the bulged section in the longitudinal direction and propagated at a growth rate high enough to penetrate the tube wall in three years of operation.

(b) Profilometry of failed tube

Just after this event, the regulatory body set up a task force team to prepare extensive measures to improve the integrity of steam generator tubes. Since the failure cause resulted from the bulge that was probably made during manufacturing process, the eddy current examination is to be introduced from the fabrication stage. Once a steam generator is put into service, the inservice inspection is the most effective way to prevent the steam generator tube failure so that the regulatory body requires the augmented inspection on all the steam generators tubes in service in Korea. For example, at the upcoming overhaul period, every steam generator will be subject to the inspections: ECT on 100% of tubes with bobbin probe, and 100% of hot leg tubes and 20% of cold leg tubes with MRPC probe, and on 100% of tubes with profilometry.
