Corrosion Degradation of Steam Generators in Korea

Seong Sik Hwang, Hong Pyo Kim, Joung Soo Kim

Korea Atomic Energy Research Institute
Yuseong Gu, Deokjin Dong 150,
Daejeon, 305-353, KOREA

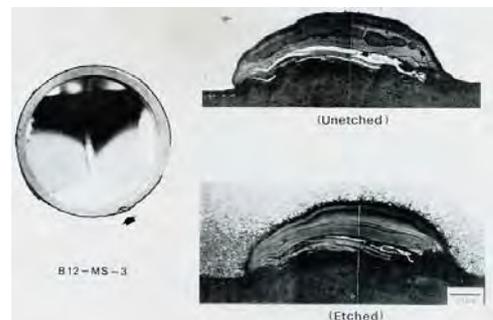
Radiography and optical microscope photos showed that pits were formed around the top of the tubesheet (TTS) on the secondary side of the tubes. Maximum penetration depth was 94 % of the tube wall (TW) on a tube of SG B. Fig. 1 is one of the tubes having pitting in plant A. Besides the main alloying elements (nickel, chromium and iron), other impurities such as oxygen, aluminum, silicon, sulfur, calcium, titanium and copper, were detected inside the pit. The band type precipitates were formed at the mouth of the pit, and were mainly composed of copper. The condenser tube material of the plant was copper alloy before it was replaced with titanium alloy in 1988; hence the condenser tubes were considered to be the main source of copper in the pit. Metallic copper and a little copper oxide (Cu_2O) were detected in the hard scale and sludge collected from the tube surface. Iron in the form of magnetite (Fe_3O_4), and metallic nickel were also detected in the sludge. Other relevant information is that occasional condenser leakage had been reported, and hideout return tests showed that the Cl^- concentration in the crevices had been up to $10^3 \sim 10^4$ times higher than in the secondary bulk water. This implies that Cl^- from seawater had been introduced into the secondary side of the SG.

Acceleration factors of the pitting were Cl^- , sulphate, dissolved oxygen, sludge. A Cl^- induced acidic environment in the crevices and oxides like Cu_2O increase corrosion potential of materials in the reducing environment of the secondary water

Fig.1 Cu band inside the pit of SG tube from plant A

Following these analyses, some countermeasures were suggested as follows: (1) suppression of impurities from condenser leaks such as Cl^- , sulphate, (2) reduction of dissolved oxygen, (3) deposit removal using chemical cleaning or sludge lancing, (4) installation of a water chemistry control program.

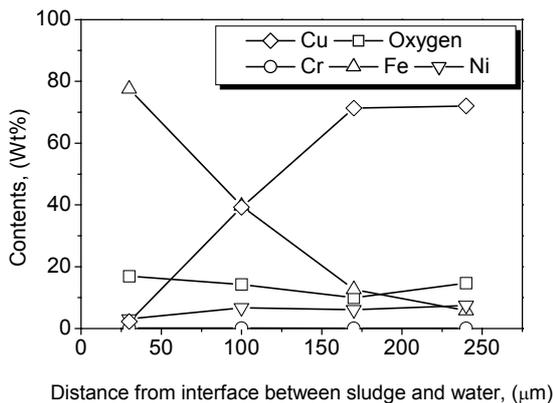
Another analysis on the pits of plant A was carried out in 1992. A pit of 44 % of TW was found with IGSCC inside the pit formed on the outer surface of the tube. Corrosion products in the pit contained silicon, nickel, aluminum, barium, iron, lead and sulfur, etc. Metallic copper was detected on the outer surface of the tube. Copper and iron were the main elements in the sludge collected from around the tube. Lanced sludge had 22 % copper and 50 % iron, and hard scale, around the pulled tubes, was found to contain 46% copper and 28% iron. The composition of the hard scale of another sampled area is shown in Fig. 2 [3]. The copper concentration at the tube surface was about 80%. This shows that the chemical cleaning solution employed did not remove this scale, totally, and considerable amounts of copper still remained on the outer tube surface.

Fig. 2 Analysis of scale collected from plant A

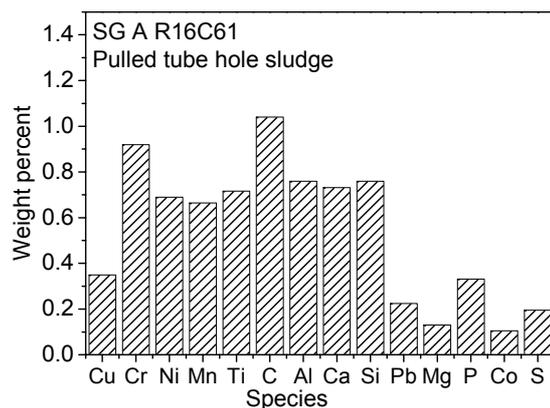
Fig. 3 major constituents in sludge collected from plant B

Aluminum, silicon, sulfur and chloride ions were detected at the surface of the tube; the sulfur seemed to come from organic compounds such as ion exchange resins. Lead was also detected in the sludge, and its maximum concentration on one specimen was 5.55%. A lead peak was also shown at the crack tip by EDX analysis as shown in Fig. 3. A total lead content of 2250 ppm was detected in the sludge collected from one of the extracted tubes. Silicon and lead were even detected on the fractured surface. The deposit was mainly composed of nimate, magnetite and nickel oxide (NiO) as shown in Table 1[4]. The nimate is a mineral chlorite, which is soluble in acidic water. Thus the fact that nimate was detected in the sludge means that the crevice between the tube and the sludge was alkaline. ESCA revealed that the copper was a form of copper oxide (Cu₂O), and the nickel was a form of nickel oxide (NiO). Metallic iron was also found around the dented tube. (Table 1)

Countermeasures suggested to reduce the threat of cracking were sludge removal using sludge lancing, pressure pulse cleaning, and suppression of impurities ingress such as oxygen and ionic impurities. An examination of the role of lead on stress corrosion cracking (PbSCC) of alloy 600 was proposed.

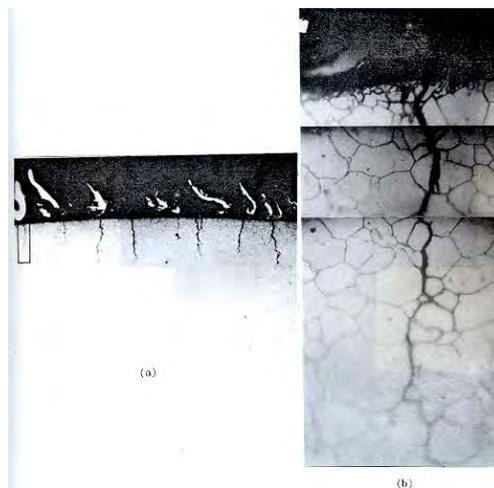
The types of defect detected in plant B were a mixture of denting, PWSCC and ODSCC. In the case of ODSCC, the cracks were aligned in the tube axial direction, and penetrated 23 % of the TW. An inner diameter circumferential PWSCC crack penetrated 14 % of the TW. As indicated before, 2250 ppm lead was detected in the sludge around the failed tube, and the crack propagated with a transgranular mode as shown in Fig. 4. This kind of transgranular stress corrosion cracking (TGSCC) has been reported in other plants such as St. Lucie-1, Calvert Cliffs-1, Farley-2, where lead was considered as the root cause of cracking[5]. Therefore the TGSCC in plant B was also concluded to be related with lead pollution.

Fig. 4 TGSCC detected in plant B

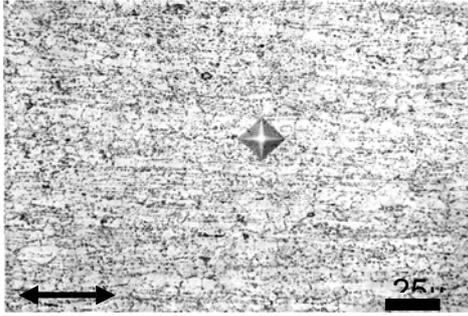
The alloy 600 tubes of unit C were mill annealed for 2 minutes at 960 °C-1000 °C, and thermally treated for 12 hours at 700 °C-730 °C to develop carbides at the grain boundaries. However, the microstructural analysis showed that many carbides were inside the grains rather than at the grain boundaries, as shown in Fig. 5. This microstructure has been

Fig. 5 Intragranular carbide of the tube(plant C)

classified as type II or type III as suggested by EdF[11], which are rather susceptible to PWSCC. The carbide microstructure seemed to be related with too high a carbon content (0.035%) to show any beneficial effect of the 700 °C thermal treatment. That is to say, the mill anneal temperature was too low to dissolve the total carbon into the solid solution prior to the thermal treatment.

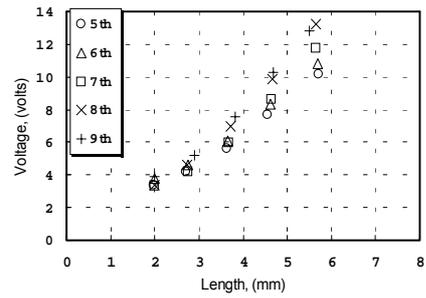
Fig. 7 Crack length saturated around 6 mm in plant C

Average crack length and EC voltage variations from whole defective tubes in each ISI are presented in Fig. 7. The crack length was about 4 mm at the 4th ISI, and it increased to 7 mm at the 7th ISI, but it did not increase very much afterwards until the 9th ISI. EC voltage, which is closely related to crack opening and depth, developed steadily from 6 volts at the 4th ISI to 15 volts at the 9th ISI. It was known that crack length tended to saturate around 6 mm regardless of which tube was examined. However, the depth increased continuously, and the crack mouth became wider every year as indicated in Fig. 7. Thus shot peening had a good influence on the suppression of crack length, but it was not so beneficial on the prevention of crack deepening.

The main cause of the PWSCC in plant C was a susceptible microstructure. Consequently, the recommendations suggested after this analysis were as follows: Tubes having large increases in EC voltage should be repaired. Detailed inspection was required of the PWSCC sensitive regions depending on the particular steam generator. An allowable leak rate limit of 10 l/min for plant C was also recommended.

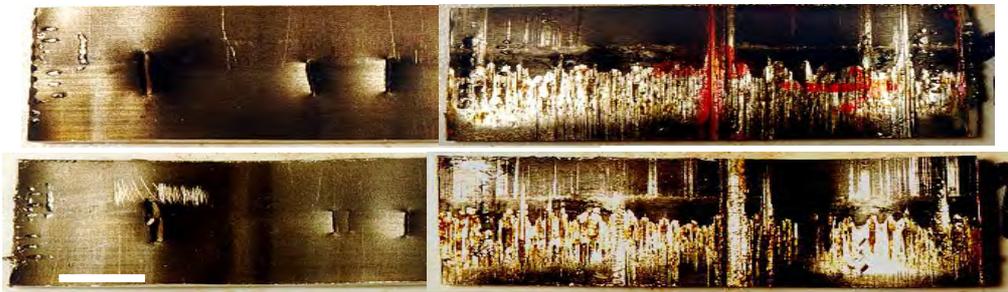
Fig. 6 PWSCC developed at similar axial location at the plant C

Inside diameter cracks 2.5mm ~ 6mm long were located at the top of the tube sheet and penetrated 72 % to 100 % of the TW as shown in Fig. 6. Another tube, which was considered as a sound tube from the ISI, had a crack 2.1 mm long and 84 % wall penetration. This means that there were likely to be many undetectable cracks on the tubes of the SG at the Kiss roll transition.
