## ECT Evaluation on Fretting Wear of Steam Generators in NPPs

Jung Ho Han<sup>1)</sup>, Myung Sik Choi<sup>1)</sup>, Deok Hyun Lee<sup>1)</sup>, Do Haeng Hur<sup>1)</sup>, Un Chul Lee<sup>2)</sup>

<sup>1)</sup> Korea Atomic Energy Research Institute (KAERI), Daejeon, Korea

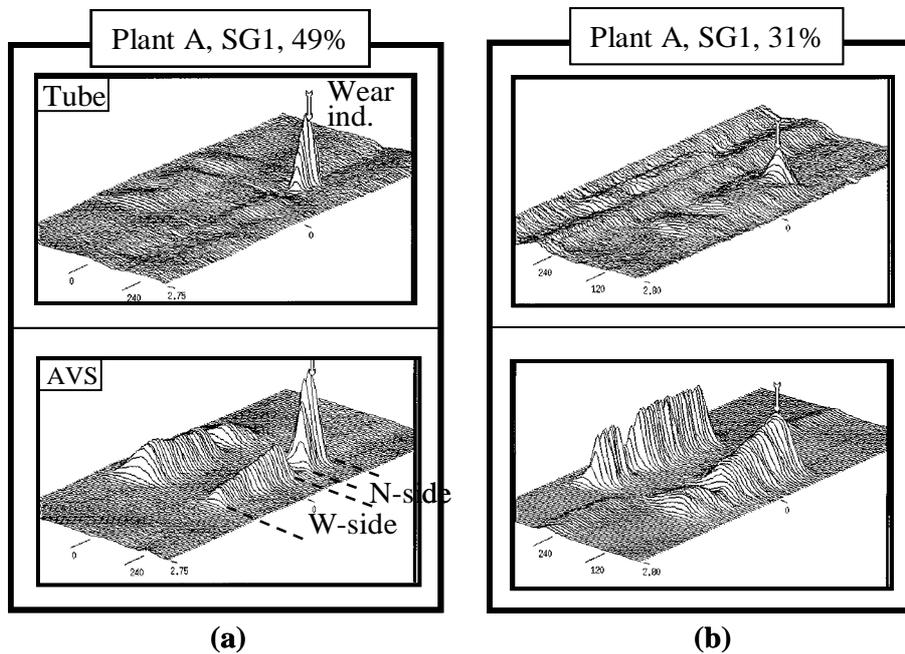
One-sided wear means the occurrence of wear at one side of the tube surface facing the adjacent AVS strip. Fig. 4 shows the typical one-sided wear of the tube surface. Most of the wear appearance of plant A operated for 1 cycle have one-sided wear characteristic. Fig. 4-(a) is a case of severe wear having 49% of wear depth and represents wear occurrence at the contact point between n-side of the AVS strip and tube surface. In this figure, it can be found that the signal amplitude at n-side of the AVS corresponding to the tube wear area is very high and amplitude decreases gradually to the w-side of the AVS strip. This means that the two components are not parallel with each other, that is, they are contacted closely at the n-side of the AVS or the n-side edge of the AVS strip is penetrated deeply into the tube surface. Fig. 4-(b) is also a one-sided wear, but there is a difference in appearance from Fig. 4-(a). It can be seen in this figure that there is no wear at the opposite side to the wear surface in spite of a high amplitude of the AVS strip at this side. In this case, a uniform height of high amplitude at this side indicates that the tube and AVS strip have good parallel alignment although they might be contacted closely with each other, therefore, wear due to the inclined alignment between the two components did not occur under this condition.

i) A slight distortion between the tube and AVS strip affects directly the wear of tube surface,

ii) This abnormal arrangement of the two components results in local high stress at a contact point between the edge of the AVS strip and tube surface and a rapid wear under the FIV condition.

Fig. 4 MRPC C-scan data of one-sided wear.

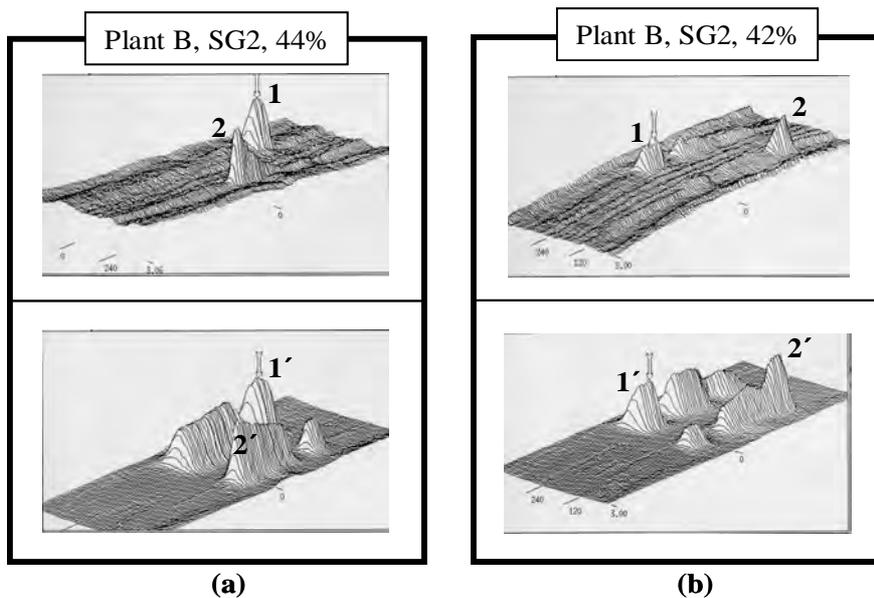
From the above results, occurrence of two-sided wear can be expected for longer operation conditions. Fig. 5 are examples of two-sided wear appearance of the tube surface for plant B after 5 cycles of operation. It can be found in these figures that two-sided wear occurred at both opposite sides of one tube contacting tangentially with two AVS strips. This result can also be explained by a signal analysis of the inclined alignment between the two components as mentioned above.

Fig. 5 MRPC C-scan data of two-sided wear.

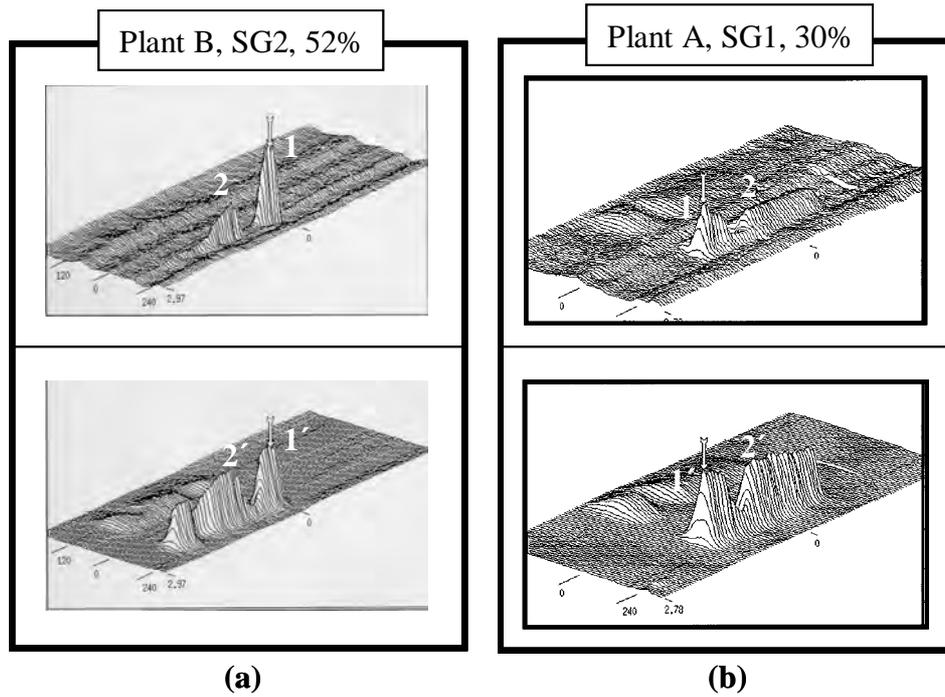
Fig. 6 represents two-stepped wear appearance. It can be seen that two wear indications on the same surface of the tube are shown in the upper C-scan displays of each figure. This wear appearance could have taken place due to the special geometrical structure of the AVS strip. As shown in Fig. 7, primary wear is initiated at the contact point between the edge of the AVS strip and tube surface under the abnormal alignment condition of the two components. After primary wear begins to continuously proceed in the direction of tube wall, a new contact - the second contact - is formed at the point between the inner edge of the AVS hole and tube surface, thus, secondary wear is produced.

Fig. 6 MRPC C-scan data of two-stepped wear.

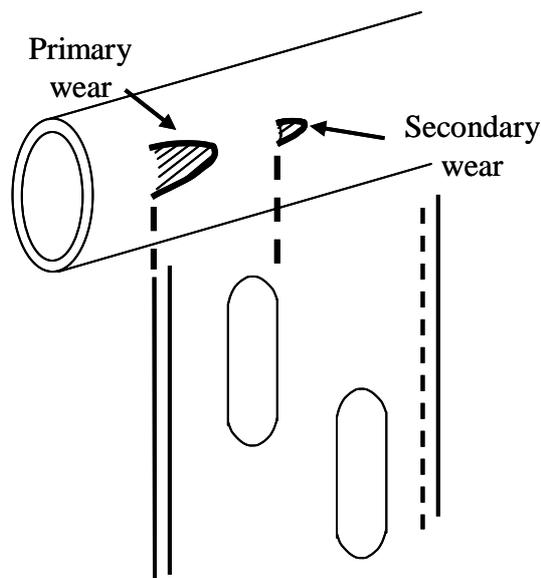
Fig. 7 Two-stepped wear due to geometrical structure between tube and AVS.
