## **Latest SCC Issues of Core Shroud and Recirculation Piping in Japanese BWRs**

Tokyo Electric Power Co. (TEPCO), Japan

### **ABSTRACT**

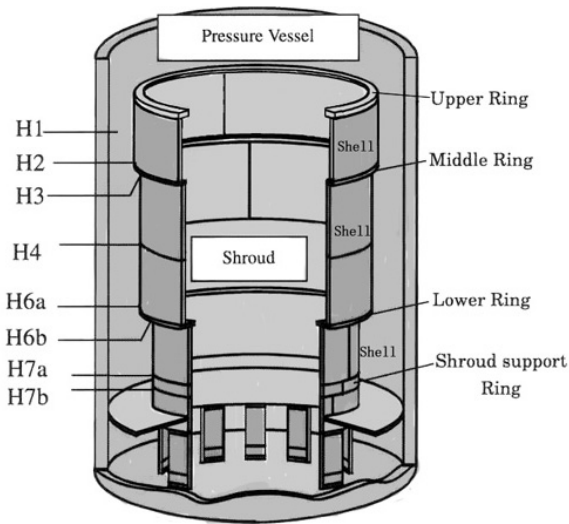
An inspection was performed on the core shroud in nine domestic plants by a remote-controlled underwater camera, which can discriminate a 1mil wire, and ultrasonic equipment. The cracking shown in Table 1 was found as a result of this inspection. Circumferential cracks in the shroud were verified on the inner surface of the shroud support ring (H7a welding line) and on the outer surface of the lower ring (H6a welding line). Isolated occurrences of radial cracking were also observed near the core region (H4 welding line). The size of these isolated radial cracks was about 10 mm in both width and height, and one of 180mm in width was also found in 1F-4.

Fig. 1. Shroud weld lines

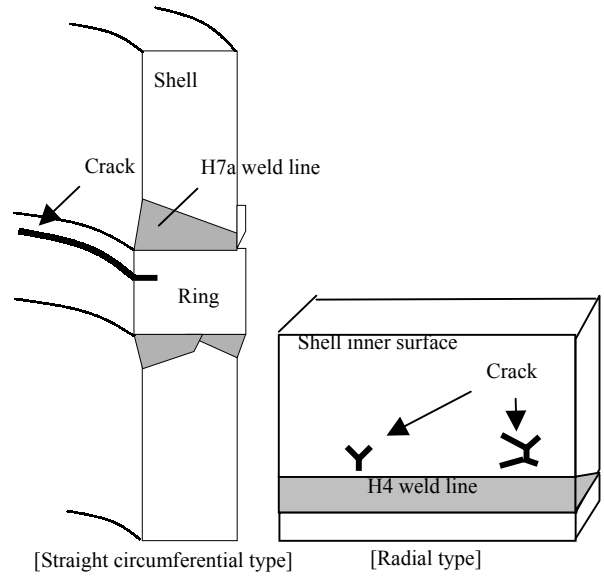
Fig. 2. Typical crack shape pattern

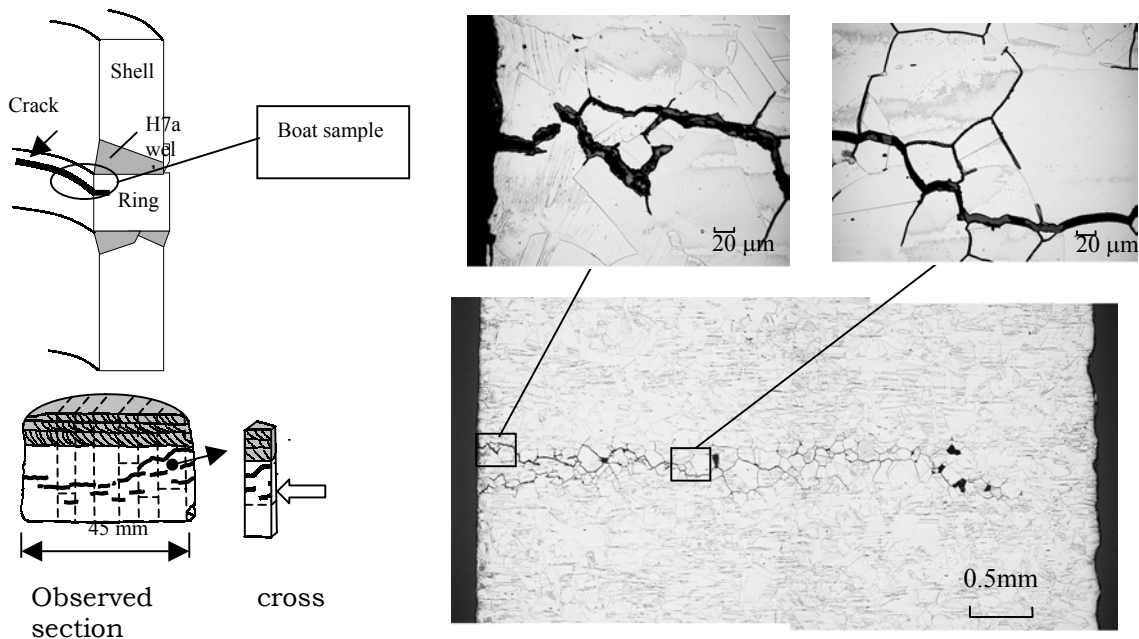
Results of a detailed investigation on boat samples from a cracked shroud are shown in Figure 3. SEM observations indicate the mechanism common to low-carbon stainless steel SCC of the initiation of cracking occurring in a hardened layer of the surface as TGSCC, and TGSCC subsequently changing into IGSCC. The sample of H7a from KK-3 shows that a deteriorated layer whose hardness exceeds Hv300 was formed on a finish-machined surface such as a shroud ring

Fig. 3. SEM observations of typical SCC crack (KK-3 shroud H7a)

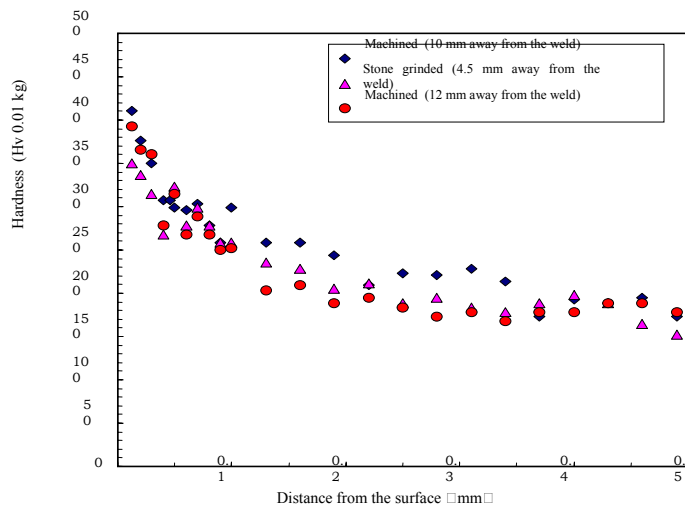
during the manufacturing process, the thickness of this layer being about  $100\ \mu\text{m}$ . The sample of H4 from KK-1, a case of a ground-finished surface such as the cylindrical core region, showed a very thin hardened layer of about  $30\ \mu\text{m}$  in thickness. The results of a chemical composition analysis of the sample showed no obvious sensitization near the welding line such as a concentration of chromium at the grain boundary. Most of the crack shapes such as the isolated radial ones were proved to depend on the local residual stress distribution on the surface.

Fig. 4. Distributions of hardness with depth (KK-3 shroud H7a )

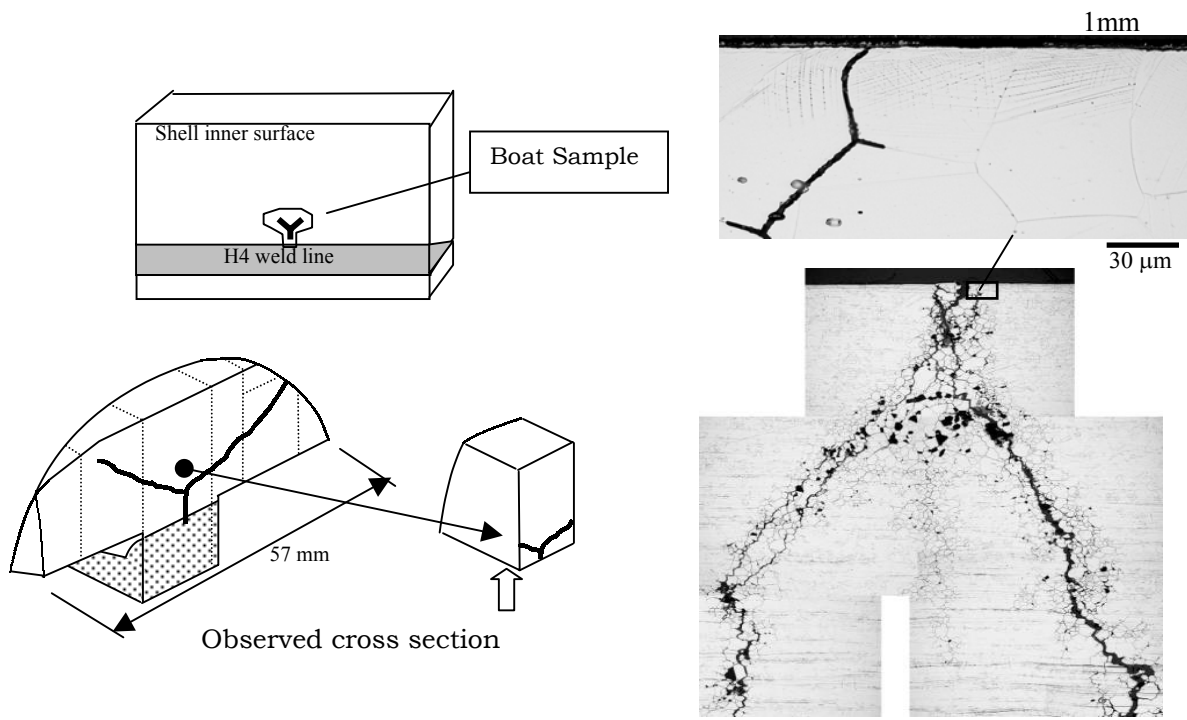
Fig. 5. SEM observation of SCC crack (KK-1 shroud H4)

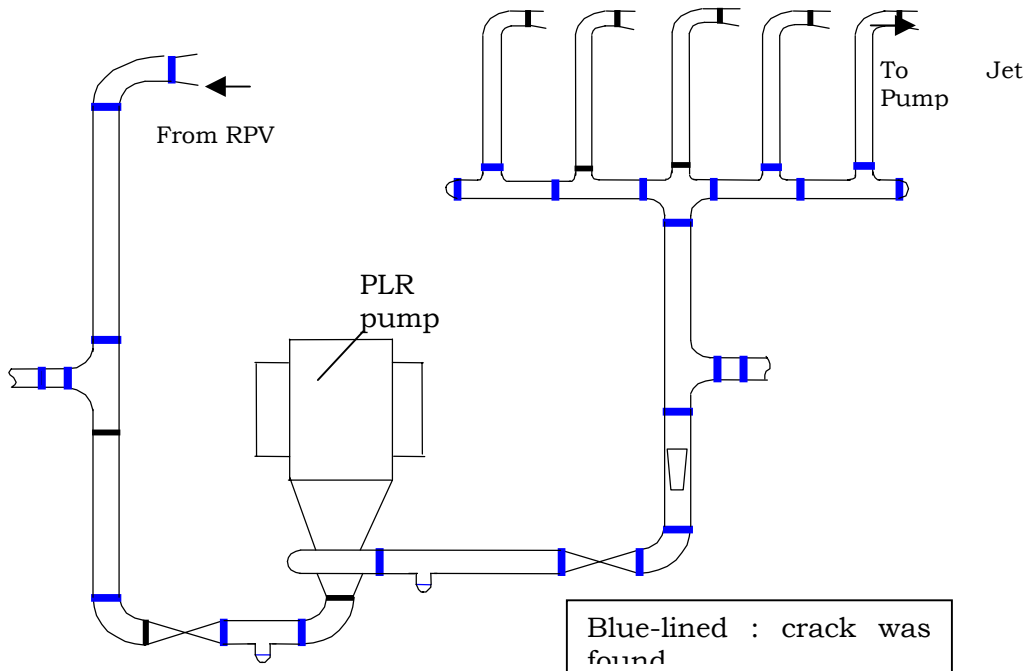
Many cracks in PLR piping were found during March 2003 in several plants as shown in Table 2. The welds in the PLR piping were inspected by an ultrasonic test from the external surface. Cracks were found near the welds inside the piping. This cracking was distributed throughout the whole of the recirculation piping (see Fig. 6) and there was no specific pattern

Fig. 6. Map of weld Cracking in primary recirculation piping (cumulative)

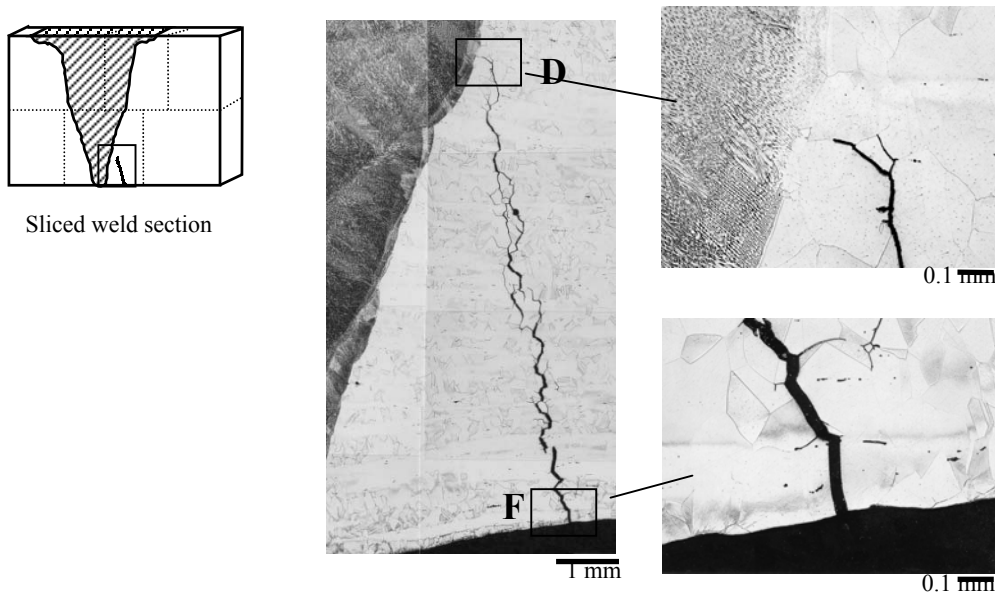
Samples of PLR piping welds were taken from KK-1. The thickness of the hardened layer was found to be 20  $\mu\text{m}$  on the inner surface of the PLR piping. We elucidated that TGSCC had been initiated from this surface layer and propagated to the inside of the pipe material by IGSCC. In some cases, the crack had penetrated the welding metal itself. The deteriorated layer whose hardness exceeded Hv300 was also formed on the inner surface of the pipe joints that had been machine-finished during the manufacturing process. It was found that the amount of ferrite had decreased to 5% or less in the boundary part of the weld metal due to the dilution of ferrite between the pipe materials, which hardly included any ferrite, and the weld metal, which contained a large amount of ferrite. This resulted in the shortage of ferrite in the weld metal. Measured data for a sample of welded PLR pipe are shown in Figure 9. No obvious sensitization at the grain boundaries was apparent, and the shape of most of the cracks also depended on the local residual stress distribution on the surface.

Fig. 7. SEM observation of cracks in welded PLR piping (KK-1)

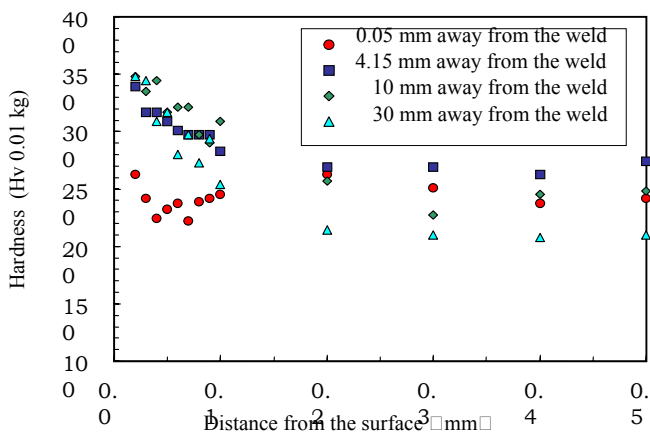
Fig. 8. Hardness Distributions with depth (KK-1)

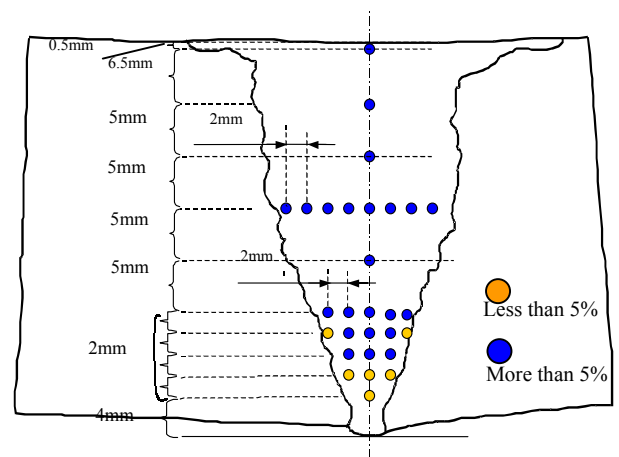
Fig. 9. Ferrite percentage in the weld metal of PLR piping (Onagawa-1)

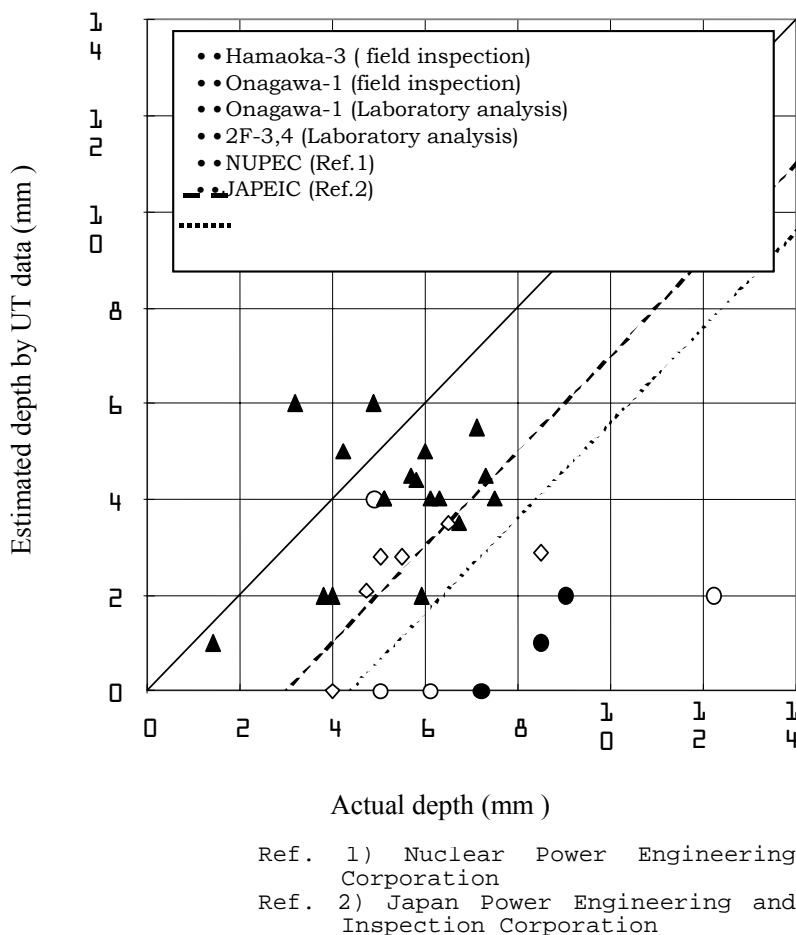
An ultrasonic inspection was carried out on PLR piping. The creeping wave method, which is hardly influenced by the signal reflected from the back surface, was applied for measuring the crack length in the circumferential direction, and the accuracy of the method was deemed to be appropriate. However, for measuring the crack depth, the share wave crack tip echo method was applied, and a substantial difference was apparent between the actual depth and that estimated from UT data. The reason for this error being generated in crack depth measurements was the direction of crack propagation toward the weld metal. When the crack propagates into the weld metal, the signal strength is significantly reduced and the echo from the crack tip cannot return to the surface. In such a case, a longitudinal ultrasonic wave is known to be more effective in the weld metal. Satisfactory results can be expected with longitudinal wave UT and phased array UT for field inspection in actual plants. It is planned to extract actual plant data further and check the validity of these measurement methods from now on. Since this problem with the accuracy of crack measurement by UT arose, evaluation of the integrity by using the present UT data has been concluded to be uncertain. It was therefore decided that the cracks needed to be removed or the piping locally replaced until sufficient accuracy of crack measurement could be established.

Fig. 10. Comparison between the estimated depth by UT data and the actual depth for PLR Cracks

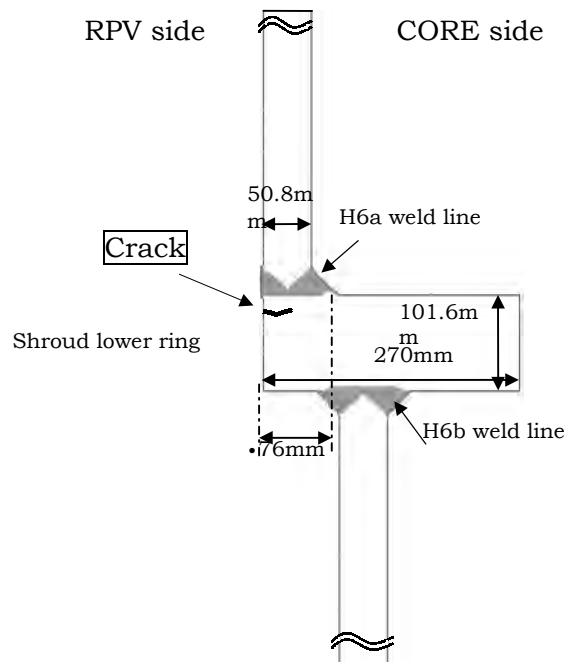
-3. A large safety margin was confirmed in the structural integrity of these shrouds at the present time and five years later. An example of the evaluation of the circumferential cracking in KK-2 is shown below.

Fig. 14. Cracking in the Shroud Lower Ring of KK-2

Initial area (mm <sup>2</sup> )	Residual area except the crack at present time (mm <sup>2</sup> )	Residual area except the crack 5 years later (mm <sup>2</sup> )	Required area (mm <sup>2</sup> )
<b>8.3 x 10<sup>5</sup> (100%)</b>	<b>6.6 x 10<sup>5</sup> (79%)</b>	<b>5.1 x 10<sup>5</sup> (61%)</b>	<b>1.4 x 10<sup>5</sup> (17%)</b>
