# ASSESSMENT, REPAIR AND MONITORING OF THE GENTILLY-1 CONCRETE CONTAINMENT STRUCTURE

A.A. Khan, M. Gray, B. Shenton, D. Panesar and M. Elgohary  
Atomic Energy of Canada Limited, Mississauga, Ontario, Canada

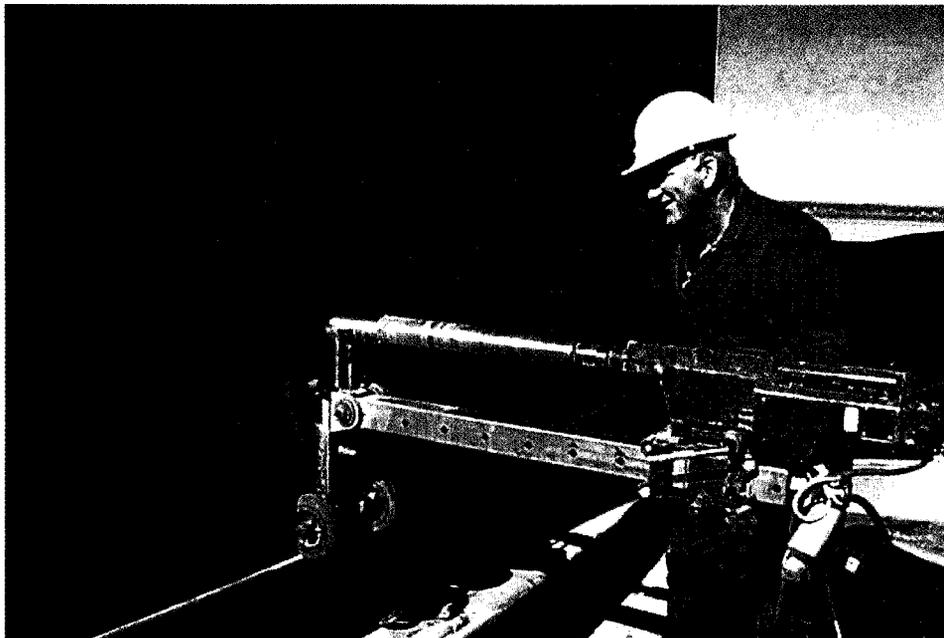
Figure 2: A typical diamond drill set up used for overcore stress measurements

As a part of condition assessment program, in-situ stresses were determined for the perimeter wall, ring beam and dome of the concrete containment structure at varying depths. The main purpose of these measurements were to produce a plan for the repair / remediation work needed to ensure the structural integrity. Overcoring stress measurements in the concrete were performed using doorstopper cells in conjunction with a compact self-contained data acquisition system, the Intelligent Acquisition Module (IAM). Testing was done in 70-mm diameter diamond drill holes. Over-core stress measurements were taken both in circumferential and meridional directions at each location. Figure 2 shows a typical diamond drill set up for doorstopper gauge overcoring.

As expected, all of the measured stresses in the containment concrete structural members were compressive. Generally, the values measured were within the range as predicted from stress calculations. It is likely that the stresses have changed since construction. However, with the competing effects of AAR, creep of the concrete and relaxation of the prestressing tendons, the exact changes cannot be determined and isolated.
