Performance Assessment and Reinstatement of Vibrating Wire Strain Gauges in Nuclear Power Plant Structures

Leslie M. Smith TD, BSc, PhD, CEng, MICE, MIStructE, MINucE, M.ASCE, M.ASME FGS
British Energy Generation (UK) Ltd.

This paper describes work carried out on vibrating wire strain gauges (VWSGs) to confirm their performance after approximately 25 years of service, the types of failure encountered, how such failures may be identified and suggested methods for restoring recoverable gauges to operation.

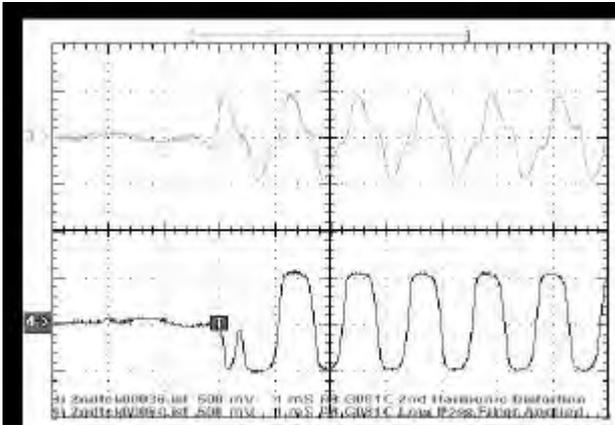
A gauge showing harmonic distortion and the correction of the distortion with a suitable filter.

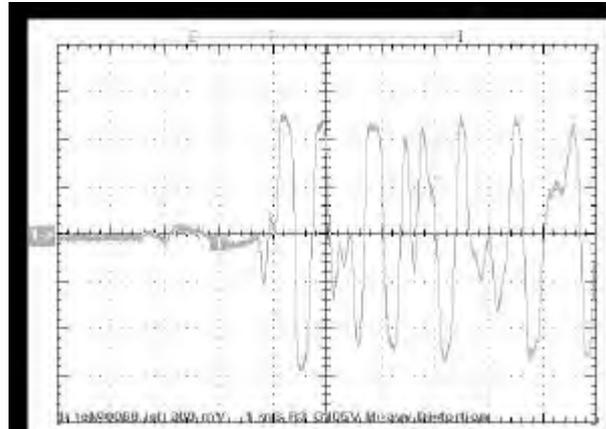
A gauge showing heavy distortion and has been proven to have an earth fault.

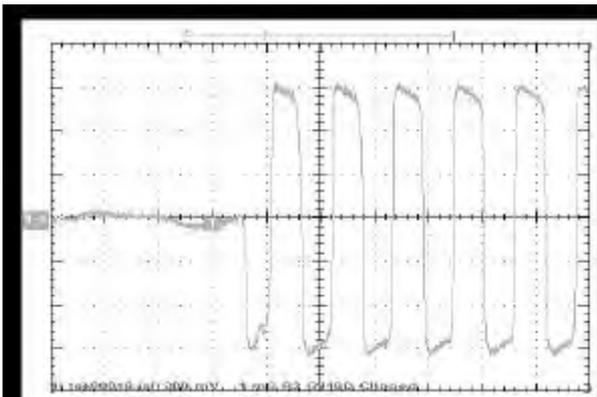
A gauge showing clipping on the top and bottom of the returned signal.

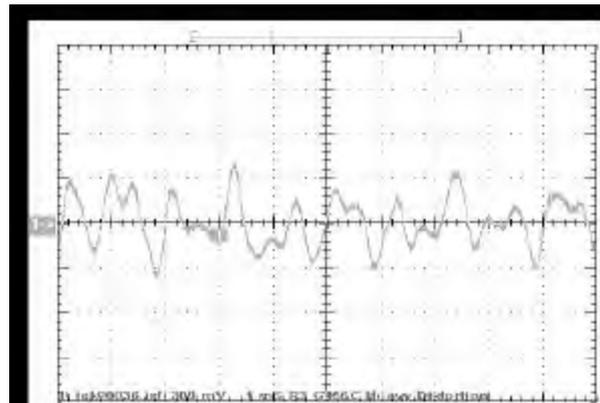
A gauge showing heavy distortion. Appropriate band pass filter should recover this gauge.
