Behavior of Spent Fuel and Safety-Related Components in Dry Cask Storage Systems

Roger M. Kenneally¹ and John H. Kessler²

ABSTRACT

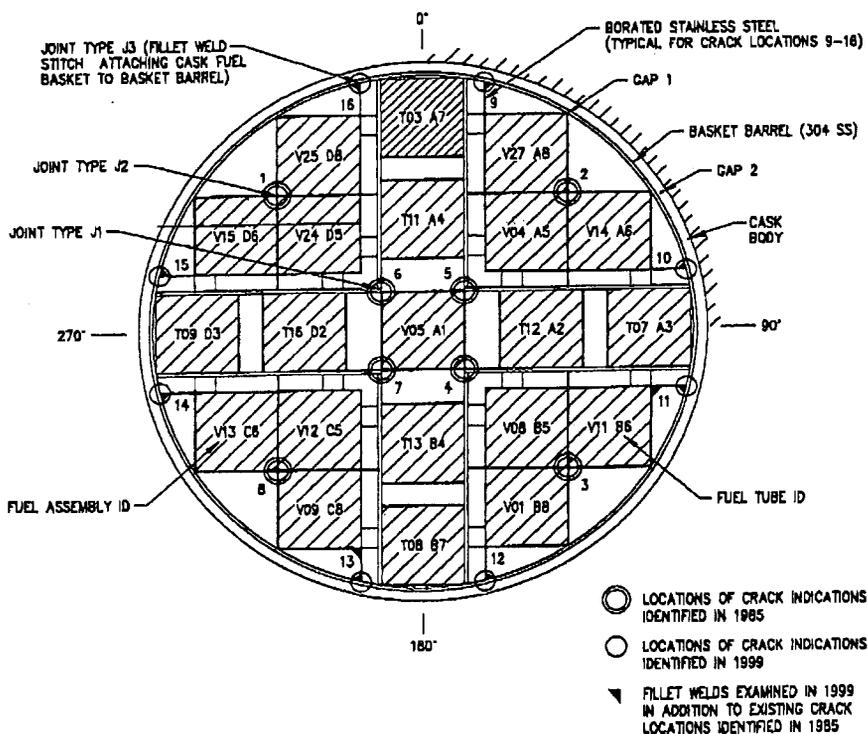
Figure 3. Castor-V/21 Cask Basket Crack Indications Locations

Basket Weld Observations. The 1985 inspection of the basket after the completion of the heat transfer performance tests identified eight broken welds (Figure 3, welds 1 - 8) in the top of the basket [4]. The welds cracked as a consequence of the stresses created by the differential thermal expansion of the tightly-fitting basket within the cask during the tests.¹ An objective of the 1999 inspections was to reexamine the affected welds for any changes in configuration, and to examine other accessible welds in the basket structure for cracks or corrosion. Unfortunately, the stitch welds of the structure are located in the flux trap and spacer channels, not inside the 21 fuel tubes. Therefore, the only accessible welds were the welds visible at the top of the basket and a few others.

Welds numbered 1 - 8 in Figure 3 appeared to be the same as in the 1985 inspection. The four welds in the corners of the central fuel tube A1 (welds numbered 4 - 7) involved welds of stainless steel to borated stainless steel, whereas the four welds joining the fuel tubes in other locations (welds numbered 2, 3, 8, and 1) involved only stainless steel. The 1999 inspection confirmed that five welds were broken clear through (as initially observed after the 1985 thermal testing), and three had substantial cracks that propagated partially through the top stitch weld. The narrowness of the flux traps and the supports within blocked the views of the stitch welds below the top welds from the top-side video cameras, and prevented the insertion of the pencil camera assembly. Therefore, the condition of those welds could not be determined.

The inspections found that all eight of the top stitch welds were cracked, and seven of the eight bottom welds. The intermediate welds did not appear to be cracked.

It is not possible to unequivocally state these stitch welds cracked during the 1985 thermal testing since no visual inspection of these welds was performed at that time. However, stress analyses undertaken to assess the weld cracks that were observed immediately after the 1985 thermal testing suggest that the yield strength of these stitch welds was also exceeded during the thermal testing [4]. Thus, it is probable that these weld cracks also occurred during the initial thermal testing and not during the subsequent years of dry storage.
