PWSCC observations in Ringhals 3 and 4 safe ends

Lars Skånberg

*Department of Structural Integrity
Swedish Nuclear Power Inspectorate*

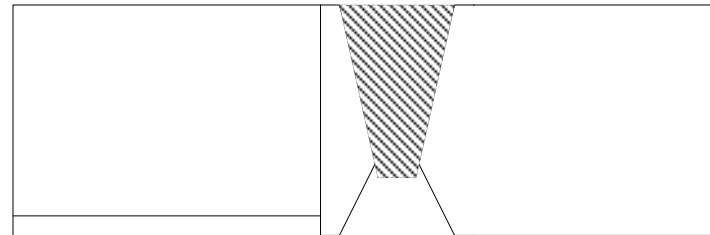
Repair of Ringhals 4 safe end pos. 25°

Slag inclusions and small weld cracks observed
by RT of Ringhals 4 safe ends \Rightarrow Repair
No documented repair of safe ends in Ringhals 3

First and second repair:
Machining 360° around the circumference
 \Rightarrow SMAW \Rightarrow grinding \Rightarrow PT and RT

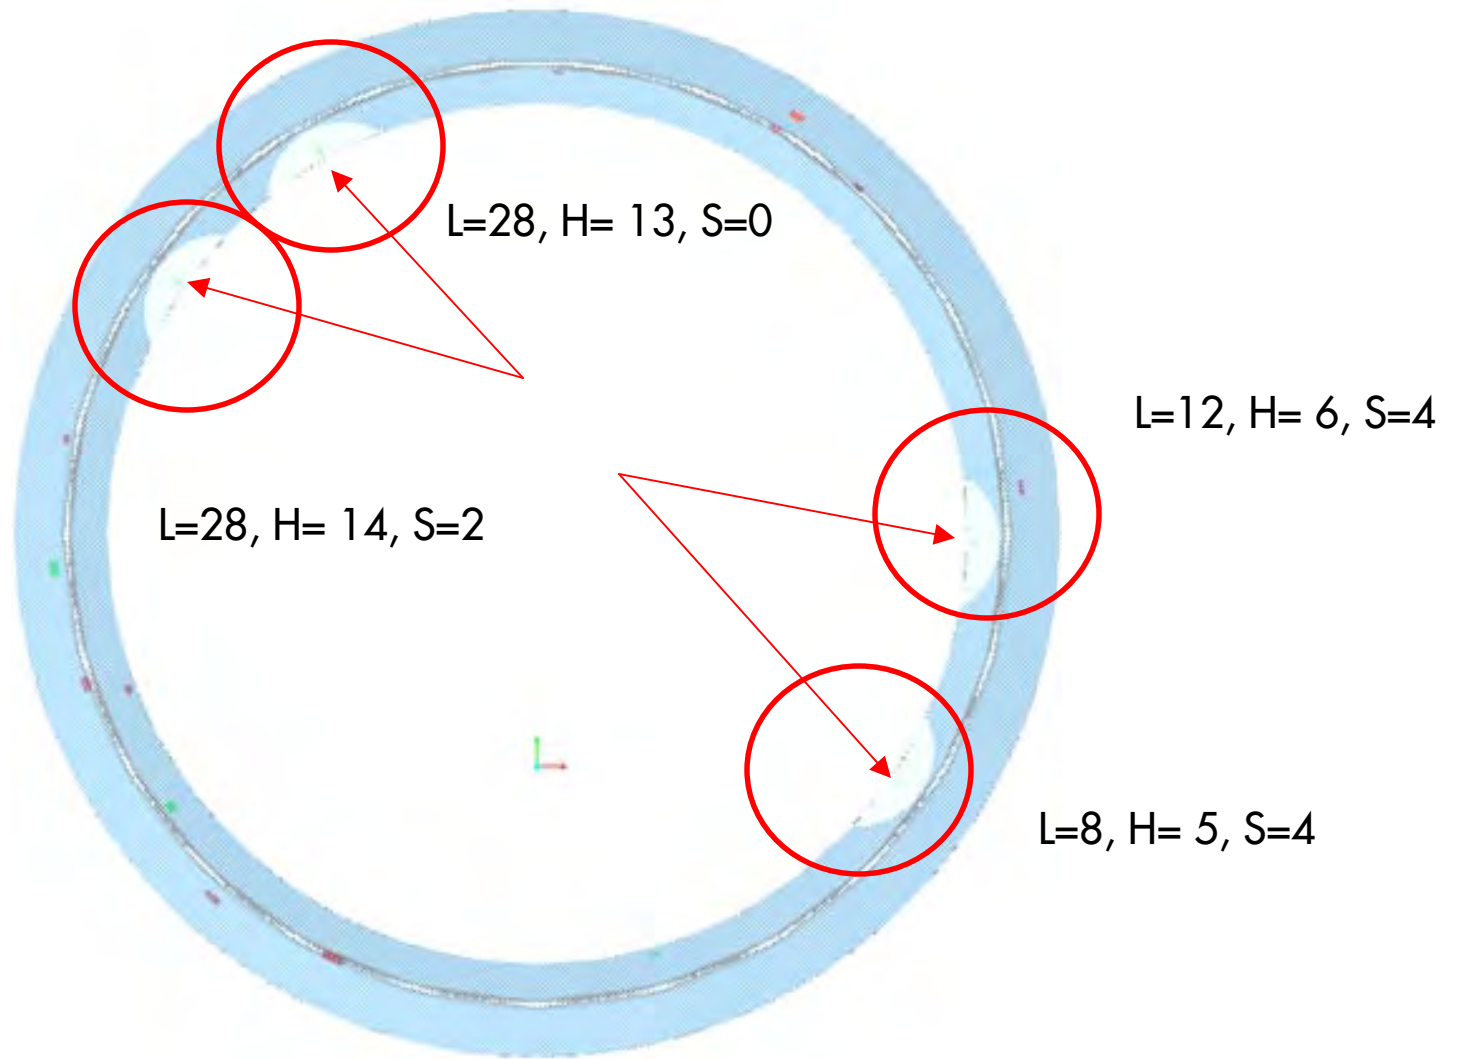
Ringhals 4 outage -00, 25° outlet nozzle to safe-end weld, UT indications.

- Several indications recorded in one safe end, evaluated as
 - volumetric defects
 - 3 sub surface planar flaws and 1 surface planar flaw > qualification targets
- Planar flaws removed by boat samples to
 - stop further growth
 - metallographic examination
- Comparison with inspection results showed that
 - two of the cracks were under sized
 - all cracks were surface breaking

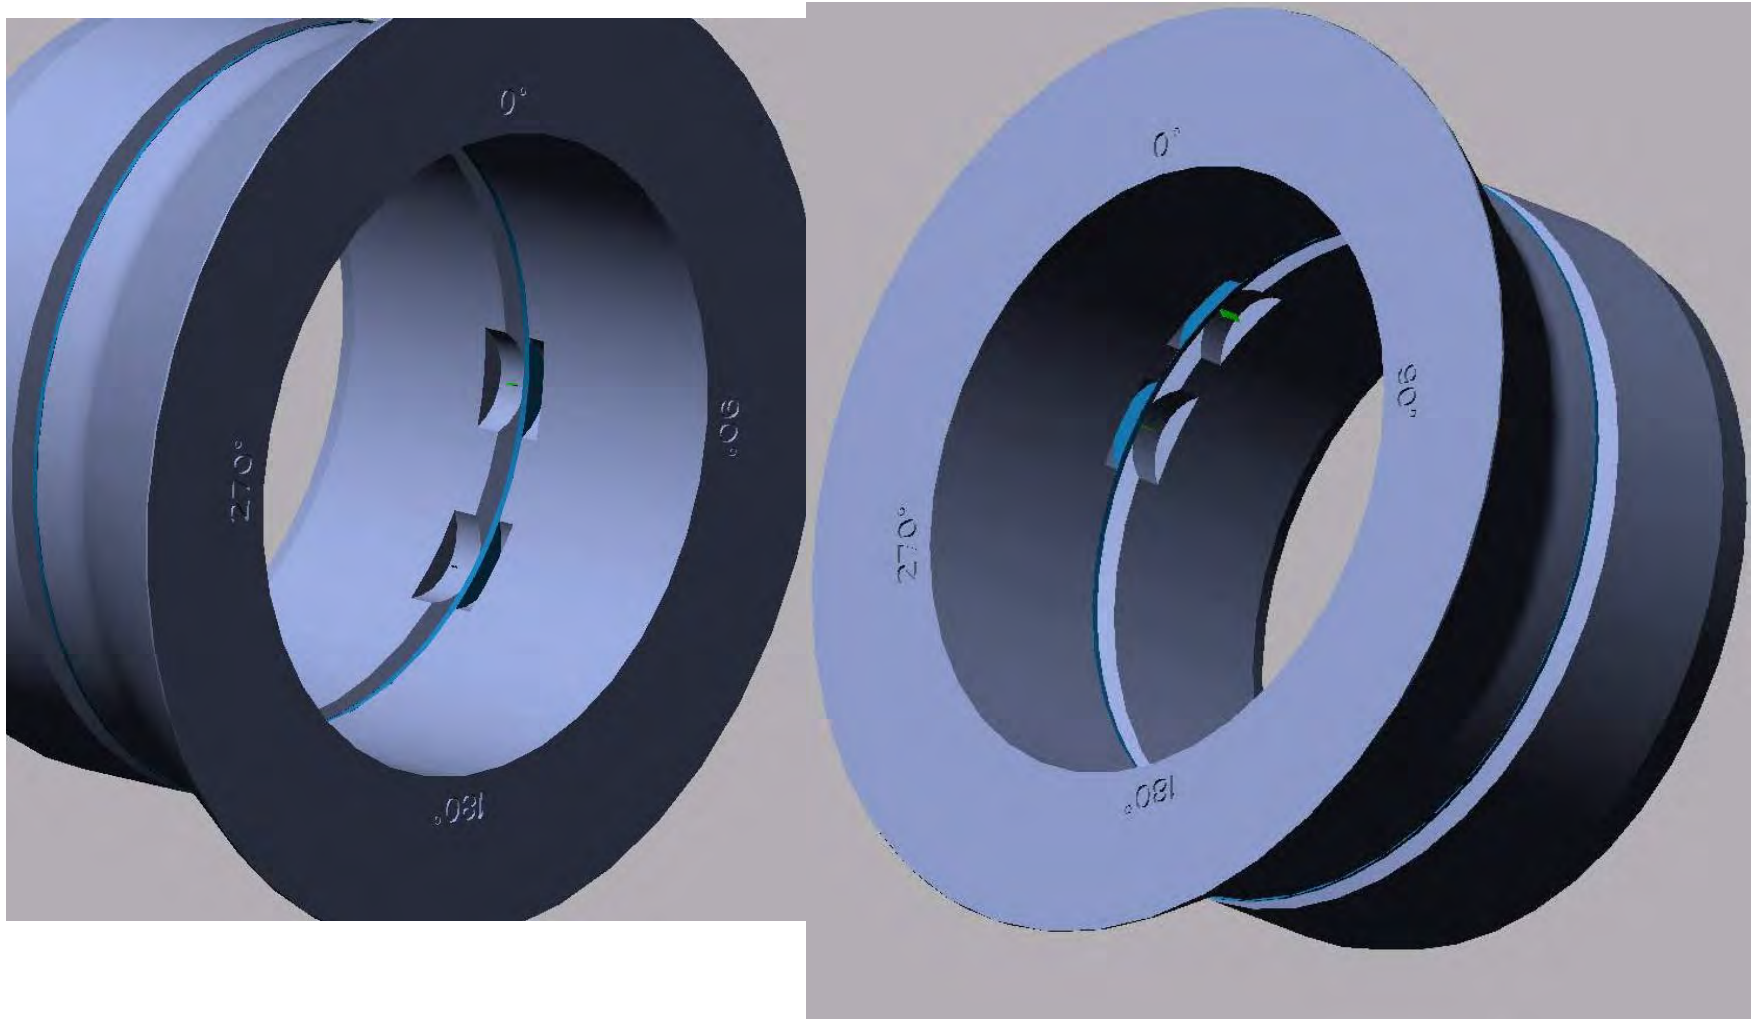
Removed boat/material samples

Crack position	Depth acc. to ultrasonic measurements	Depth acc. to destructive examination
91°	10 ± 3 mm	9 ± 1 mm
124°	9 ± 3 mm	6 ± 1 mm
305°	16 ± 3 mm	22 ± 3 mm
330°	13 ± 3 mm	22 ± 3 mm

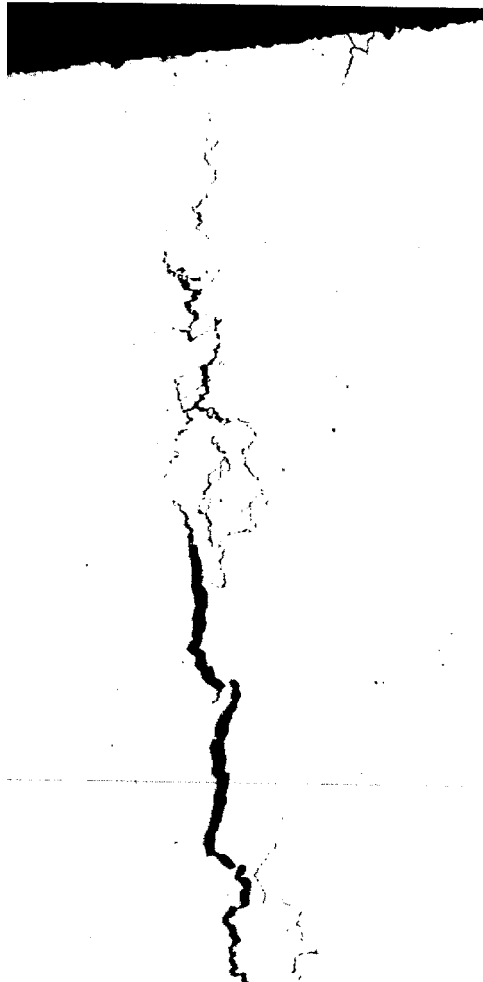
Surface in contact with primary water

- IDSCC in weld repaired Alloy 182 material
- significant branching of some cracks
- very tight crack tips and also tight crack parts connected to inner surfaces
- some hot cracking and small lack of fusion
- no IDSCC propagation into RPV CS and SS
