Alloy 600, 82/182 Weld Integrity Issue

Larry Mathews,
Southern Nuclear Operating Co.
MRP Senior Representatives' Meeting
August 15, 2001

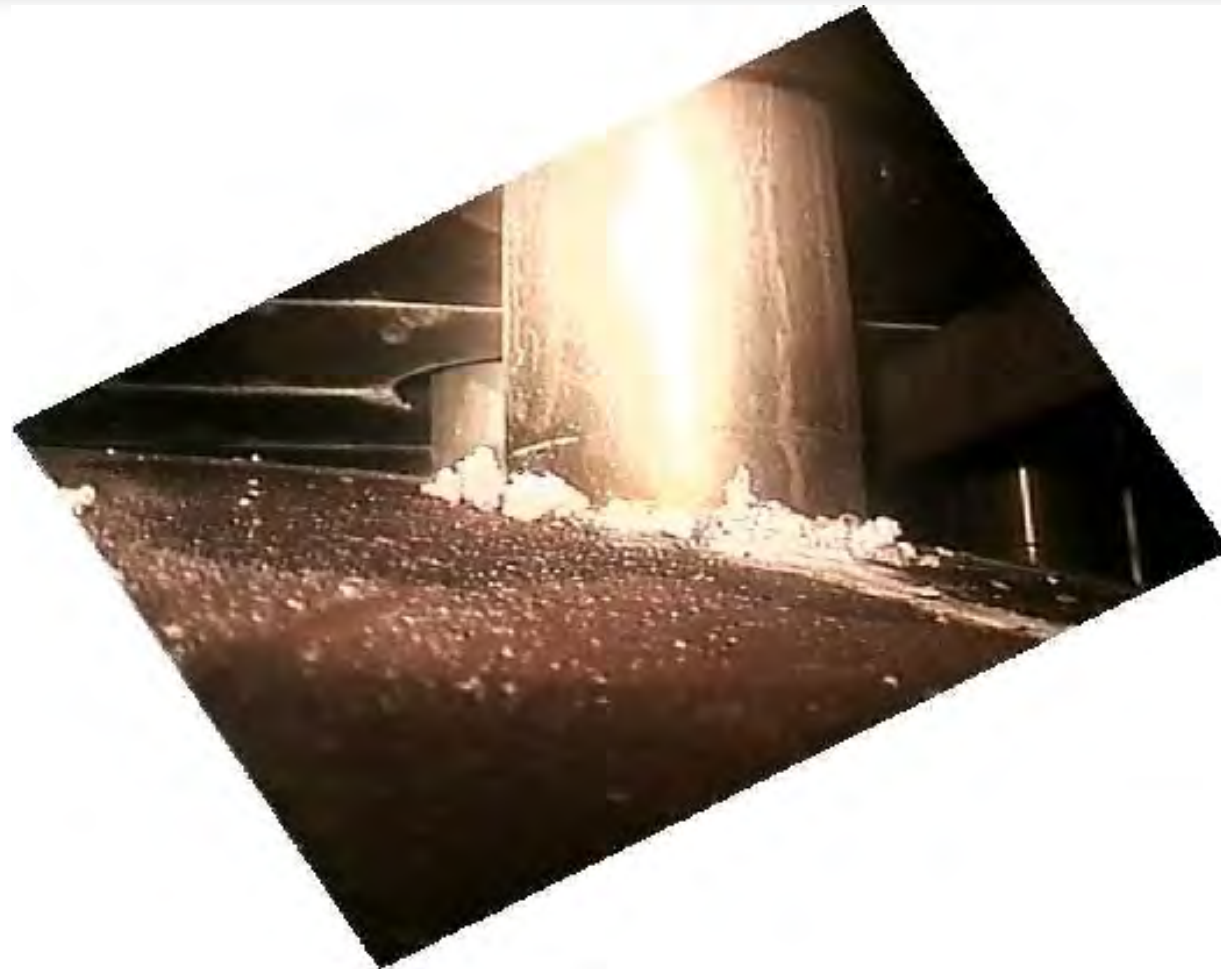
- Oconee 1 - a single CRDM and several T/C nozzles found leaking
- Oconee 3 - nine CRDM nozzles leaking, two with circumferential flaws above the weld
- ANO 1 - a single CRDM found leaking
- Oconee 2 - four CRDM nozzles leaking, one with small circumferential flaw above the weld

ONS-1 RV Head Showing Boric Acid At CRDM Nozzle 21

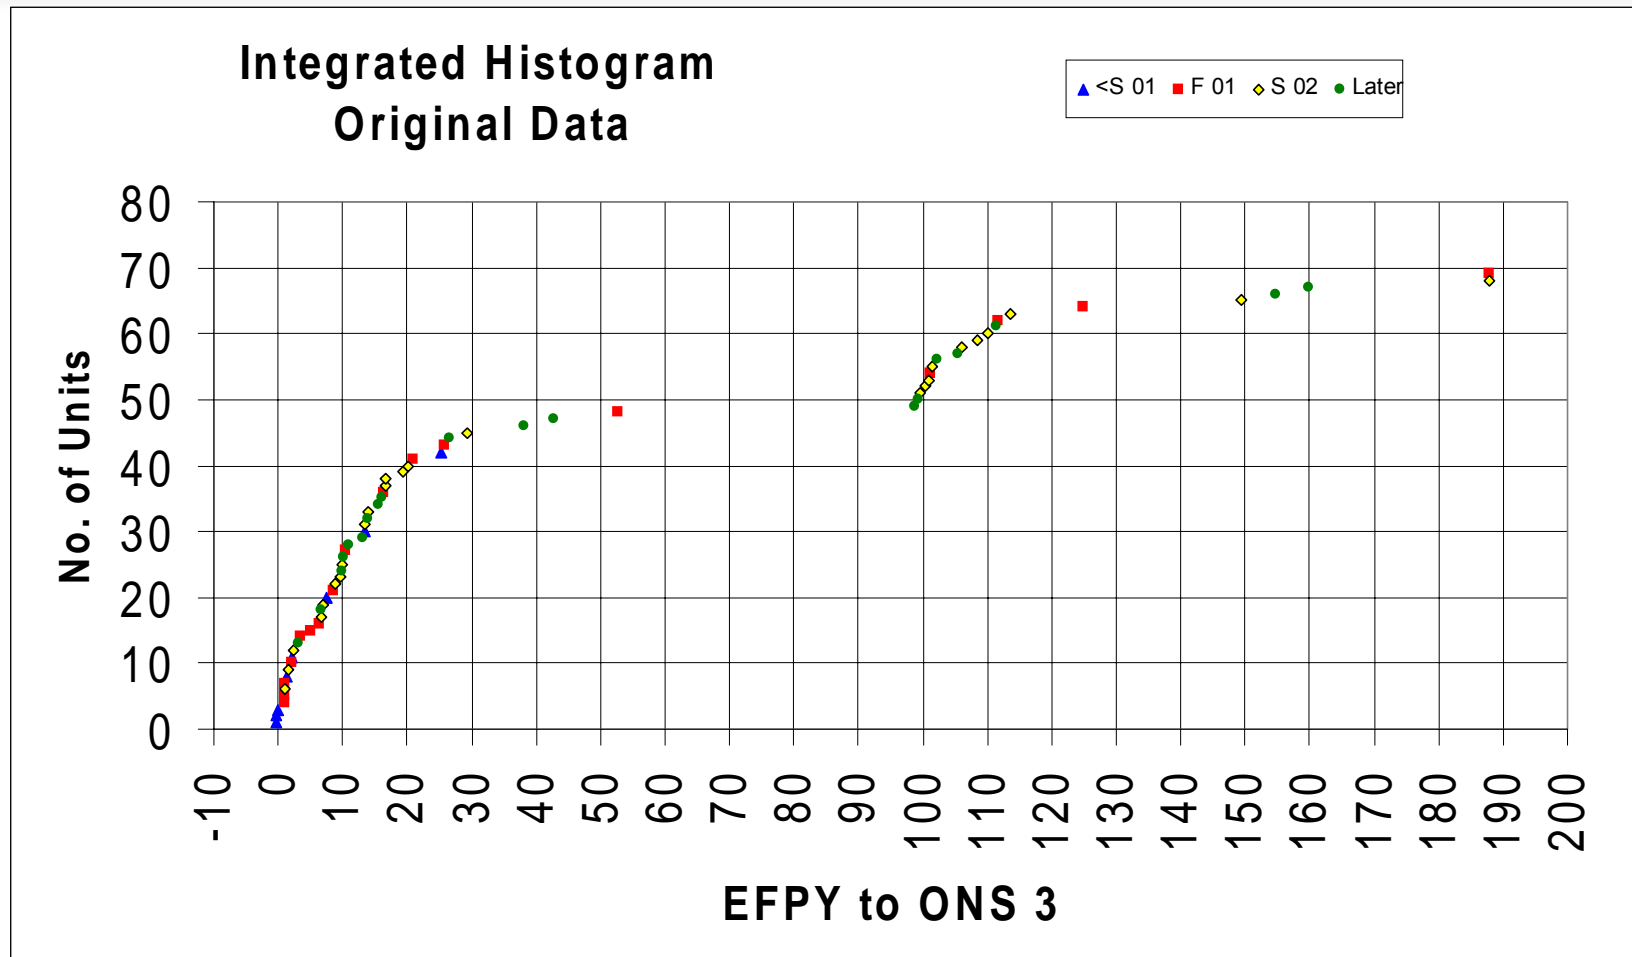
Time-Temperature Histogram

- Interim safety assessment submitted May 18, 2001
- Developed a histogram of time for each unit to reach the equivalent time at temperature as ONS 3 (normalized to 600F)
- Recommended plants <10 EFPY from ONS 3 with Fall outages perform visual inspections
 -
 -
 -
- Had already recommended <10 EFPY plants with Spring outages perform a “best effort” at visual examination
