Ageing aspects of Concrete Containments from a Regulatory Point of View

Behnaz Aghili¹

¹ Department of Reactor Technology and Structural Integrity, Swedish Nuclear Power Inspectorate, SKI

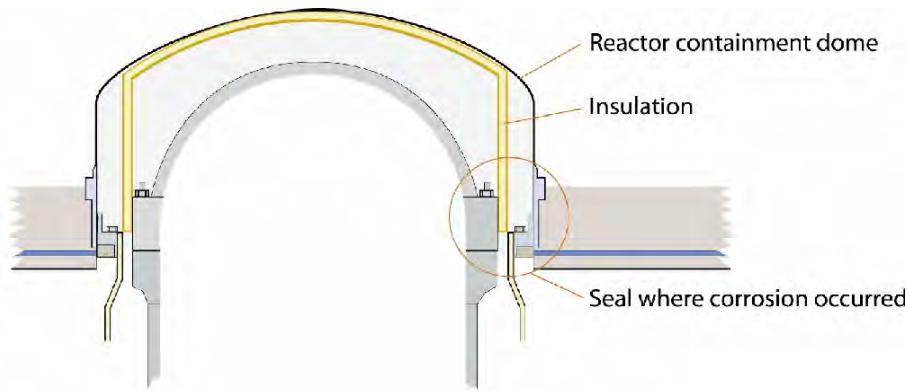
Figure 2: Location of the damage discovered at Formark 1.

The damage in Forsmark 1 was discovered during a leak test of the containment, when leaks were found in both an outer and an inner seals (Figure 2). These were removed for further inspection. It was then found that corrosion had occurred as a result of moisture inside the insulation. A plastic film, intended to protect the insulation from moisture, was discovered. On removal of this a considerable amount of water was released.

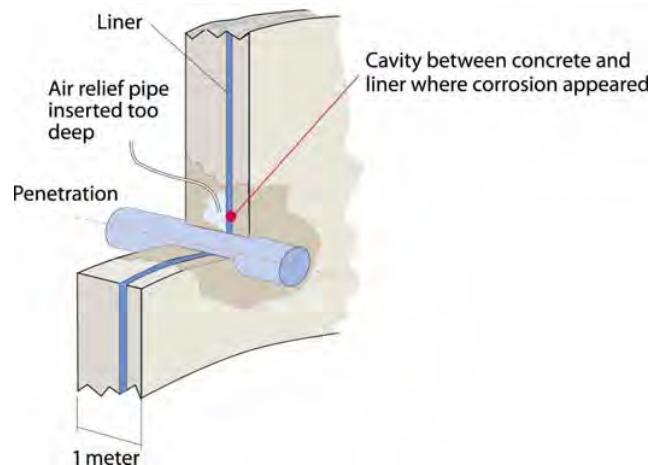
Figure 3: Location of the damage discovered in Barsebäck 2.

The damage at Barsebäck 2 was also discovered during a leak test. Investigation revealed corrosive damage to the liner. This had resulted from an incorrect refilling of a cavity around a pipe penetration where water had been allowed to remain (Figure 3). When the cavity was to be refilled with concrete, containing a swelling agent, this later reacted with the water producing porosities in the concrete. Furthermore, the cavity had only been partly filled in, and in this environment corrosion ensued.

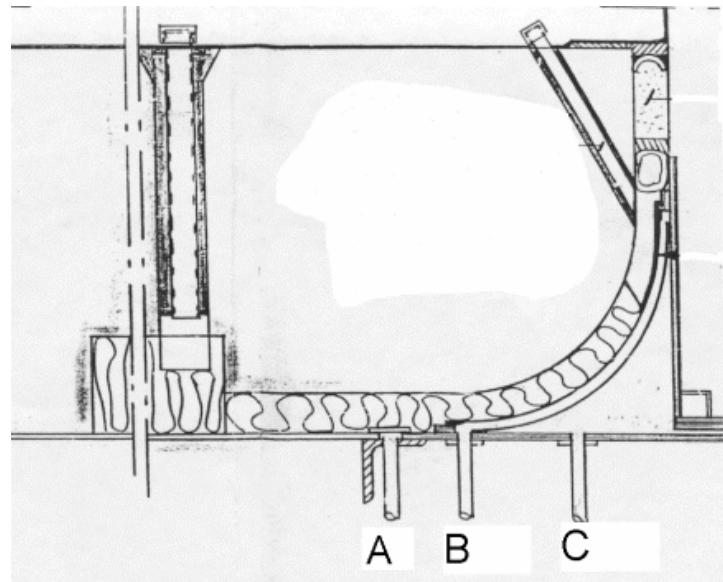
Figure 4: Location of the damage discovered at Ringhals 2.

The damage at Ringhals 2 was discovered during a routine leakage control. Investigations revealed excessive corrosive damage to both inner and outer seal sheets which connected the liner located in the ground to the liner located in the concentric wall of the containment. Water with high pH had been injected between the two seal sheets to avoid corrosion. Investigations revealed that the amount of water had been varying during the time and sludge of cement containing high amount of silicon was remained on the seal sheets and had contributed on the corrosion damage (Figure 4 and 5).

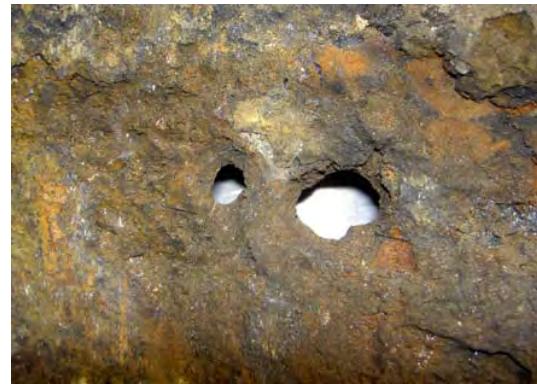
Figure 5: Corrosion damage at Ringhals 2.

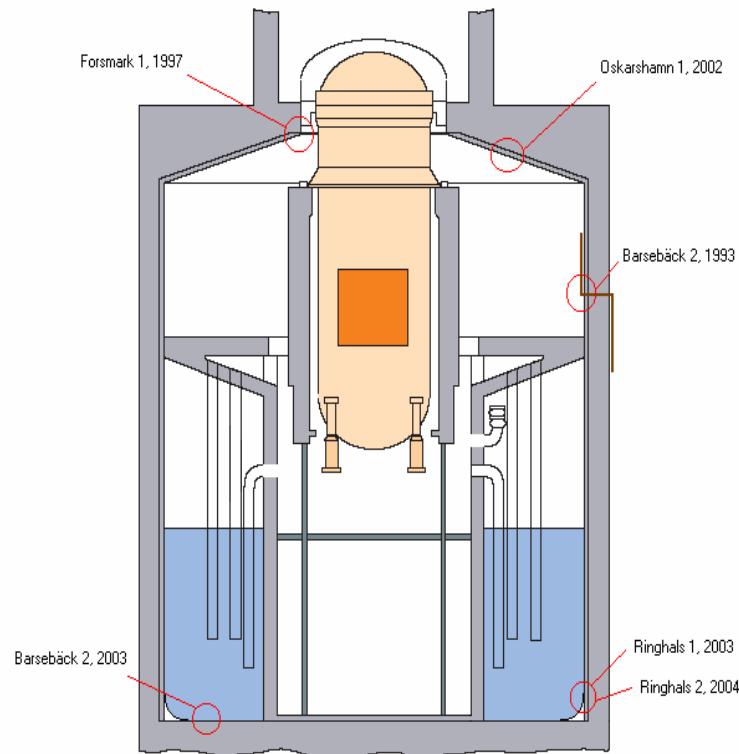
Figure 6: Location of discovered damages in different containment buildings in Swedish NPPs.

Other incidents which can be mentioned here are: accumulation of water between the seal and concrete at Forsmark 3, water inside the containment liner at Ringhals 2, holes in the roof plating at Oskarshamn 1, erosion of the exterior concrete of the containment at Ringhals 3, damaged pre-stressing cables at Forsmark 3, and the so called “plug” at Barsebäck 2 – the result of an incorrect drilling into the floor framing, (Figure 6).
