## Analysis and Solution for Angra 1 Electric Generator Lead Box Vibration

Othon Luiz P. da Silva, Lúcio Ferrari, Renato Victorio, Rodolfo Suanno, Carlos Prates, Joaquim Leães  
Eletronuclear - Eletrobrás Termonuclear S.A.- Brazil

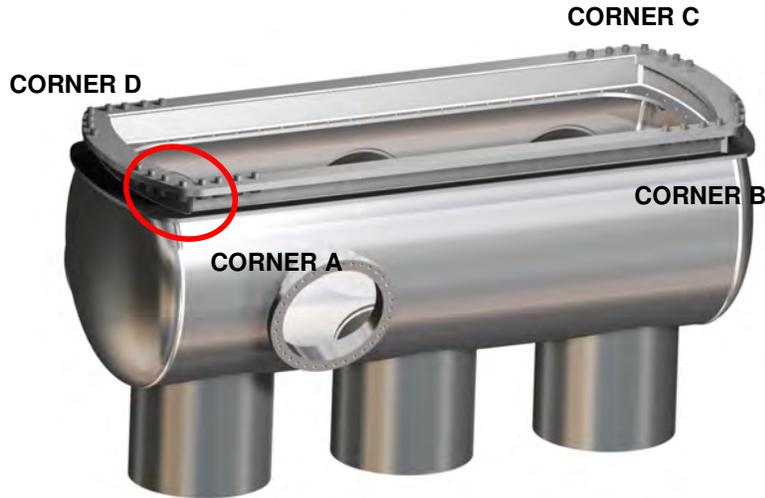
Figure 2 - Disposition of the corners A, B, C and D.

After this event there were three more shutdowns caused by through wall cracks located in the corners A and C of the flange connected to the EG base frame.

The figure 2 presents the disposition of the corners A, B, C and D described at the Table 1.

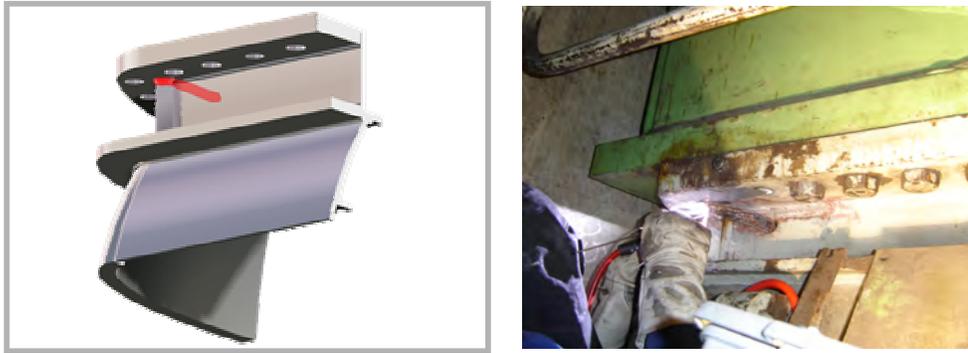
Figure 3: 2<sup>nd</sup> Event – Position of the crack and photo of the repair

The second event was a through wall crack located in the corner A, upper weld. The crack was fully removed and repaired by welding. The figure 3 shows the location of the crack and a photo of the repair.

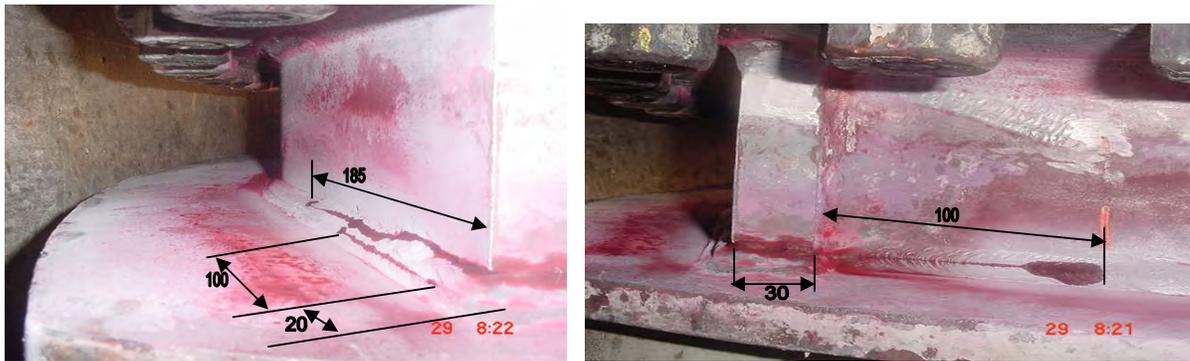
Figure 4: 3<sup>rd</sup> Event – Cracks at corner A – lower weld

The third event was caused by two through wall cracks. One located in the corner A lower weld and other located in the corner C upper weld. The cracks were fully removed and repaired by welding. The figure 4 shows the location of the crack at corner A and the dimension of the crack.

The crack in the corner C upper weld was similar to the one found in the corner A in the 2<sup>nd</sup> event. One additional shutdown occurred in the 4<sup>th</sup> event caused by cracks in the corner C (lower and upper weld).

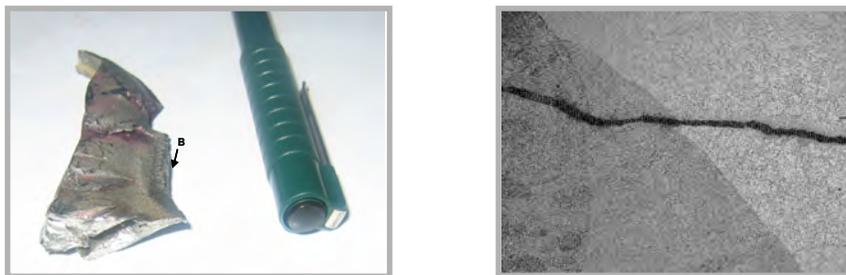
Figure 5: Sample removed and transgranular crack observed from microscope.

A sample removed from the fractured material, in the 3<sup>rd</sup> event was submitted to metallurgical evaluations. The characteristics of the fracture surface indicated transgranular crack caused by fatigue as can be observed in the Figure 5.

That result confirmed that a high cycle fatigue degradation mechanism, caused by the primary vibration of the electrical generator and amplified by the resonance effects of the Lead Box, was the main failure cause for the repeated cracks nucleation and quick propagation.

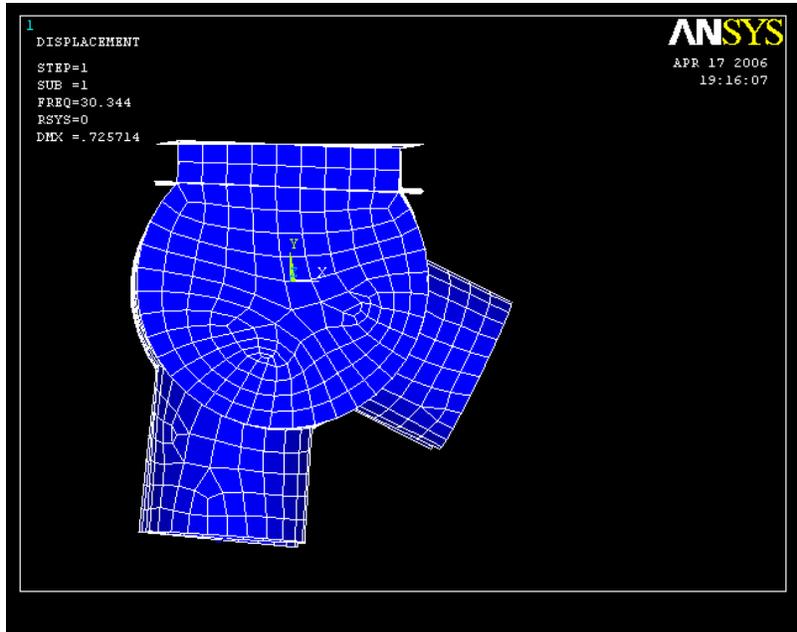
Figure 7 – 1<sup>st</sup> Mode shape of the Lead Box (Frequency – 30,3 Hz)

After the 3rd event detailed vibration measurements were performed for several points of the Electric Generator casing and Lead Box. The measurements showed a natural frequency of 30,3 Hz for the Lead Box, which was very close to the operating velocity of 1800 rpm (30Hz). Vibrations Measurements during normal operation confirmed very high amplification from EG to the Lead Box.

The first analysis performed was the extraction of the frequencies and mode shapes. The first mode shape was the rotation of the Lead Box in the plane XY as presented in the figure 7 with a frequency of 30,3 Hz, confirming the measurements obtained in the field.

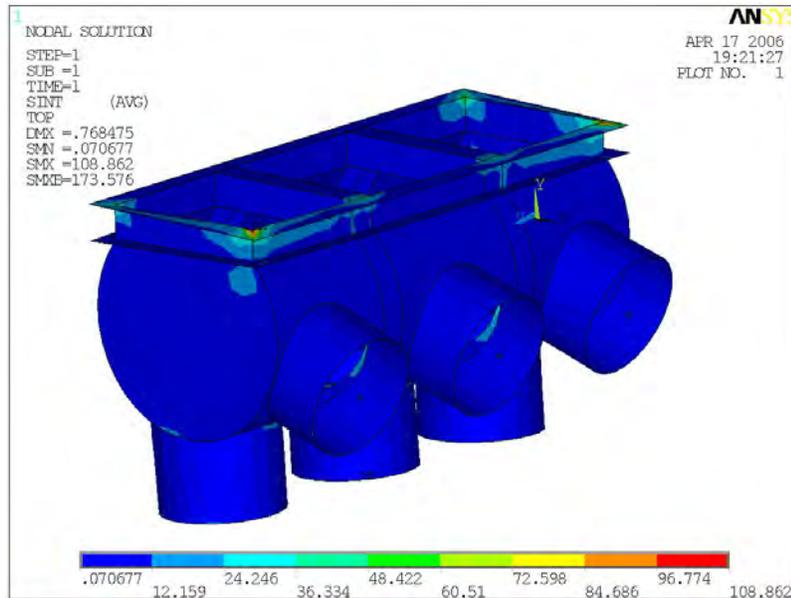
Figure 8 – Stress Distribution of the Lead Box – Original Design.

The stress distribution of the Lead Box was also determined with the finite element model. The figure 8 shows the high stress concentration around the corners which would be the primary cause of the fatigue.

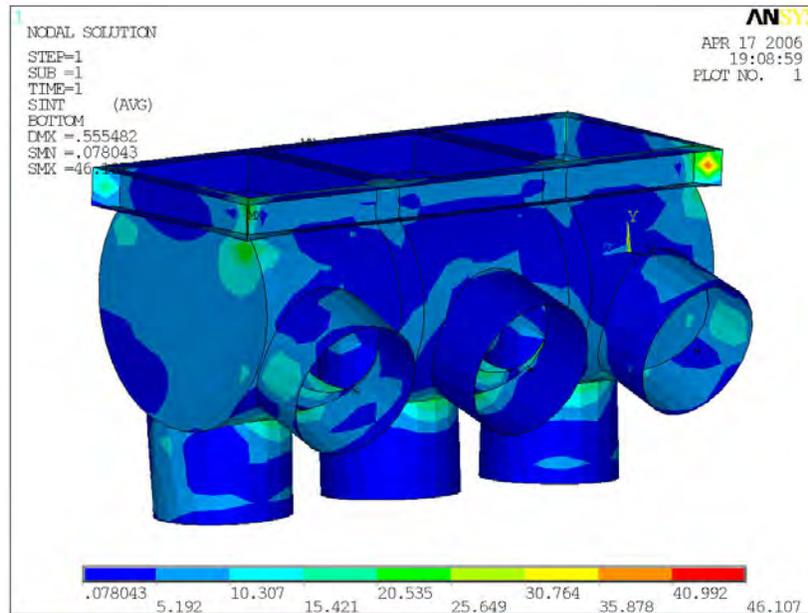
Figure 9 – Stress Distribution of the Lead Box – Stiffened Structure

A model of the Lead Box with the stiffening of the corners with one rib for each, showed a much better behavior. The natural frequency increased from 30,3 to 33,0 Hz which reduced the dynamic amplification factor from 12,2 to 5,3. The maximum stress in the model decreased from 108,8 to 46,1 N/mm<sup>2</sup>. An additional advantage of this second model was that the maximum stress would occur in the ribs and no more in the pressure boundary shell.

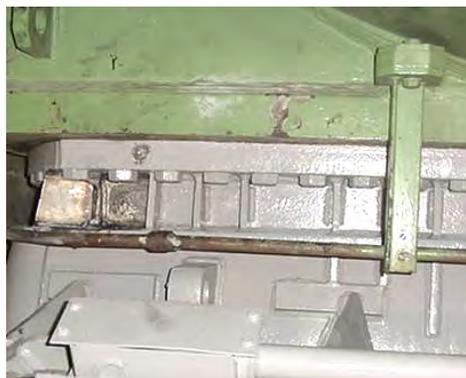
Figure 10 – Stiffening Ribs installed in the Lead Box flange.

The installation of the ribs was performed during Angra 1 Outage, 1P14, in May 2006.

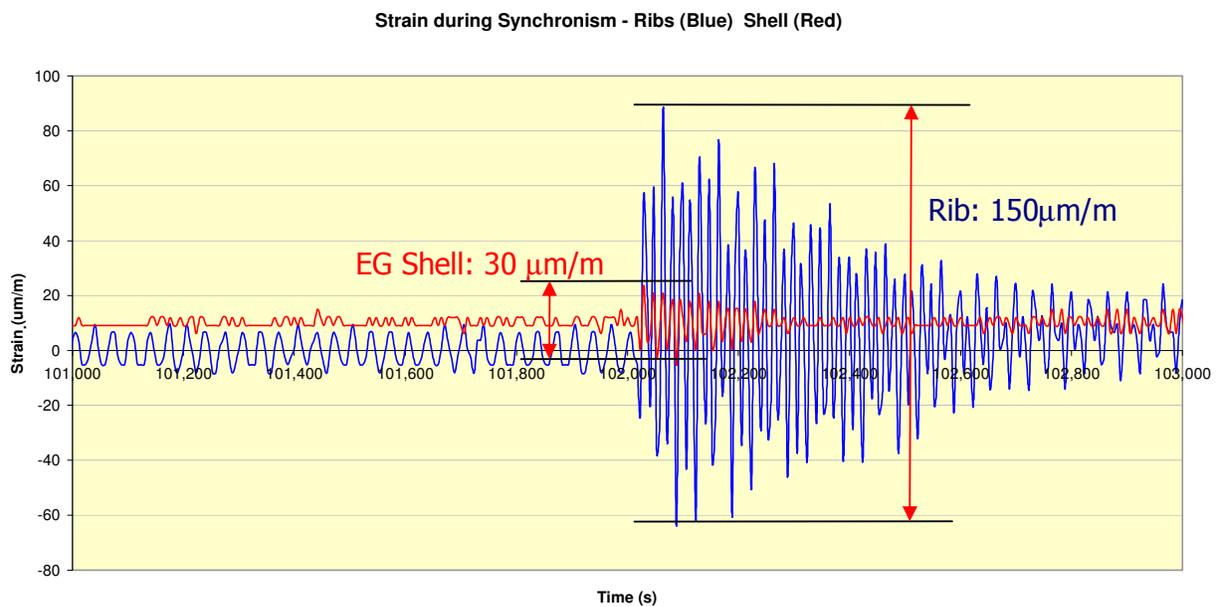
Figure 12 – Deformations in the rib (blue) and in the shell of the Lead Box (red) measured with strain gages

The figure 12 shows the time-history of the deformations during the synchronism of the plant measured at the shell and at the ribs. The maximum value occurred at the rib:  $150\mu\text{m/m}$  while at the shell the deformation was  $30\mu\text{m/m}$ . The results of the strain-gage measurements showed the cyclic effects of the deformation in the Lead Box, a factor of 5 between the stresses in the rib and in the shell of the Lead Box.

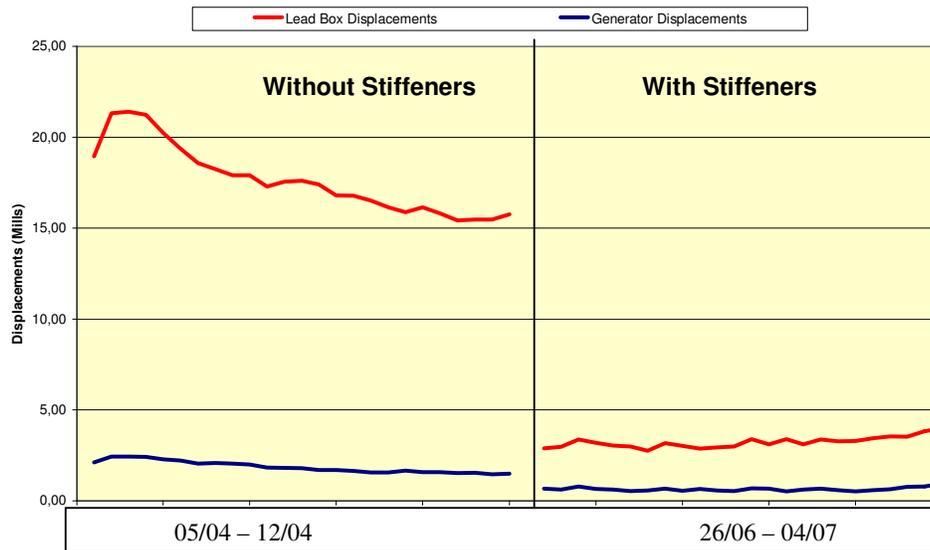
Figure 13 – Lead Box and Generator vibration measurements

Figure 13 compares the evolution of the displacement levels at the Lead Box and at the Electric Generator showing the effectiveness of the applied structural reinforcement. The vibration level of the Lead Box is still being monitored and the vibration amplitudes remain below 5.0 mills which is an acceptable value recommended by the Electric Generator manufacturer. The hydrogen consumption is also within the normal range.
