## HIGH CYCLE THERMAL FATIGUE FATHER EXPERIMENT: NON DESTRUCTIVE AND METALLOGRAPHIC EXAMINATIONS

S. Courtin<sup>1</sup>, J.A. Le Duff<sup>1</sup>, B. Tacchini<sup>1</sup>, A. Fissolo<sup>2</sup>, L. Vincent<sup>2</sup>, J.M. Stephan<sup>3</sup>, R. Tampigny<sup>4</sup>

<sup>1</sup>AREVA NP, 92084 Paris La Défense, FRANCE

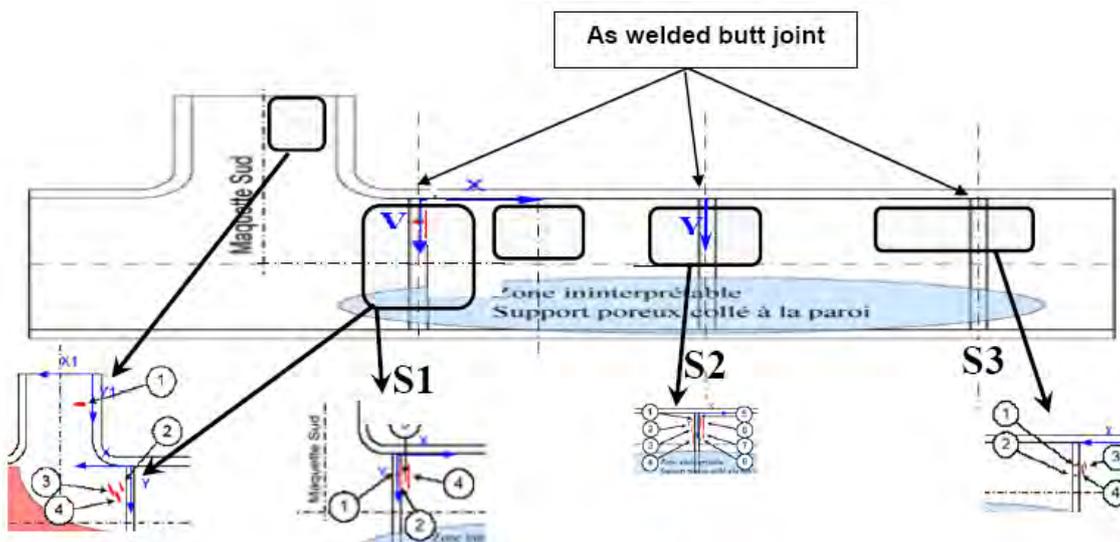
A good correlation was obtained between these four different NDT techniques. Main localizations of the thermal fatigue damage were near the as welded butt joints S1, S2 and S3 (Fig. 1).

Fig. 2: First half mock-up containing the as welded butt joint S1, S2 and S3 - Long dye penetrant inspection results and location of plate samples containing all defect indications

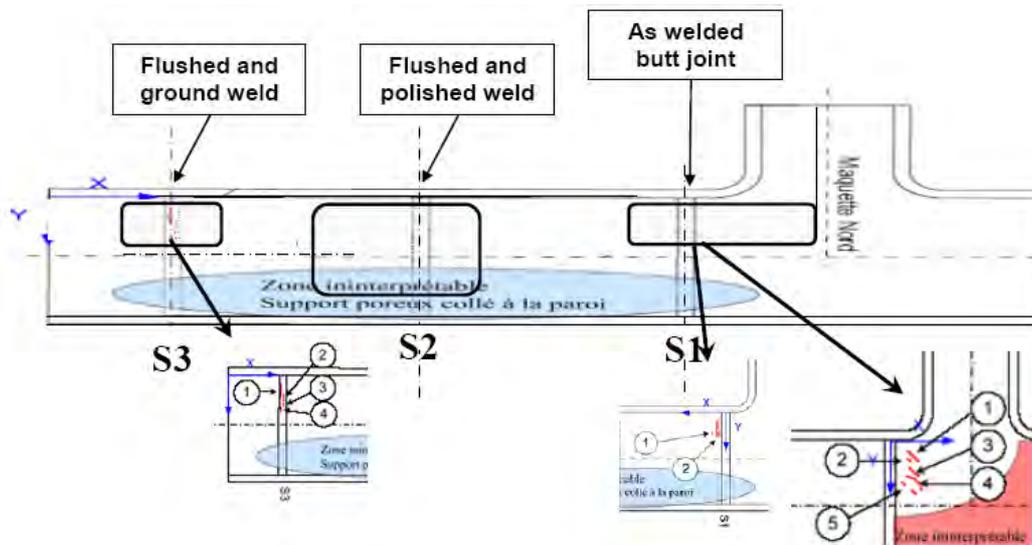
Fig. 3: Second half mock-up containing the as welded butt joint S1 and the flushed welds S2 and S3 – Long dye penetrant inspection results and location of plate samples containing all defect indications

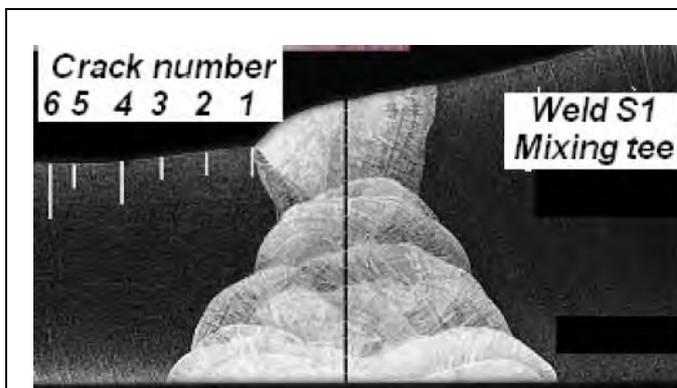
Metallographic cut shows that 6 cracks of depths varying from 120 to 630µm were seen near the S1 as welded joint in the straight pipe (Fig. 4a). Fig. 4b shows a micrograph of the crack number 6 initiated in the taper on an irregularity of the ground surface.

Fig. 4a: Cracks near the S1 as welded joint in the straight pipe

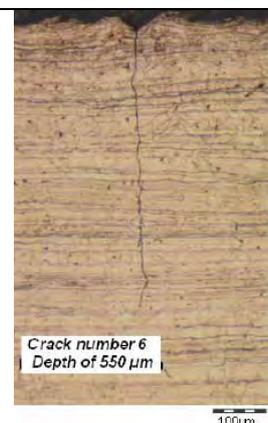
Fig. 4b: Crack 6 (S1 as welded joint)

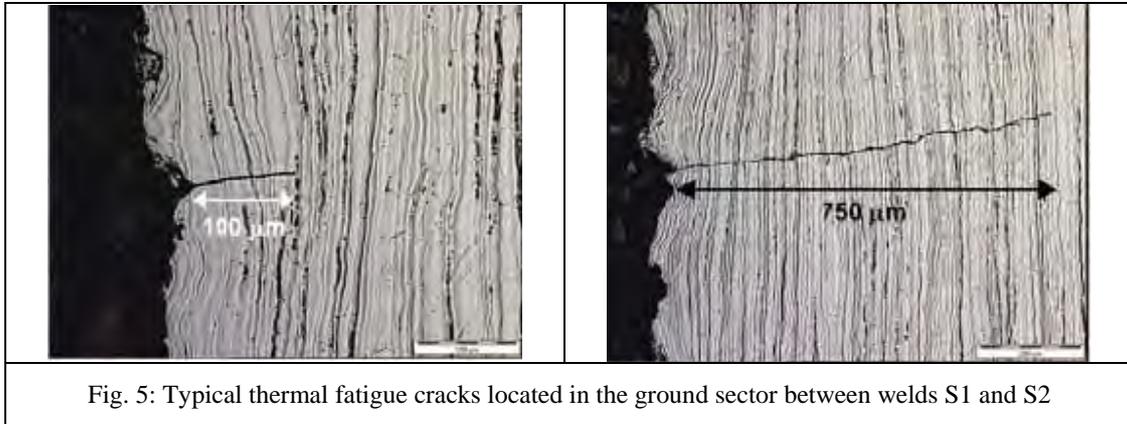
Metallographic cuts in the ground sector between S1 and S2 show the presence of 7 parallel cracks with depths varying from 100 to 750µm, all initiating from bottom of grinding striations (Fig. 5).

Fig. 5: Typical thermal fatigue cracks located in the ground sector between welds S1 and S2

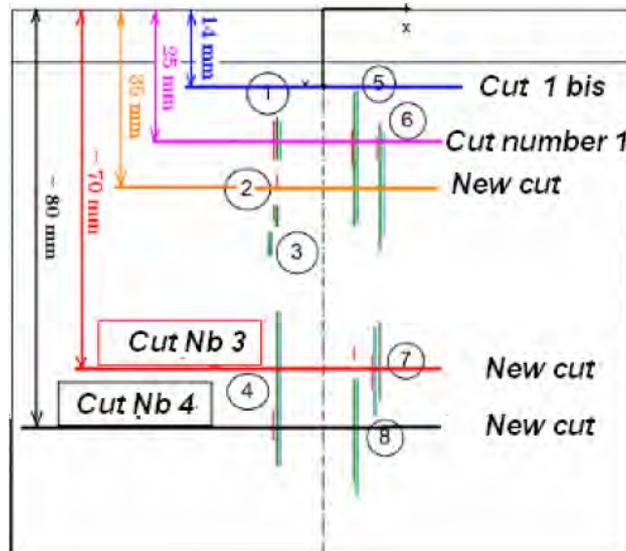
This S2 sample plate contains 8 indications of cracks revealed by NDT examinations (UT and dye liquid penetrant test). Five metallographic cuts have been done for illustrating the 8 indications reported on Fig. 6. Fig. 7a shows the results of the metallographic cut number 4 made through the defects number 4 and 8. This metallographic cut number 4 revealed the presence of 11 defects instead of the two indications 4 and 8 seen after NDT inspections. However, the depths of these 2 cracks 4 and 8 are the most important of the 11 defects seen on the metallographic cut number 4. Their depths are respectively equal to 800 and 1000µm. It appears that little cracks are not systematically detected by NDT methods. Fig. 7b gives a view of the deeper crack observed on the metallographic cut Nb 4 of the S2 as welded joint.

Fig. 6: Various NDT examinations results (UT & dye penetrant) of the S2 as welded joint sample

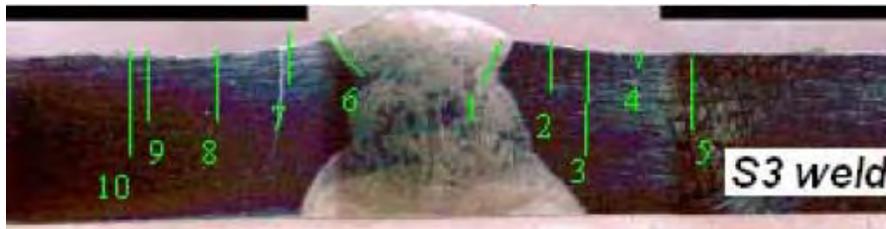
Metallographic cut shows that 10 cracks are located near the S3 as welded butt joint (Fig. 8). These thermal fatigue cracks initiate just at the weld toe and also in the ground tapers on each side of the weld bead. Fig. 9 shows that cracks initiate at the weld toe or in the tapers on surface irregularities. Surface finish presents some irregularities and thermal fatigue cracks initiate preferentially on these irregularities.

Fig. 8: S3 as welded butt joint (not flushed)

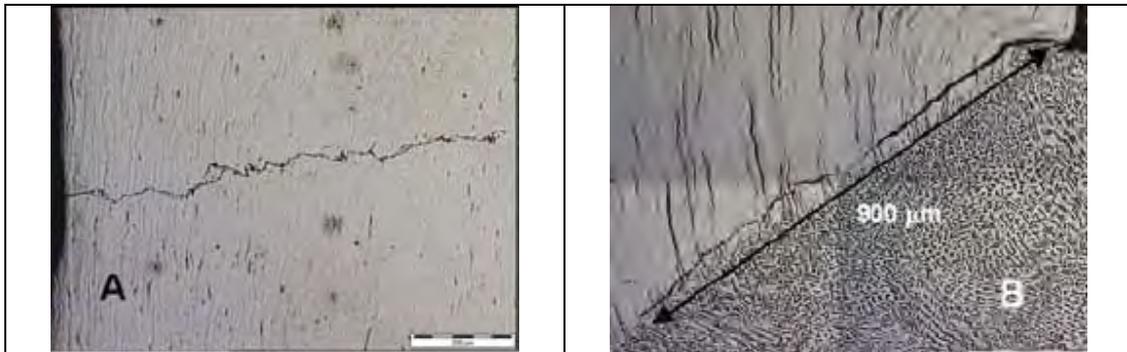
On this sample plate, 5 cracks have been observed in the S1 weld taper on the T-junction side with depths of 500 to 920µm (Fig. 10a). One thermal fatigue crack of 900µm initiates near the weld toe (Fig. 10b) and 6 other fatigue cracks with depths of 100 to 800µm were located near the S1 weld root. All thermal fatigue cracks are oriented in the circumferential direction and follow directions of grinding striations or of weld toes.

Fig. 10a: Crack of 900µm near the S1 weld root	Fig.10b: Crack of 900µm at the S1 weld toe
--	--

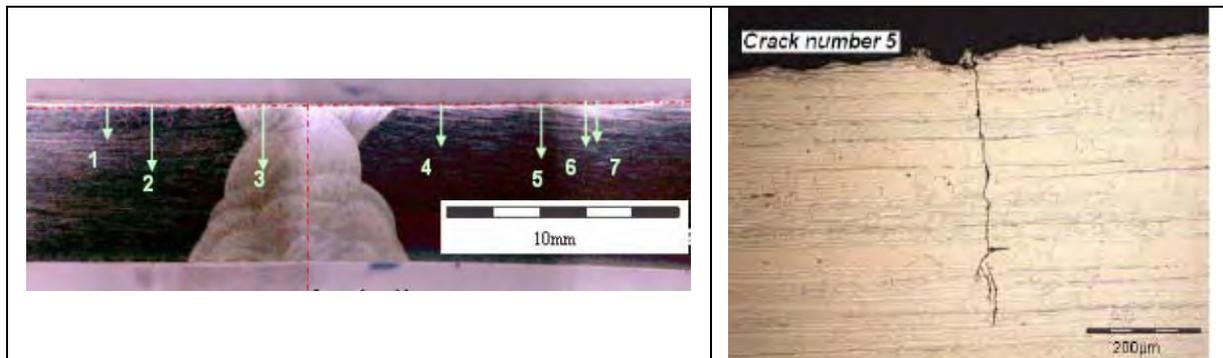
Metallographic cut shows that 7 fatigue cracks are located in the flushed and ground area of the S3 weld (Fig. 11a). These fatigue cracks are particularly fine and initiate on irregularities of the inner surface. Fig 11b gives a view of the crack number 5. It shows that surface finish of the flushed and ground weld S3 presents inner surface irregularities and cracks initiate on these irregularities.

Fig. 11a: Cracks in the flushed and ground weld S3	Fig. 11b: Crack 5 (flushed & ground weld S3)
--	--
