EVALUATION AND REPAIR OF SPENT FUEL DRY STORAGE STRUCTURES

Julia Tchner¹ and David Tanner²

ABSTRACT

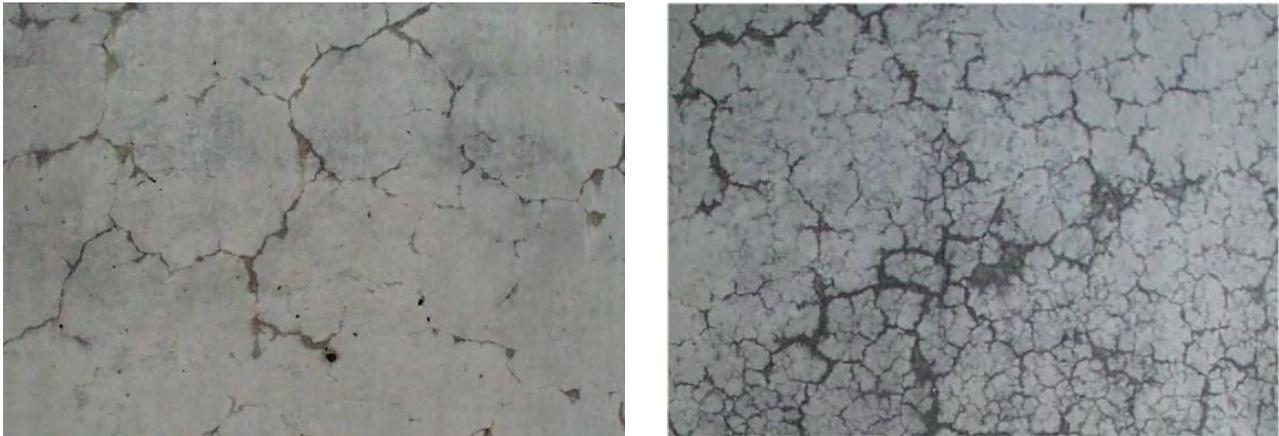
Pattern cracking was observed during inspection of the concrete canisters at one of the sites (Figure 1). An investigation of the canisters to determine the cause and extent of cracking to develop a repair scheme was undertaken.

Typical cracking on the surface of the concrete ranged in width from 0.1 to 0.25 mm and extended through the cores in most cases to approximately 50 percent of the core length. In some cases, deposition of secondary mineralization on the surface of the canisters at crack locations was observed. Efflorescence was observed in many cases below the crack. Although the pattern of cracking and leaching deposits often associated with Alkali Aggregate Reaction (AAR) were observed on most canisters, petrographic examination did not reveal features typically associated with AAR.

The distribution and character of the cracking suggests they are principally the result of factors such as restrained drying shrinkage and thermal effects, enhanced by the geometry of the structures and construction practices used. Although efforts were taken to reduce the effects of thermal stresses developed during the hydration of such large masses of concrete mostly by using low heat of hydration cement, the impact of temperature differentials on the concrete canisters is important when considering that canisters were constructed in cold weather conditions.

Figure 1 Close up View of Typical Cracking Pattern on the Outside Surface of Concrete Canisters

Although cracking has had little effect on the performance of the canisters and quality of concrete, the long term integrity of the structures might be jeopardized as the existing crack network acts as conduits for moisture movement into the interior of the concrete, which is evident by the widespread occurrence of leaching on the exterior of the canisters. Thus, it was recommended to protect the canisters from further deterioration by preventing the moisture from penetrating the canisters.

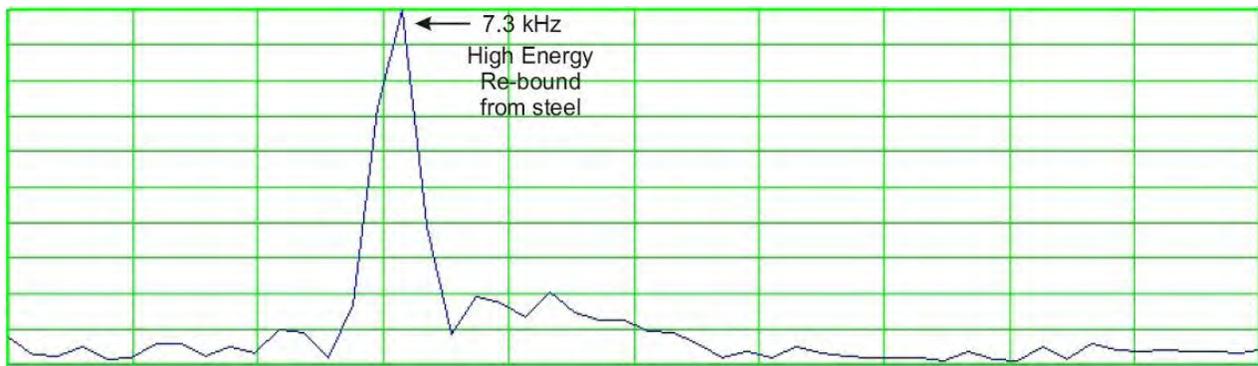
The impact echo survey was conducted at forty-two locations evenly spaced around the canister and along its length. All impact echo tests showed similar results. Figure 2 shows an example of the type

of signal obtained. Invariably there was a very large peak around 7 kHz. In addition, some tests showed very minor peaks around 15 kHz and at 1 to 1.5 kHz. To analyse the probable location of these reflected signals, calculations were made of the expected frequencies from known design details within the canisters.

Based on the analysis, the 7 to 7.5 kHz peak was from the outer reinforcing steel, while minor peaks at 1 to 1.5 kHz were reflections from the inside steel cylinder or inside reinforcing cage. The minor peaks around 15 kHz were from the cracks in the concrete cover. There were no significant peaks noted between 7 kHz and 1.5 kHz, which indicated the absence of internal defects or flaws beyond the level of the outer reinforcing steel.

Example 1. impact-echo signal showing all rebound energy from outer steel

Figure 2 Example of Impact Echo Signal in Canister

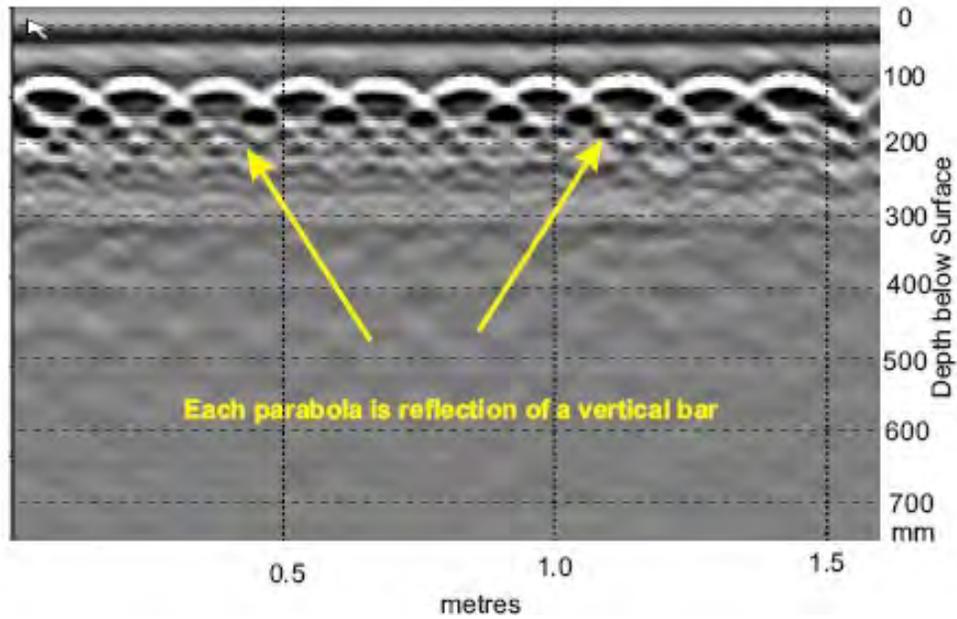
Another possible interpretation of the dominant peak frequency result of 7.5 kHz, which was considered, is that there is a crack at approximately 230 mm inside the concrete. This interpretation was considered improbable since it is unlikely for the crack to be present at exactly the same location in each of the tested canisters. However, it was prudent to include alternative technique (i.e. GPR scans) to rule out the existence of anomaly at that location. A limited number of GPR scans were conducted. The GPR survey showed a very tight pattern of reinforcing steel in the outer reinforcing cage, but did not show any indication of deterioration in the main body of the concrete (see Figure 3).

Figure 3 Horizontal GPR Scan of Canister

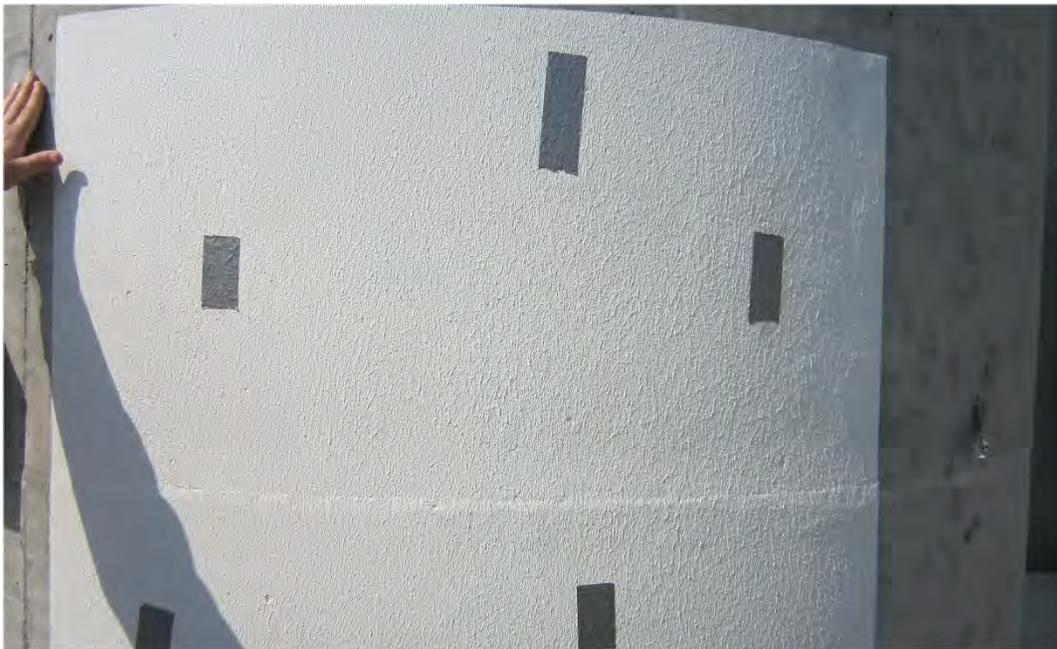
Figure 4 Test Patch

Quality control / quality assurance activities were implemented for this application. A few test patches were prepared to confirm surface preparation and application method (Figure 4). Measurements of the wet film thickness during application of the coating are shown in Figure 5. X-cut test was performed following requirements of ASTM D3359 to confirm adhesion thus qualifying surface preparation and curing (Figure 6).

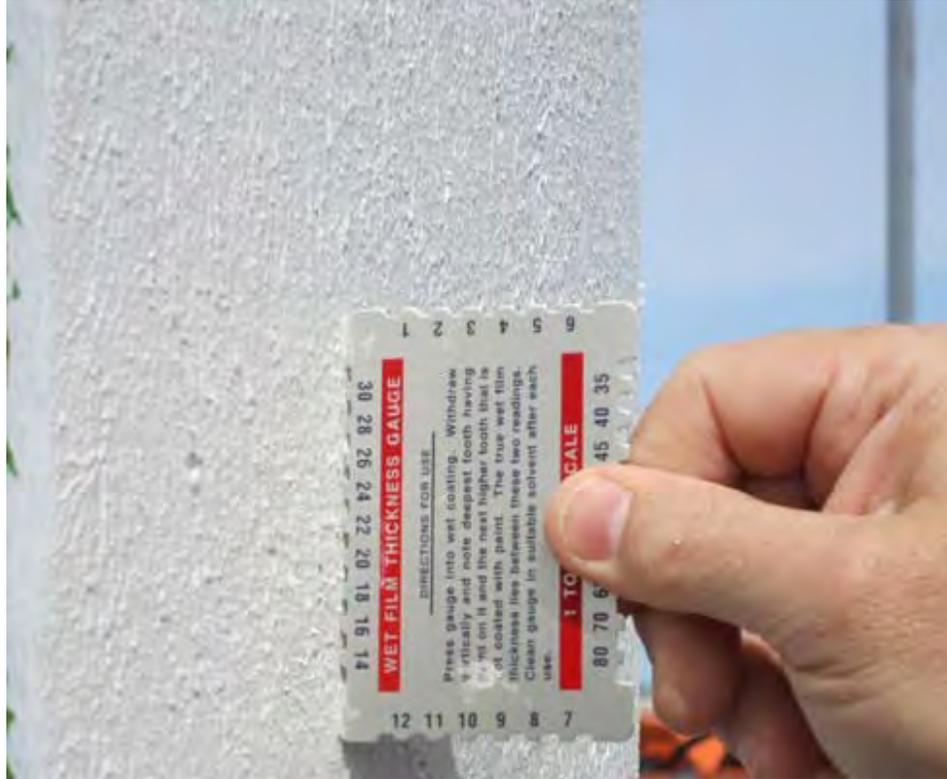
Figure 5 Measuring Wet Film Thickness

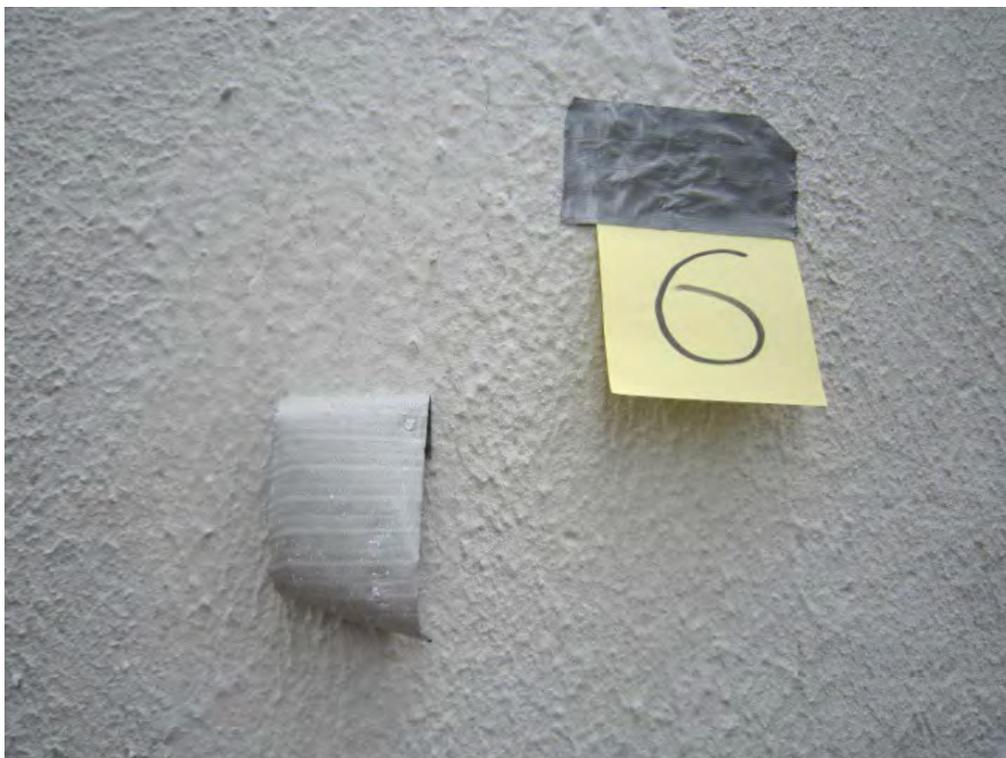
Figure 6 X-cut Test

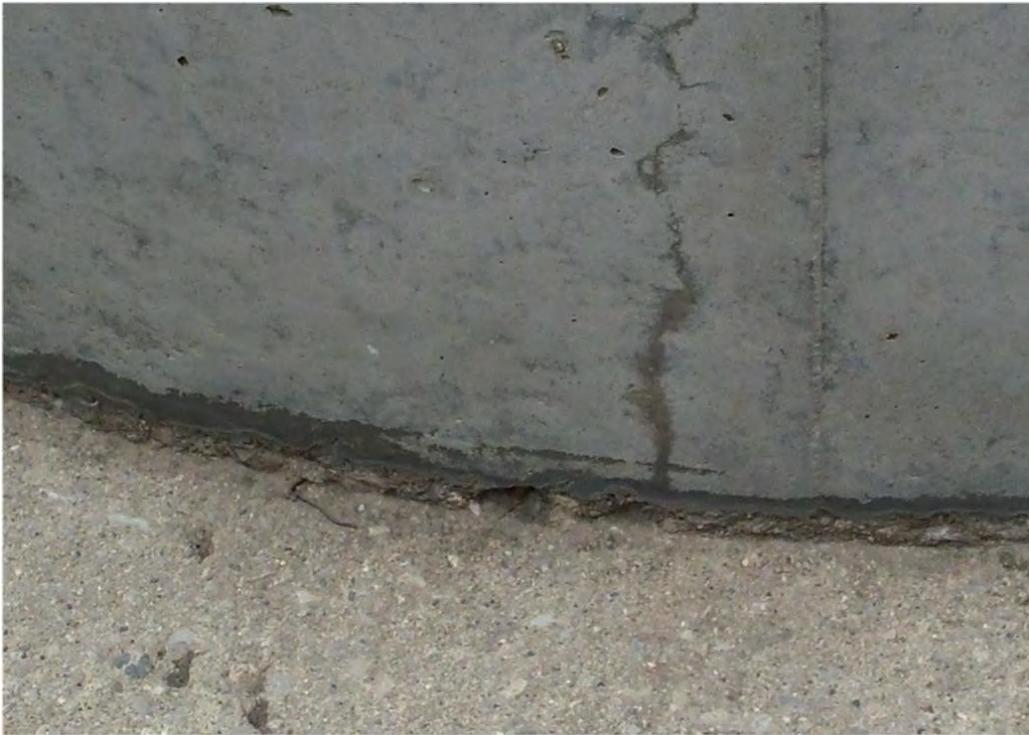
Figure 7 Deterioration at the Bottom of the Canister

Deterioration at the bottom of the canisters shown in Figure 7 was repaired using Gel Patch by BASF and sealed with a "cant-bead" of NP1 by BASF (single component polyurethane sealant). Flexible joint sealant SL2 by BASF was installed between the base slabs treated with Enviroseal 40 to provide waterproofing (Figure 8). Repaired canisters shown in Figure 9 are performing well after nearly three years since weatherproofing.

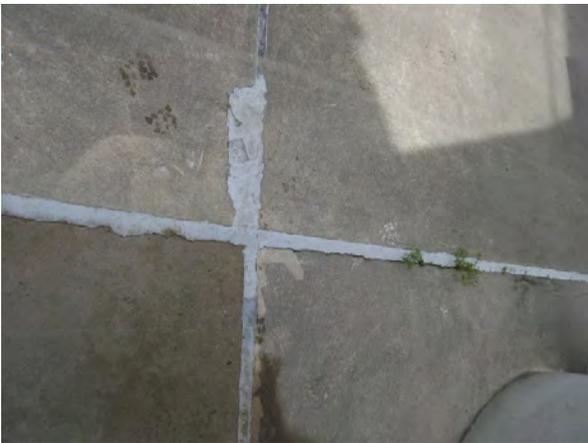
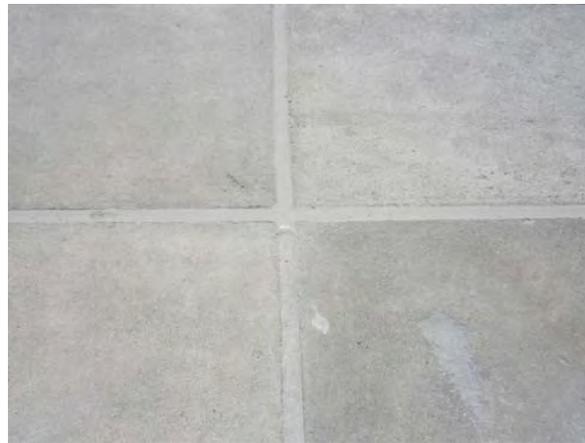
Figure 8 Base Slab (before and after repair)

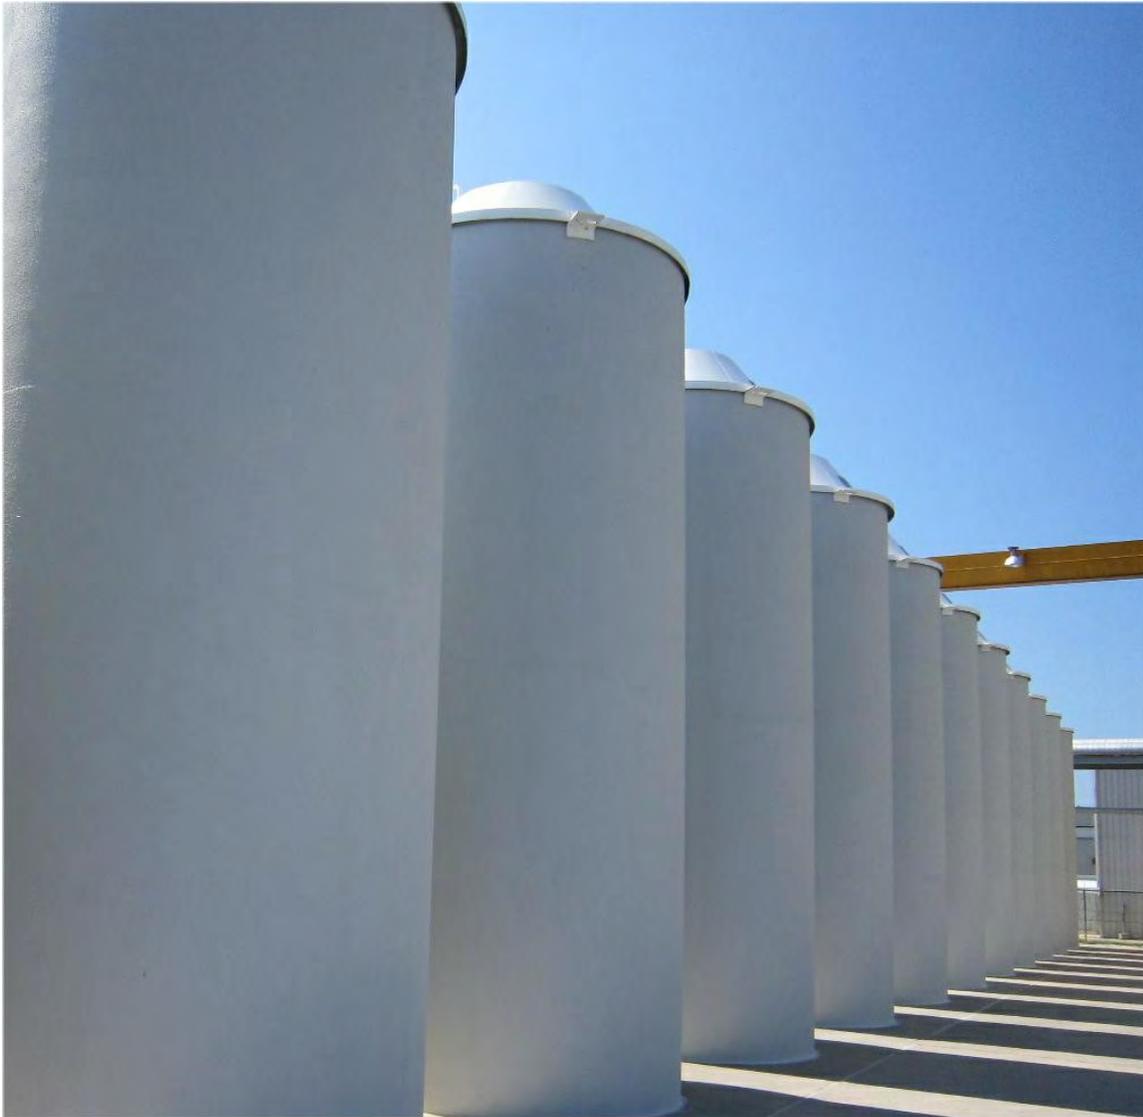
Figure 9 Repaired Canisters
