## Structural Integrity Assessment of Turbine Driven Feed Pump Line due to Water Hammer

<sup>1</sup> Nuclear Project Safety Division, Atomic Energy Regulatory Board, India

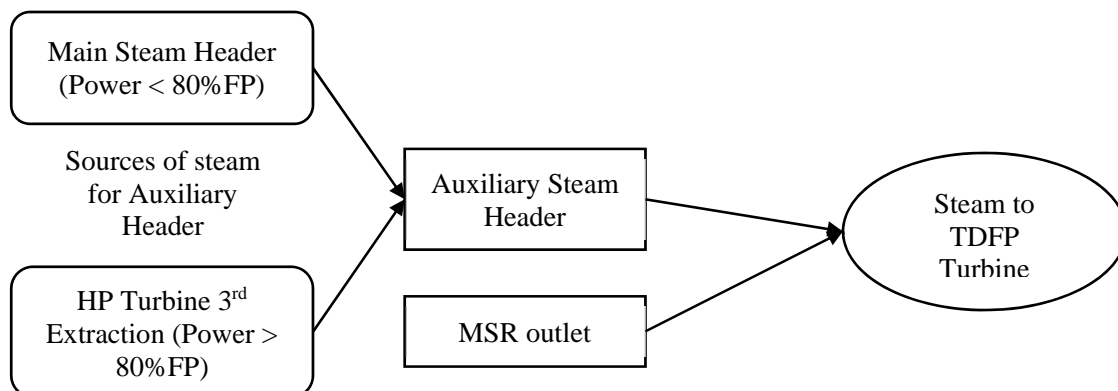
Figure 1: Layout of TDFP Pipeline experienced to water hammering

During mandatory tests for ensuring preparedness for plant start-up, an event of inadvertent opening of TDFP drive steam supply valve resulted in sudden supply of high temperature steam to the cold pipelines resulting in water hammer in the pipe lines connecting TDFP steam supply header and MSR outlet. Damage was noticed in supports of pipe line located between two anchors of Low Pressure Turbine steam header and TDFP steam header. Anchor supports (fixed) were observed to be healthy without any visual deformation, however sliding supports on straight portion of pipeline were found dislodged from the location and supporting members were observed in deformed condition. The straight portion of pipeline supported by sliding support was found displaced during visual inspection (around 225 mm) due to impact of water hammer and could not come to original position due to locking with support bottom base plate. However, after cutting the damaged support metal structure, it came to normal position indicating no plastic deformation of straight portion of pipeline, whereas, perhaps the piping elbows which absorbed the displacement loading had undergone plastic deformation.

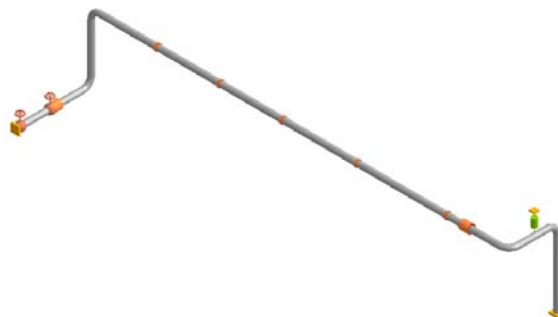
Figure 2: Layout of TDFP steam supply piping

The layout consists of 5 straight pipe portions and 4 elbows as shown in Figure-2. The span of straight pipe which experienced a displacement of 225mm was 27.5m. The salient geometric parameters of piping are provided in Table-1.

Due to the displacement induced loading, the maximum values of stress intensity were observed in the elbows shown in Table-4. The stress intensity has exceeded the yield stress in 3 out of 4 elbows and maximum stress intensity (354MPa) was observed in elbow-3. Stresses in the straight pipelines were less than yield stress indicating elastic behaviour of the straight piping. Based on the preliminary estimation of stresses, yielding has occurred in 3 out of 4 elbows.

Based on the current study, AERB recommended utility to replace all 4 elbows of TDFP Piping. It was also recommended to ensure healthiness of all affected TDFP piping supports and weld joints by carrying out MPT and UT. As a part of NDT inspection, PT and MPT was carried out on fixed supports and no reportable indications were noticed. Embedded Parts of the supports, which were damaged, have been replaced.

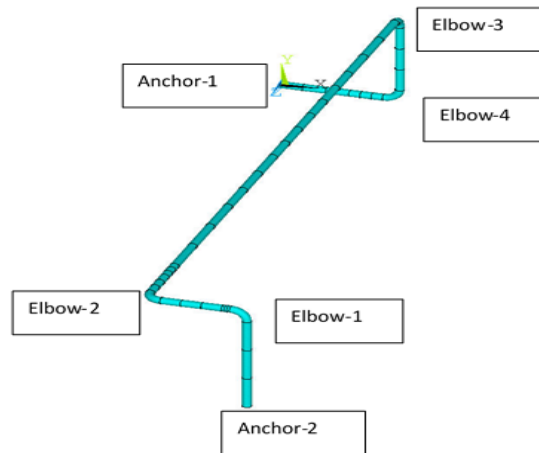
Figure 3: Finite Element Model of TDFP line

For the anchor supports (on both extreme ends of pipeline), all 6 degrees of freedom are constrained. For the sliding supports located on straight pipeline, the displacements are constrained in X & Y direction, while it is allowed to displace freely in axial (z) direction. Spring support located on straight pipe near to Anchor-2 was modelled by constraining in Y- direction (vertical). As per the observed displacement of straight pipeline portion, a displacement loading of 225mm in -Z direction was imposed on longer straight line to take into account the effect of water hammering impact.

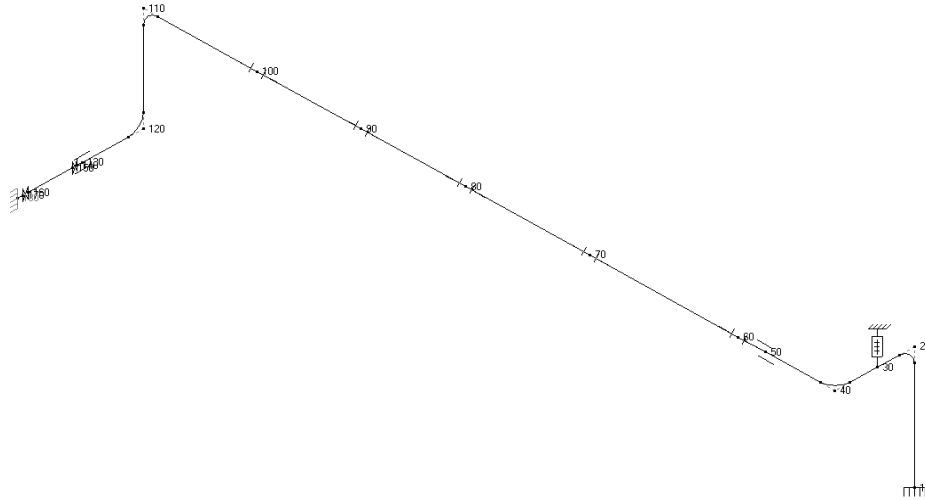
Figure 4: CAE Pipe model of TDFP piping

Since the term  $B_1$  for elbows is zero (due to very high bend radius), it implies that the stress induced in elbows due to effect of pressure surge is zero and the only stress inducing load on elbows is the bending moment. Table-6 brings out compliance to Section-III NC, Level-D stress limits for elbows of piping. The value of stress ratios computed by ratio of stress evaluated from Equation (1) and the limiting stress  $2S_y$  for elbows are presented in the Table-6 (for Elbows, A&B denotes two ends). For remaining portion of pipeline, the stress ratios were less than 1.

Even though the stress ratio exceeded 1 in elbows as per analysis, no physical failure of elbows was observed (during post-event inspection) because the current analysis considers elbows material as elastic neglecting strain hardening behaviour and stress redistribution due to plastic deformation. From the results it can be concluded that the elbows might have undergone significant plastic deformation.
