Behavior of Mixed-Oxide Fuel Elements in a Tight Bundle under Duty-Cycle Conditions

T. ASAGA, S. SHIKAKURA
Power Reactor and Nuclear Fuel Development Corporation, Oarai, Japan

H. TSAI, L. A. NEIMARK
Argonne National Laboratory, Argonne, IL USA

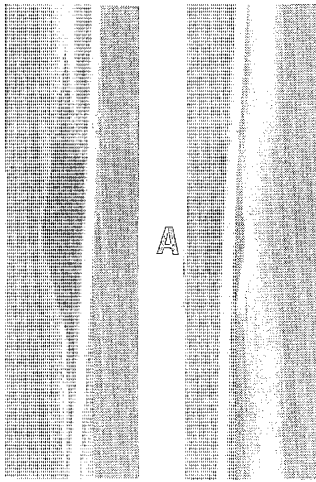
During postirradiation examination, two breached pins, both D9-clad, were identified. None of the 316SS-clad pins, some with higher fuel smear densities, developed breach. The condition of the cladding breach is shown in Fig.1. Both cladding breaches were longitudinal cracks, initiated under the wire and at an axial location near the top of the fuel, $x/l \sim 0.93$. The appearance of the cladding breach suggested the failure mode was a gas-driven burst rupture. The significant nondestructive and destructive examination results for the TOB-10 fuel pins are presented below.

Fig.1. Two views of the cladding breach of the D9-clad pins. The bulge at "A" caused the contact with a neighboring pin.

Both cladding breach in the D9-clad pins took place near the top of the fuel column where extensive FCCI and cladding thinning occurred. Meanwhile, cladding profilometry data showed no appreciable cladding ovality in any of the pins examined. This suggested that pin bundle-duct interaction was minimal and not a principal cause of cladding breach. The principal cause of cladding breach in the TOB-10 test was apparently the significant cladding thinning resulting in an increased hoop stress in the cladding. In addition, the fission gas pressure in the central void in the fuel column could have been substantially enhanced due to FCCI-induced blockage. The burst-type rupture of the cladding in the fuel column region strongly suggested high gas pressure in the fuel column.

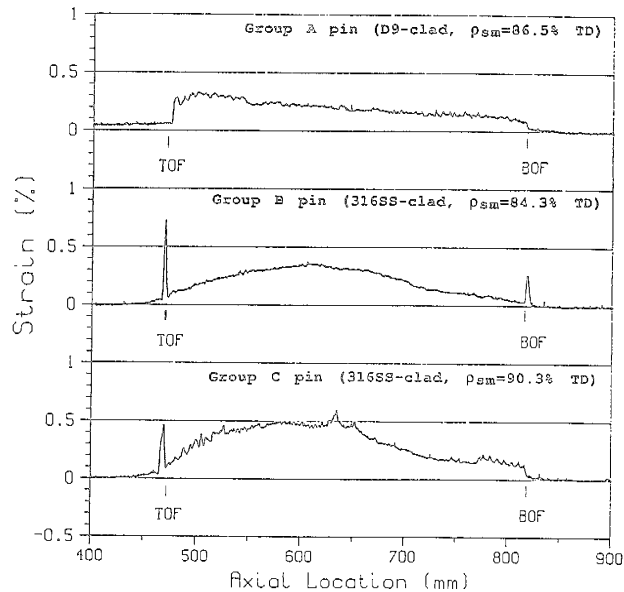
Fig.2. Cladding strain profiles of three TOB-10 test fuel pins with different designs.

The strain profiles for the TOB-10 fuel pins vary systematically with pin design, particularly, cladding material. The measured cladding strain profiles for the D9- and 316SS-clad pin groups are illustrated in Fig.2. The overall strain for the D9-clad pins was small, with a maximum of ~0.30%. At the top end of the fuel column, there was a region of increased strain. This strain plateau, ~70-100 mm long, appeared to be present in the two breached pins as well. The step change of the strain profile at the end of the fuel column indicated that the strain in the low-swelling D9 clad-pins was induced mainly by fuel/cladding mechanical interaction (FCMI).

The strain profiles of the 316SS-clad pins, on the other hand, had a generally chopped-cosine shape with the sharp strain peaks at the end of the fuel column. The maximum strain in the fuel column was also small, ~0.4-0.5%, occurring $x/l \sim 0.6$. The chopped-cosine strain profiles in the fuel column region in the 316SS-clad pins suggested that a significant portion of the overall strain in the fuel column region was due to irradiation-induced swelling of the 316SS cladding material.

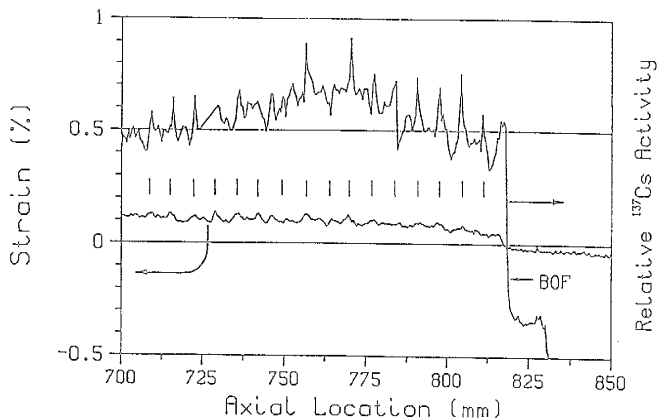
Fig.3. Correlation between the local strain peaks and accumulation of ^{137}Cs at the pellet/pellet interfaces (tick marks) in the bottom portion of the fuel column.

Within the fuel column, the cesium distribution pattern showed local variations depending on the axial location. In the cooler bottom portion of the fuel, cesium accumulated predominantly at the pellet/pellet gaps, as shown in Fig.3 for a D9-clad pin. The superimposed cladding strain profile showed that the periodic high strain peaks are associated with the cesium buildup at the pellet/pellet interface. In the upper portion of the fuel column, shown in Fig.4, there were greater cesium activities along the fuel pellet than at the pellet/pellet interfaces. Metallography and electron microprobe analyses indicated that the cesium at these upper locations had reacted extensively with the cladding but little the fuel (see below). The cesium in the cooler region may be in compounds with other fission products, such as Cs_2MoO_4 . That in the hotter region may be reaction compounds with the cladding, such as cesium chromates. An electron microprobe examination is under way to identify the chemical forms for the Cs-bearing compounds in bottom regions.

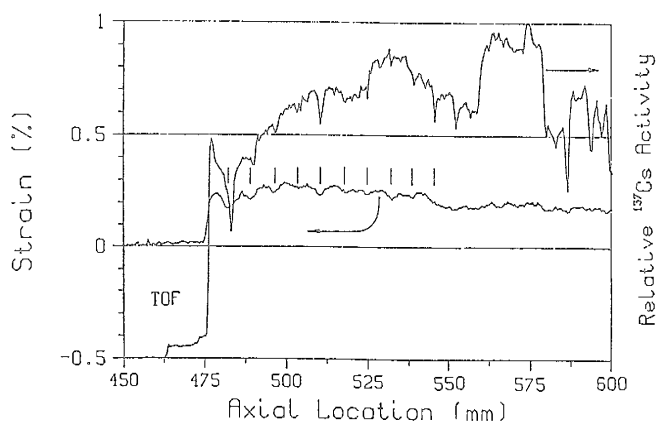
Fig.4. Correlation between the local strain minima and ^{137}Cs distribution in the top portion of the fuel column. The tick marks denote the pellet/pellet interfaces.

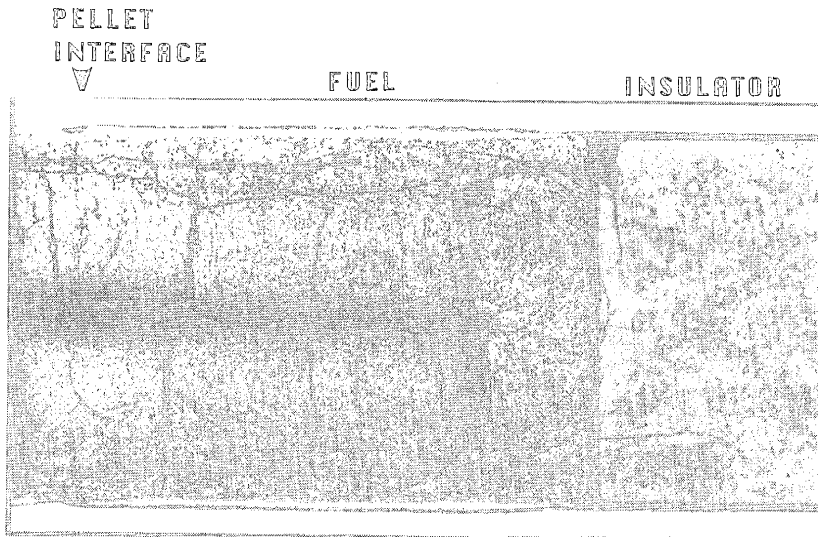
Metallographic examination revealed significant fuel/cladding chemical interaction (FCCI) near the top end of the fuel column in the D9-clad pins, as shown in Fig.5. There was appreciable cladding wastage due to the FCCI; the wastage was smaller at pellet/pellet interface, corresponding to the cladding strain pattern mentioned above. The maximum cladding wastage was $\sim 80\mu\text{m}$ ($\sim 20\%$ of the cladding thickness), somewhat greater than that observed in the D9-clad fuel pins in the single-pin tests. Penetration into the cladding was predominantly a broad-front matrix attack, which filled the fuel/cladding gap. The FCCI in the 316SS-clad pins was minor and resulted in no measurable cladding wastage.

Fig.5. Fuel/cladding chemical interaction of the D9-clad pins.
(at the top end of the fuel column)

(2) Severe fuel/cladding chemical interaction (FCCI), which resulted in substantial cladding thinning and probably restricted venting of fission gas from the fuel column into the pin plena, apparently caused the earlier-than-expected cladding breaches in the D9-clad pins. No such severe FCCI was noted in the 316SS-clad pins.
