## DEFECT ANALYSIS OF RECIRCULATION PUMP SHAFT CRACKING

U.R. Blumer and A. Frei

Sulzer Winterthur, Switzerland

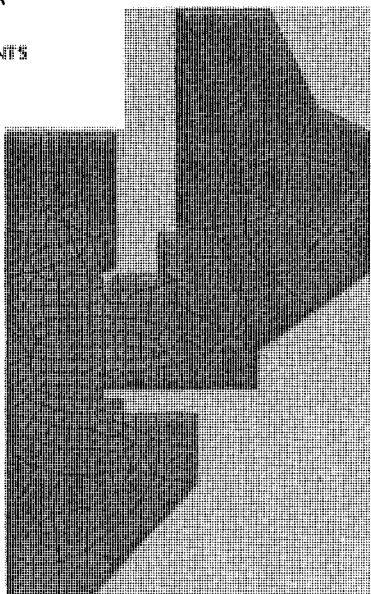
Fig. 3

The finite element mesh is shown in fig. 3. It shows the

shaft, the sleeve, and parts of the impeller and the casing in an axisymmetric model. Along the inside and outside of the sleeve, fluid elements have been placed.

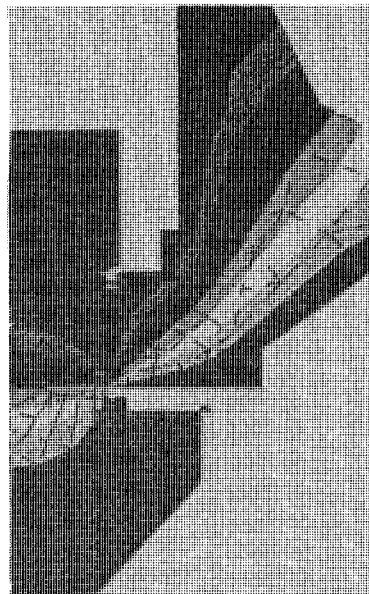
Fig. 4

Figure 4 shows the temperature contour plot of the case with no water flow between shaft and sleeve.

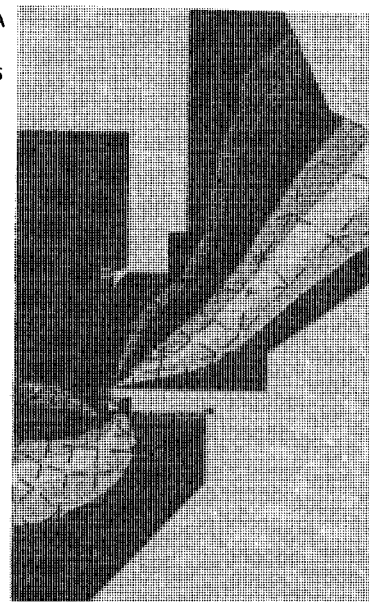
Fig. 5

Figure 5 shows the temperature contour plot of the case with an upper bound water flow between shaft and sleeve.

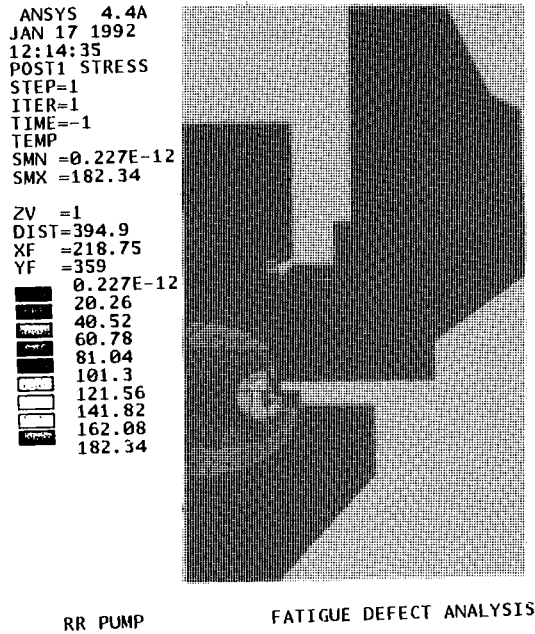
Fig. 6

Figure 6 shows the contour plot of the difference field. It is very interesting to see, that the maximum differences are located exactly at the position where the cracks have been found. This is a strong indication that the phenomenon is actually caused by a fluctuating mass flow between shaft and sleeve due to the unstable thermal "breathing" of the sleeve as described above.

- The water has to be prevented from flowing between shaft and sleeve by appropriate machining tolerances and/or welding
- The small radial ring which acts as a pump should be eliminated

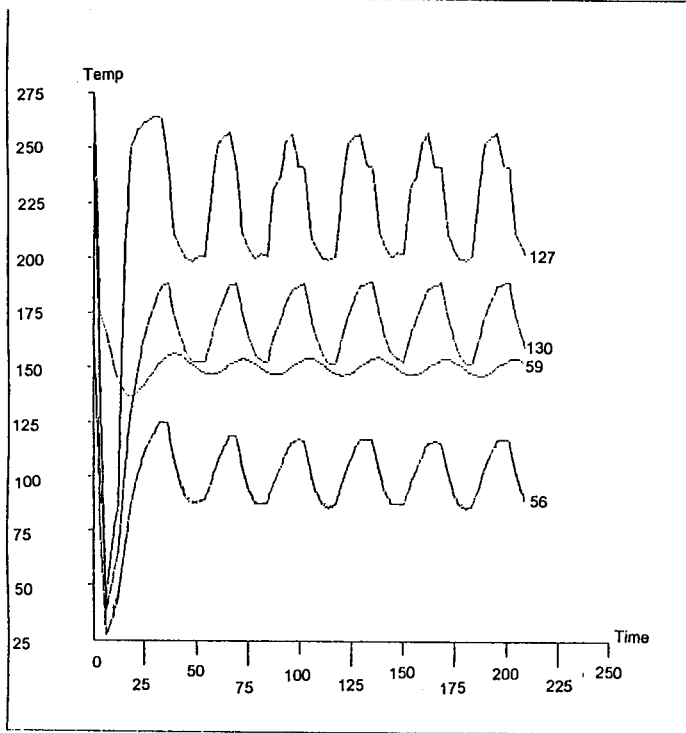
Fig. 7 shows some results of the analyses performed: The curves show the behaviour of some node temperatures in the critical region. It can easily be seen that the process is really unstable and that a frequency of about  $0.03 \text{ sec}^{-1}$ . Fig. 8 shows the graph of the flow rate between shaft and sleeve and which also fluctuates between a maximum value and almost zero.

This frequency of thermal fatigue would lead to high cycle type of failure. The temperature fluctuation range obtained was

somewhat too low to explain the formation of cracks. However, the analysis was found sensitive to several poorly known parameters like exact gap width, exact injection water temperatures etc., so that it cannot be excluded that other assumptions would lead to larger temperature ranges.
