General description of the great Devnya's accident of a gas explosion

Dzhupanov V.A.

Bulgarian Academy of Sciences, Bulgaria

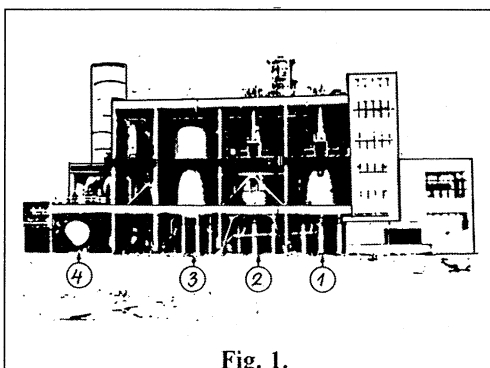
Fig. 1.

3.2. *Two pictures of the Polymerization Workshop.* On Fig 1 the picture of the Polymerization workshop before the accident is shown. By numbers 1 and 2 both pairs of reactors are denoted. By number 3 the pair of two degasators is denoted. Outside, but behind is seen a tall cylindrical tank. Three concrete plates form two working levels and a roof, but all the technologic equipment is on open air. On Fig 2 the four non-broken reactors and both degasators before the full dismantling after the accident are shown. All destroyed structures are avoided.

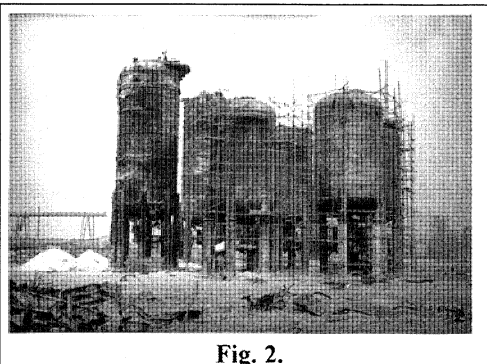
and metallographic X-ray investigations did show that the reactors as geometric structures, as well as a metallic material, were not destroyed at all. This is seen by the view on Fig. 17 and Fig. 2. However the Polymerization Workshop was disposed close to the silos scaffold bridge and in contrast all of the silos were fully destroyed, Ref. [01].

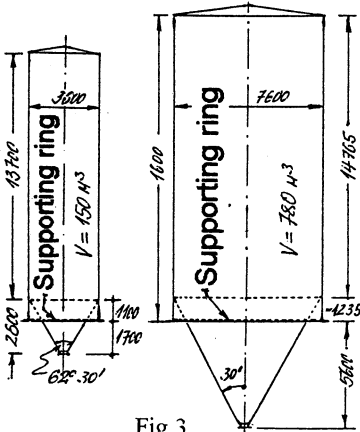
Fig. 3.

- (1). The long cylindrical shell serving as a basic body for the product stored (PVC powder).
- (2). The short supporting cylindrical shell (called "supporting ring").
- (3). The conical-shell hopper serving as a bottom holding the contents.
- (4). Conical roof shell.

All these components are well observed on Fig.3, and so they do not need additional explanations.

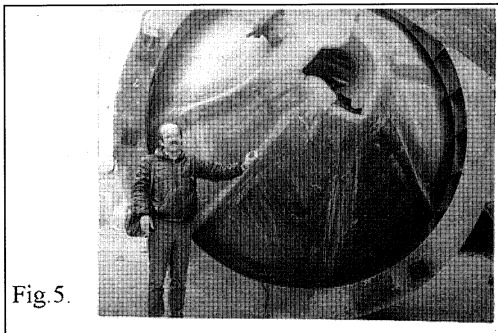
4.3.4. *The conical hopper shells* of the large silos had been torn off from the cylindrical shell and fell down from the scaffold bridge. over the railway transport hoppers. The conical hopper shells of the small silos Fig.5 were found to be joined to the supporting cylindrical shells, but all the 5 of them had characteristic longitudinal ribs, well seen on Fig. 5. Their probable origin is under discussion. One of the small silos was remained on its place on the scaffold bridge. This helped us very essentially, permitting to check the presupposed working hypotheses on place.

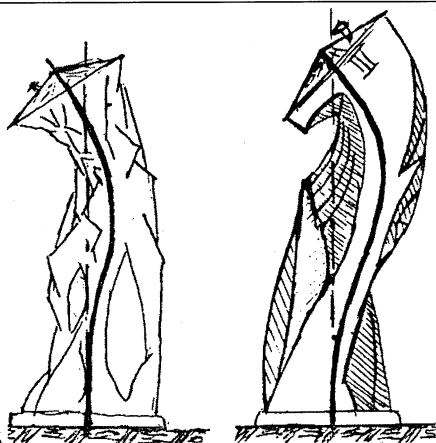
Fig. 6.

4.3.5. *General considerations.* On Fig. 6 the character sketches of two of the destroyed large silos are given. On Fig. 7 a photo-picture of a typical destroyed large silo is shown. On Fig. 8 and Fig. 9 upward views of two different large silos (lying on the ground) are shown. They prove that 5 large well expressed semi-waves in circumferential direction were formed as a result of the cylindrical shell destruction. This fact can be used for considerations on the inverse problem.

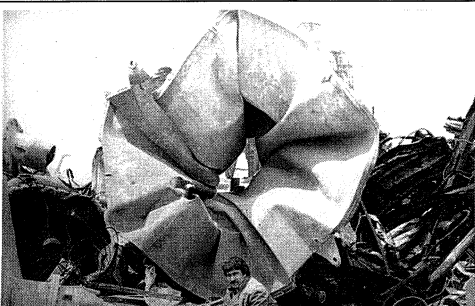
In taking e.g. the forced circular frequency $\sigma_{1,5}$ as responsible for the deformation observed, one can find the velocity of the escaping corky powder PVC. On Fig. 10 a specific deformation of a small silo from the Drying Workshop is shown. Its comments can be found in the text after Fig. 16.

5.4.3. *An exotic tank deformation.* An exotic peristaltic destruction (large deformation) of a vertical cylindrical tank *partially filled with liquid (dense oil)* is shown on Fig. 16. Analogous was the deformation of one of the "small" silos shown on Fig. 10. Both cases demonstrate that the random combination of the causes produce particular action of the pressure, and the corresponding particular deformation of the thin-walled structures, if there are cavity zones in the filling. In both cases the great rigidity of the roof conic shells is well observed.

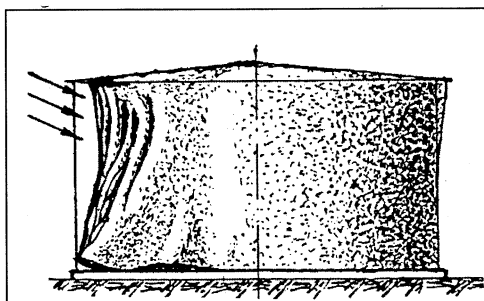
Fig. 13.

5.4. *Three cases of real destruction.* 5.4.1. *The vertical cylindrical tanks* storing liquid dichloroethane are destroyed just following the scheme of the first theoretical pattern. However, the sample sketch is shown on Fig. 13, a confirming photo-picture being given on Fig. 14.

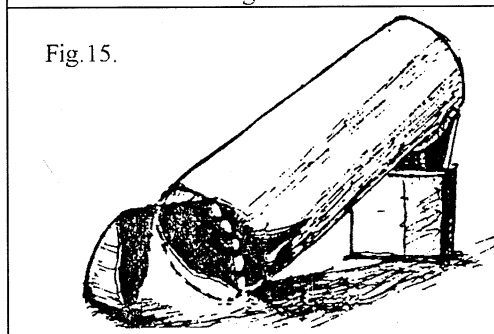
5.4.2. *A horizontal tank.* A sketch of a destroyed "small" horizontal tank for hot liquid VC processing is shown on Fig. 15. The temperature of the liquid VC in this tank had 96°C , which after break, at 0°C and normal atmosphere pressure explosive-like turned itself into gas and together with the air formed the explosive mixture causing the accident under consideration.
