Examination of Overlay Pipe Weldments Removed from the Hatch-2 Reactor

J.Y. Park, D.S. Kupperman, W.J. Shack

*Argonne National Laboratory, Materials Science and Technology Division, 9700 South Cass Ave.,
Argonne, Illinois 60439, U.S.A.*

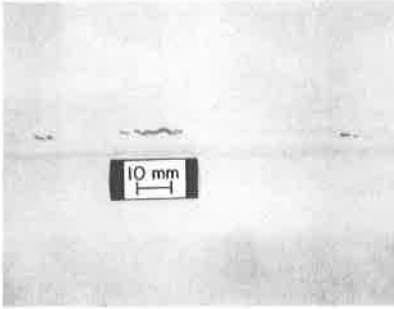
or point), and most of them were located within 8 mm of the weld fusion lines (WFLs). There were no undercuts at the WFLs that produced PT indications in either weldment. Figure 1 shows a photograph of the PT indications observed at circumferential positions 79 and 81 cm from the origin (see Table I) on the elbow side of weldment C2.

1. Three PT Indications at Inner Surface of Weldment C2 (Elbow Side).

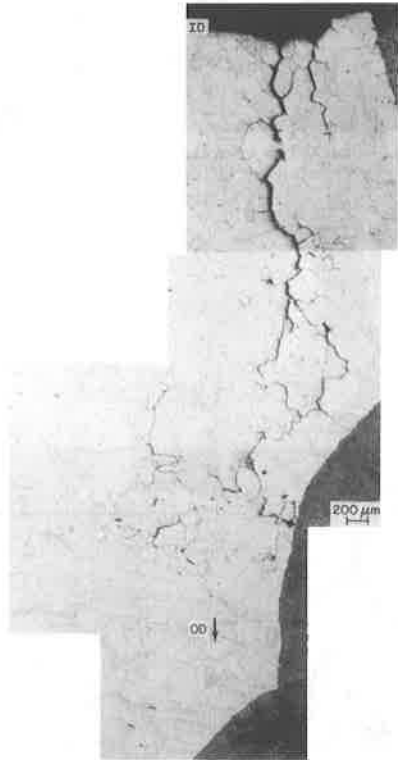
The sectioning (Table I) showed that the circumferential and point indications (22, 29, 33, and 65 EL and 95 PP) were associated with circumferential intergranular cracks, one axial indication (81 EL) was associated with an axial intergranular crack, and one skewed indication (3 EL) was associated with a skewed intergranular crack. It also confirmed that the circumferential cracks 22, 29, and 33 EL were not linked. Figure 3 shows a cross section of the circumferential crack 29 EL. The crack has not propagated into the weld metal. Branching of the crack near the crack tip has occurred.

3. Circumferential Intergranular Crack at 29-cm Position of Weldment C2.

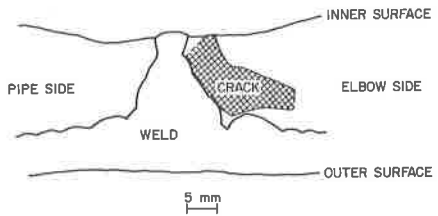
A cross section of axial crack 81 EL is shown in Fig. 4. Within the wall, the crack is much longer (17 mm) than suggested by the PT indication (2 mm long) at the inner surface. The crack profile, as determined by metallography (Fig. 5), is somewhat unusual in

5. Mapping of Axial Crack at 81-cm Position of Weldment C2.

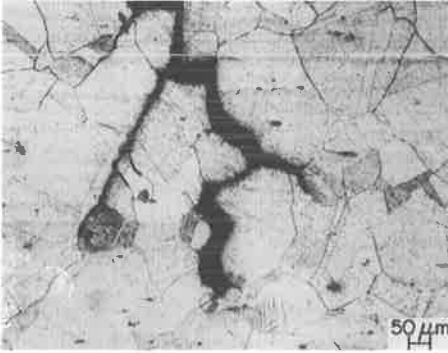
shape (Park and Kupperman [1]; Cheng [2]). It is possible that the crack is growing axially in the HAZ associated with the overlay, but this is uncertain because the extent of the HAZ associated with the original weld is unknown. Also, the crack tip near the original outer surface was blunted as shown in Figs. 4 and 6. Blunting of crack tips by application of a weld overlay has been predicted by finite-element analyses (Maiya and Shack [3]) and would be expected to inhibit further throughwall crack growth. There was no evidence of tearing or extension of the crack beyond the blunted region. In no case did cracks propagate more than a distance of roughly a grain diameter into the original weld metal (Fig. 7).

6. Crack Tip of Axial Crack at 81-cm Position of Weldment C2.

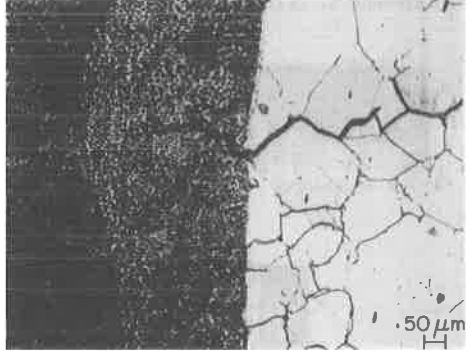
7. Propagation of Same Crack Shown in Fig. 6 into Weld Metal.

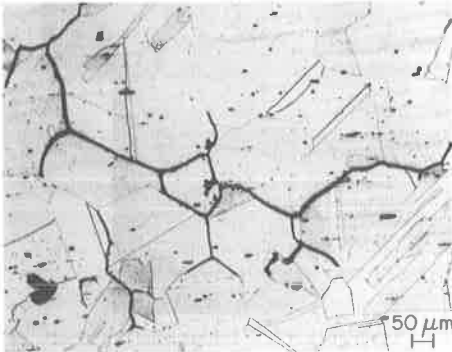
8. Extension of Intergranular Crack into Region of Step Etch Structure.

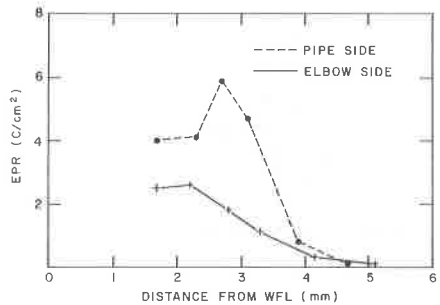
The degree of sensitization produced by the combination of the original weld and the overlay was evaluated by the ASTM A262-A procedure [4]. Dual and ditch etch structures were observed in the HAZ. The observed cracks were located within the HAZ of the original weld, except for one crack (65 EL) that extended into the region of the step etch structure (Fig. 8) and perhaps for the one axial crack noted above (81 EL) that showed fairly extensive axial growth. The throughwall EPR measurements at an axial location well removed from the original weld are shown in Fig. 9 for a specimen from weldment C2 at the 82 to 83-cm position. The HAZ of the overlay does not extend more than 5 mm into the pipe wall from the overlay WFL on the original outer surface. However, the maximum EPR values on both the pipe and elbow sides exceed the proposed critical value of 2 C/cm^2 (Clarke [5]). The maximum EPR value occurred at 2-3 mm from the WFL for both sides of the weldment. Larger EPR values were observed on the pipe side as compared to the elbow side.

9. Throughwall EPR Measurements at 82 to 83-cm Position of Weldment C2, at Sites Well Removed from Original Weld. Measurements were made at various distances from the overlay WFL.
