# Fire Protection Failures During the Whittier, California and New Zealand Earthquakes

L. J. Bragagnolo, M. J. Griffin, S. P. Harris  
*EQE Engineering Inc., San Francisco, CA USA*

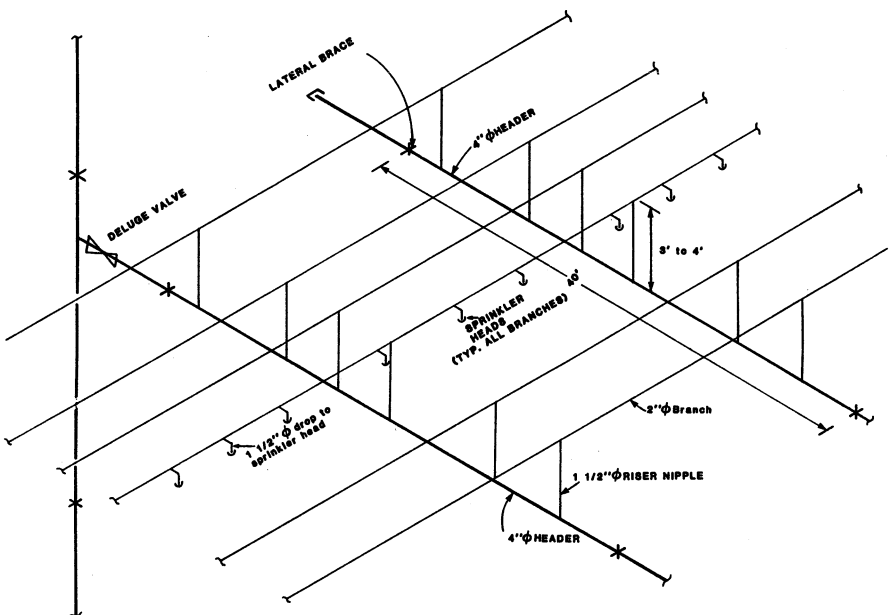
Water damage to the interior of the CalFed facility was one of the major causes of damage. The CalFed fire protection system is a pre-action system, requiring two conditions to actuate and release water. Initially, a detection signal causes a deluge valve to open and flood the system with water. This signal can originate from loss of air pressure in the piping system, loss of off-site power, etc. Secondly, the piping pressure boundary must be breached, normally through the activation of fusible link sprinkler heads (line breaks in this case). Each floor in the CalFed facility has its own separate pre-action system fed from one vertical riser. The fire protection system consists of a single deluge valve which feeds 6-in (18-cm) diameter and 4-in (10-cm) diameter main headers. 1-1/2-in (4-cm) diameter pipes 3 to 4 ft (about 1 m) long vertically connect to 2-in (5-cm) diameter branch lines. 1-1/2-in diameter drops connect sprinkler heads to the branch lines. The piping is typical cast steel Sch 40 pipe with cast-iron threaded fittings used on the branch lines. The piping system is supported with standard National Fire Protection Association (NFPA) type rod hangers, with lateral sway bracing on the 4- and 6-in diameter main headers. Lateral bracing is typically spaced at 40-ft (12-m) centers. A sketch of a typical piping configuration is shown in Figure 3.

- Several failures of 1-1/2-in diameter Sch 40 riser nipples occurred near to where they connected to the main headers. "T" couplings connecting the tops of the riser nipples to the branch lines also failed. The failures occurred where the riser nipples connected the branch lines to the main headers near the midpoint between lateral bracing of the main lines. Although the mains were laterally braced at 40-ft spacings, deflections near midspan were probably substantial.

- A sprinkler head sheared off when the piping system displaced and the branch line impacted an adjacent wall. The wall was an interior partition wall and was not laterally braced at the top.

- Several sprinkler heads penetrating the ceiling hardboard sheared off. The attached branch lines were connected to a long section of unbraced main header. Displacement of the header caused the branch lines and sprinkler heads to act as inadvertent support points due to the stiff restraint provided by the heads penetrating the ceiling.

Figure 3: Typical fire protection piping configuration at CalFed.
