SUPERPHENIX Fuel Storage Tank Investigations Concerning the Sodium Leak - Dimensional and Material Aspects

J. C. Blaix, J. Archer, N. Foucher, C. Escaravage
NOVATOME, Lyon, France

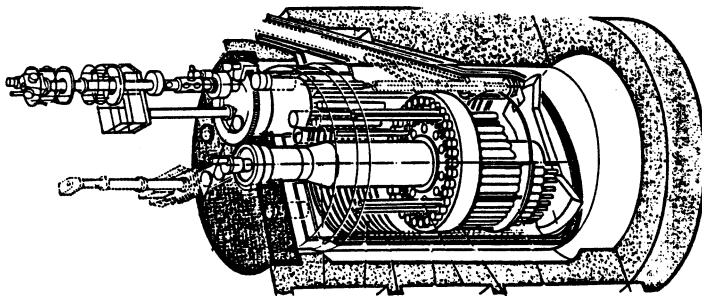
FIGURE 1

Following the detection, in march 1987, of a sodium leak from the fuel storage drum (figure 1) of the SUPERPHENIX LMFBR reactor, investigations have been undertaken by NOVATOME in order to :

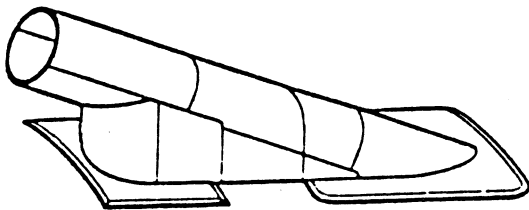
FIGURE 2

- a cylindrical shell,
- a torospherical bottom shell,
- a "bec de cafetiere" (figure 2) : an inclined nozzle implemented on the cylindrical shell, which permits the handling of the fuel assemblies.

The junction "bec de cafetiere"/cylindrical shell was supposed to be the most sensitive point of the safety vessel, owing to the geometrical discontinuity in this region.

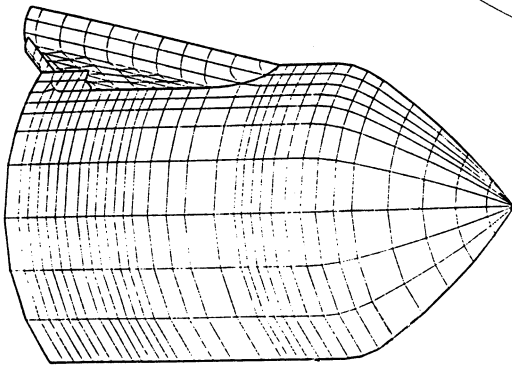
FIGURE 3

The resulting F.E. model (figure 3) has been subjected to three kinds of loadings :

The calculations showed that the most highly loaded regions were the upper and the lower junctions between the "bec de cafetiere" and the vessel (figure 3). In order to have stresses within the allowable values, a plot showing the allowable values of gas pressure versus the sodium filling level has been built. This plot enabled to determine operating conditions for repairing the structures. These conditions were in a good compliance with the scheduled actions.

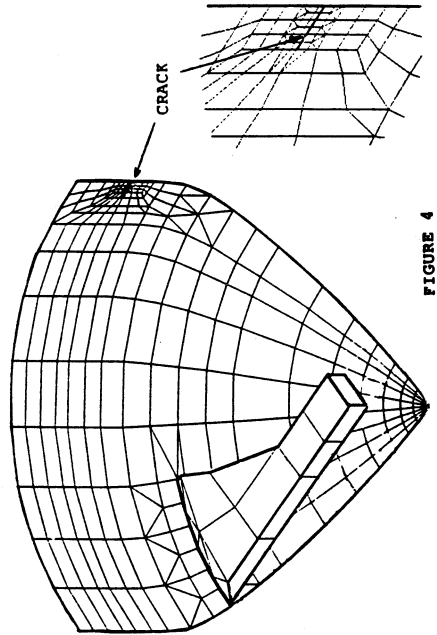
FIGURE 4

- the junction between the main vessel and the strongback (figure 4).

These calculations, performed with 2D axisymmetric Finite Elements, showed that even with a temperature step at the junction vessel/ strongback, the fatigue damage induced by 200 cycles loading \leftrightarrow unloading was not significant.

A 3D Finite Element model has thus been built (figure 4) including :

The through-crack was supposed to be 435 mm long (which corresponds to the average value of the real crack). The computations performed showed that the sodium hydrostatic pressure could open the crack :

the computed axial opening is : 0.038 mm
 The calculated value, necessary to permit the measured sodium flow-rate (20 l/h), was 0.04 mm.

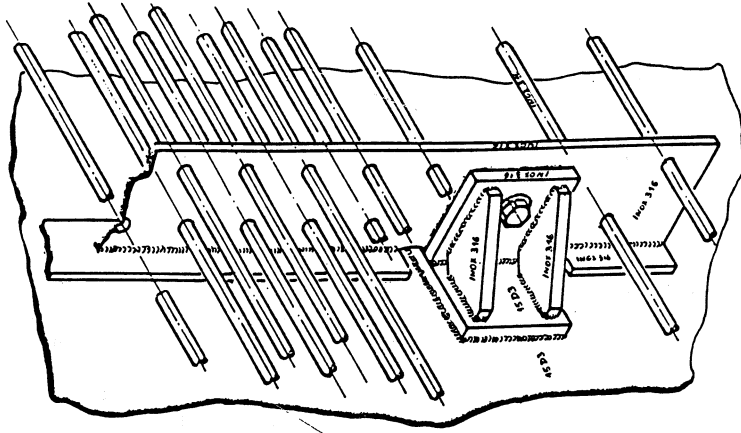
FIGURE 5

In September 1987, the leak was located at level 10400 in azimuth 270°, which corresponds to the lower weld of a fastener guide plate of the cooling systems (figure 5). In this region, austenitic 316 L and ferritic 15D3 steels are welded together.

The leaking crack (\approx 450 mm length) and other samples were examined. All the fracture facies are typical of a mechanism of hydrogen induced cracking in region of high residual stresses.
