Irpinia 1980, Southern Latium and Abruzzi National Park 1984, Zafferana Etnea (Sicily) 1984, Mexico City 1985 earthquakes: Catalogues of damage

G.Sofò

ENEA, Commission for Nuclear and Alternative Energy Resources, Rome, Italy

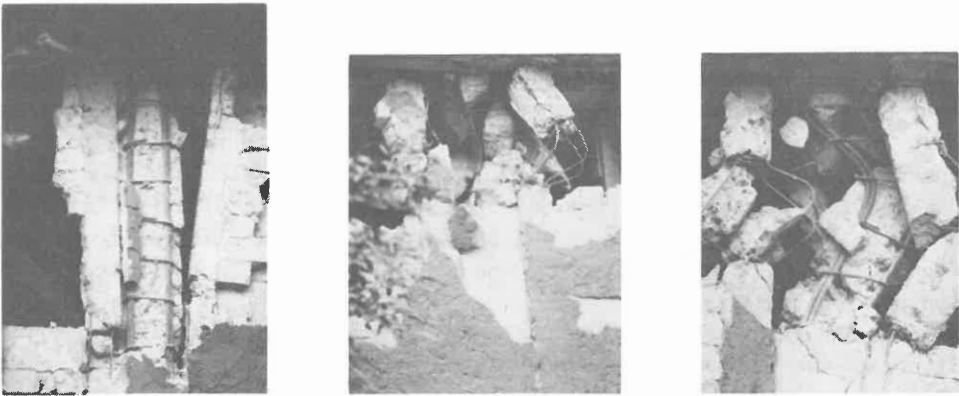
Fig. 1. IV) An ideal sequence shows an usual collapse mechanism in columns without sufficient ties.

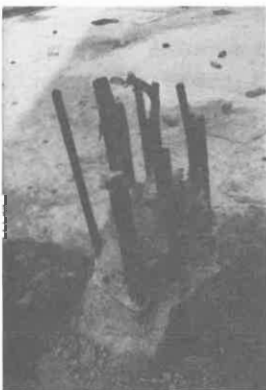
Fig. 2. IV) Brittle type failure in a heavily reinforced column partially induced by non-negligible stiffness of bars.

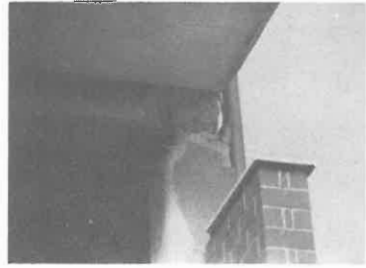
Fig. 4. I) Loss of bonding between steel and concrete in a column-beam connection. The earthquakes show that confidence in the use of high bond deformed bars is not completely justified.

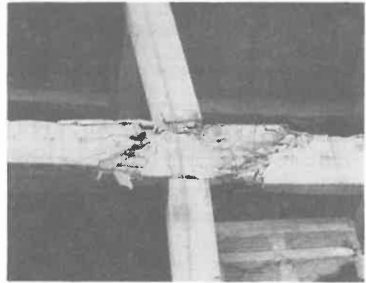
Fig. 6. IV) Failure of longitudinal steel in a beam. This type of damage is much less common than brittle type failure of heavily reinforced concrete.

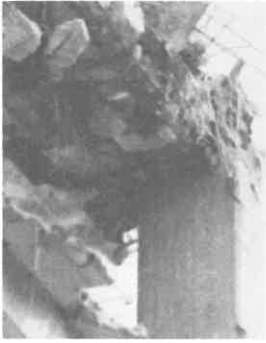
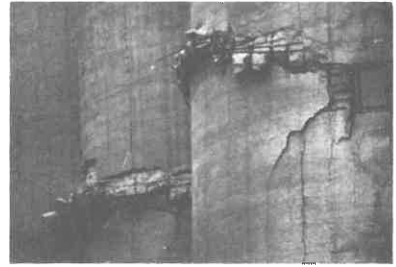
Fig. 7. IV) Direct and indirect effects of lack of transversal reinforcement in bidimensional structural elements.

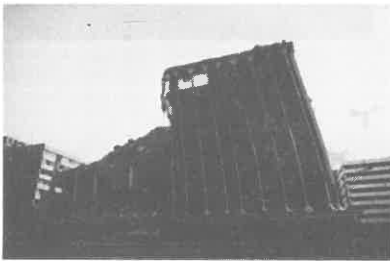
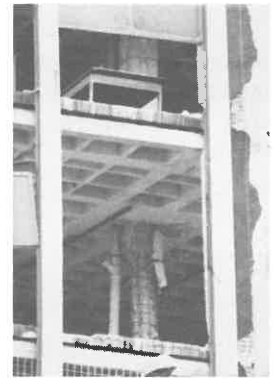
Fig. 8. IV) Greater ductility (e. g. achievable by making use of spirally reinforced columns) can have a harmful effect if attained at stiffness expense because it involves a greater demanded ductility.

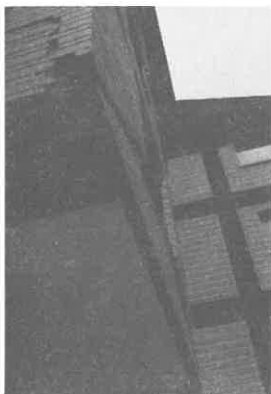
Fig. 9. II) A common type of damage resulting from brick infill panels not properly tied to structural frame.

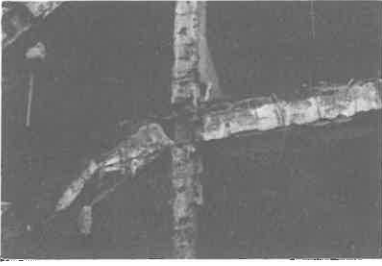
Fig. 10. IV) In old steel construction bolted connections are a weak point. In new steel construction weld failure in steel box columns resulting in buckling of steel plates.

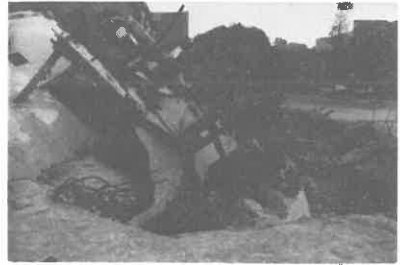
Fig. 12. IV) A spectacular example of foundation settlement caused by flow of clayey soil.

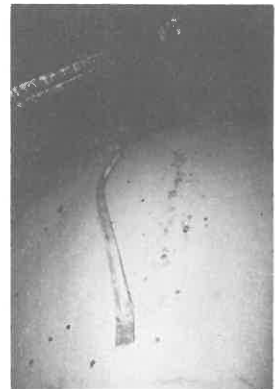
Fig. 13. IV) Damage to an aqueduct and to an unused rail line that had been covered by pavement.
