# Seismic Fragility Pipe Testing

Vincent DeVita

*Rockwell International, Canoga Park, CA USA*

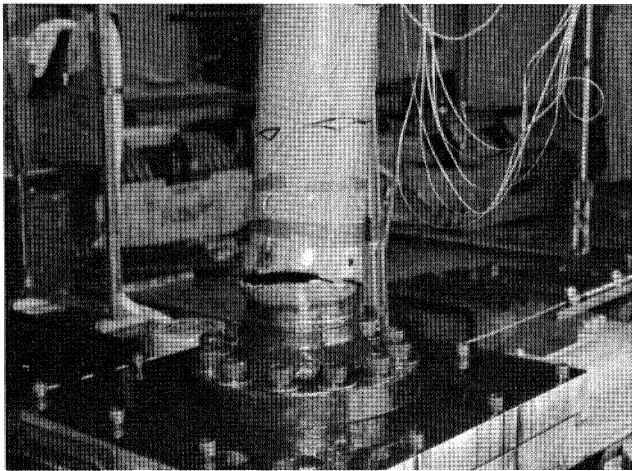
Figure 1. Failure Location, 6-In. Pipe Test

Failure (i.e., rupture) of the test article did not occur during seismic testing. However, a 1-in. wide circumferential bulge indicative of ratchetting was observed following the high level (30 g actual ZPA) seismic test in a vertical leg of the test article. The bulge was located in a straight pipe section some 2 to 3 in above a welding neck flange at an anchor location. Subsequently, failure occurred during the second sine burst test. Rupture occurred in the previously observed circumferential bulge during the 6th of the planned 11 cycles of maximum displacement of the 5 Hz harmonic input. Failure resulted from a 300° circumferential break in the bulge; a double-ended guillotine break was avoided with prompt termination of testing. Fig. 1 shows the failure location.

Failure of the test article was attributed to incremental ratchetting due to the internal pressure in the piping system resulting in wall thinning and bulging and subsequent fracture due to tensile overloading. Although fatigue contributed to the failure, the cumulative fatigue usage factor (not considering ratchet effects) for the test series was estimated to be between 0.13 and 0.27. The failure mode was not predicted by any of the current nonlinear failure analyses which are based on the collapse failure mode. Furthermore, failure did not occur in any of the locations of high stresses considered critical by the ASME Code.
