SMiRT LBB Workshop

V. C. Summer Experience

Dulal Bhowmick,
Westinghouse Electric Company, LLC
August 16, 2001

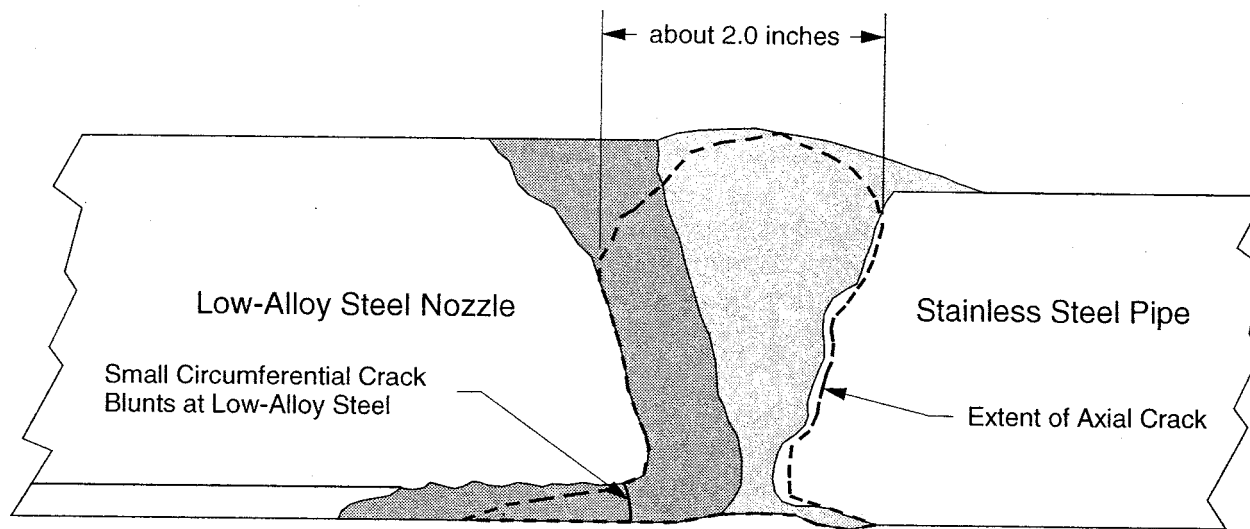
- Destructive examination confirmed axial primary side initiated cracking confined to the Alloy 182 nozzle to pipe weld and to the Alloy 182 buttering on the inside surface of the low Alloy steel nozzle near the weld
- A short shallow circumferential (a maximum depth of 0.20 inches and length 1.6 inches) crack in the buttering which arrested at the low alloy steel nozzle
- A number of small indications were also characterized and verified by destructive examination
- Based on detailed investigation, it was concluded that this incidence was due to the primary water stress corrosion cracking (PWSCC) in the Alloy 82/182 welds

Location of Axial and Circumferential Cracks in V.C. Summer Hot Leg Nozzle to Primary Coolant Pipe Weld

- Safety assessments show that there is a very low risk of pipe rupture as a result of PWSCC of Alloy 82/182 welds
- There have been no previous reports of leakage from these types of welds worldwide. V. C. Summer was discovered well before there was a risk of failure
- Existing Alloy 82/182 weld was removed and replaced with crack resistance Alloy 52/152 weld
