# Requalification for Beznau (Switzerland) NPP Auxiliary Building

## Abstract

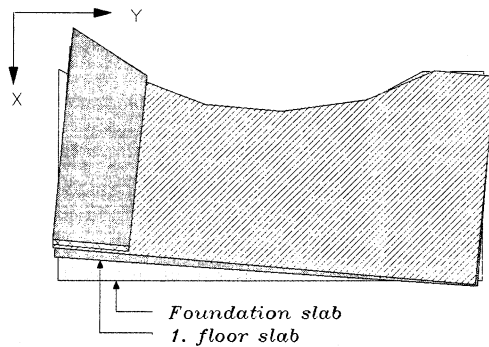
The dynamic behaviour of the Auxiliary Building A is primarily influenced by the asymmetric configuration of the shear walls in the ground floor, as shown in Fig. 1. This leads, as shown in Fig. 3, to a rotational motion of the building in the first mode, with the centre of motion near the intersection of the two perpendicular shear walls. This in turn produces large moment and shear forces in the outer columns (left side of the building in Fig. 1).

Fig. 3 Displacement of floor and diaphragms in 1. mode.

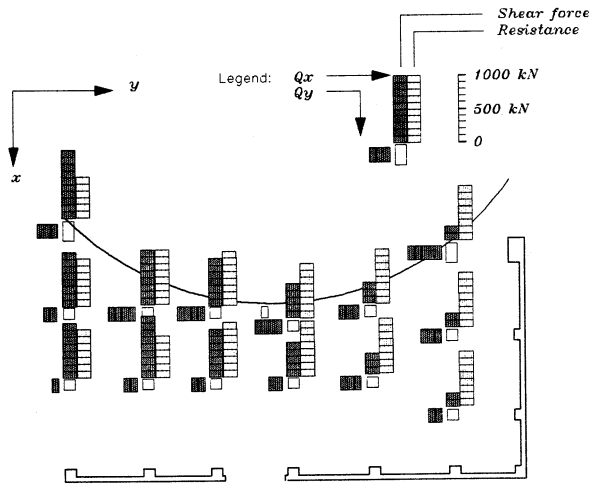
The *outer columns* in the ground floor have to resist, as previously mentioned, large shear and bending forces due to the rotational motion in the first mode. Fig. 4 shows the shear forces and the shear resistance of the columns in the ground floor. The critical failure mode of the columns is the shear failure, a brittle failure mode, for which a safety factor of 1.4 is required. No advantage can be taken therefore of the ductility of the columns, although they have a displacement ductility of 2 to 3.

Fig. 4 Shear forces and shear resistance of the columns in the ground floor.

The analysis of the Auxiliary Building A has shown, that structural strengthening of the outer columns in the ground floor is required. The strengthening is best achieved by introducing two new infill walls as shown in Fig. 7. Special attention has to be paid to the connection of the new infill walls to the existing structure. The reinforcement of the infill wall has to be anchored in the existing structure by means of a two compound adhesive, which assures that the yield strength of the reinforcement is reached before the reinforcement is pulled out.

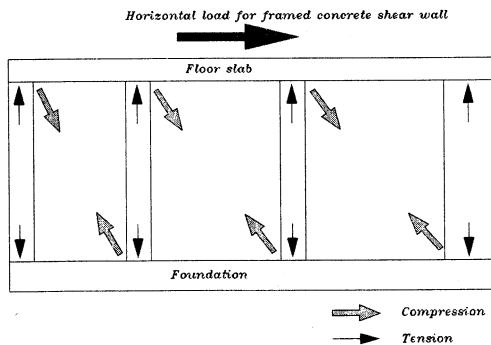
Fig. 5 Framed concrete shear wall

For the analysis of the framed shear walls of the Auxiliary Building A the failure modes 4, 5 and 6 are relevant, i.e. a truss model, where the vertical frame and panel reinforcement represent the tension elements and the concrete diagonals represent the compression elements. For all shear walls the safety factor exceeds the required value of 1.4.

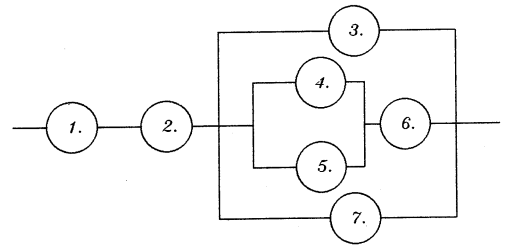
Fig. 6 Failure diagram for framed shear wall

Failure modes 1 and 2 can lead to collapse individually, the other five failure modes only in combination. For the squat shear walls of the Auxiliary Building A the most probable failure modes are mode 3 (link 3 in Fig. 6) and subsequently the failure mode 4, 5 and 7 or 6 and 7. Failure mode 3, i.e. small diagonal cracks occur at comparatively low load levels or even due to shrinkage. For sufficiently reinforced panels they do not pose any problems. In failure mode 4 and 5 a truss system with vertical tension elements and diagonal compression elements is formed. If the reinforcement of the frame and the panels is high enough diagonal shear cracking occurs, i.e. failure mode 6 takes place.

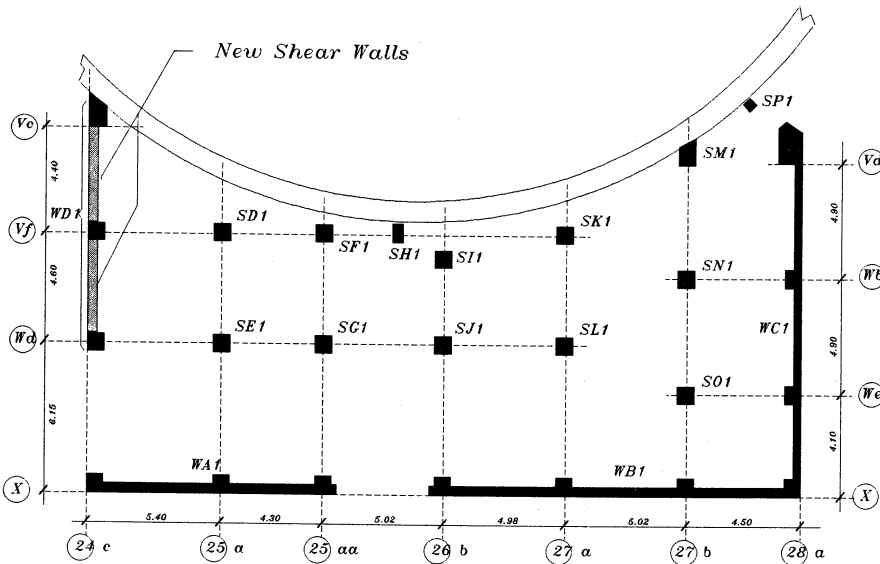
Fig. 7 Structural strengthening with two infill walls

With the new infill walls an approximately symmetric distribution of the shear resisting elements is achieved. The horizontal loads on the columns are reduced by as much as 90%. The first eigenfrequency is raised from 3.5 to 5 Hz.
