## EXPERIMENTAL SEISMIC ASSESSMENT OF FULL SCALE NON-SEISMICALLY DETAILED RC STRUCTURE BY PUSHOVER METHOD

Akanshu Sharma<sup>1</sup>, G.R. Reddy<sup>1</sup>, R. R. Babu<sup>2</sup>, D. Revanna<sup>2</sup>, K.K. Vaze<sup>1</sup>

<sup>1</sup>Reactor Safety Division, Bhabha Atomic Research Centre, Mumbai 400085, India

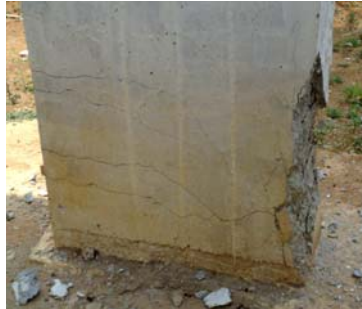
Fig.8 shows the failure of bottom storey columns on (a) compression side and (b) Tension side. The failure patterns are typical for the reinforced concrete members subjected to combined axial load and uniaxial bending. Compressive loads along with high bending moments result in, crushing of concrete on front face of the column and tension cracks on rear face (Fig.8 (a)). Tension loads along with bending moment result in cracks from the rear face of the columns that grew, as the load increased, towards the front face of the columns. The spalling on the front face was nominal compared to that of compression side columns (Fig.8 (b)).

(a) Compression side column, CL 16

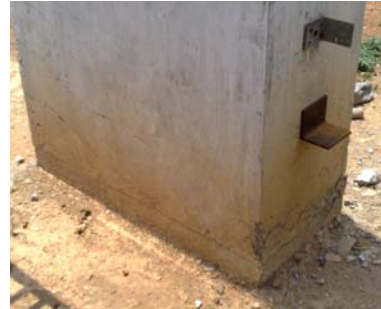
(b) Tension side column, CL 15

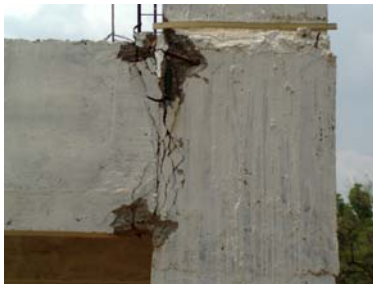
Fig.9 (a) shows the failure mode of the beam BF 205 connected to CL 15 at 1st floor in flexural mode combined with bond slippage of the beam tension reinforcing bars. Due to lateral loading, the bending moments were generated in the beam with hogging moments towards the end fixed with column CL16 and sagging moments towards the end fixed with column CL15. As a result, flexural tension cracks could be seen initiating from the soffit of the beam and propagating towards the slab. Due to high tensile stresses generated in the beam bottom bars, a slippage of the bars seems to have occurred. Spalling of concrete was observed on both the tension and compression

(a) Beam BF 205 at 1<sup>st</sup> floor, flexure failure

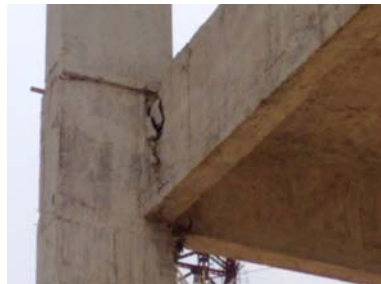
face of the beam due to extensive cracking and crushing respectively. Fig.9 (b) shows the failure of the beam BF 223 transverse to the direction of loading. As the lateral load increased, the beams transverse to the direction of loading (BF223) were pushed by the slab. This push was resisted by the stiffness provided at the ends due to restraining action of columns CL16 and CL 20. Due to the end restraints, the beams suffered high compatibility torsion moments at the fixed ends.

(b) Beam BF 223 at 1<sup>st</sup> floor, torsion failure

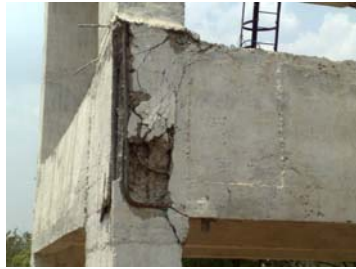
Fig.10 shows the failure of joint of CL 19 at first floor. High stresses in the joint resulted in diagonal cracks in the core followed by cover spalling due to the pressure exerted by the beam longitudinal reinforcement. Fig.11 shows the failure of joint of CL 19 at 2nd floor level, which shows the beam bar bursting out of the joint. This is a typical failure mode for joints with unrestrained bars. This occurred since in order to provide the development length of the beam main reinforcement, the bent bars had a long free length beyond the bent and there were no transverse reinforcement to provide any restraint to the same. Such a failure can, in general, be prevented if proper confining reinforcement is provided in the joint core. Fig.12 shows the failure of the joint of CL16 at first floor level that exhibited bond failure along with beam flexural failure and spalling of side cover due to pressure exerted by the reinforcement. High tension force in the beam reinforcement resulted in bond deterioration and ultimately failure with splitting of concrete. Also, large cracks along with spalling of concrete can be seen at the beam-column interface. Fig.13 shows diagonal shear crack in the joint of CL20, 2nd floor during the test with flexural cracks in

Fig.10 Joint failure of CL 19 at 1<sup>st</sup> floor

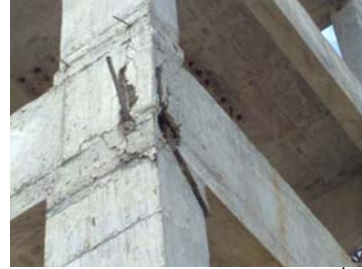
Fig.11 Joint failure of CL 19 at 2<sup>nd</sup> floor

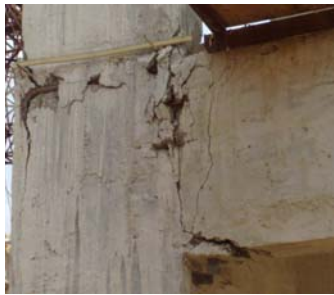
Figs.10 through 13 show different types of joint failures observed in the structure. Under the action of lateral forces, beam-column joints are subjected to large shear stresses in the core. Typically, high bond stress requirements are also imposed on reinforcement bars entering into the joint. The axial and joint shear stresses result in principal tension and compression that leads to diagonal cracking and/or crushing of concrete in the joint core. The flexural forces from the beams and columns cause tension or compression forces in the longitudinal reinforcements passing through the joint. During plastic hinge formation, relatively large tensile forces are transferred through bond. When the longitudinal bars at the joint face are stressed beyond yield, splitting cracks are initiated along the bar at the joint face. If the cover to the reinforcement bars is less and if the joint core is not confined by confining reinforcement in the form of stirrups, the cover concrete is spalled off due to the pressure exerted by the beam reinforcement bars. Most severe joint failures were found in the case of column CL 19. This might be attributed to the relatively low column depth (400mm) than beam depth (1000mm). In such cases, plasticization of columns can occur which may also lead to damage ingress in the joint core. Moreover, there was high eccentricity between beam and the column since the beam of width 230mm was flushed with the face of the column with the width of 900 mm.

Fig.12 Joint failure CL16, 1<sup>st</sup> Floor

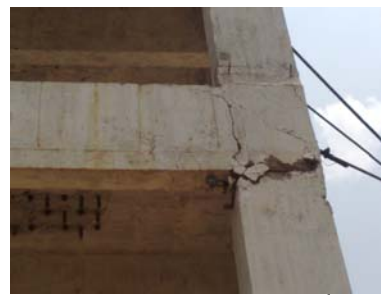
the beam and bond failure of the tension reinforcement. It can be observed that a clear diagonal shear crack appeared in the joint during the test but it was not further opened and the failure essentially got transferred through bond mechanism. Although, the beam longitudinal reinforcement was bent up to the required development length inside the column, it indicates that such development by bending in the re-bars may not be good enough to prevent the bond failure.

Fig.13 Joint Failure CL20, 2<sup>nd</sup> floor
