LUCIER, GREGORY W. Evaluation of MMFX Steel for Concrete Bridge Decks.
(Under the direction of Dr. Sami Rizkalla.)

Evaluation of MMFX Steel for Concrete Bridge Decks

A thesis submitted to the graduate faculty of

North Carolina State University

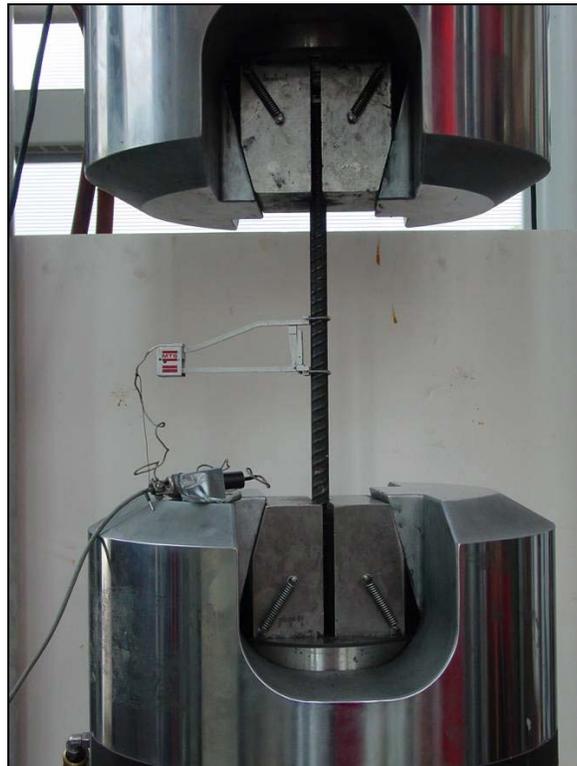
Figure 3-1: Extensometer Attached to a #5 MFX Bar in the Testing Machine

Each of the tested samples were prepared with an 8 inch gage length for measuring the total elongation at failure. The gage length was marked on each specimen, and elongation measurements were made over this length. The center of the gage length was aligned with the center of the specimen along its length. Each bar sample was sized to accommodate the 8 inch gage length, at least two bar diameters between each end of the gage length and the grips of the testing machine, and an additional length to fill both 5 inch grips of the tension testing machine. An MTS axial-mechanical extensometer that measures the change in length over a 2-in gage length was attached to each test specimen at mid-height to measure the deformation during loading, as shown in Figure 3-1.

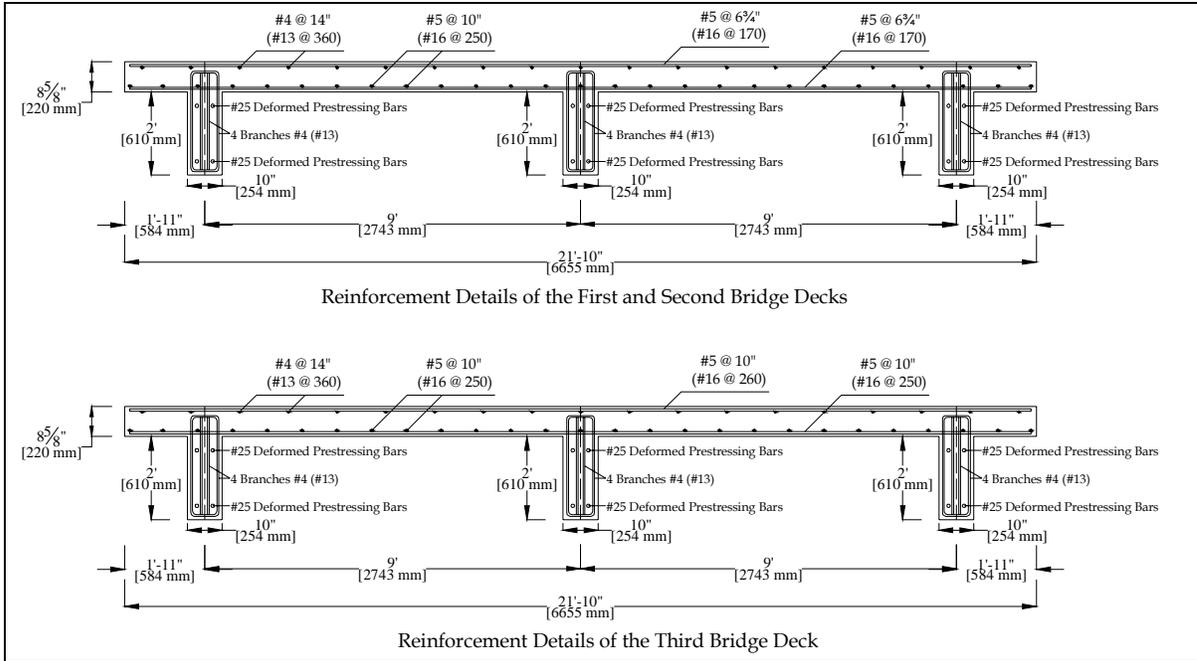
Figure 3-4: Reinforcement Details for All Tested Decks

It should be noted that the reinforcement ratios (ρ) shown in Table 1 were calculated using the total slab thickness. Longitudinal reinforcement ratio is the same for all three decks. Transverse ratio, however, is reduced by 33% in the third deck.

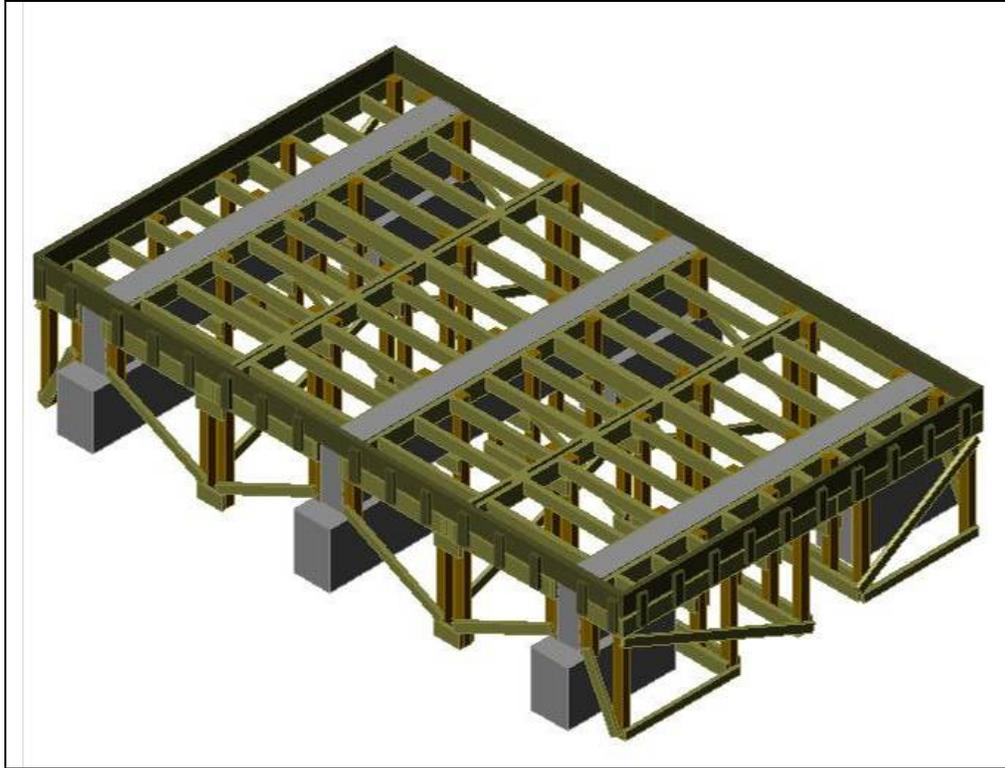
Figure 3-5: Wooden Forms Used for Casting the Decks

Each test specimen was cast in the position in which it was tested. The supporting blocks and girders were positioned for each slab, and wooden formwork was constructed around these elements. A concrete deck was cast on the forms, and after 14 days of moist curing, the forms were removed and saved for reuse. After completion of testing, the specimen was cut up and removed, and the next specimen was constructed in the same location using the same procedure. A sketch of the formwork used is shown in Figure 3-5. The plywood casting surface is not shown on the sketch for clarity. The formwork was designed to deflect only minimally under the weight of the fresh concrete so as to ensure as flat a slab as possible. The formwork was also designed to allow for it to be reused for each of the three deck specimens.

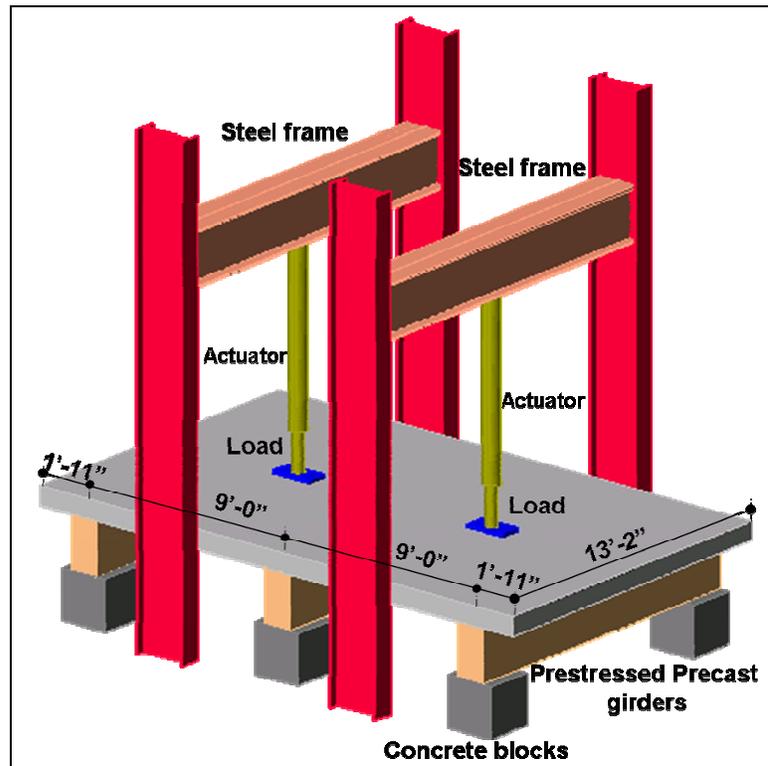
Figure 3-7: Isometric view of the bridge decks test setup

Each of the actuators was suspended over the deck specimen by a steel test frame anchored securely to the strong floor. The concrete support blocks were also anchored to the strong floor. The girders rested directly on a level grout bed which was prepared on each block. Figure 3-7 and Figure 3-8 show a schematic view of the test setup and a photograph of the first bridge deck prior to testing.

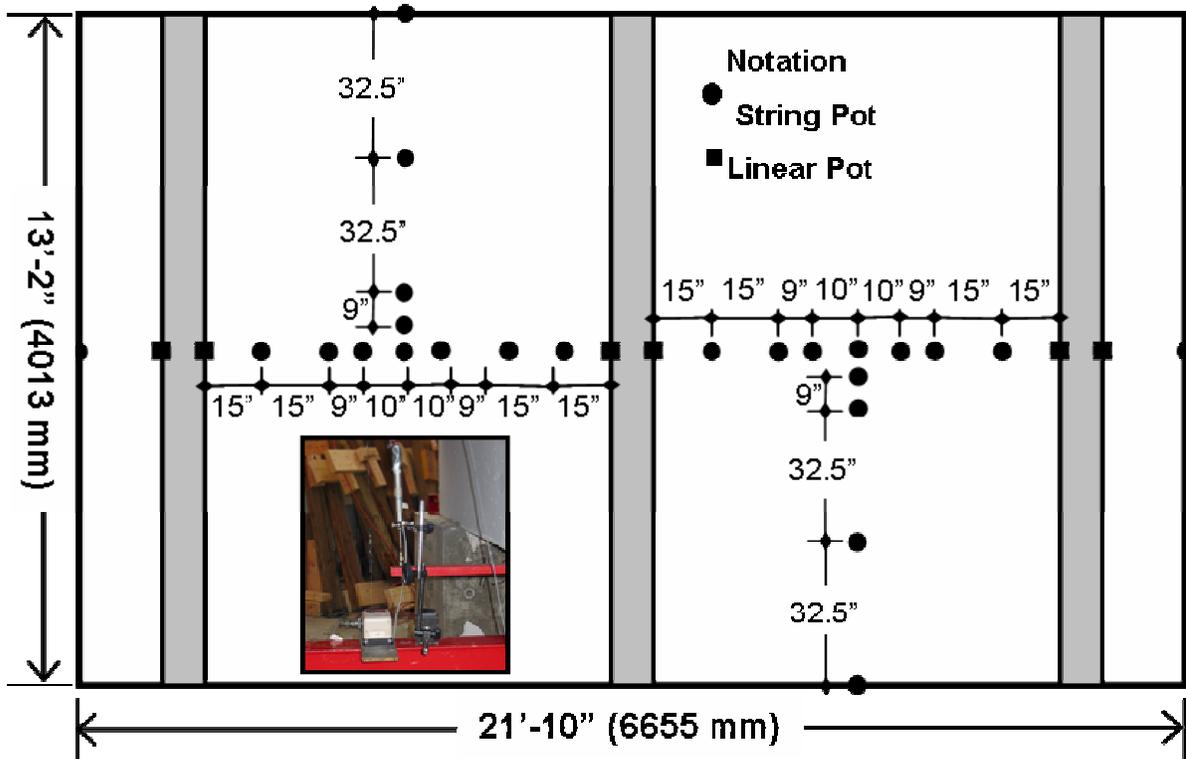
Figure 3-9: Locations of String and Linear Potentiometers

In addition to the string pots, two linear potentiometers were used to measure the vertical rotations of each supporting girder (six linear pots in total). A 24" (610 mm) long bar was attached to the bottom surface of each girder at the midspan. The bar was oriented perpendicular to the length of the girders. A linear potentiometer was used to measure the deflection at each end of this bar, and the difference between those measurements was used to calculate girder rotation. The location of these linear potentiometers is also noted on Figure 3-9.

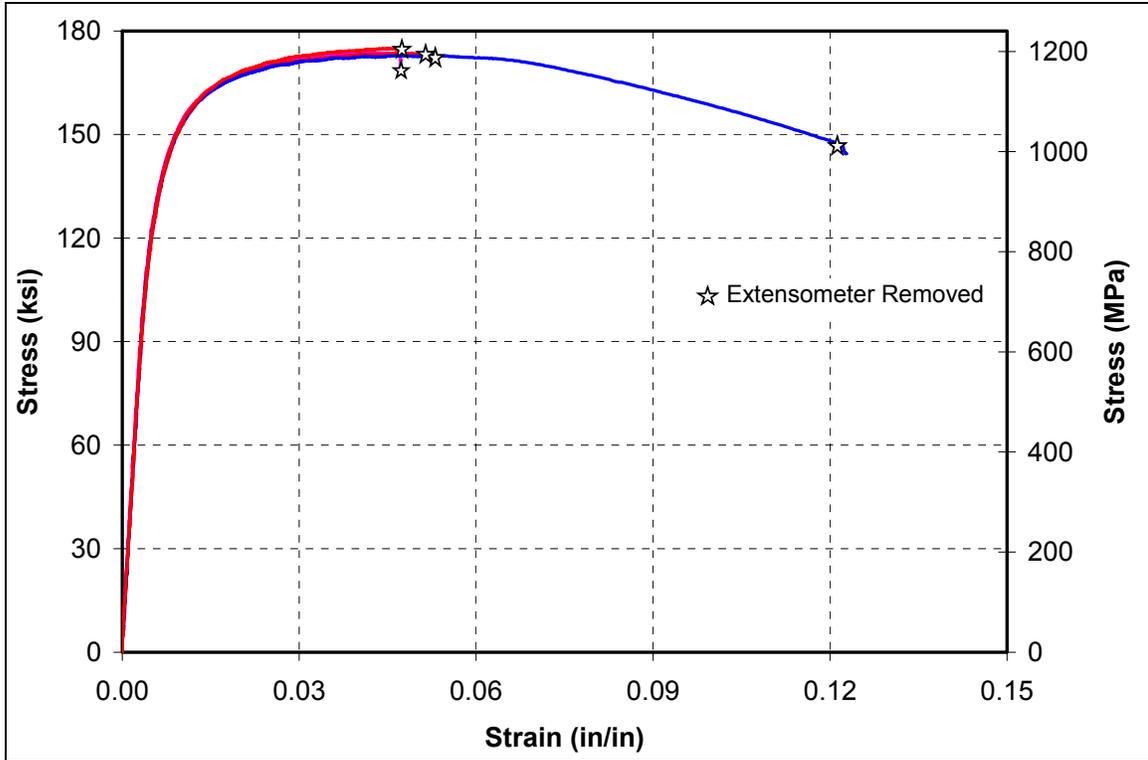
Figure 4-2: Engineering Stress-strain Relationship for #4 MMFX Steel Bars

The measured engineering stress-strain characteristics of the #4 (No. 13) and #5 (No. 16) MMFX bars are shown in detail in Figure 4-2 and Figure 4-3, respectively.

After rupture of each specimen, the pieces were re-aligned, the final gage length was measured, and the ultimate elongation was recorded. The #4 and #5 bars had an average ultimate elongation of 7.2% and 6.3% in their 8 in gage lengths, respectively. It should be mentioned that necking occurred outside the MTS extensometer (2-in gage length) for all the specimens, except for one #4 (No. 13) MMFX bar. The results from this test were used to obtain the descending branch of the stress-strain curve as shown in Figure 4-2.

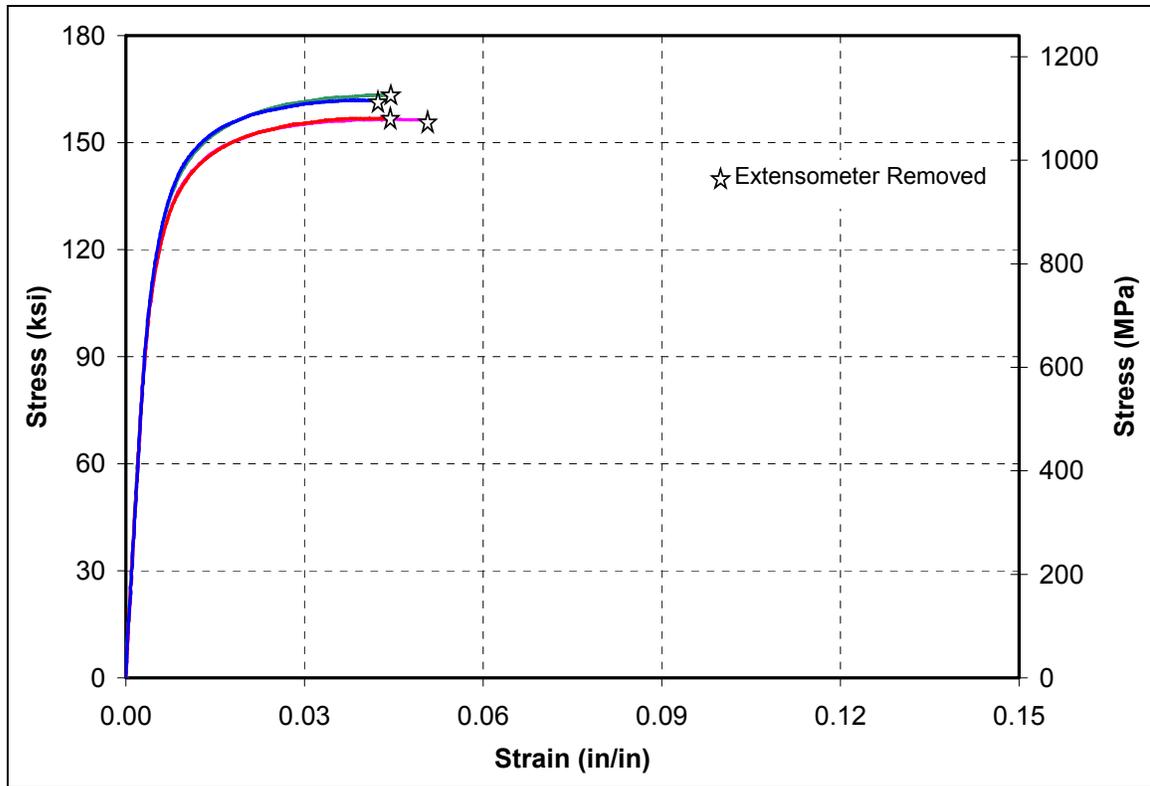
Figure 4-3: Engineering Stress-strain Relationship for #5 MMFX Steel Bars

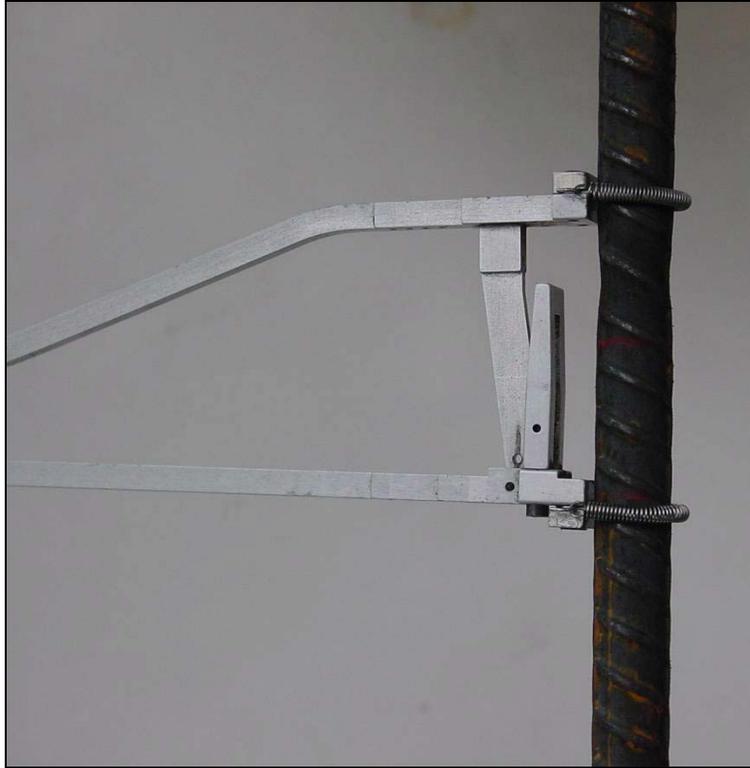
Figure 4-4: Necking Inside the MTS Extensometer Gauge Length

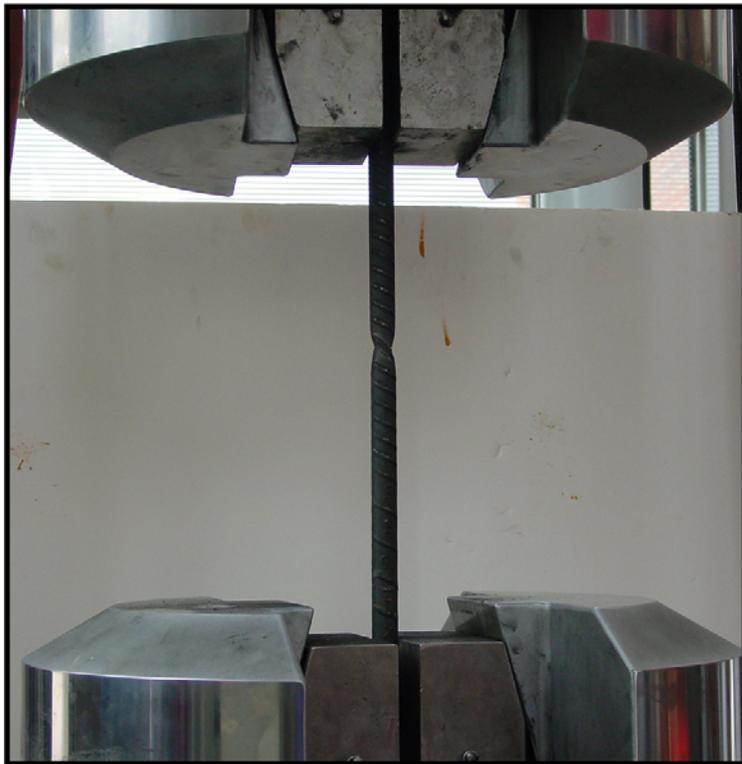
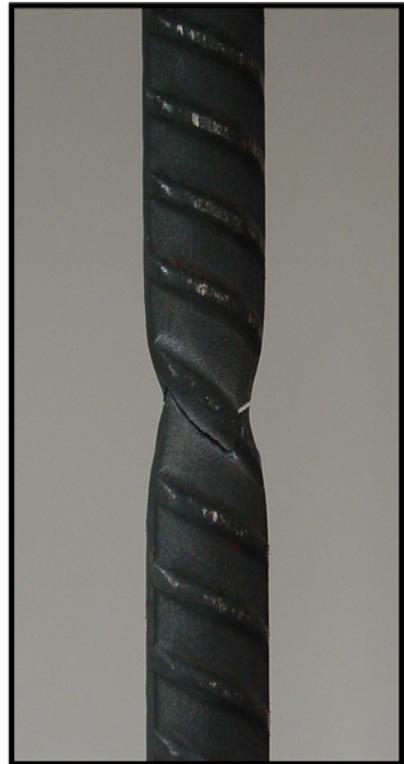
Figure 4-5: Rupture of #5 MMFX Bar After Necking

After the maximum load was reached in all tests, the diameter of the specimen started to decrease, and the reduction of cross-sectional area was clearly visible in one particular location. The behavior, known as “necking,” is shown in Figure 4-4. It was observed that rupture occurred along a cone-shaped surface which forms an angle of 45° with the longitudinal axis of the specimen as shown in Figure 4-5.

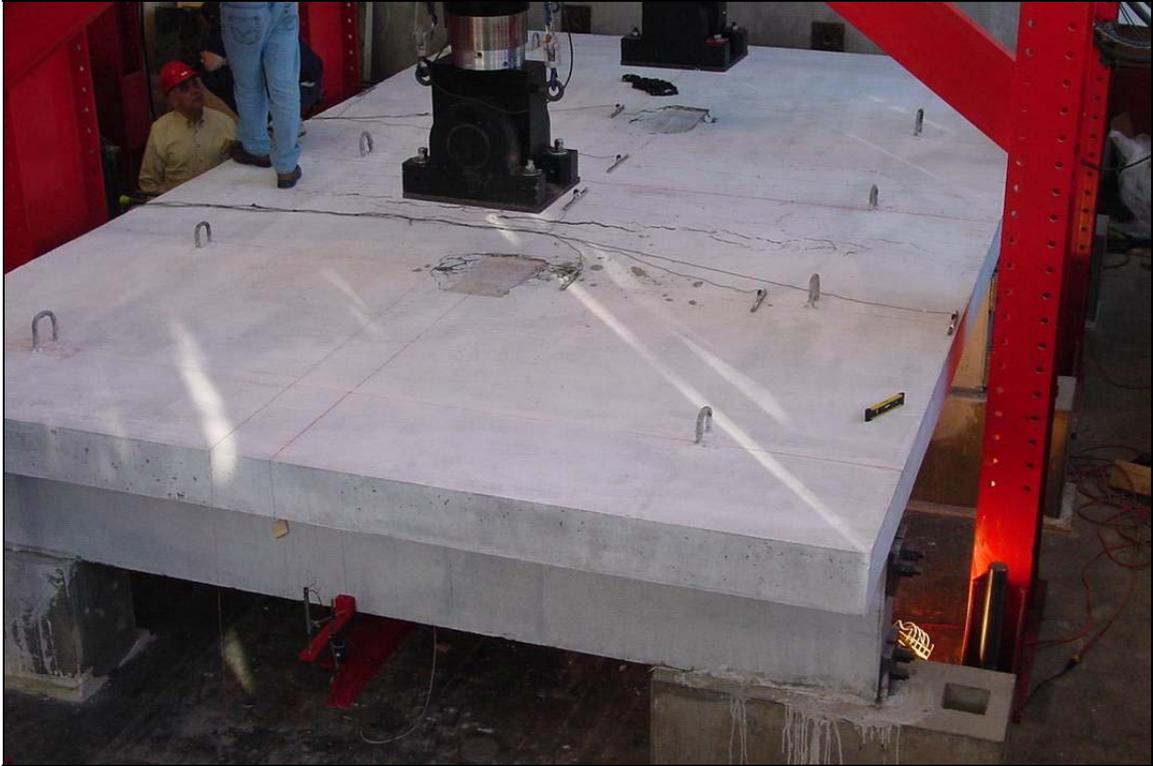
Figure 4-6: First Bridge Deck at the Conclusion of the Test

At the first peak load of the first bridge deck, a gradual drop in the load occurred due to the formation of flexural-shear cracks along the top surface of the bridge deck on both sides of the middle girder, a few inches from the girder face. Further loading led to the widening of those cracks and to a slight increase in the load until punching failure occurred. Punching failure of both spans occurred simultaneously at a load level of 229 kips (1019 N) for the left span and 216 kips (961 N) for the right span. Figure 4-6 and Figure 4-7 show the first bridge deck at the conclusion of the test, where the punching areas underneath the two loading plates can be clearly seen along with the shear cone protruding from the bottom of the left span. This shear cone can be seen in greater detail in Figure 4-8, which shows a section through the shear cone after the bridge deck was cut for removal. This shear cone is perhaps the most recognizable characteristic of a punching shear failure.

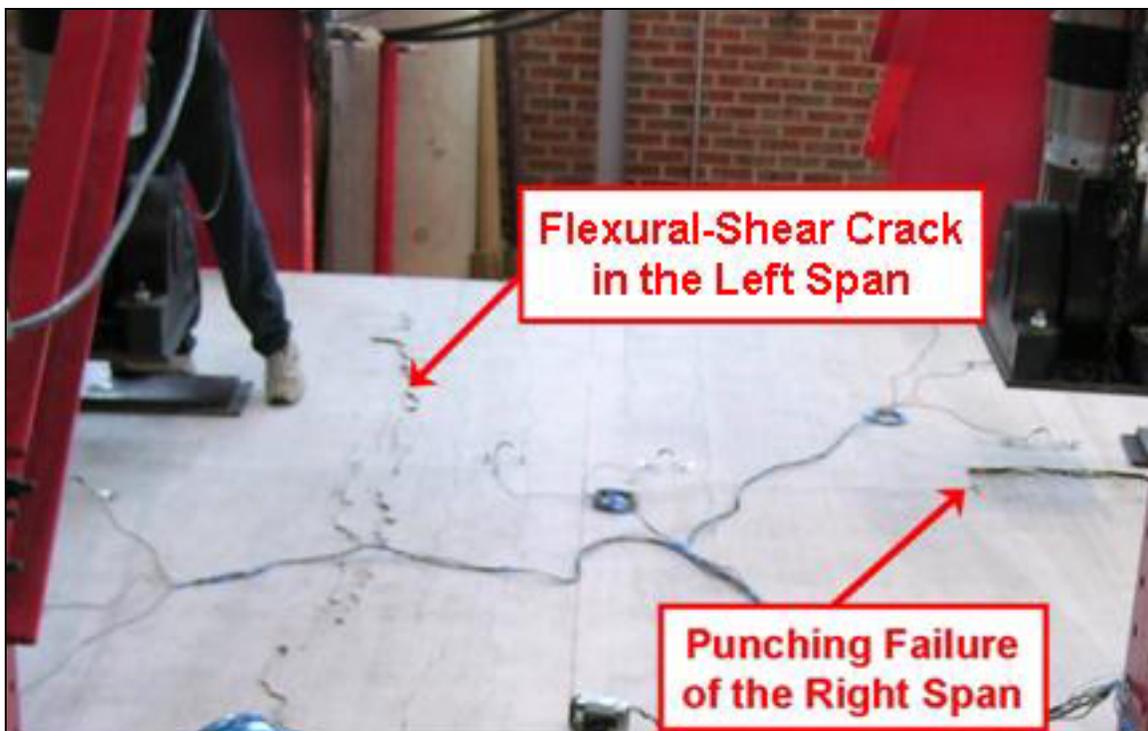
Figure 4-9: Second Bridge Deck at the Conclusion of the Test

Failure of the right span was due to punching shear at a load level of 204 kips (907 KN). Figure 4-9 shows the second bridge deck after failure, where the punching area under the actuator in the right span, and the flexural-shear crack formed in the left span are both clearly visible.

In the tests of the second and third bridge decks, however, significant flexural-shear cracks developed only on the left side of the middle girder. This allowed the load to remain virtually constant in the left span while continuing to increase in the right span, subsequently causing a punching shear failure in the right span only, as shown in Figure 4-9 and Figure 4-10 above.

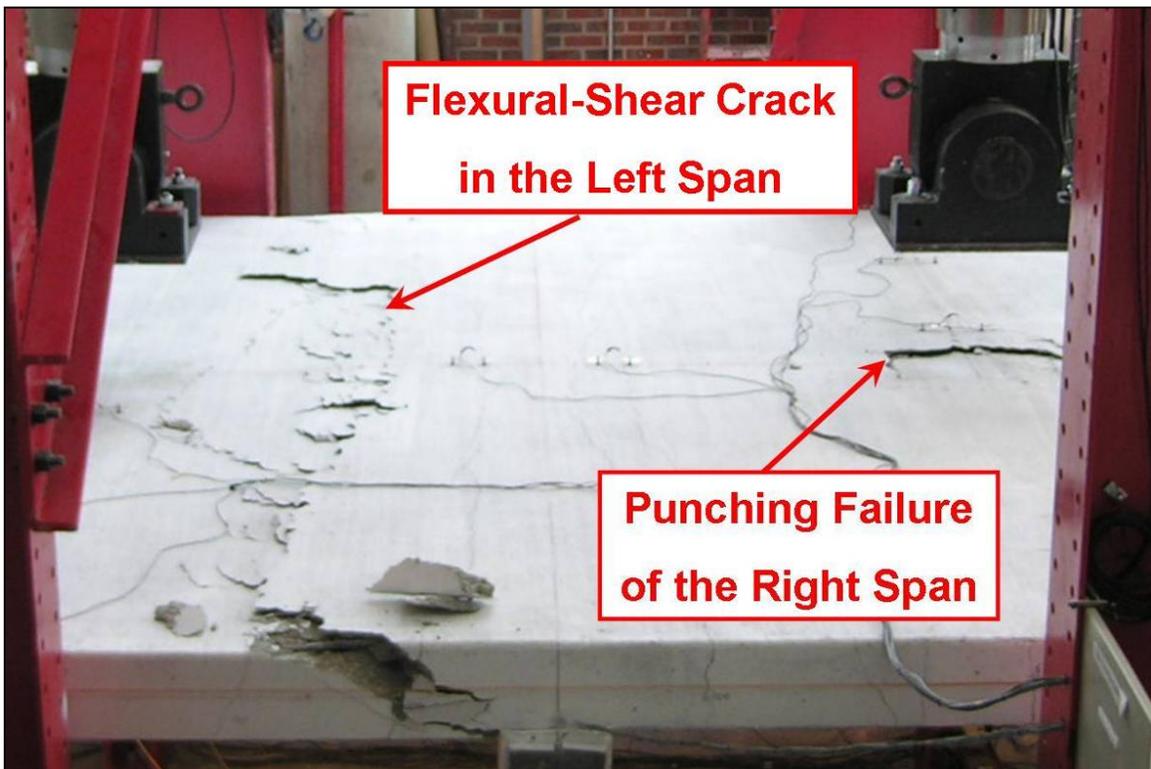
Figure 4-10: Third Bridge Deck at the Conclusion of the Test

The right span of the third deck failed in punching shear at a load level of 203 kips. Figure 4-10 shows the third bridge deck at failure, where the punching area under the actuator in the right span, and the flexural-shear crack formed in the left span are clearly visible.

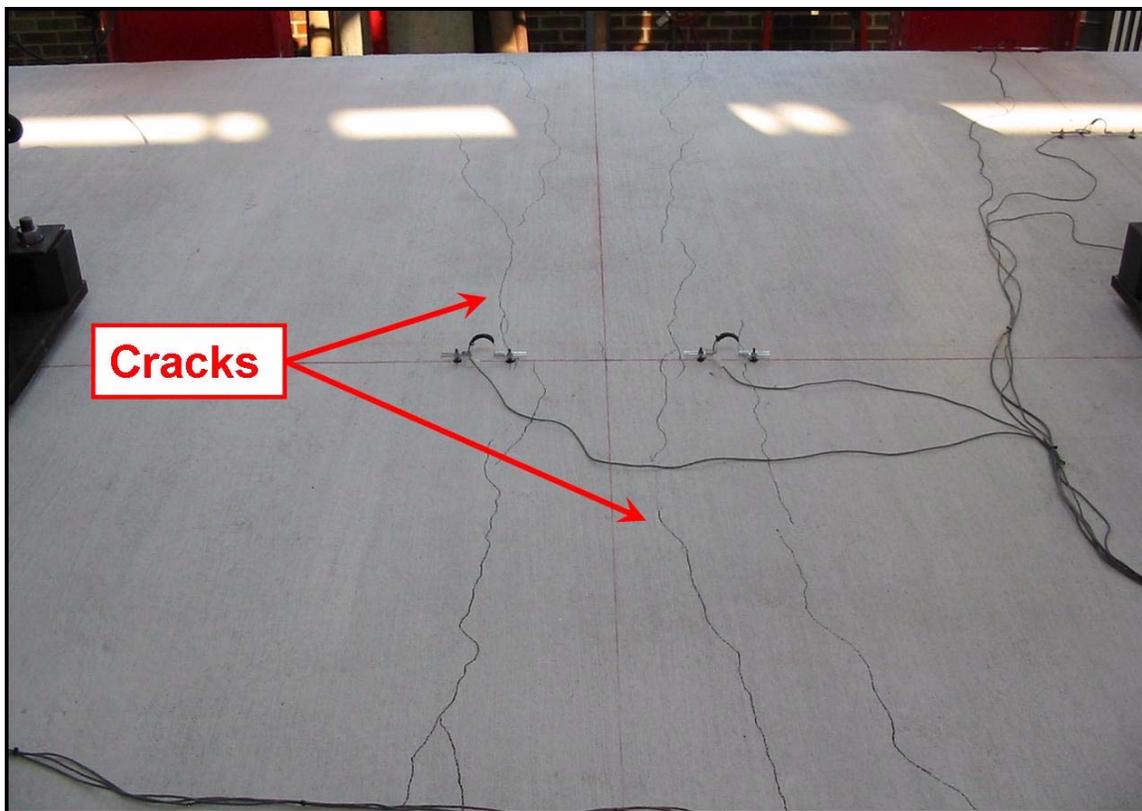
Figure 4-11: Negative Flexural Cracks at 100 kips in Third Deck

In all three decks, no cracks were observed at a load level corresponding to 50 kips (222 KN) on each span. However, visible top cracks appeared running parallel to the middle girder, a few inches from each face, at a load level of roughly 60 kips (267 KN) for each deck. Figure 4-11 shows these top cracks at a load level of 100 kips (445 KN) for the third bridge deck. The figure is typical of all three decks at that load level. It can be assumed that these negative flexural cracks formed before any positive cracks due to the higher values of negative moments at the center girder in comparison to the positive moments at the center of the spans.

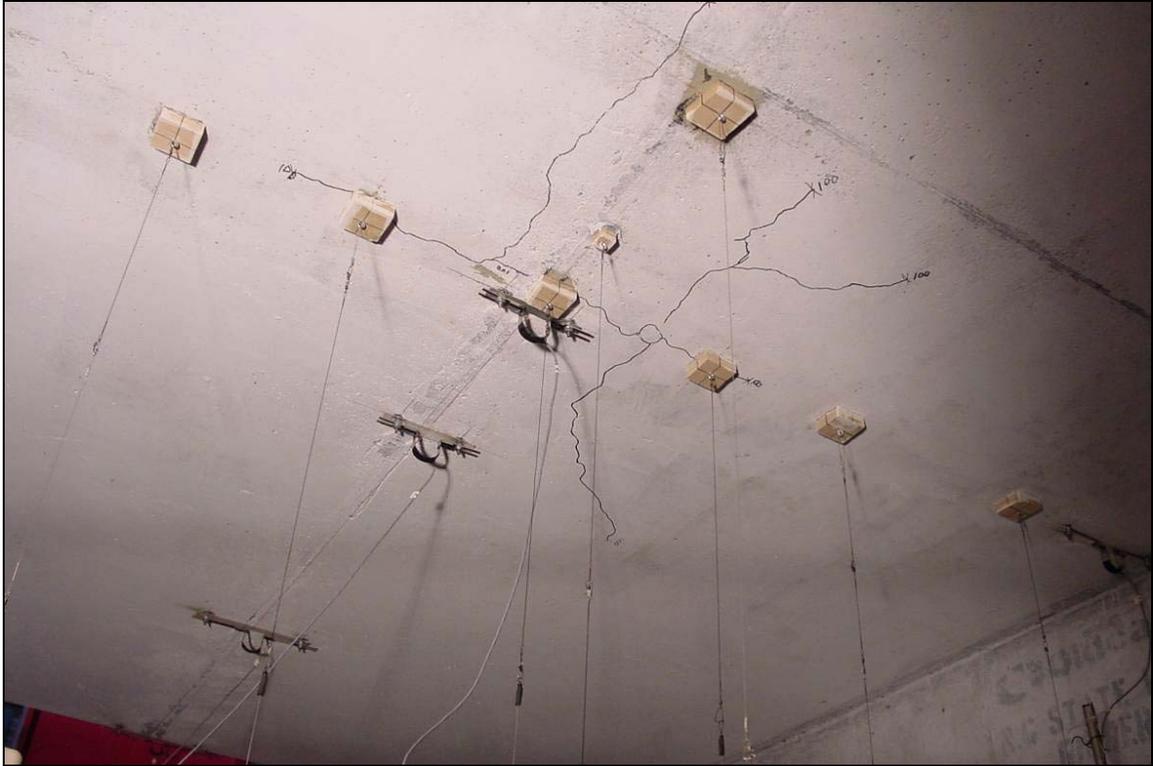
Figure 4-12: Positive Flexural Cracks at 100 kips in First Deck

Positive moment flexural cracks were clearly developed at load levels of 100 and 150 kips (445 and 667 KN) in all three tests. The cracks at these load levels are shown for the first bridge deck in Figure 4-12 and Figure 4-13. Again, these figures are typical of all three tested decks. The pattern of cracks radiating outward equally in all directions from a point directly under the load confirms that two-way distribution of the load is taking place.

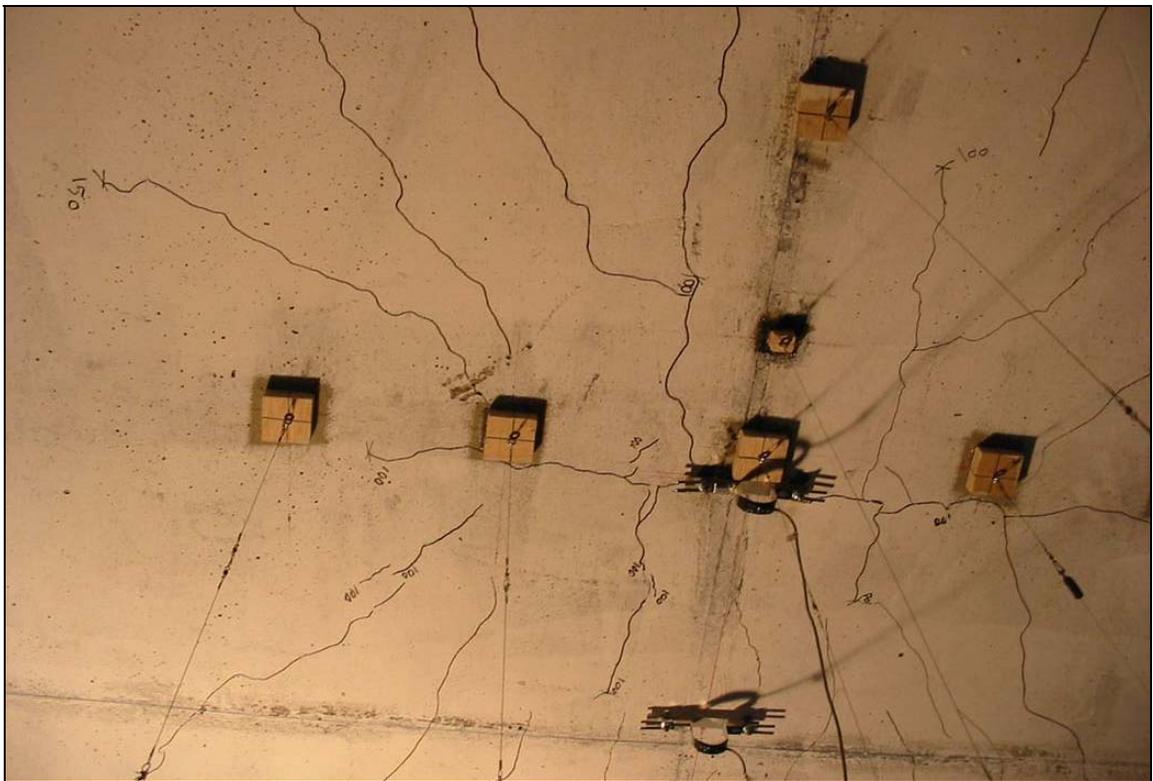
Figure 4-13: Positive Flexural Cracks at 150 kips in First Deck

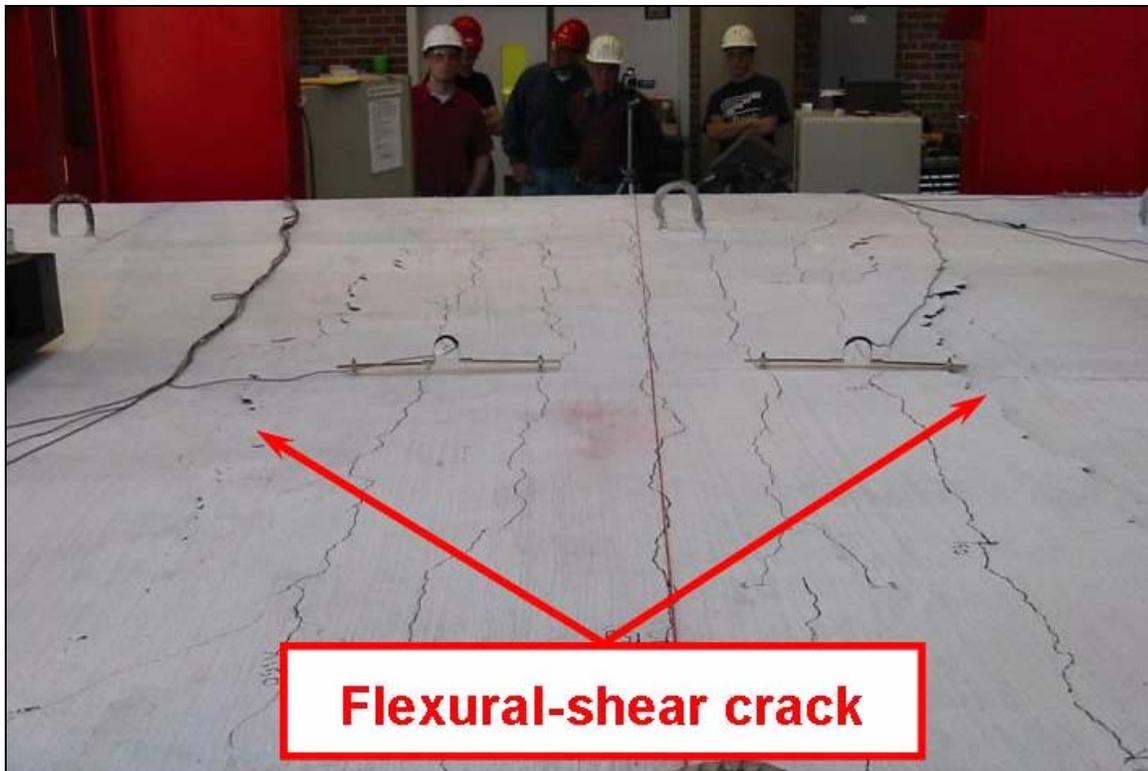
Figure 4-14: Flexural-Shear Cracks in the First Bridge Deck

As loading continued, the negative flexural cracks on the top surface of the slab near the middle girder spread and widened until they developed into flexural-shear cracks. The distinguishing characteristic between the flexural cracks and the flexural-shear cracks was that the concrete on both sides of the flexural cracks was at the same vertical elevation. For the flexural-shear crack however, the concrete on the side of the flexural-shear crack closest to the load was at a noticeably lower elevation than was the concrete on the side of the flexural-shear crack opposite the load. Formation of these flexural-shear cracks led to a gradual drop in load as the stiffness of the spans deteriorated. In the first bridge deck, these flexural-shear cracks formed simultaneously on both sides of the middle girder, as shown in Figure 4-14. This symmetry allowed for a subsequent simultaneous increase of the load on both spans which caused the nearly-simultaneous punching shear failure in both spans.

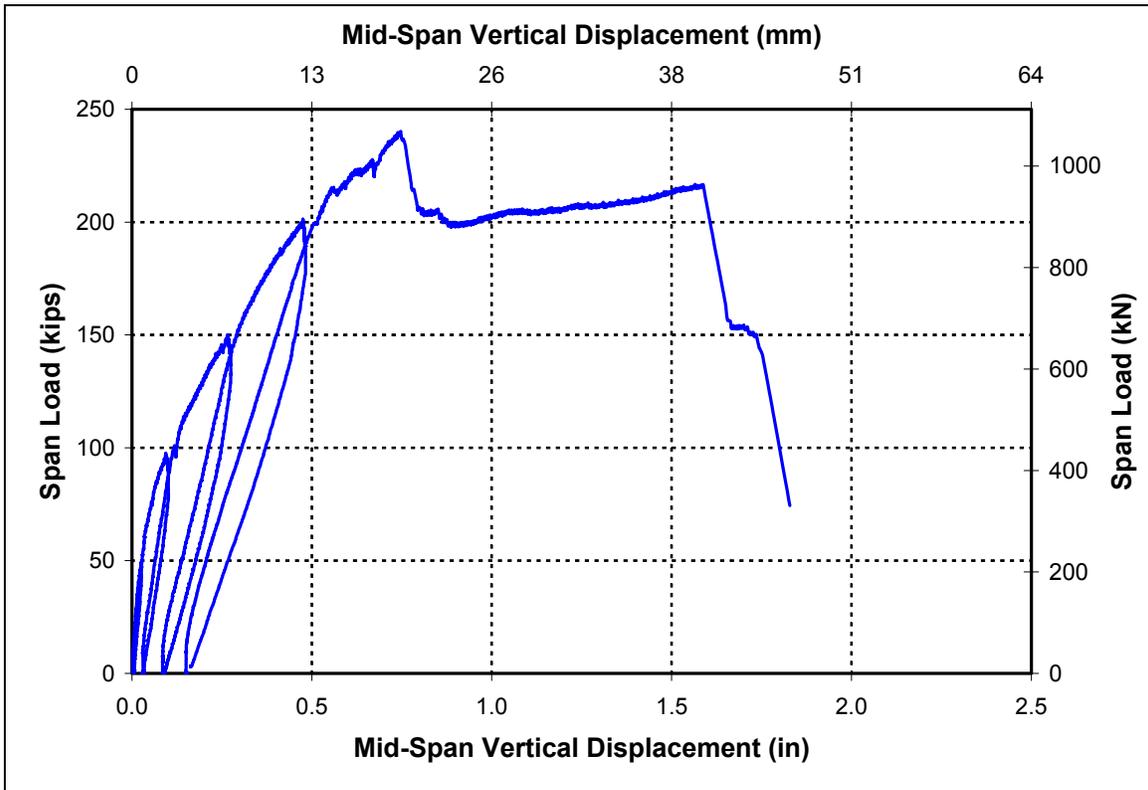
Figure 4-15: Load-Deflection Curve for the Right Span of First Deck

then meet those previous cycles at their peak loads. This cyclical behavior was typical of all spans tested, and can be seen in Figure 4-15 showing the complete load-deflection profile for the right span of the first deck.

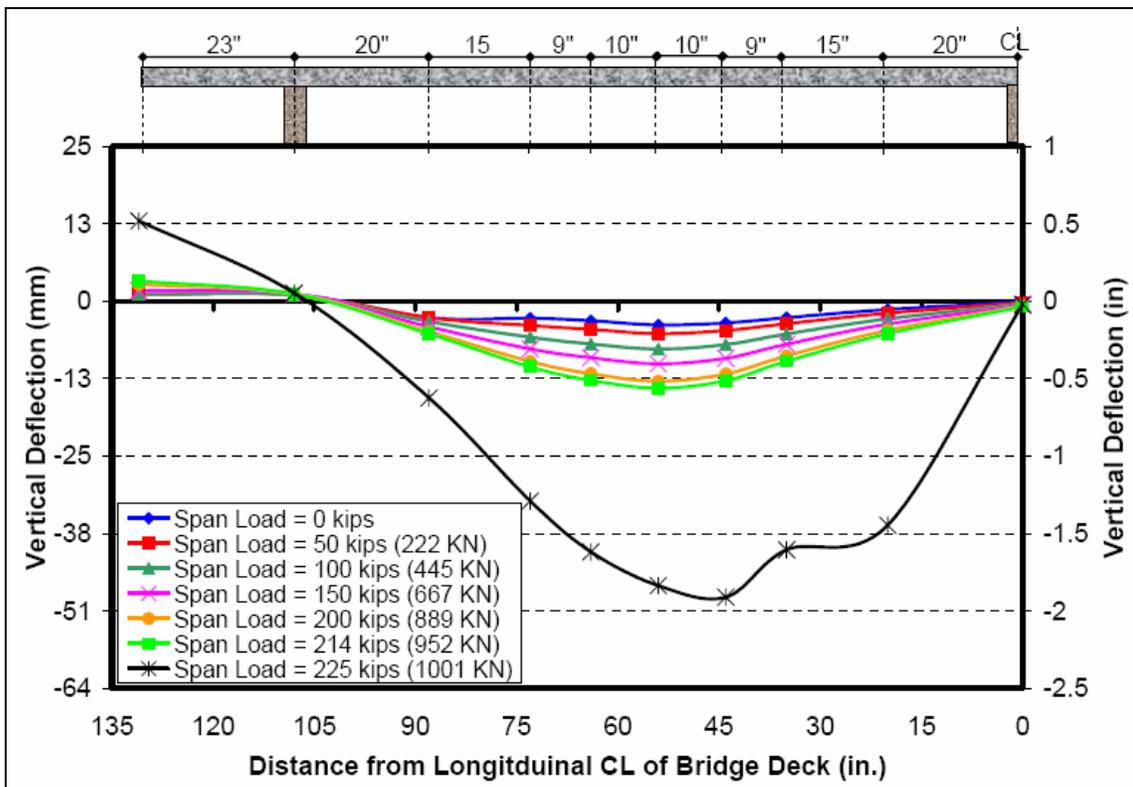
Figure 4-18: Transverse Deflection Profile for Left Span of First Deck

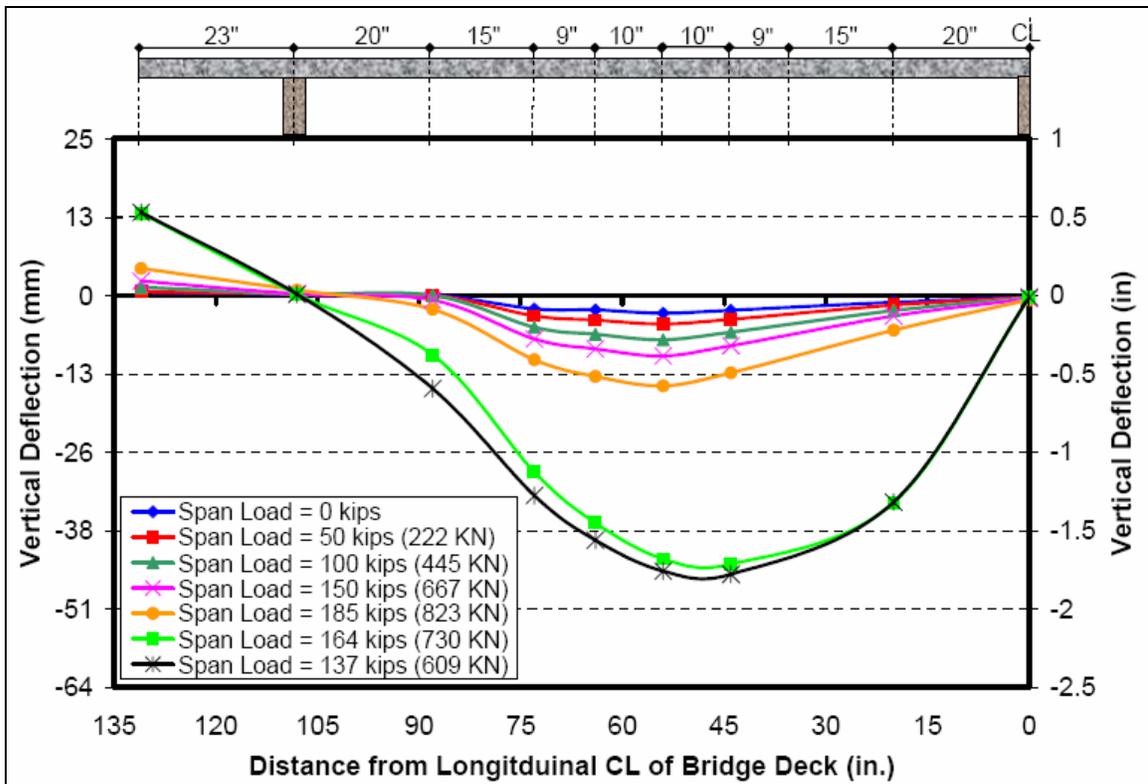
Figure 4-20: Transverse Deflection Profile for Left Span of Second Deck

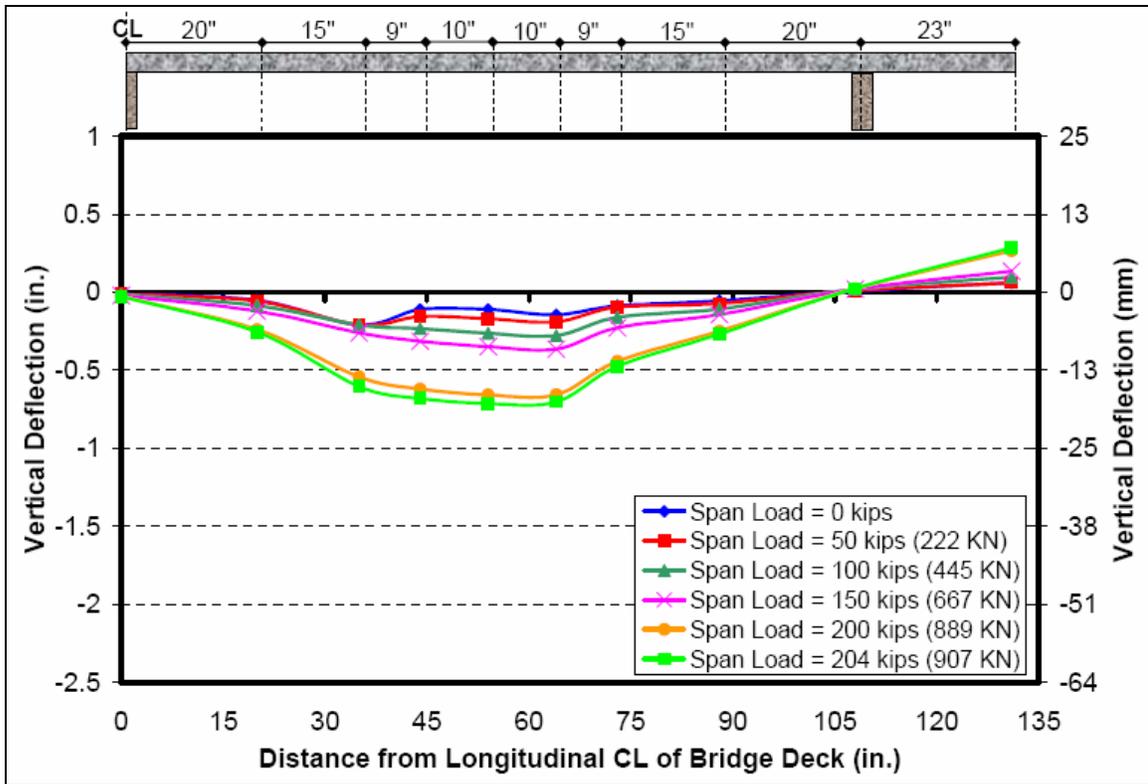
Figure 4-21: Transverse Deflection Profile for Right Span of Second Deck

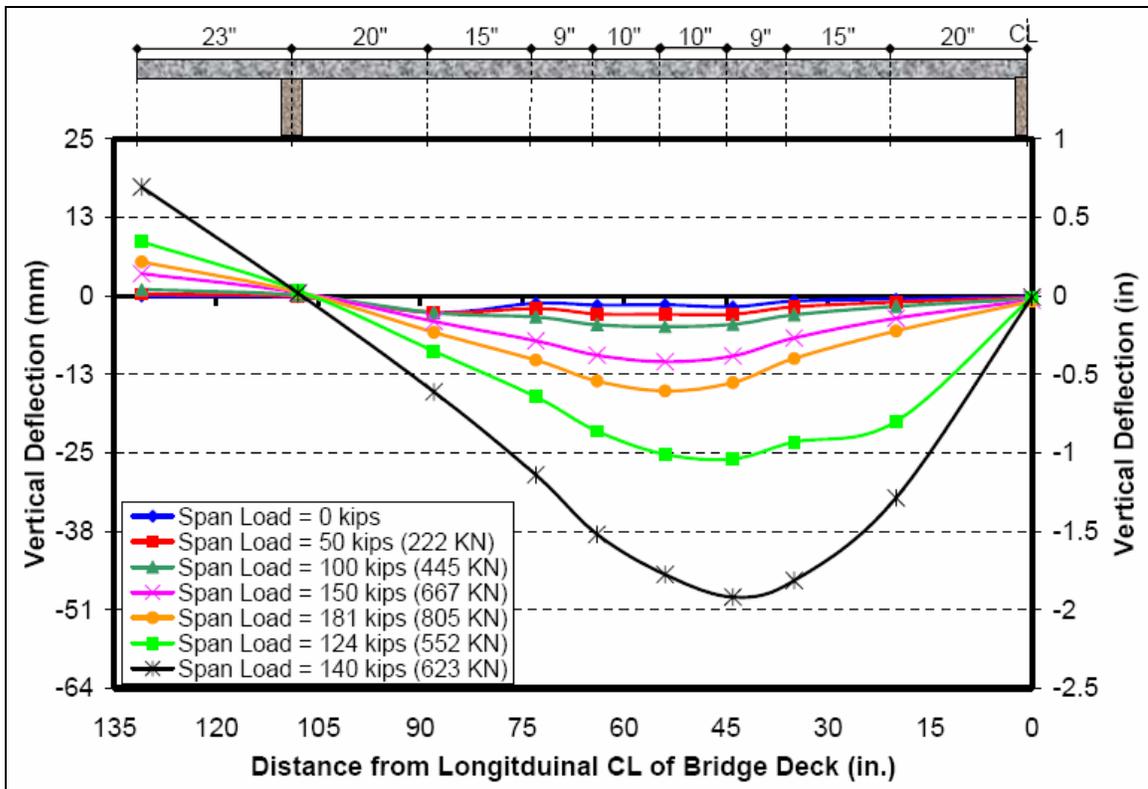
Figure 4-22: Transverse Deflection Profile for Left Span of Third Deck

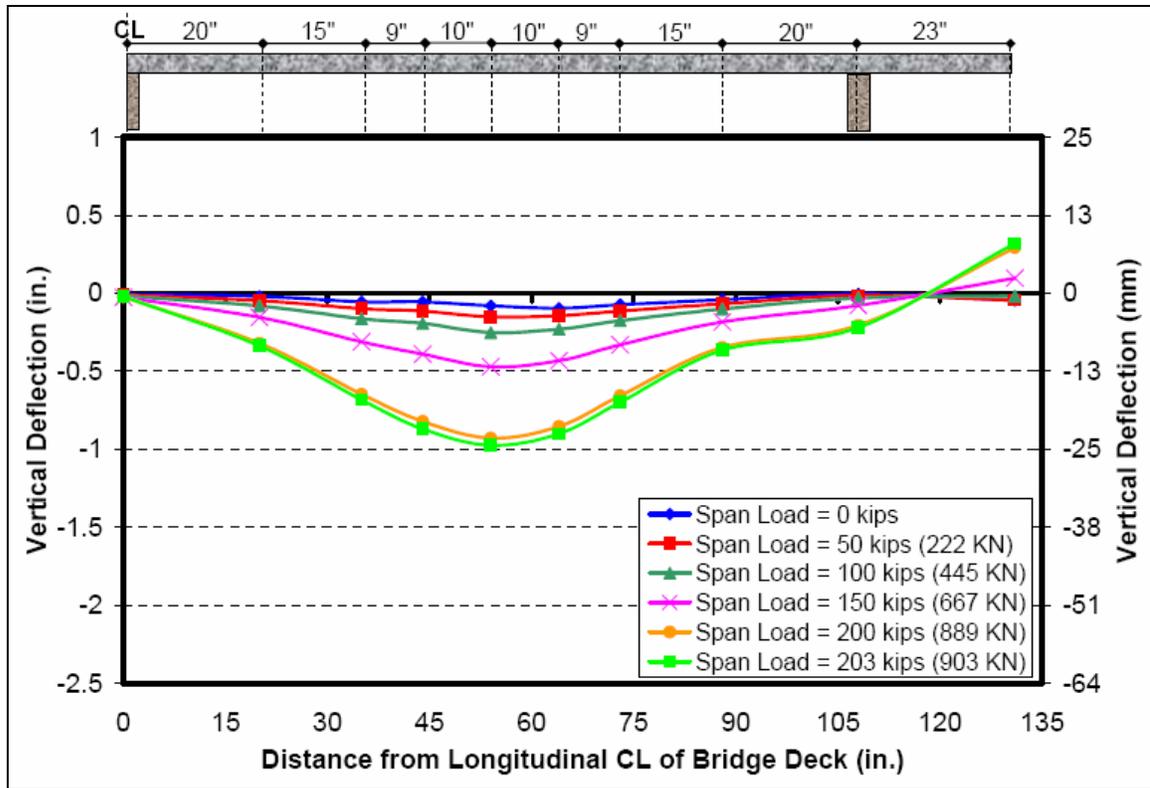
Figure 4-23: Transverse Deflection Profile for Right Span of Third Deck

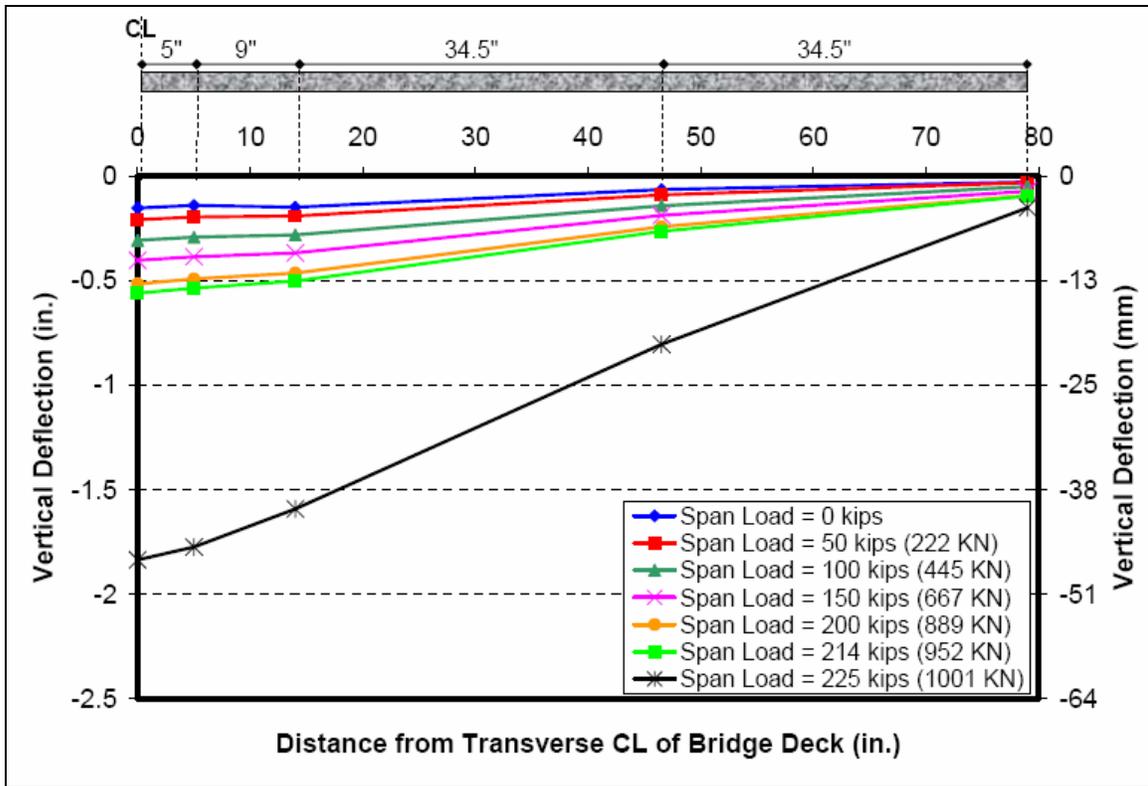
Figure 4-24: Longitudinal Deflection Profile for Left Span of First Deck

Deflection profiles plotted along the longitudinal direction (parallel to the girders) of the three bridge decks are shown in Figure 4-24 through Figure 4-29. These profiles are plotted using the same conventions that were used in above figures corresponding to transverse profiles. Again, a section of the tested deck is sketched above each deflection profile to assist in visualizing where the measurements were taken.
