LUCIER, GREGORY W. Evaluation of MMFX Steel for Concrete Bridge Decks.
(Under the direction of Dr. Sami Rizkalla.)

Evaluation of MMFX Steel for Concrete Bridge Decks

A thesis submitted to the graduate faculty of

North Carolina State University

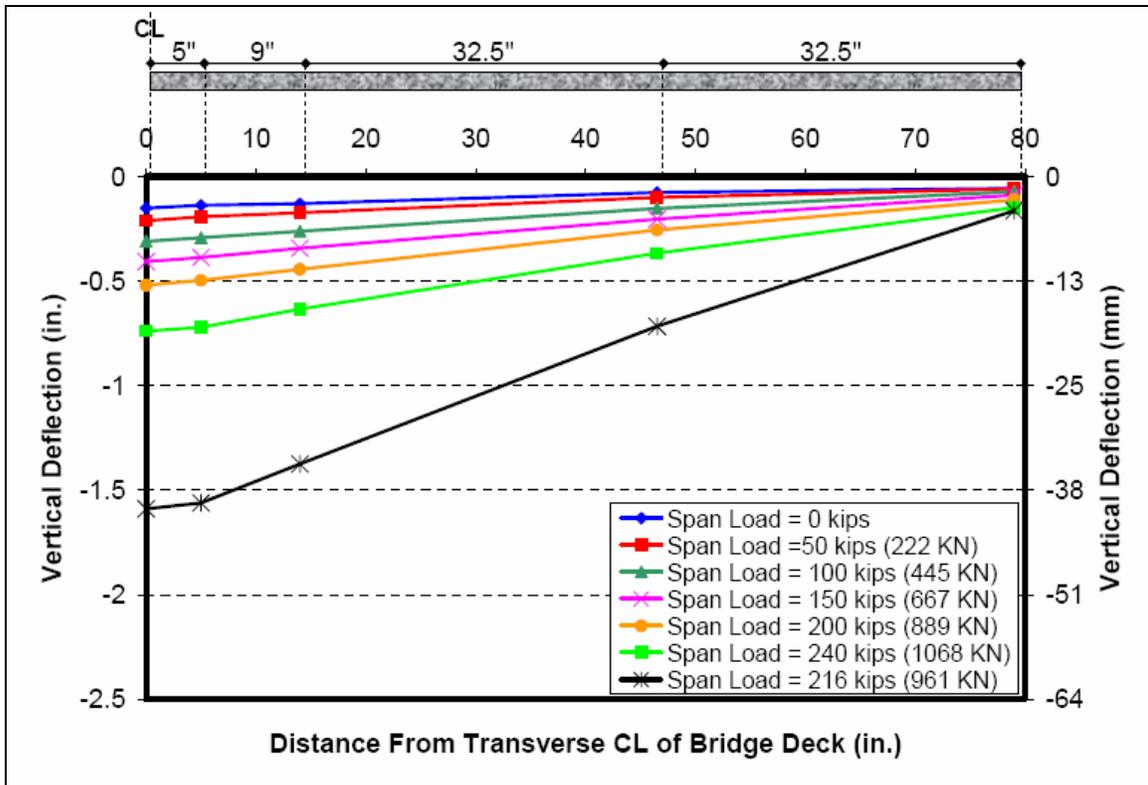
Figure 4-25: Longitudinal Deflection Profile for Right Span of First Deck

Deflection profiles plotted along the longitudinal direction (parallel to the girders) of the three bridge decks are shown in Figure 4-24 through Figure 4-29. These profiles are plotted using the same conventions that were used in above figures corresponding to transverse profiles. Again, a section of the tested deck is sketched above each deflection profile to assist in visualizing where the measurements were taken.

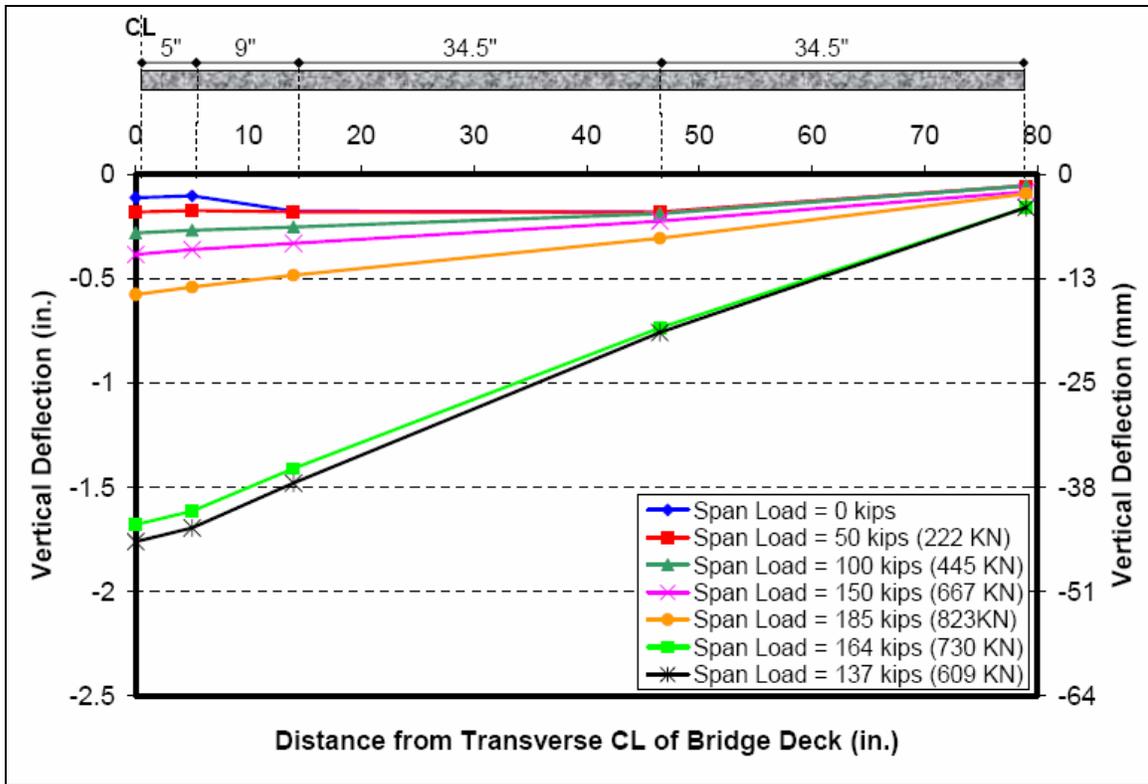
Figure 4-26: Longitudinal Deflection Profile for Left Span of Second Deck

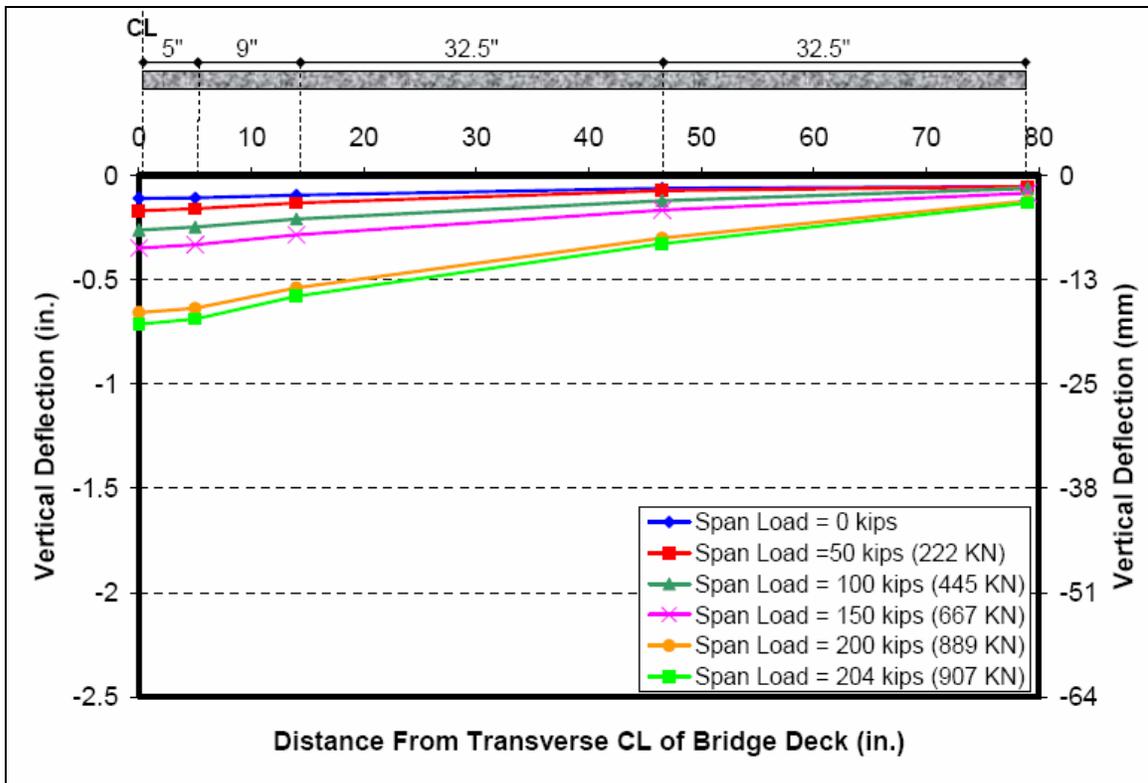
Figure 4-27: Longitudinal Deflection Profile for Right Span of Second Deck

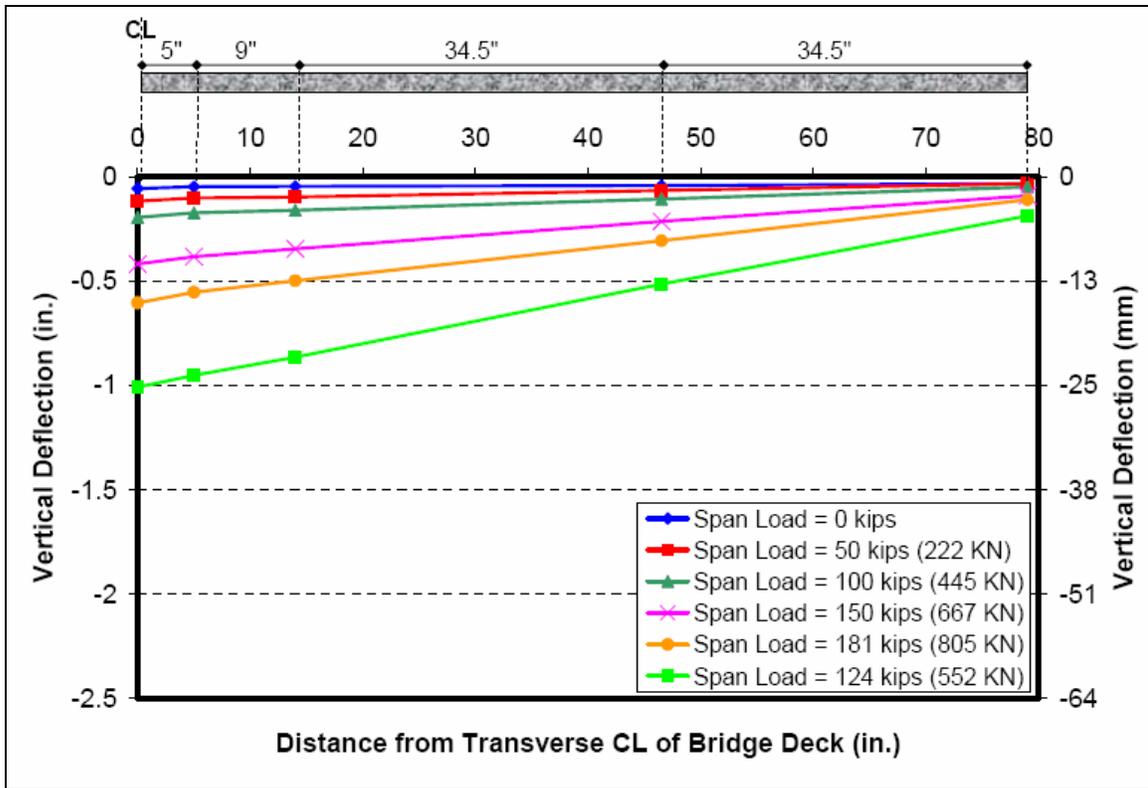
Figure 4-28: Longitudinal Deflection Profile for Left Span of Third Deck

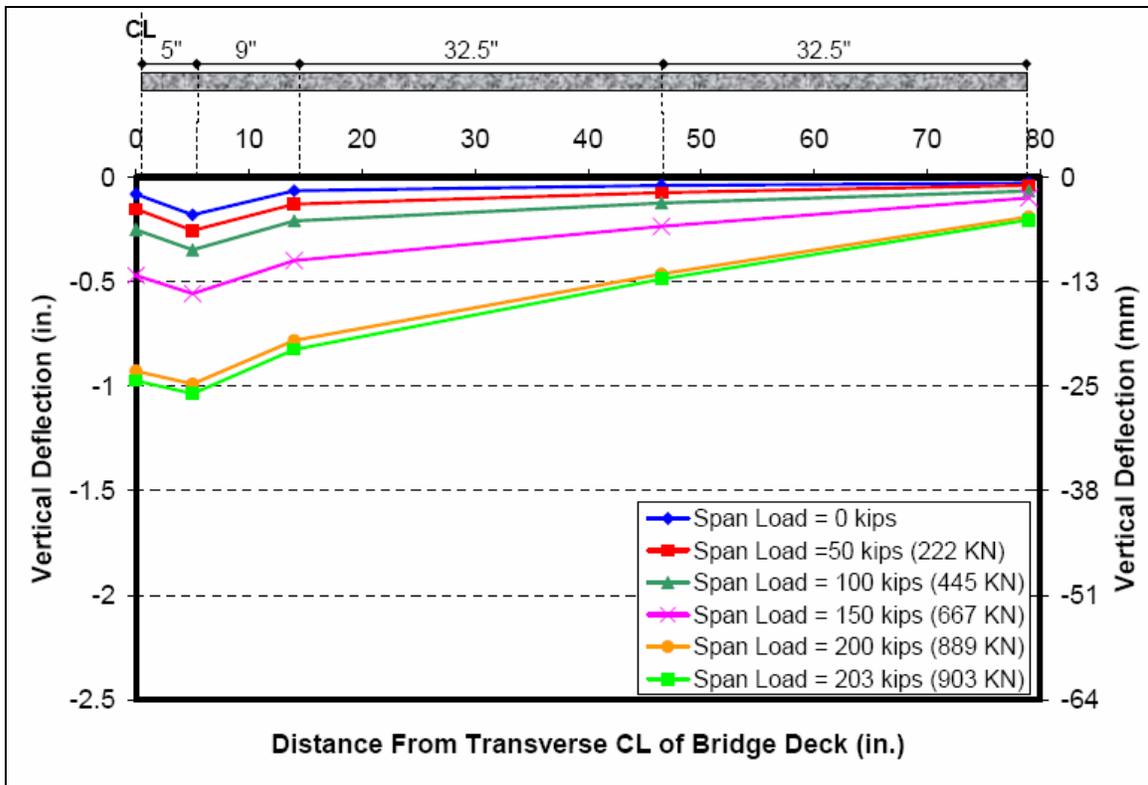
Figure 4-29: Longitudinal Deflection Profile for Right Span of Third Deck

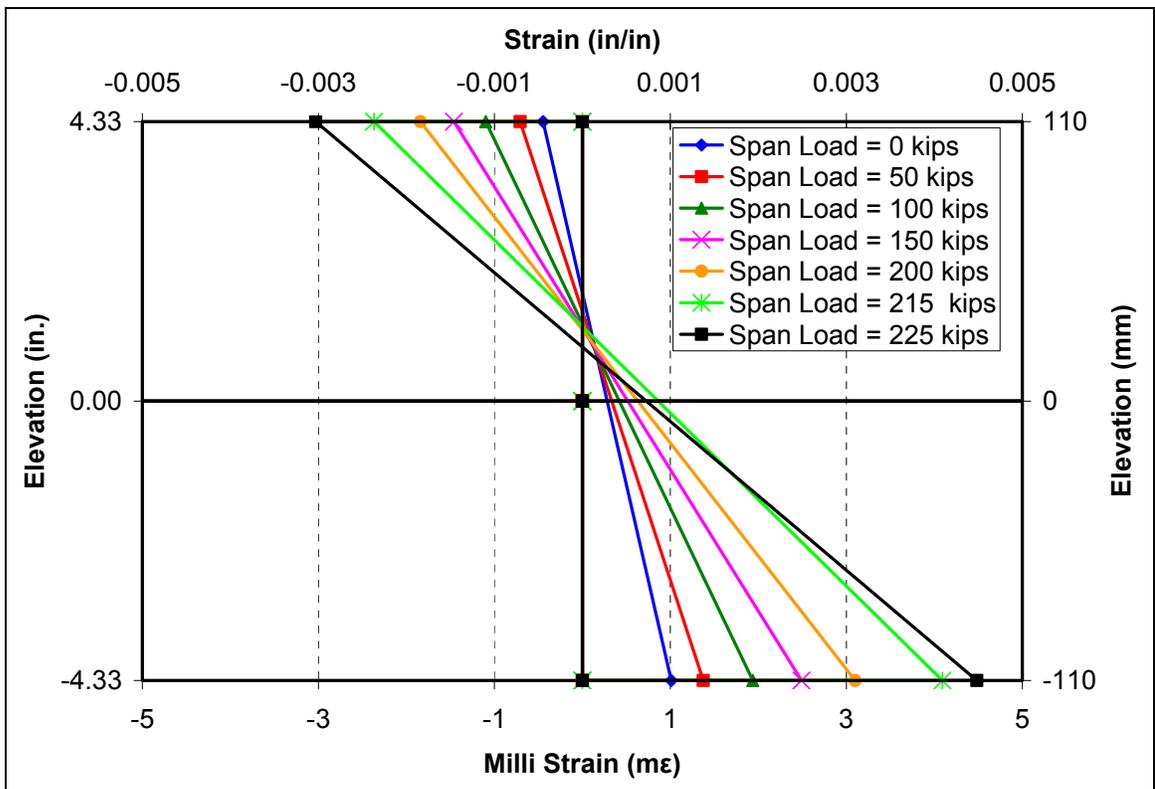
Figure 4-31: Strain Profiles from PI gages T6 and B10 First Deck

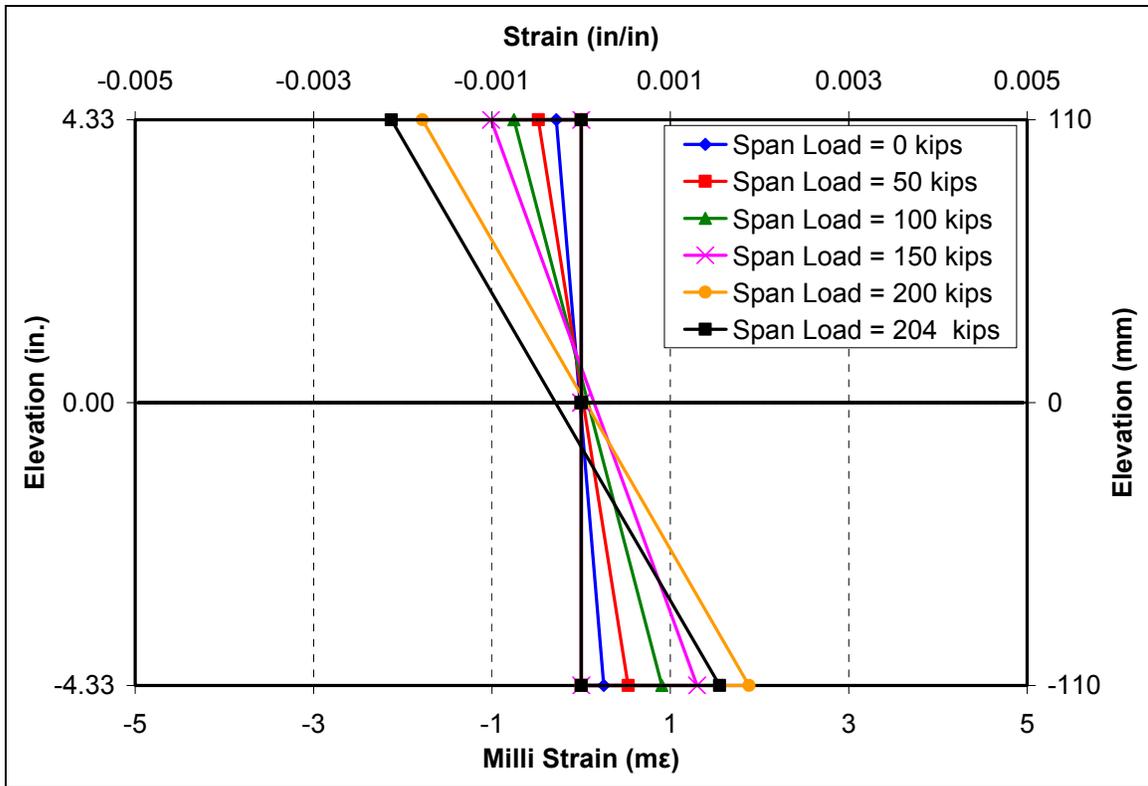
Figure 4-32: Strain Profiles from PI Gages T6 and B10 Second Deck

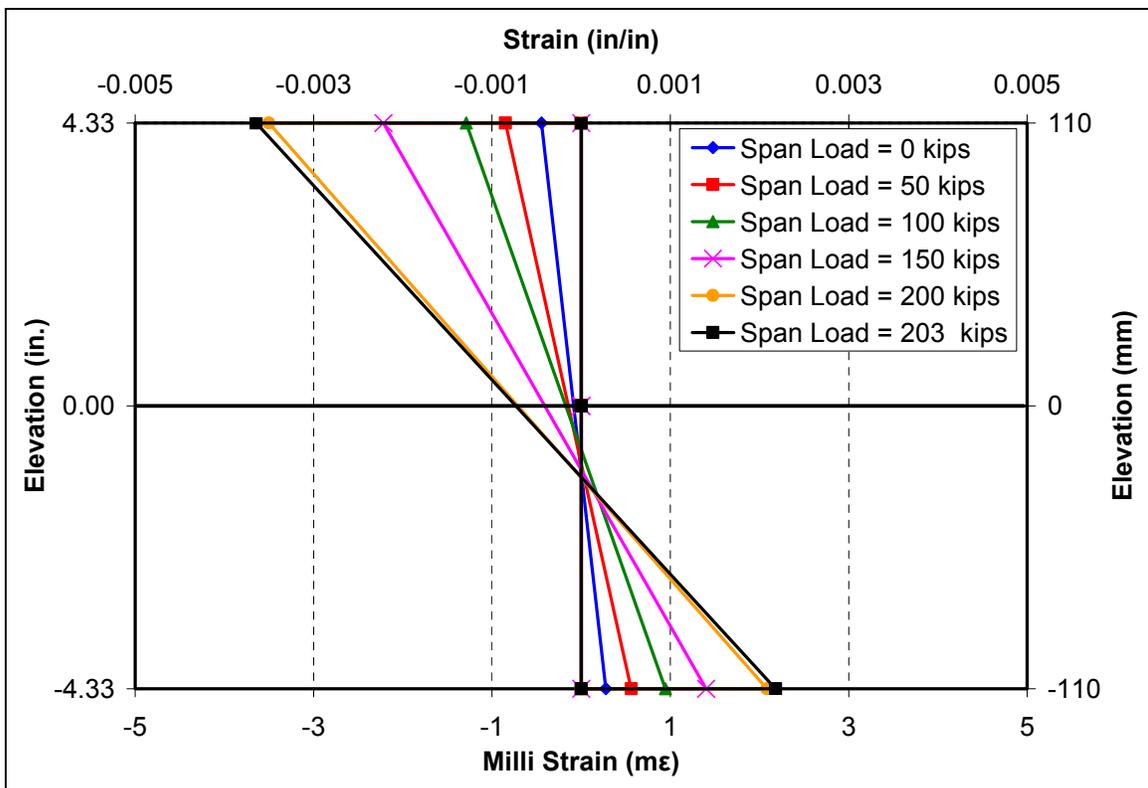
Figure 4-33: Strain Profiles from PI Gages T6 and B10 Third Deck

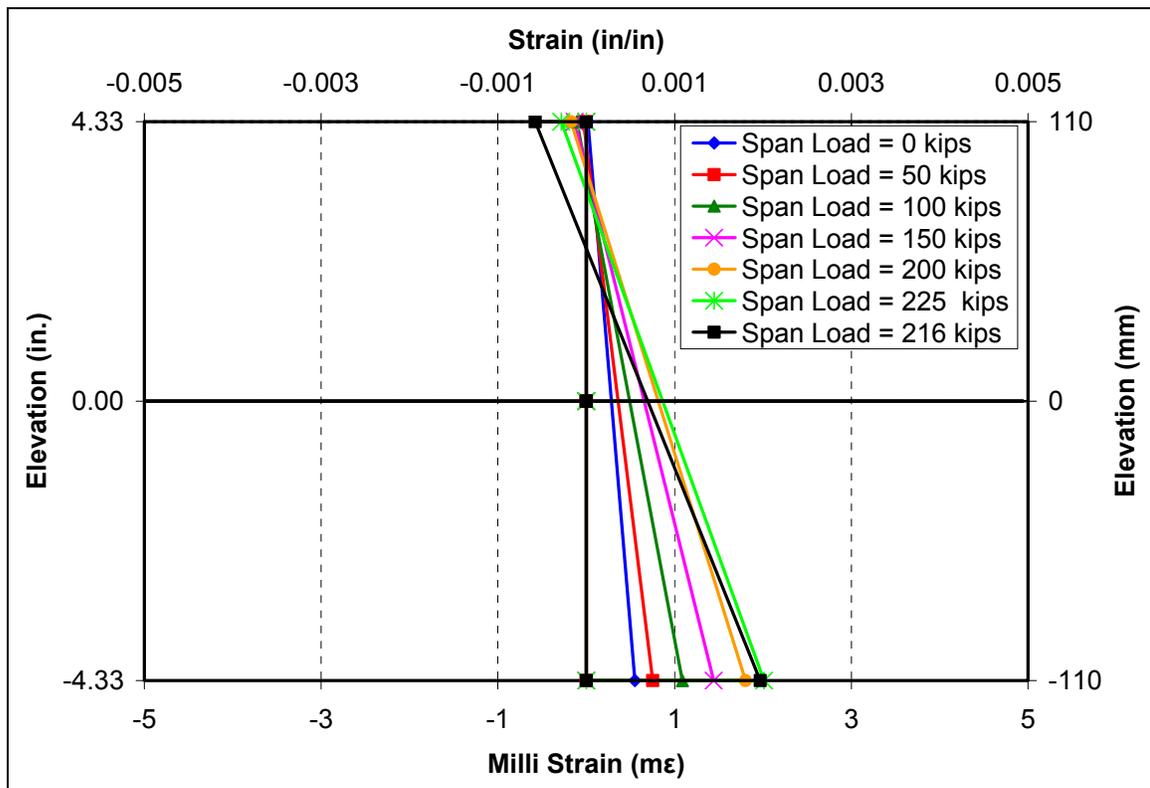
Figure 4-34: Strain Profiles from PI Gages T8 and B12 for First Deck

Strain profiles obtained from the PI gages T8 and B12 are shown in Figure 4-34, Figure 4-35, and Figure 4-36 for the three bridge decks, respectively. These gages are located at the outer edge of the right span, centered between the girders. Refer to Figure 3-10 for detailed gage locations. Gage T8 is located on the top of the deck and B12 is located directly beneath T8 on the bottom of the deck. The strain profiles for the three decks show that the strain values in these locations were very small, especially in compression. This finding is another indication that two-way slab action is taking place, and that the selected length of the bridge deck is representative of the actual bridge behavior. Strain profiles from the rest of the gages are provided in Appendix A.

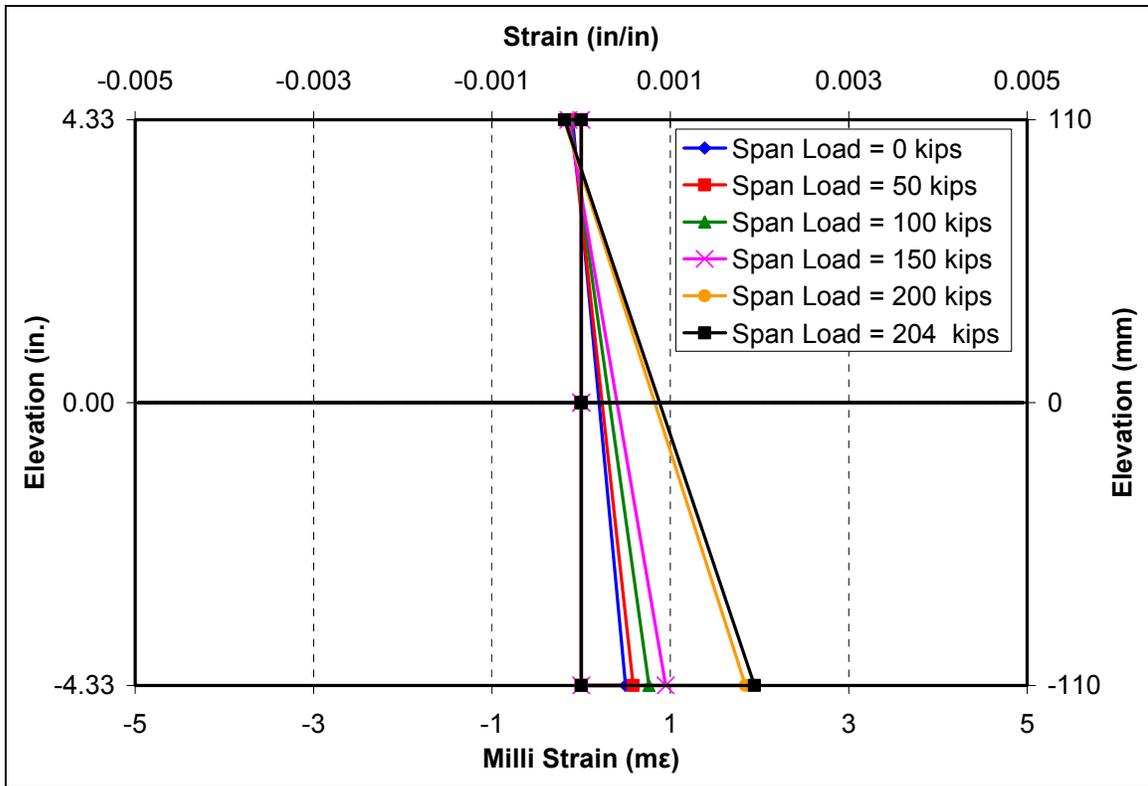
Figure 4-35: Strain Profiles from PI Gages T8 and B12 for Second Deck

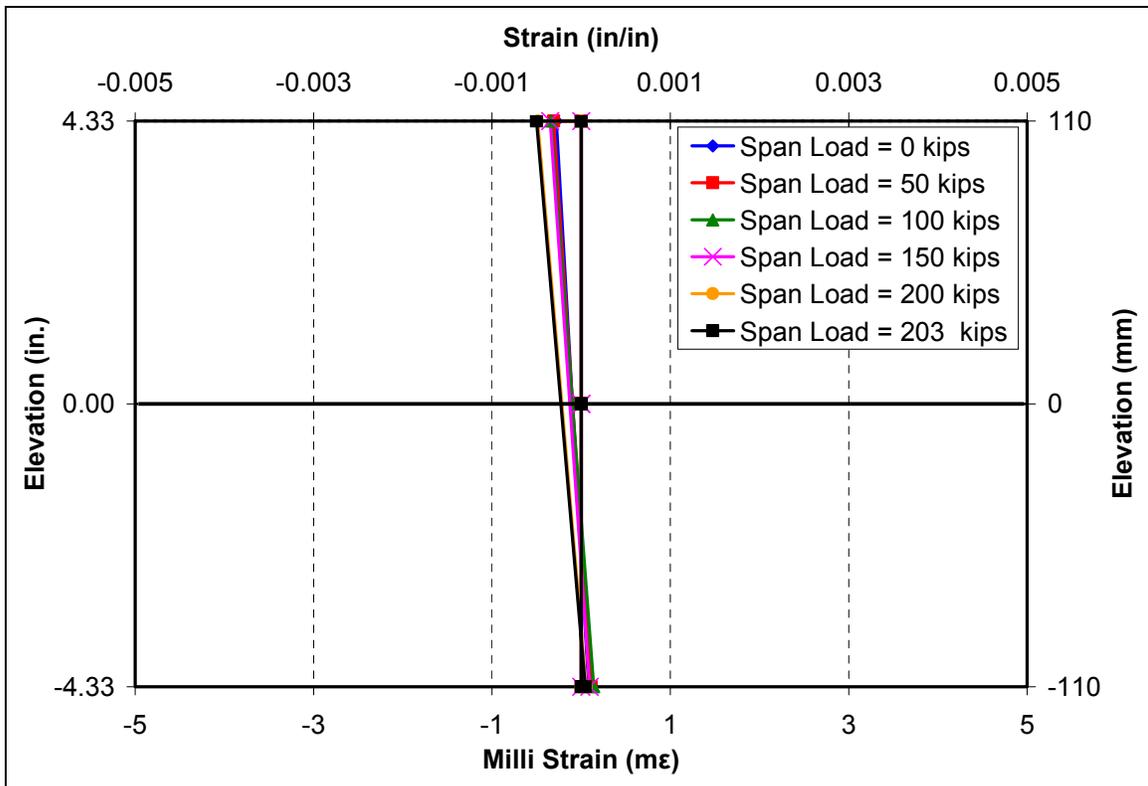
Figure 4-36: Strain Profiles from PI Gages T8 and B12 for Third Deck

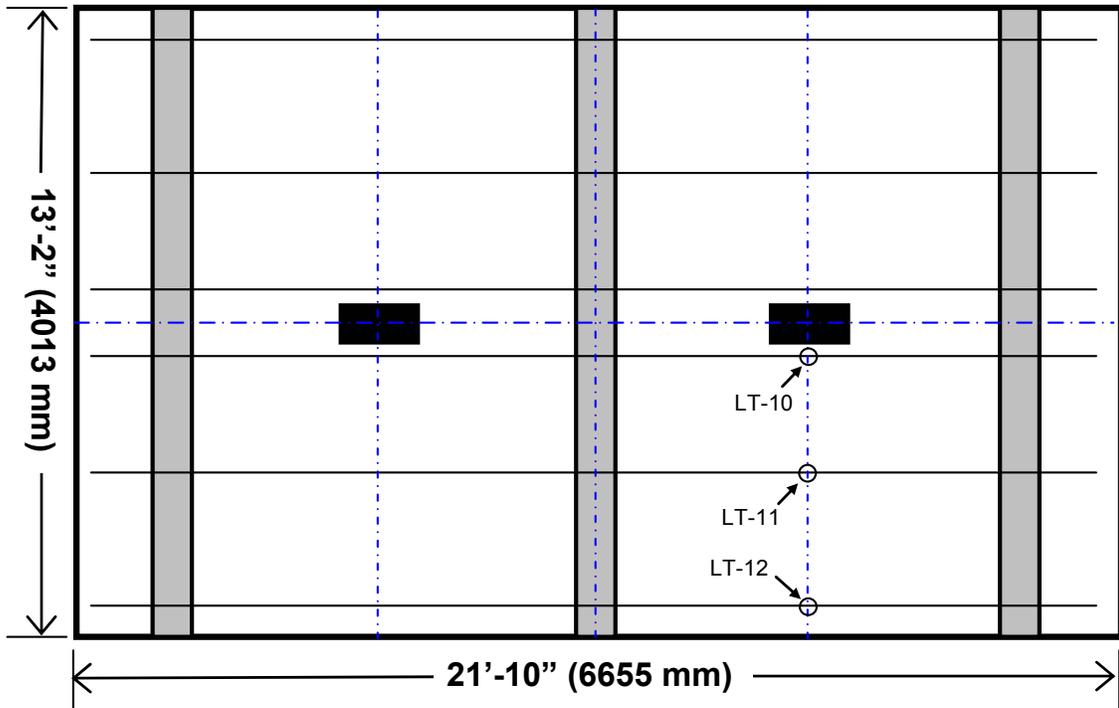
NOTE: Only Lower-Mesh Transverse Bars with Gages Shown

Figure 4-37: Location of Strain Gages LT-10, LT-11, and LT-12

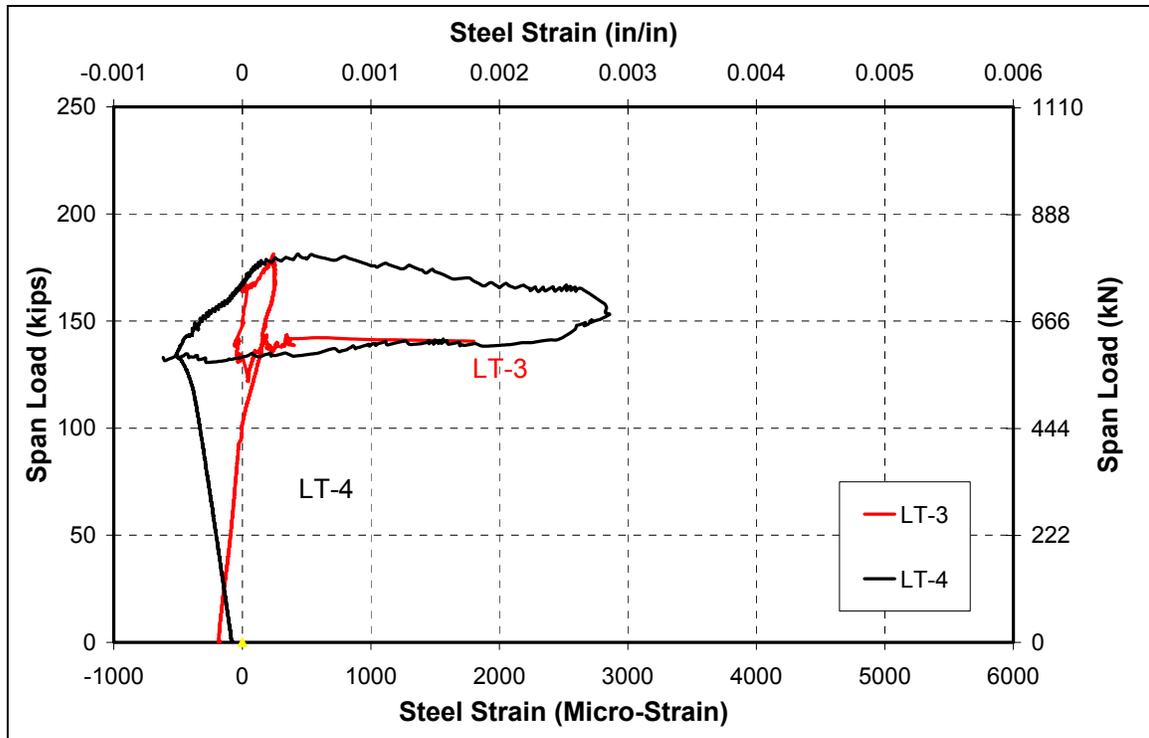
Figure 4-42: Left Span Lower Transverse Steel Strain of Third Deck

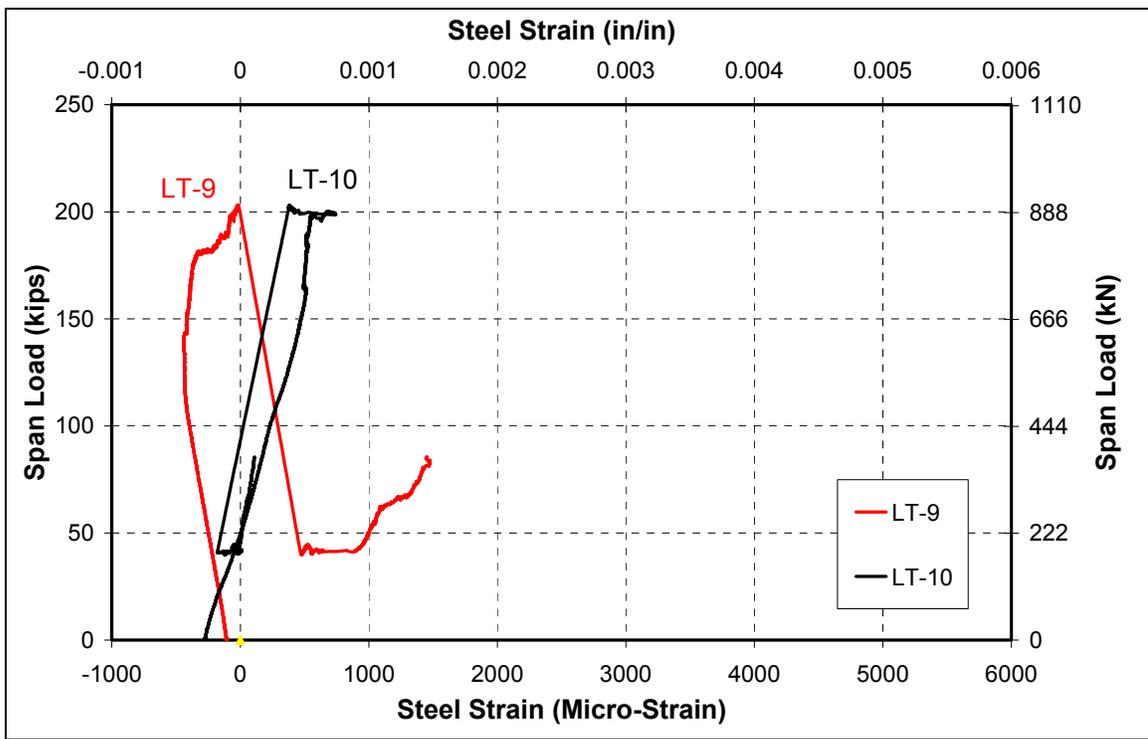
Figure 4-43: Right Span Lower Transverse Strains of Third Deck

To confirm the presence of so called net action for the spans with significant flexural-shear cracking only, consider the data from the same gages in the right span of the third deck. These data are presented in Figure 4-43. Recall that the right span of the third deck failed in punching shear, prior to the development of significant flexural-shear cracking. Data plotted for the lower transverse strain gage near the face of the center girder (LT-9) show that the bar in this location remained in compression for the duration of testing, up until punching failure. The strain gage on the upper mesh, directly above LT-9, remained in tension for the duration of testing (see Appendix B for data from gage UT-3). For such a negative moment region, this is classical flexural behavior for a doubly-reinforced section.

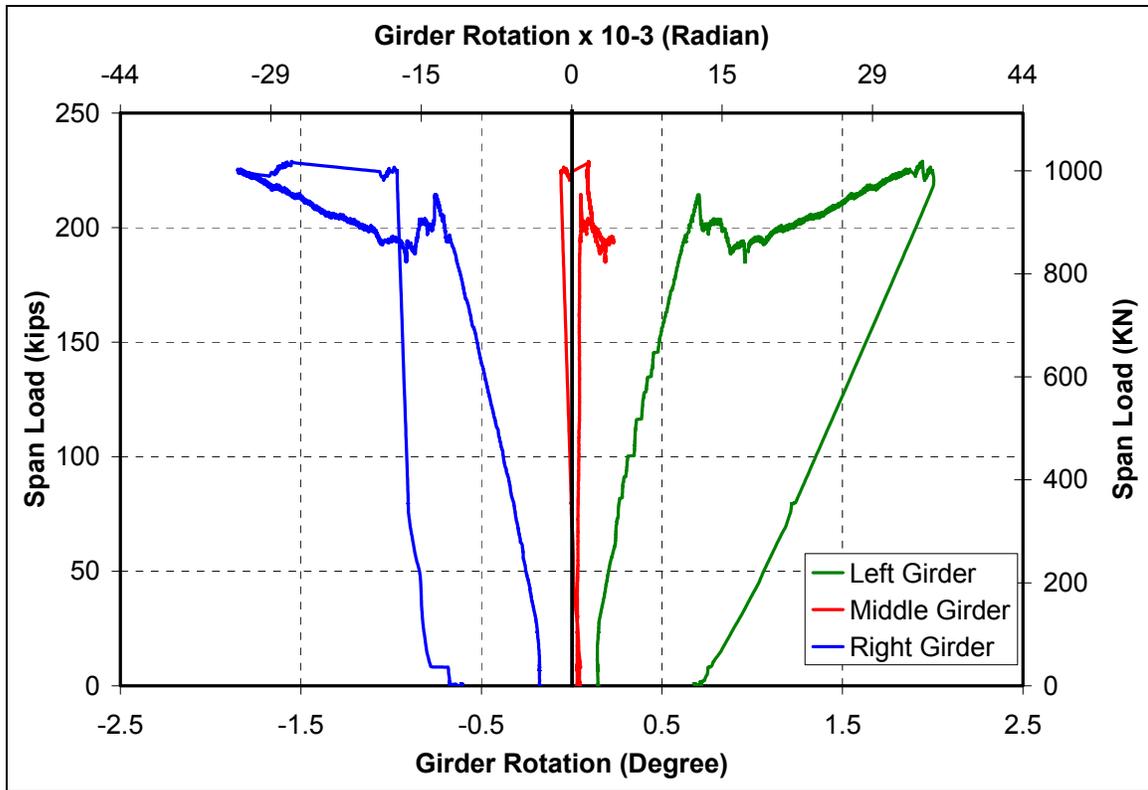
Figure 4-44: Girder Rotation for the First Deck

Rotation of the three supporting girders was monitored throughout the test of each bridge deck. The rotations of each of these girders are shown in Figure 4-44 through Figure 4-46 for each of the decks, respectively. Data are plotted in radians with zero radians being defined as vertical, and positive rotation being defined as rotation towards the right side of a given bridge deck. Again, data is plotted for the final loading cycle only, and thus, some plots show rotations at zero load, representing residual rotation from previous cycles. Note that after failure, the rotation of some girders trends back towards vertical, representing the recovery of a bridge deck after loading was terminated due to failure.

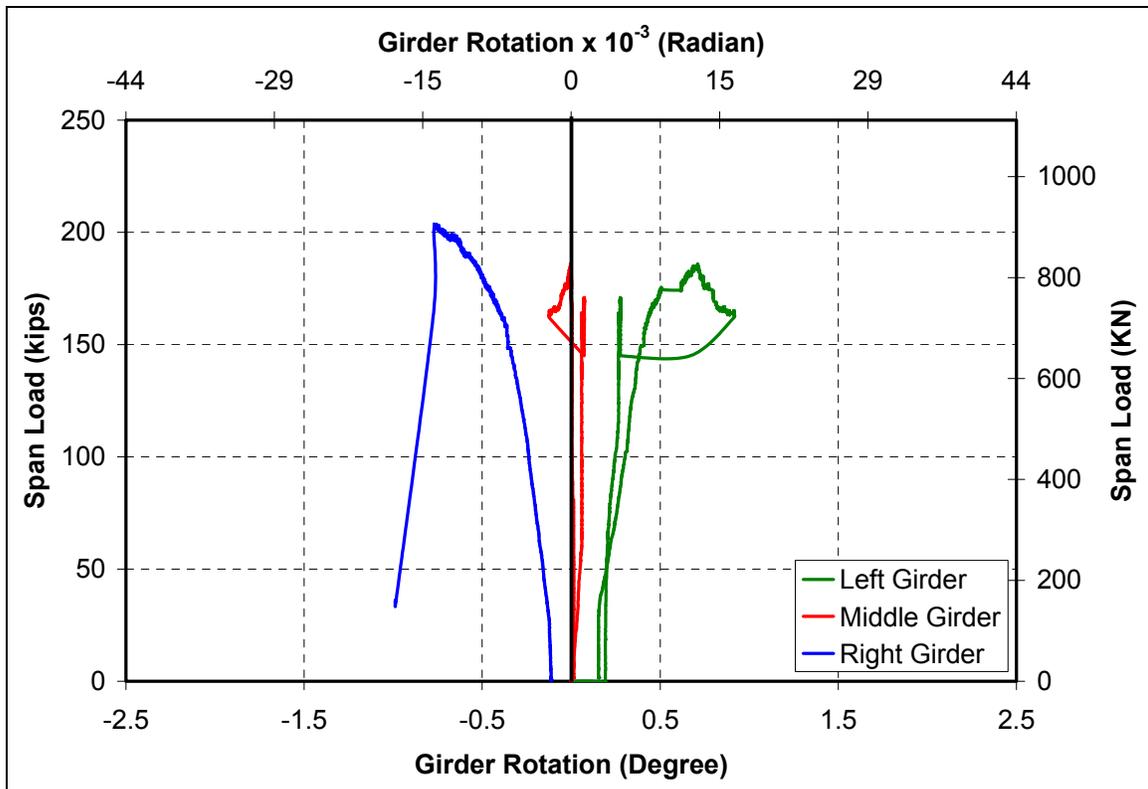
Figure 4-45: Girder Rotation for the Second Deck

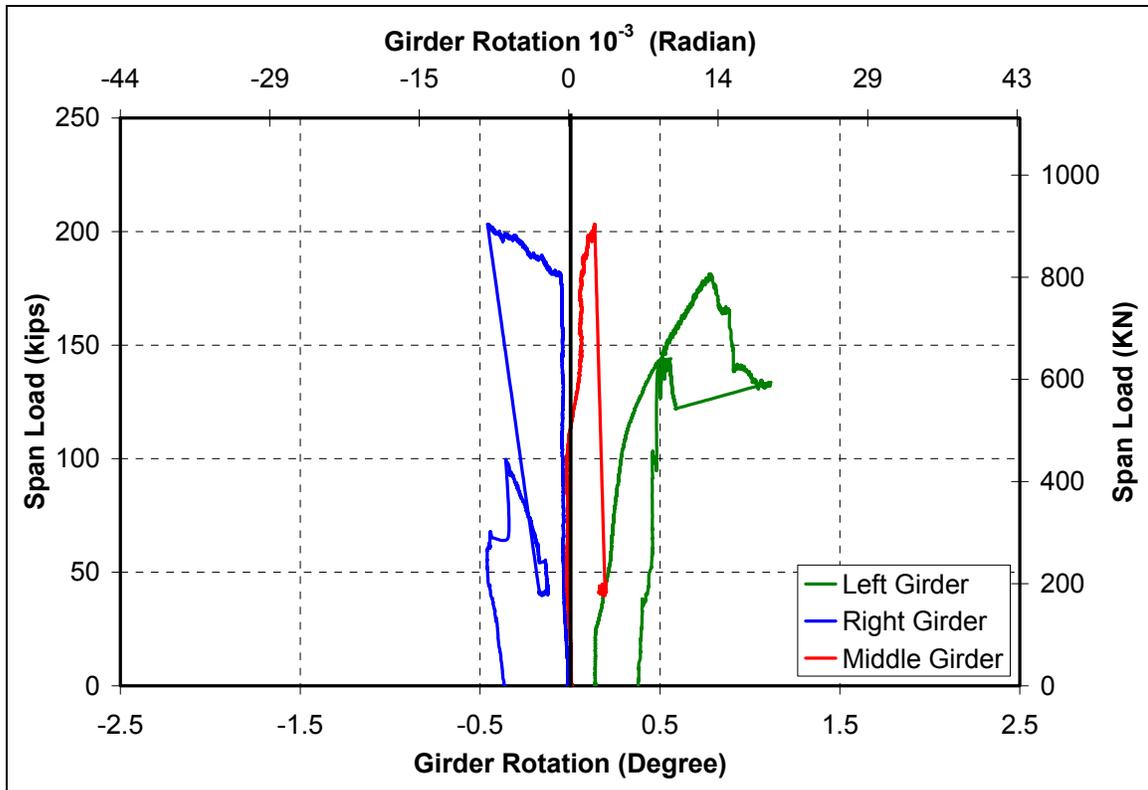
Figure 4-46: Girder Rotation for the Third Deck

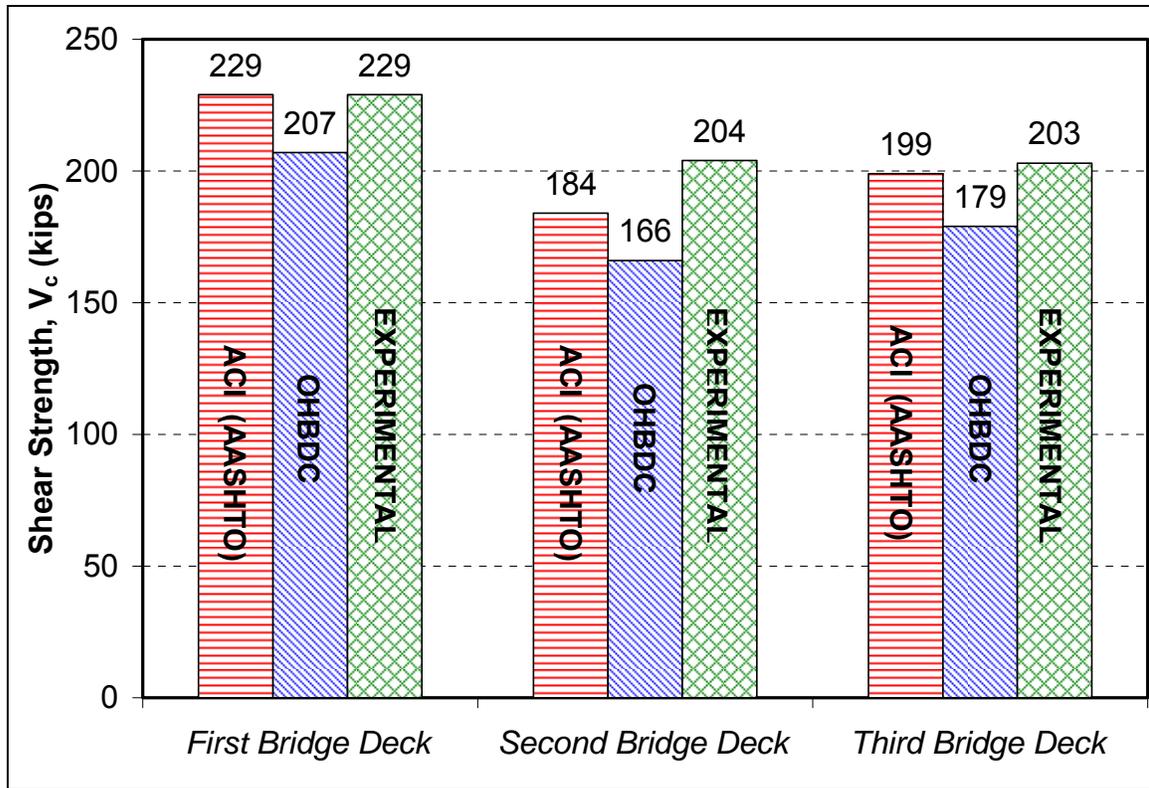
Figure 4-47: Predicted and Experimental Shear Strengths

The predicted shear strengths for the three bridge decks as determined by relevant design codes are given in Figure 4-47. These values are compared to the values for punching strength that were determined experimentally. The design codes included are: American Concrete Institute ACI 318-05(2005), American Association of State Highway Transportation Officials AASHTO LRFD (2004), and Ontario Highway Bridge Design Code (1991). The code equations used are given in the literature review.
