ASSESSMENT OF SUPERPOSITION AS A DESIGN FRAMEWORK FOR THE
COMBINED EFFECTS OF SOIL IMPROVEMENT AND FOUNDATION
REMEDICATION

A thesis submitted to the Graduate Faculty of
North Carolina State University
in partial fulfillment of the
requirements for the Degree of
Master of Science

CIVIL ENGINEERING

Raleigh
2004

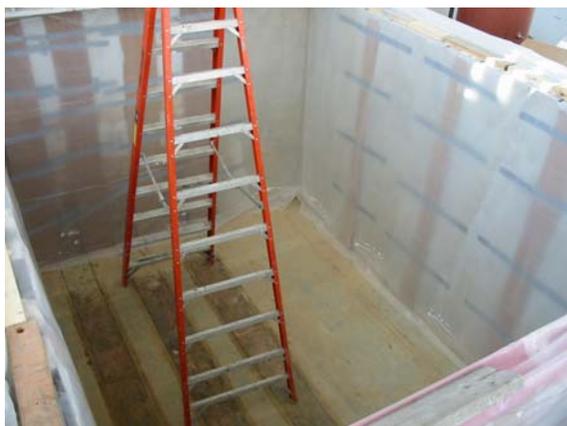
The location of this experimentation was an indoor testing pit in the Geotechnical Systems Lab of the Constructed Facilities Laboratory at North Carolina State University. This $12' \times 9' \times 7'$ pit (Figure 3.7) provided sufficient space for six foundations to be tested per filling of the pit, with minimal influence from surrounding foundations or the rigid walls and base of the pit (Appendix A). The foundations being tested can be considered either spread footings (for pile caps with no piles) or pile foundations. The layout for each of four rounds can be seen in Figure 3.8.

Figure 3.7 Testing pit

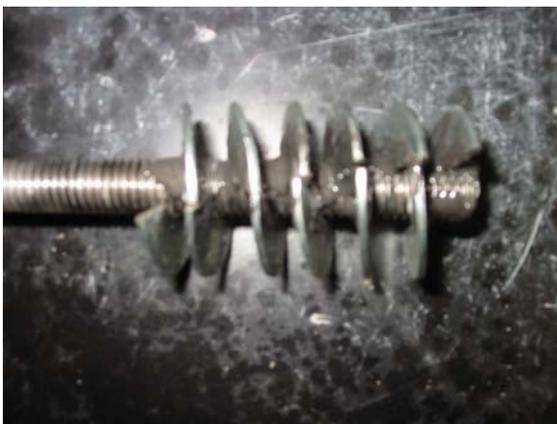
Figure 3.9 Auger bit

2) Cap and piles: When piles were involved, the same procedure was followed as that for the pile cap placement, except that prior to the casting of the cap the piles were installed. This was achieved with a casing in a manner similar to full-scale cast in place piers. The modeled casing was a 2.25" diameter piece of PVC, and the auger was a threaded bar with helical shaped washers welded to the shaft and driven by a drill (Figures 3.9 and 3.10). The four PVC casings of a pre-designated length were initially inserted into the sand through a guide (Figure 3.11) to ensure that the piles were installed vertical. The piles were then advanced into the ground by manually pushing on the end of the PVC and inserting the auger until the PVC could no longer be advanced

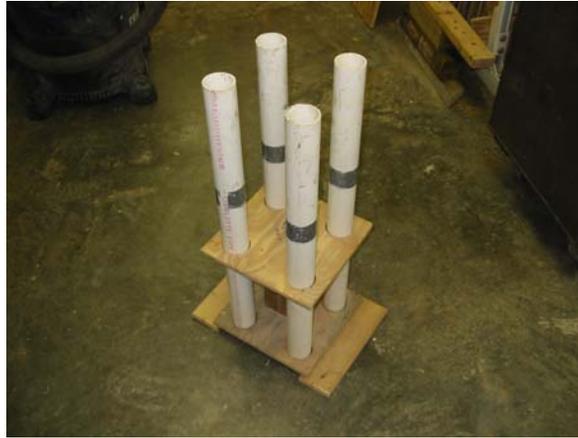
Figure 3.11 Casing guide (not installed here)

The sand inside the PVC was then removed using a vacuum, with careful attention paid to ensure that the sand beneath the base of the casing was not disturbed. When the sand was removed, the PVC was again advanced with the auger and the sand was removed until the PVC reached a depth of 18" below the ground surface. Once the PVC was fully installed, a lead reinforcing cage (Appendix B) was set into each of the PVC casings. The concrete (as described in section 3.4.2.2) was mixed, and a funnel with a 1" diameter spout was used to tremie the concrete down the center of the cage into the PVC. The concrete mix was sufficiently thick to prevent a free flow from the funnel, so a concrete vibrator was briefly held against the side of the funnel to decrease the viscosity of the concrete causing it to flow into the PVC until the casing was filled to the top. A rod was then placed down the center of the piles to check for any air pockets, and the vibrator was again used to vibrate the rod as it was removed to further reduce the possibility of honeycombing. The PVC was then removed from the sand while vibrating the PVC to ensure concrete flow as the PVC was removed. For the axially loaded tests, a well greased telltale was cast in the center of the reinforcing cage (Appendix B). The remainder of the cap formwork was filled with concrete and leveled

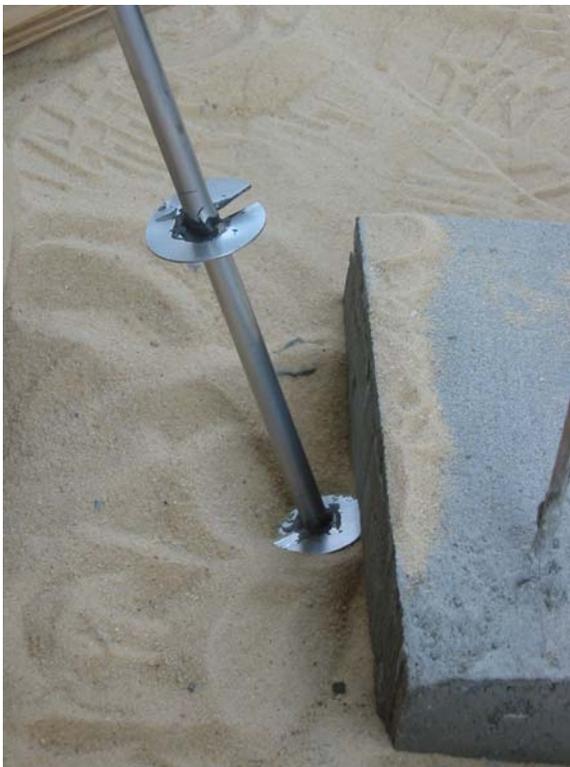
Grouting was performed for two foundation types: those with a grouted helical pier, and those where the helical pier was removed leaving only a grouted column. In both of these foundation arrangements, the concrete was allowed to cure for two days prior to grout installation. The pier installer (as described in Appendix B) was placed such that the pier consistently entered the ground at the middle of the side of the pile cap and at an angle of 79° from horizontal (Figure 3.12), such that the base of the helical pier would reach the base of the cast-in-place piles (Figure 3.13).

Figure 3.12 Installation of helical pier

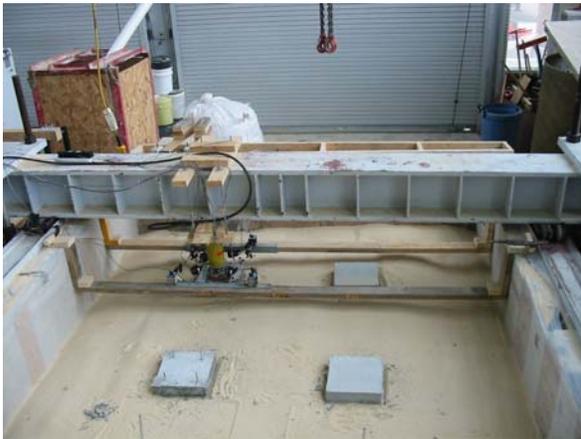
Figure 3.14 Axial test setup

An overall view of an axial load test setup can be seen in Figure 3.14. The axial load was applied in 50-100 pound increments by a hand-pump driven, 30-ton hydraulic piston jack (Figure 3.15) mounted to a steel reaction beam (Figure 3.16) bolted to the walls of the test pit (Figure 3.17).

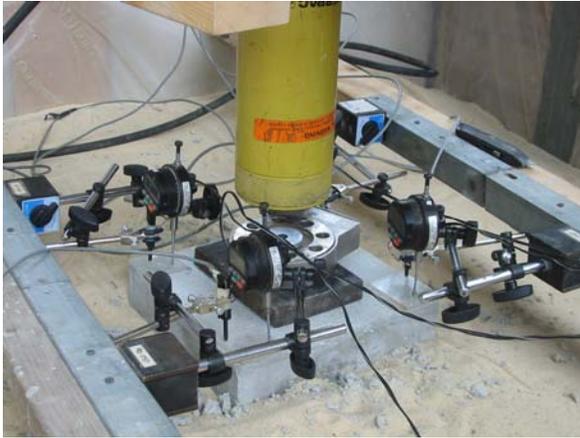
The axial load test instrumentation setup for a cap only test can be seen in Figure 3.18 and for a cap and piles test in Figure 3.19, with the only difference being extra instrumentation for the telltale displacement. A load cell was placed between the jack and a plate on the pile cap to measure the applied load, and an electronic and manual displacement gage was set up on each corner of each foundation (Figure 3.20). The displacement gages were attached to an independent reference frame that was suspended across the pit (Figure 3.14), and was clamped to the pit walls for stability (Figure 3.21). The electronic load and displacement data were collected via a computerized data acquisition system, while the manual gages were hand recorded correlating to the load read from the electronic load cell.

Figure 3.18 Cap test setup

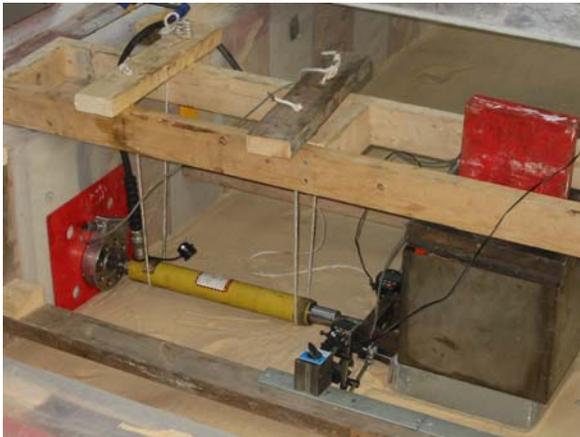
An overall view of the lateral load test setup can be seen in Figures 3.22 and 3.23. The lateral load was applied in 20-40 pound increments by a hand-pump driven, 10-ton hydraulic piston jack (Figure 3.24) that was loaded against the pit wall (Figure 3.25). Approximately 428 lbs of dead weight was placed on top of each laterally loaded foundation to represent a static vertical load applied to the foundation. Each of the two corners on the loaded side was instrumented with both electronic and manual displacement gages (Figures 3.26 and 3.27). The displacement gages for each of the tests were set up on the same independent reference frame as that for the axial load tests.

Figure 3.22 Lateral test setup

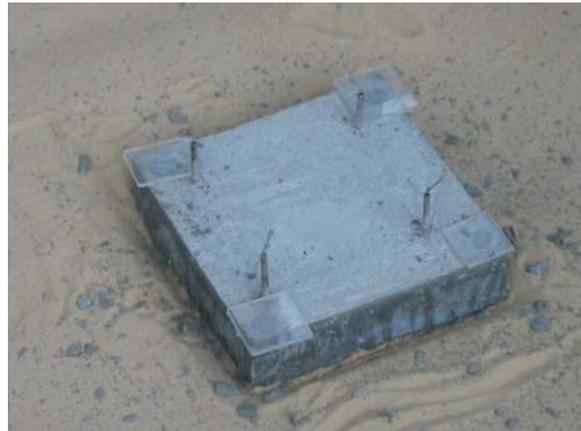
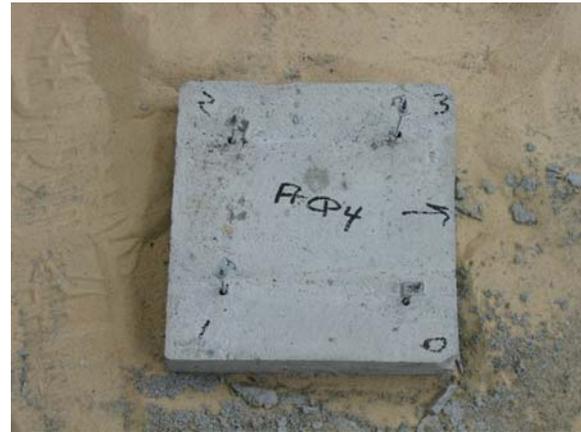
The cap and piles axial load test was conducted to determine how the addition of the piles would affect the cap only load-deflection curve. Several of these tests were performed to show the repeatability of the results. Additionally, various methods of telltale installation were evaluated. Figures 4.5-4.7 show pictures of various ACP tests with the main difference being the method of telltale installation.

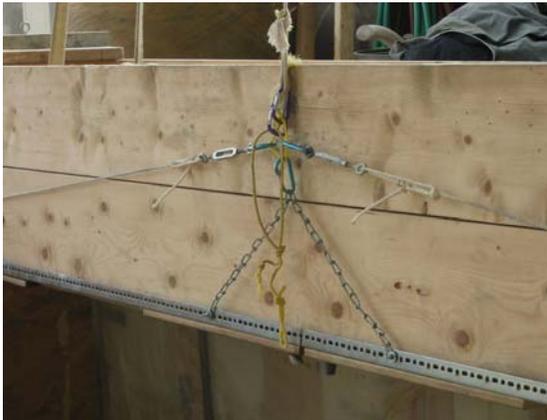
Figure B. 4 Box opening system

To obtain a repeatable soil profile, the sand was pluviated from a constant height and at a constant rate. To achieve this, a 12' x 2.5' x 2' sand pluviation box was designed with a pegboard bottom, consisting of $\frac{1}{4}$ " holes spaced on a 1" grid pattern. An external door was used to keep the sand from falling until it was moved into position, whereupon the door was released and the sand began pluviation (Figures B.1-B.4). The door was controlled using ropes and pulleys, such that to open the door a central rope loop was cut.

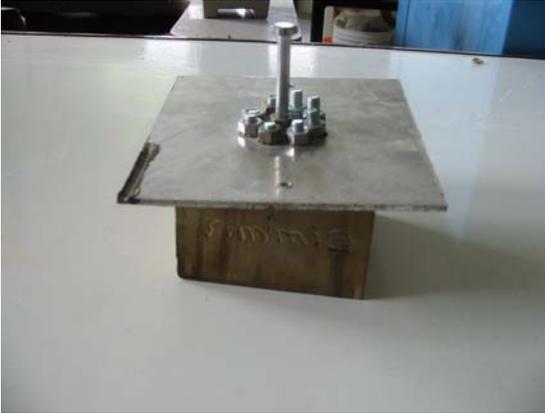
Figure B. 8 Helix press in mold

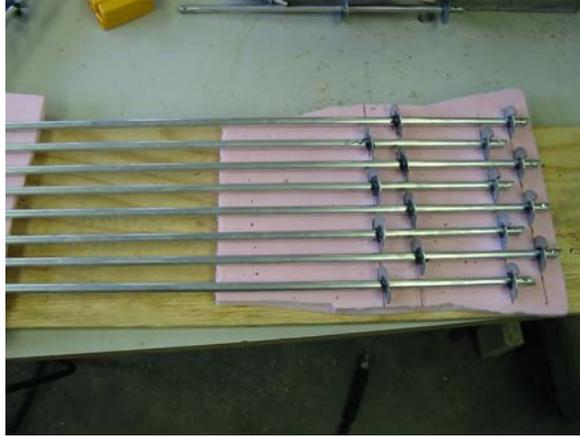
Figure B. 13 Mass production of helical piers

The installation of the grouted helical piers into the sand required both a consistent rate of installation and the simultaneous injection of the grout. The rate of installation of a helical pier depended on two variables: the pitch of the helices and the rotation rate of the pier. The construction of the helices was consistently achieved through the helix press previously described. However, in order to attach the helices to the shaft in a repeatable manner, a template was made of styrofoam and eight piers were simultaneously constructed (Figure B.10).

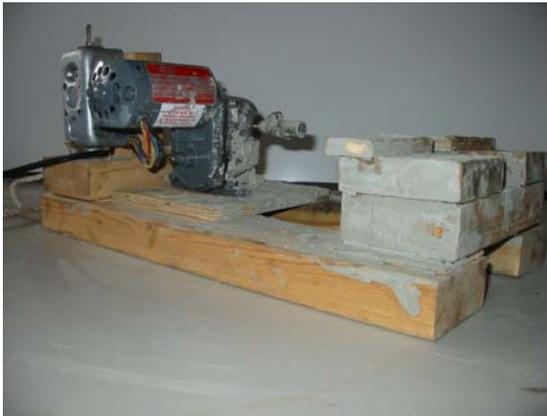
Figure B. 14 Motor mounted jig

To achieve the consistent installation rate, a single speed motor (9 rpm) was mounted to a wooden frame to create a sliding jig (Figures B.11-B.12). The pier was attached to the motor using a coupler (Figure B.18), and the jig was then placed on an angled platform such that the pier could rotate itself into the ground (Figures B.13-B.14). The platform was angled at 79° and was leveled before each pier was installed to ensure a consistent angle of installation.

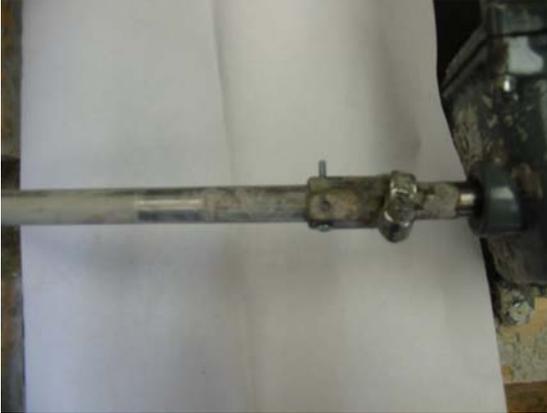
Figure B. 21 Pier-motor coupler

With the motor being attached to the end of the pier (Figure B.18), the grout has to be injected into the pier through a slot cut into the side of the pier (Figure B.19). To accomplish this, a grouting system was designed to allow for the simultaneous rotation of the pier and for the injection of the grout via a grout swivel.

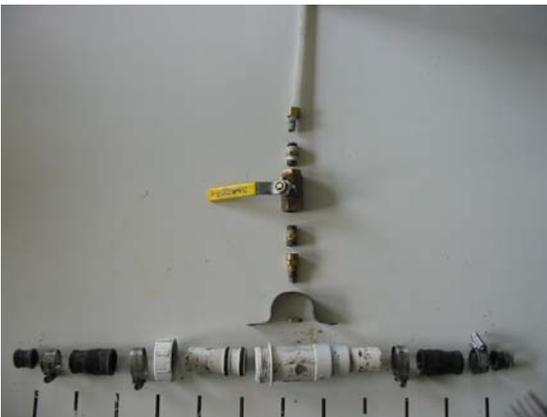
Figure B. 23 Grout swivel exploded view

A grout swivel is a mechanism that allows for the helical pier to rotate while injecting grout (Figures B.20 and B.21). The pier was placed through the swivel and attached to the motor such that the pier's slot was aligned with the swivel's grout reservoir (Figure B.22). When the reservoir was full, the grout was then forced into the slot on the helical pier and out the base of the pier. The swivel was attached to the pier using a rubber hose and hose clamps (Figure B.23).

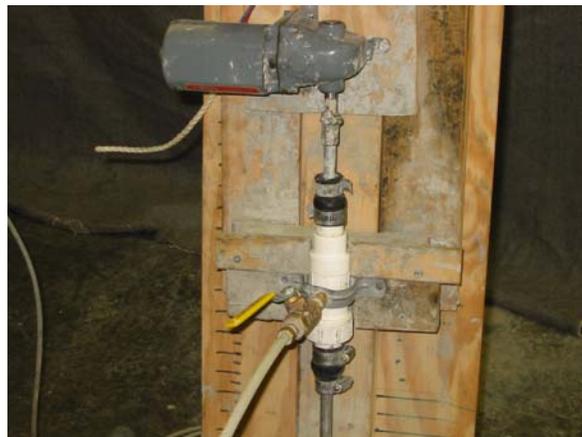
Figure B. 27 Grout tube connected to grout swivel

Once the grout was in the pressurized cylinder and the helical pier and grout swivel were mounted on the motor jig, the cylinder was attached to the swivel via a grouting tube and the jig was placed on the angled platform (Figure B.24). The entire grouting system can be seen in Figures B.25 and B.26. When the helical pier was to be backed out for installation of the grouted columns, a weight equal to the weight of the jig was hung from a rope that passed over a pulley and attached to the back of the jig (Figure B.26).

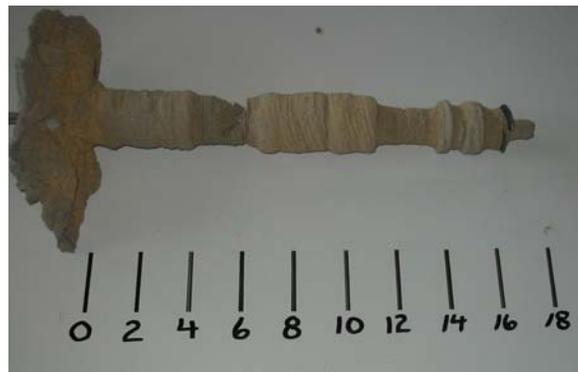
Figure C. 1 Pier with constant pressure

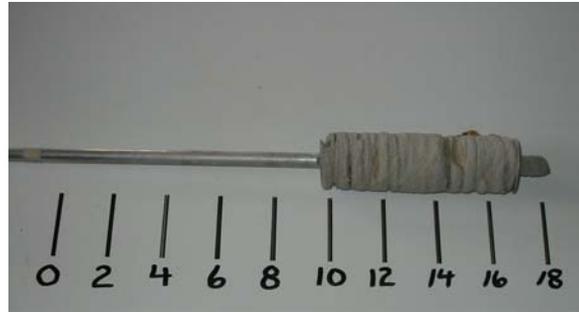
Figure C. 2 Pier from two pressures (12 psi and 18 psi)

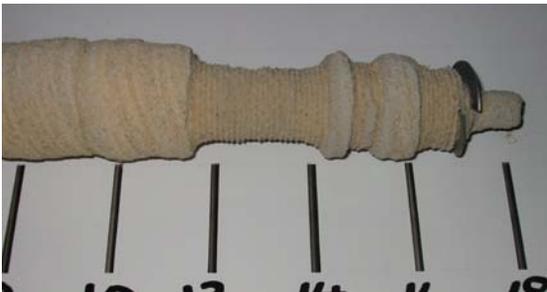
Figure C. 3 Insufficient grout pressure

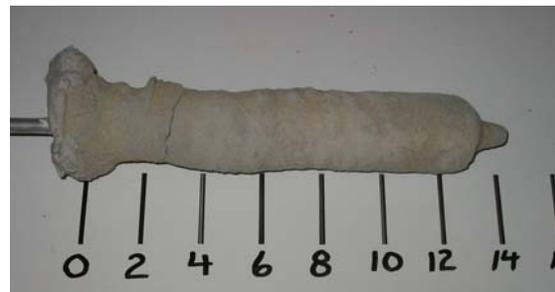
When the pressure was too low, the ridges failed to extend to the edges of the helix (Figure C.3). Conversely, when the grout pressure was too high, the grout extended past the diameter of the helix and failed to form the ridges (Figure C.4). Eventually, a proper grouting pressure was found that produced a ridged pier at a diameter of the helix (Figure C.5).

Figure C. 4 Excessive grout pressure

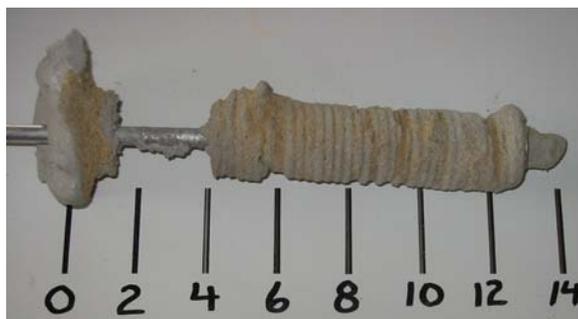
Figure C. 5 Good grout pressure

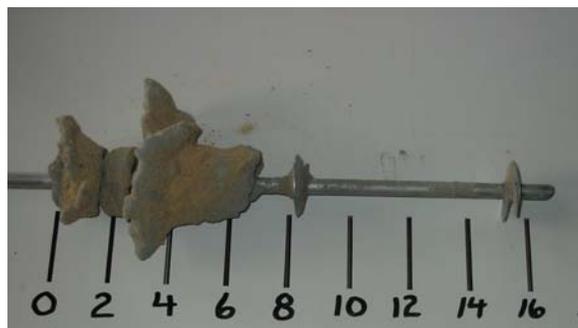
Figure C. 6 Erratic pier diameter

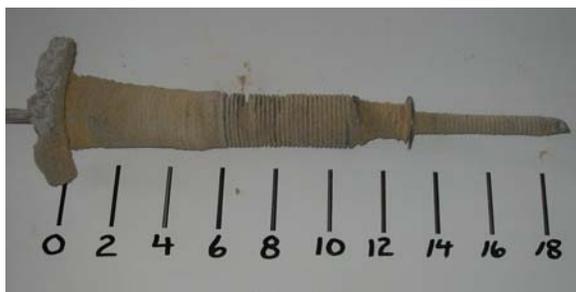
Figure C. 7 Pier with displaced helix

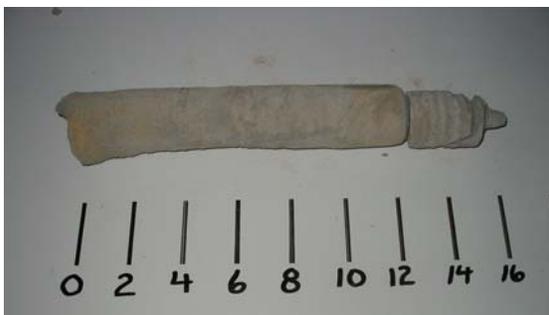
Figure C. 8 Grouted column

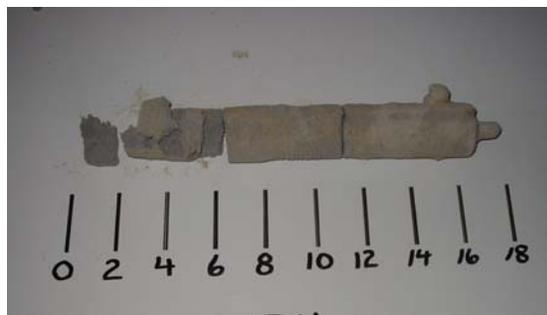
Figure C. 9 Grouted column

Pressures were also needed to be determined when the helical pier was to be backed out and only a grouted column was to be installed. Once the pier reached the desired depth (as described in C.2.2) the pier rotation was reversed and a force was applied to assist in the pier removal. The pressure was reduced to a constant 18 psi for the removal of the entire pier length. It was found that the pressure could be reduced for removal as the wet grout kept the sand from clogging the grout hole. Also, as the pier was backed out, the ridges formed from the installation were disturbed, as has been found to be typical in the real world installation, as the helices do not follow the same path as when installed (Figures C.8 and C.9).

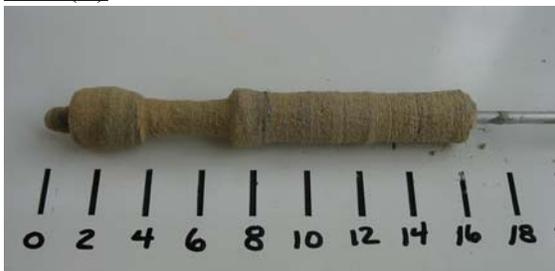
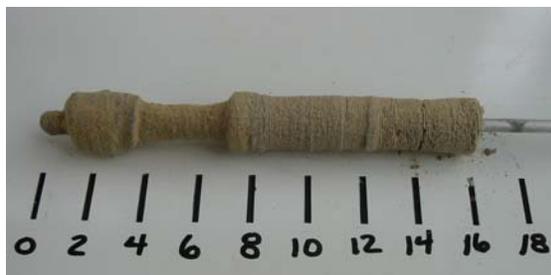
East (E)

The top of the pier is to the right in each picture, while the bottom is to the left.

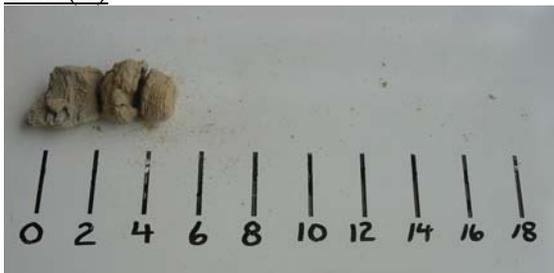
East (E)

The top of the pier is to the left in each picture, while the bottom is to the right.

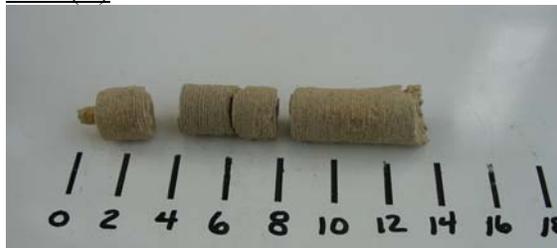
East (E)

The top of the pier is to the right in each picture, while the bottom is to the left.

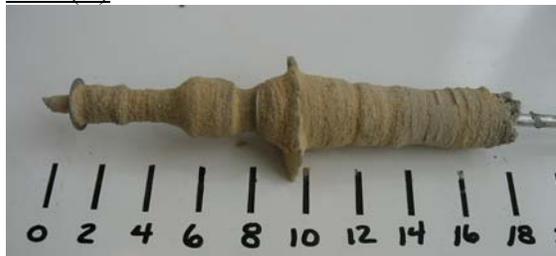
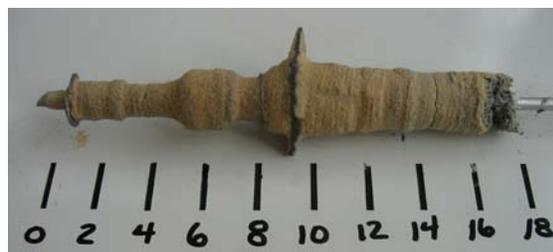
East (E)

The top of the pier is to the right in each picture, while the bottom is to the left.

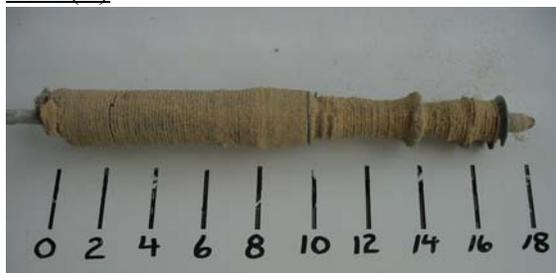
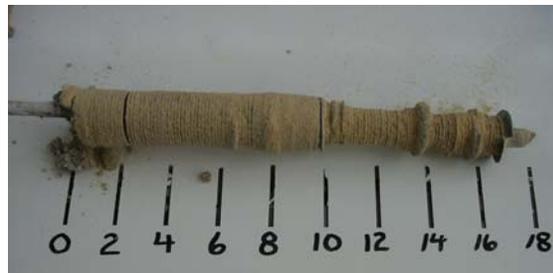
East (E)

The top of the pier is to the left in each picture, while the bottom is to the right.

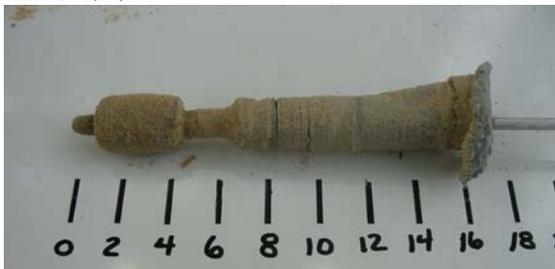
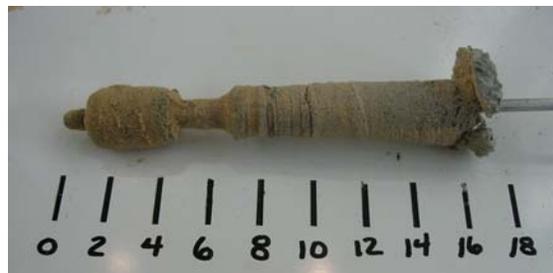
North (N)

The top of the pier is to the right in each picture, while the bottom is to the left.
