HISTORICAL RECORDS OF AGRICULTURAL PRACTICES PROVIDE INSIGHT ON HYDROLOGY AND SOILS AT WETLAND RESTORATION SITES

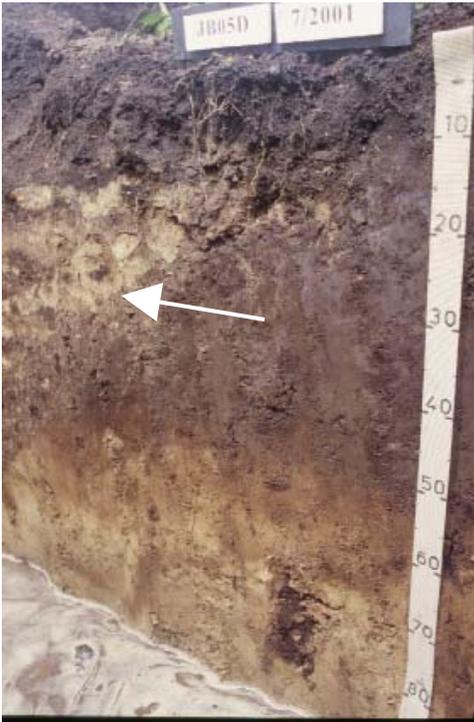
Figure 2.4. Soil profile showing a prior ditch and subsequent fill material from the railroad transect. Arrow points to the interface between undisturbed soil and ditch fill. Scale is in cm.

While the railroad's tracks are visible in the 1938 photograph, it was apparently abandoned by that time. It is uncertain if the tracks were removed by 1938. During our soil sampling, pits placed where the old railroad bed was did have evidence of disturbance by excavation and filling to a depth of one meter (Fig. 2.4). This disturbance could be traced along the railroad line, and was considered to be of small extent.

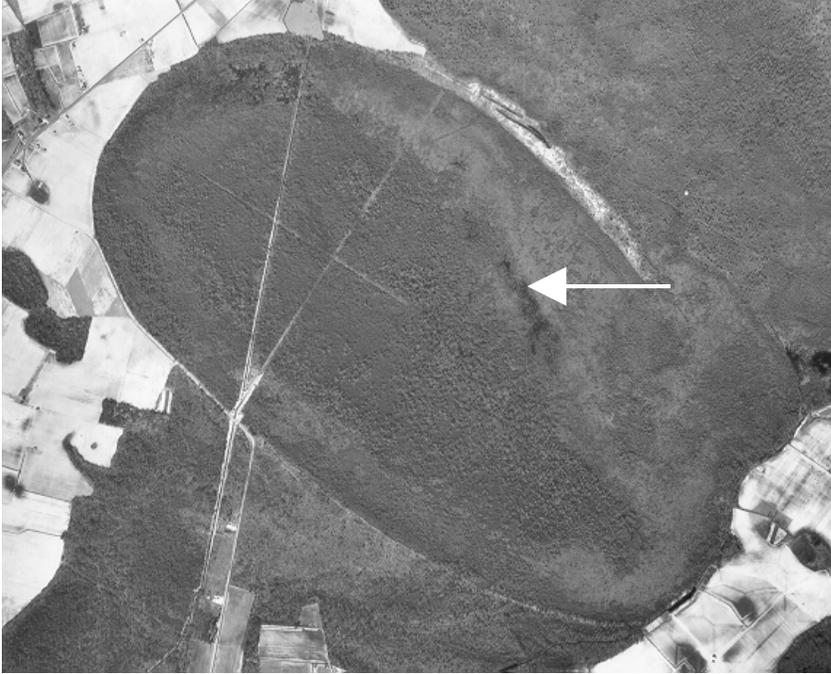
Figure 2.5. Aerial photo from 1966 (USDA-FSA). Arrow indicates potential location of 'lake' mentioned by Mr. Freeman.

Aerial photos from 1955 showed little change in Juniper Bay since 1938, but by 1966 some major changes had occurred. M. Carr Gibson of Canal Industries bought the land from Lawrence Ballard in the mid 1960's to harvest trees. The 1966 aerial photo (Fig 2.5) shows an outline through the vegetation where drainage ditches will be located, and also shows that some of the vegetation has been thinned. One ditch runs parallel, and possibly adjacent to, the old railroad bed. Another ditch will run SW to NE and with a perpendicular ditch running SE to NW. Canal Industries harvested timber from the entire the bay except for the area around the center of the bay that contained a shallow lake and parts of this lake can be seen in the 1966 photo.

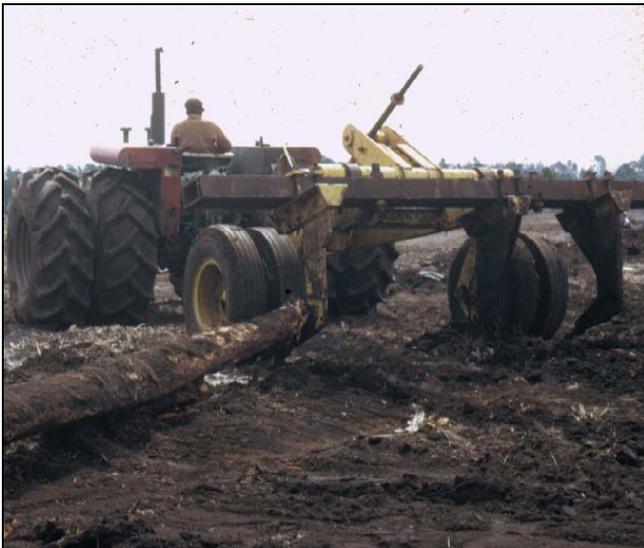
Figure 2.6. Log-rake pulling log from the soil in the Blacklands of North Carolina (with permission S.W. Buol).

Once trails for the ditches were cut, a trencher was used to excavate the ditches inside the bay. Workers had to lay logs and other debris ahead of the trencher so it had a “solid surface” to work on. A dragline was used to dig the perimeter ditch on the sandy rim of the bay. During the ditching and clearing operations, many preserved trees, logs and roots were pulled from the muck with tree rakes. For example, see Fig 2.6 photo taken in the Blacklands of North Carolina. For years after the clearing occurred, any time the fields were tilled, wagonloads of roots and debris had to be removed. During our sampling of soils in 2001 we did find buried roots of trees in many pits.

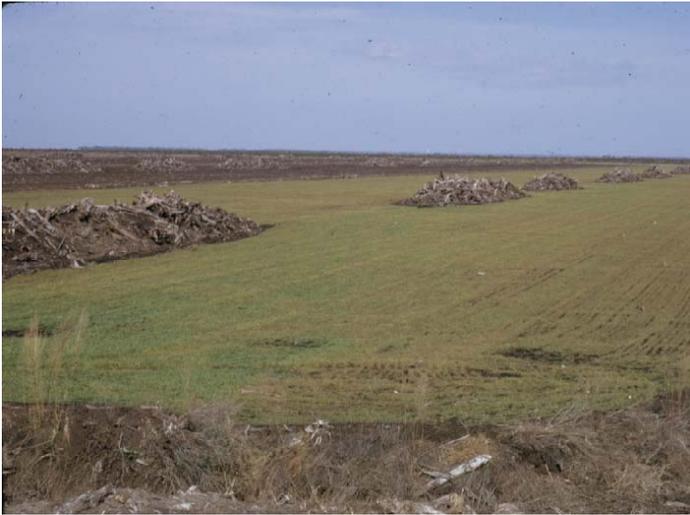
Figure 2.7. Debris from clearing piled into windrows in the Blacklands of North Carolina (with permission S.W. Buol).

After enough drainage had occurred to allow the soils to support the weight of heavy equipment, debris was windrowed with bulldozers into piles 15-20 m wide that ran the length of the bay and is illustrated in Fig. 2.7. The debris was then burned, with some piles burning for 2 to 3 years. The debris fires ignited the peat that lined the bay floor, and in some areas burned the surface was lowered 50-90 cm to either a mineral layer or the water table. This created a depression that filled with water and was inaccessible with any equipment (Fig. 2.8). To drain the depressions, an additional ditch had to be dug or the depression had to be filled. Fill material would come from another ditch, located near the depression. According to Mr. Freeman, this is why the lateral ditches do not match up across the length of the bay, the cuts are of uneven size, and the distance between cuts decreased. After the ditches were in place and sufficient drainage had occurred, spoil from the ditches were used to shape all the fields such that the center of the field was approximately 45 cm higher than the edges to increase surface runoff. This practice is locally called “crowning” or “turtle backing.”

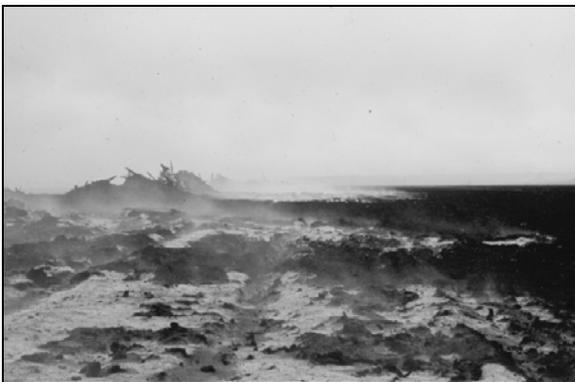
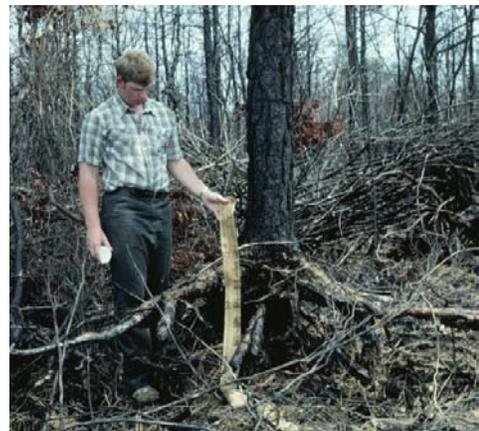
Figure 2.8. a). Windrows burning down to mineral. The white areas are ashes from the most intense fire and the black areas to the right are areas of largely unburned organic soil. b). Loss of approximately 30 miles (48km) organic soil after a wild fire in the Blacklands of North Carolina (with permission S.W. Buol).

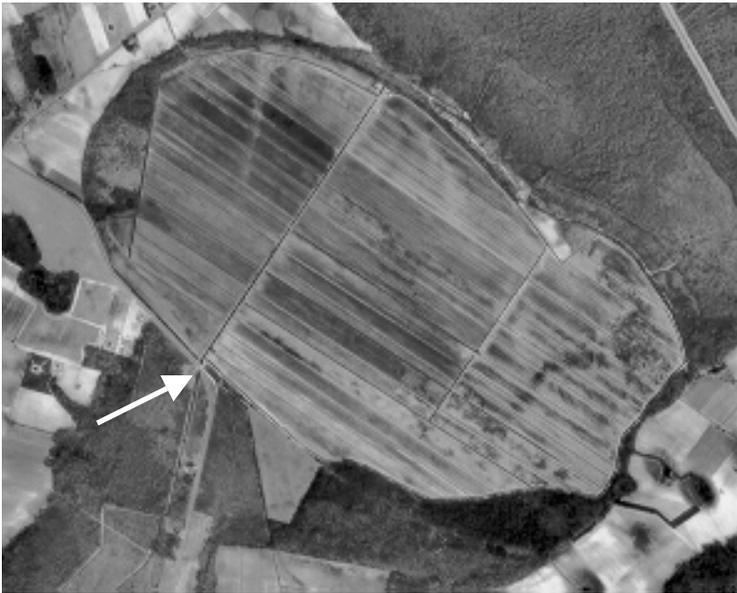
Figure 2.10. Aerial photo of Juniper Bay from 1993 (USDA-FSA) Arrow indicates drainage outlet of ditching system.

Currently, 2003, Juniper Bay is drained through one outlet point (Fig. 2.10). There is a perimeter ditch around the whole bay, and two main ditches that run SW/NE and one that runs SE/NW, which are approximately 3 m deep and 6 m wide. Perpendicular to the SW/NE main ditches are lateral drainage ditches that are approximately 1 m deep and 1.5 m across. Mr. Freeman stated that ditches were maintained as needed yearly. Every 5 or 6 years all ditches were cleaned using a piece of equipment, called a Dondi ditcher (Fig. 2.11), that dredged out the ditch and slung the spoil out over the field, where it was disked in.

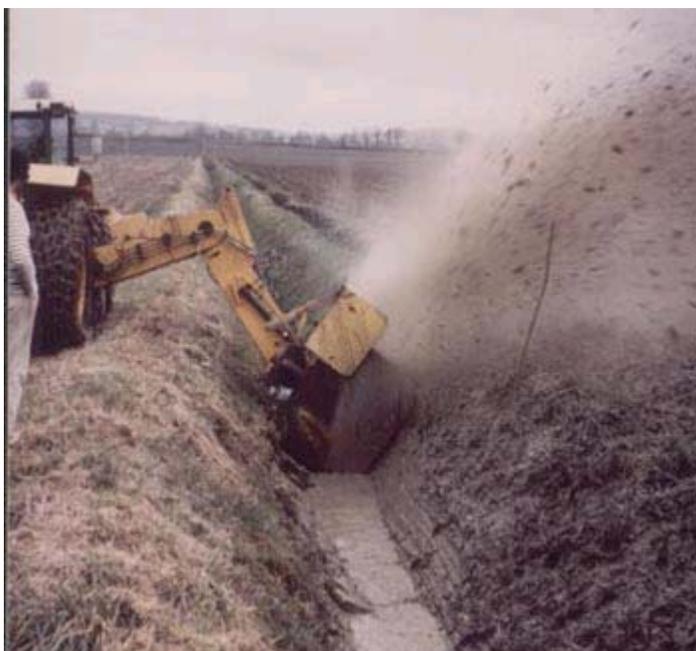
Figure 2.11. Ditch maintenance with a Dondi ditcher.
