Advanced Fiber Strengthening Systems for Concrete Structures

by
Benjamin Thomas Mielke

A thesis submitted to the Graduate Faculty of
North Carolina State University
in partial fulfillment of the
requirements for the degree of
Master of Science

Civil Engineering

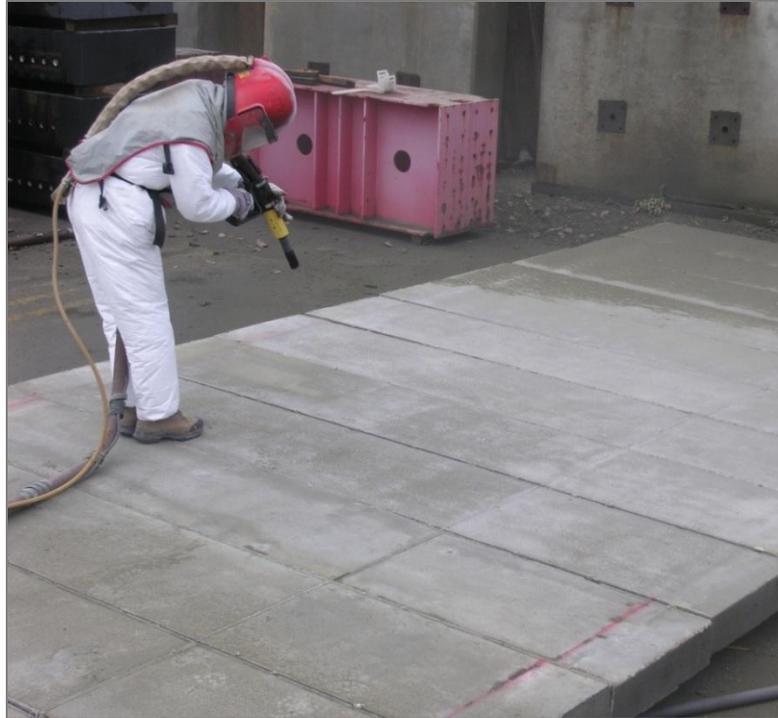
Figure 1: The use of Sandblasting as a Surface Preparation Technique

The externally bonded (EB) technique is the oldest technique used to attach the FRP material to the concrete surface. Through extensive research and field application, it has proven to be a very effective and economical strengthening technique. The externally bonded technique is a multi-step process that begins with the preparation of the concrete surface. This is one of the most important steps in the strengthening process. It is critical to remove all loose particles from the concrete substrata and expose the aggregate in order to ensure a full bond between the adhesive and the concrete substrata. This is usually done with a rough-disk grinder or sandblasting as shown in Figure 1.

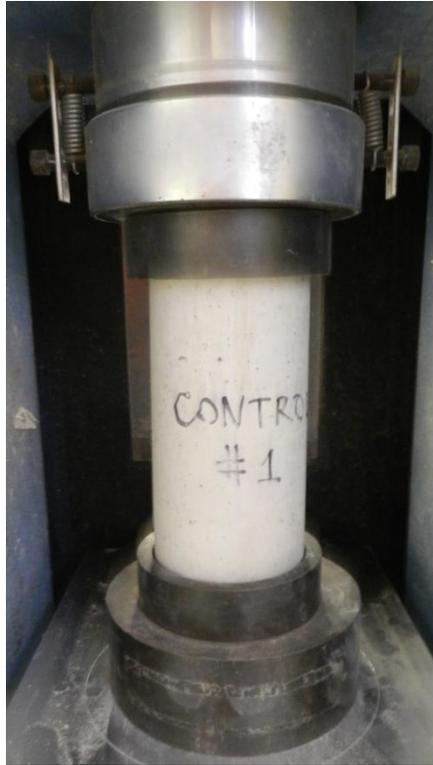
Figure 12: Typical Compressive Strength Test Setup

Portland cement (PC) concrete was used to cast the one-way slabs for both phases of the experimental program. The two phases of the experimental program were cast using different batches of Portland cement concrete. The Portland cement concrete was provided by a local ready mix company. The target 28-day compressive strength (f'_c) of each of the batches was 5,000 psi using a 3/8" max size aggregate. A number of 4"x8" concrete cylinders and 6"x6"x18" prisms were made and tested from each batch so that the 28-day and day of testing compressive strength could be determined as well as the rupture strength of the Portland cement concrete. The 28-day 4"x8" cylinders were removed from their casing and moist cured in water saturate with calcium hydroxide as described in ASTM C31/C31M standard. They were then removed from the moist curing at 28 days and tested using the procedure outlined in ASTM C39/C39M standard. The cylinders that were designated to be used to determine the concrete strength of the slabs at day of testing were air cured next to the slab specimens so that they would subjected to the same curing conditions as the one-way slabs were. The cylinders were tested in a set of three and the average compressive strength was used as the compressive strength for that set. The typical test setup used for determining the compressive strength of the Portland cement is shown in Figure 12.

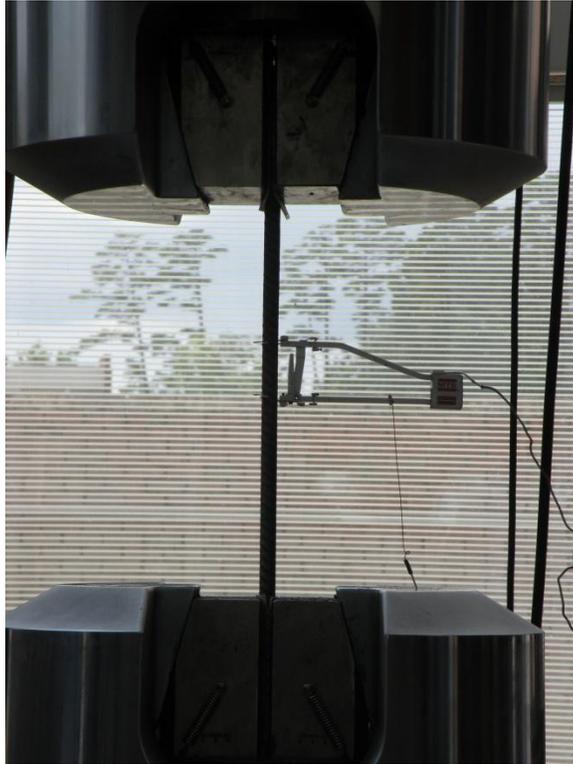
Figure 15: Typical Tensile Test Setup

The steel that was used to reinforce the concrete slabs was Grade A706 and was chosen due to the high quality control requirements and high ductility in comparison to the regular Grade 60 steel. The steel reinforcement was tested using an MTS machine prior to casting of the one-way slabs to determine the material properties. A typical tensile test set up is shown in Figure 15. The material properties that were investigated were the yielding stress and strain, as well as the elastic modulus. The strain was measured using a MTS extensometer with a gauge length of 2". The average stress-strain response of the steel is shown in Figure 16. Based on these results, the stress and strain at yielding of the steel was 70 ksi and 0.00255

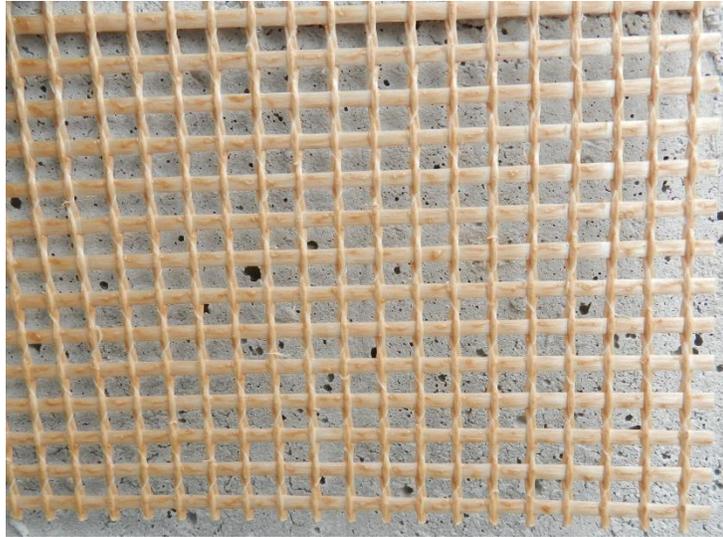
Figure 19: 1/4" Glass Grid

The $\frac{1}{4}$ " glass grid is made up of glass stows woven in both the longitudinal and transverse directions. This weave produces a grid spacing that is approximately $\frac{1}{4}$ " square. This $\frac{1}{4}$ " glass grid is shown in Figure 19. The glass stows are coated with a vinyl coating to improve handling of the sheets as well as to protect the fibers. However, this vinyl coating significantly reduces the bonding of the fibers to the adhesive, creating a weak bond at this interface. This weak bond interface is compensated by the mechanical interaction of the transverse stows and the friction forces that develop between the vinyl coating and the fibers and does not take advantage of the interaction between the fibers and the concrete substrata. The mechanical properties of the $\frac{1}{4}$ " glass grid are given in Table 4. The cross sectional area was determined using a micrometer. The typical, measured stress-strain behavior for the $\frac{1}{4}$ " glass grid is shown in Figure 20.

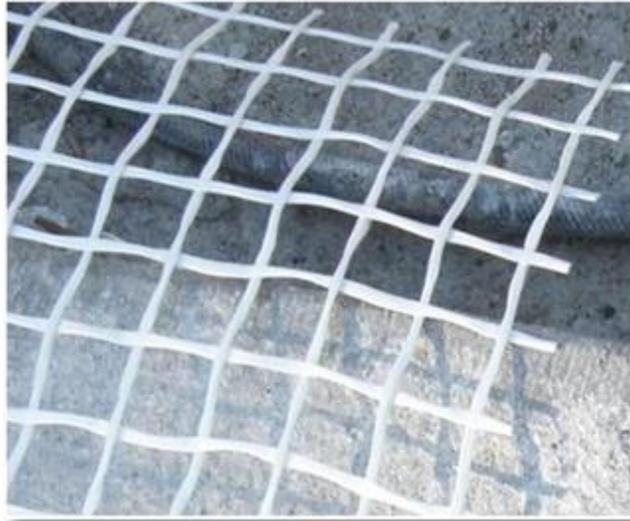
Figure 21: 1" Glass Grid

The 1" glass grid is made up of glass stows woven in both the longitudinal and transverse directions. This 1" glass grid is similar to the 1/4" glass grid but has a greater number of fibers per stow, increasing the rupture load per strand when compared to the 1/4" glass grid. This weave produces a grid spacing that is approximately 1" square. This 1" glass grid is shown in Figure 21. The glass stows are coated with a vinyl coating to improve handling of the sheets as well as to protect the fibers. However, this vinyl coating significantly reduces the bonding of the fibers to the adhesive, creating a weak bond at this interface. This weak bond interface is compensated by the mechanical interaction of the transverse stows and the friction forces that develop between the vinyl coating and the fibers and does not take advantage of the interaction between the fibers and the concrete substrata. The transverse and longitudinal glass stows are connected with a small amount of adhesive, which is very weak and can be easily pulled apart. This may be the cause for the lower stiffness of the grid. The mechanical properties of the 1" glass grid are given in Table 5. The cross sectional

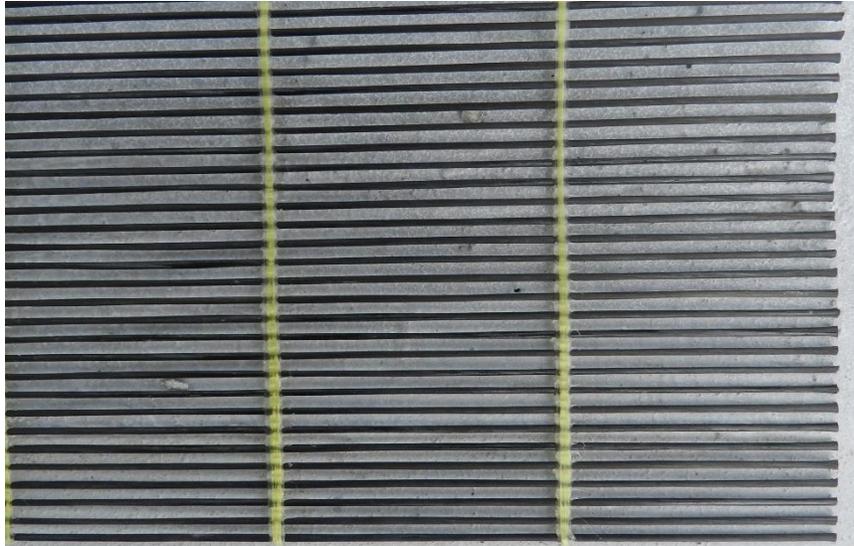
Figure 23: High Tensile Carbon Strand Sheet

The carbon fiber strands are produced using three different types of carbon fibers; high-modulus, intermediate modulus, and high-tensile strength. The high-tensile strength was chosen to be used in this experimental program due to its potential to greatly increase the load carrying capacity. The sheets are produced by tying together unidirectional carbon strands together. The strengthening system has a designated epoxy resin which has been proven to work well with the fibers. The sheets are also produced with different spacing between the unidirectional carbon strands. The center-line to center-line distance between the high-tensile carbon strands can range from 1.64 mm to 4.92 mm. The larger spacing between the carbon strands promotes the use of cementitious materials, like Grancrete, as the adhesive, which can increase the fire resistance of the strengthening system. The high-tensile strength carbon strand sheet was selected for this project due to their high rupture load per strand and high rupture strain. The high-tensile carbon strand sheet is shown in Figure 23.

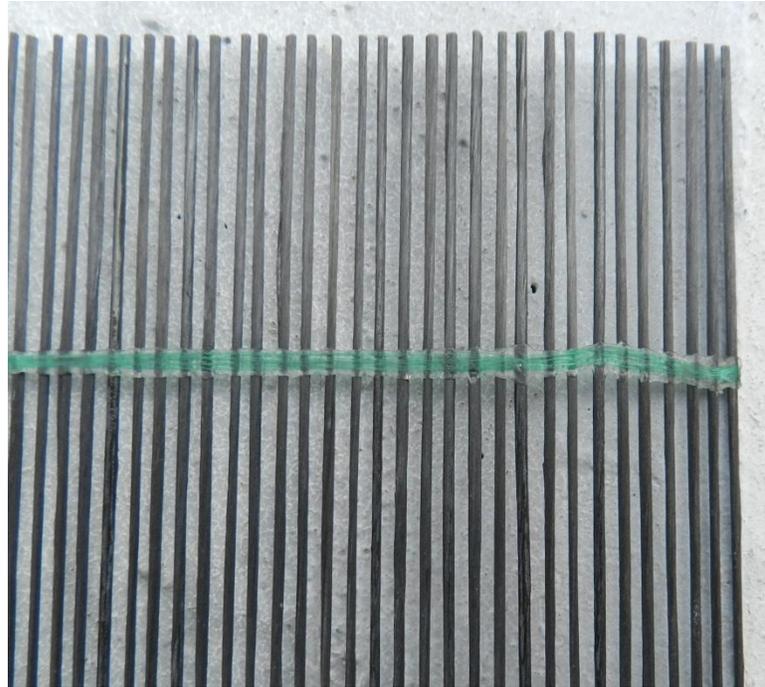
Figure 25: High Modulus Carbon Strand Sheet

The carbon fiber strands are produced using three different types of carbon fibers; high-modulus, intermediate modulus, and high-tensile strength. The high-modulus stand was chosen to be used in this experimental program due to its potential to greatly increase the load carrying capacity. The sheets are produced by tying together unidirectional carbon strands together. The strengthening system has a designated epoxy resin which has been proven to work well with the fibers. The sheets are also produced with different spacing between the unidirectional carbon strands. The center-line to center-line distance between the high-modulus carbon strands can range from 1.42 mm to 4.26 mm. The larger spacing between the carbon strands promotes the use of cementitious materials like Grancrete as the adhesive, which can increase the fire resistance of the strengthening system. The high-modulus strength carbon strand sheet was selected for this project due to the high stiffness of the carbon fibers. The high-modulus carbon strand sheet is shown in Figure 25. The

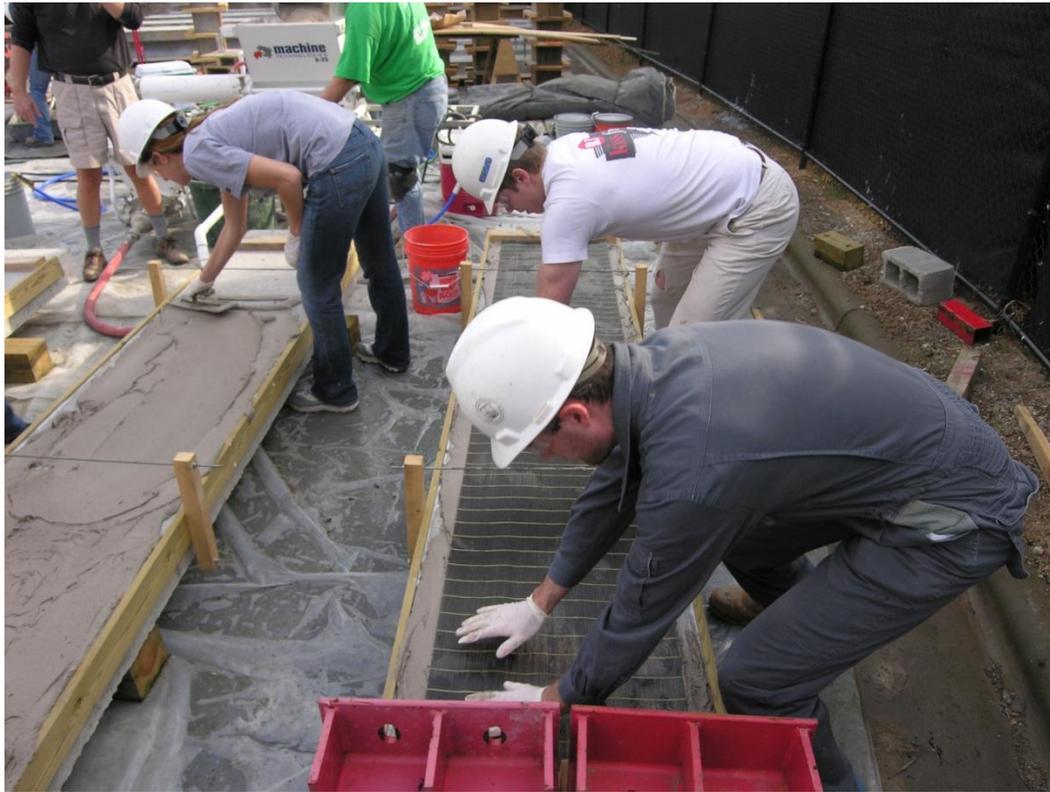
Figure 31: Using Cementitious Adhesive in the Externally Bonded Technique

was used with the cementitious adhesives as well as the epoxy adhesive as shown in Figure 31 and Figure 32. For this application, the slab was flipped up-side-down in order to expose the tension face for strengthening. A bottom layer of adhesive was then applied to the concrete surface. Once this layer was applied, the fibers were placed on top of the adhesive and pressed into the adhesive to ensure the fibers would be completely encased in the adhesive. A top layer was used to coat the fibers and to form the level surface of the strengthening system.

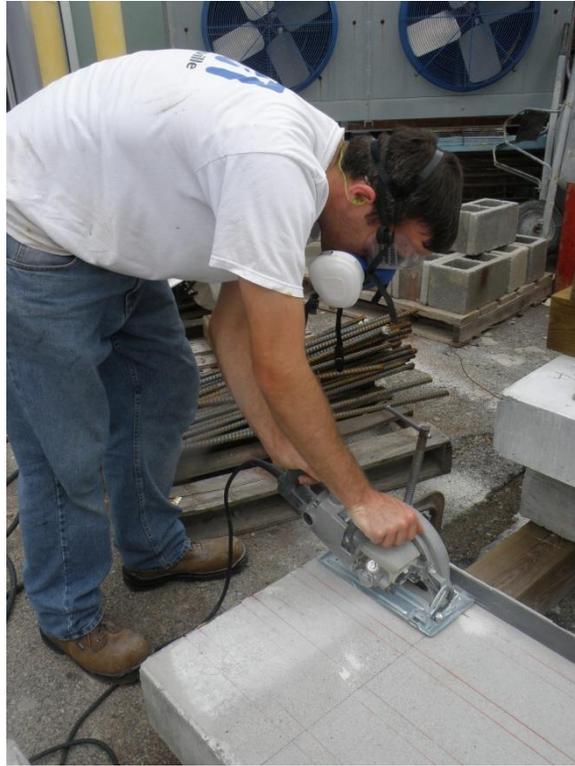
Figure 33: Cutting Grooves for NSM technique

The near surface mounted technique (NSM) is an innovative application technique that has been proven to be more effective than the externally bonded technique. The technique usually involves cutting grooves into the reinforced concrete structure and then bonding the FRP into these grooves with either a cementitious or epoxy adhesive. Since the FRP strengthening system is cut into the grooves, there are fewer complications aesthetically than the externally bonded technique. In this experimental program, the near surface mounted technique is used with the cementitious material so a direct comparison can be made with the externally bonded technique that uses the same cementitious adhesive. The first step of the near surface mounted technique was to cut grooves in the slabs with a concrete skill saw as shown in Figure 33. Next the strengthening system was applied. This was done in several phases. The first phase included applying a bottom layer of adhesive into the grooves. This layer was spread out along the bottom and sides of the groove to ensure that the entire groove was coated with the adhesive. After this the carbon strand sheet, which had been cut into four even bundles, was impregnated with the adhesive, rolled into circular bundles, and then placed into the grooves. A top layer of the adhesive was then applied and leveled with the existing concrete surface to form a level surface. The applications of the strengthening system are shown in Figure 34, Figure 35, and Figure 36.

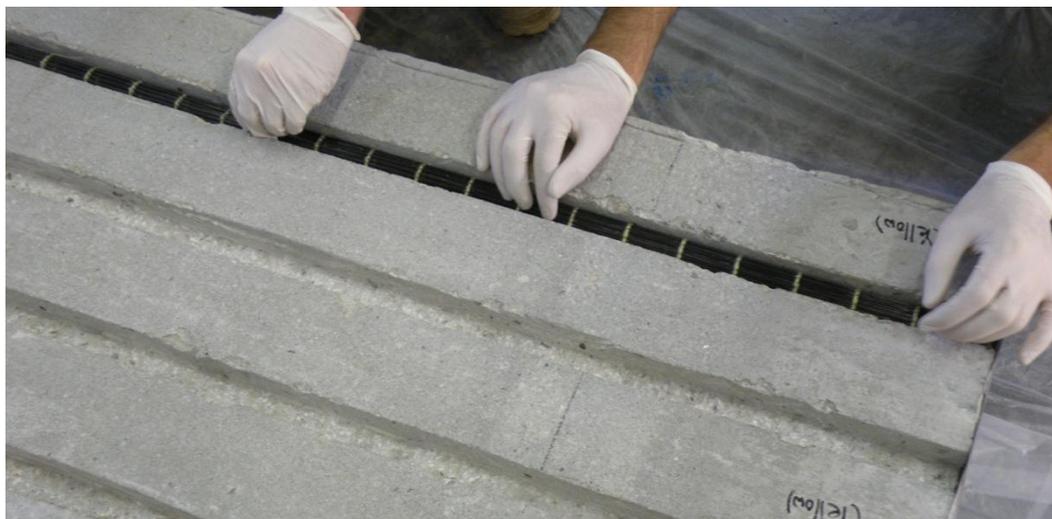
Figure 34: FRP Bundle in Groove before Adhesive is Applied

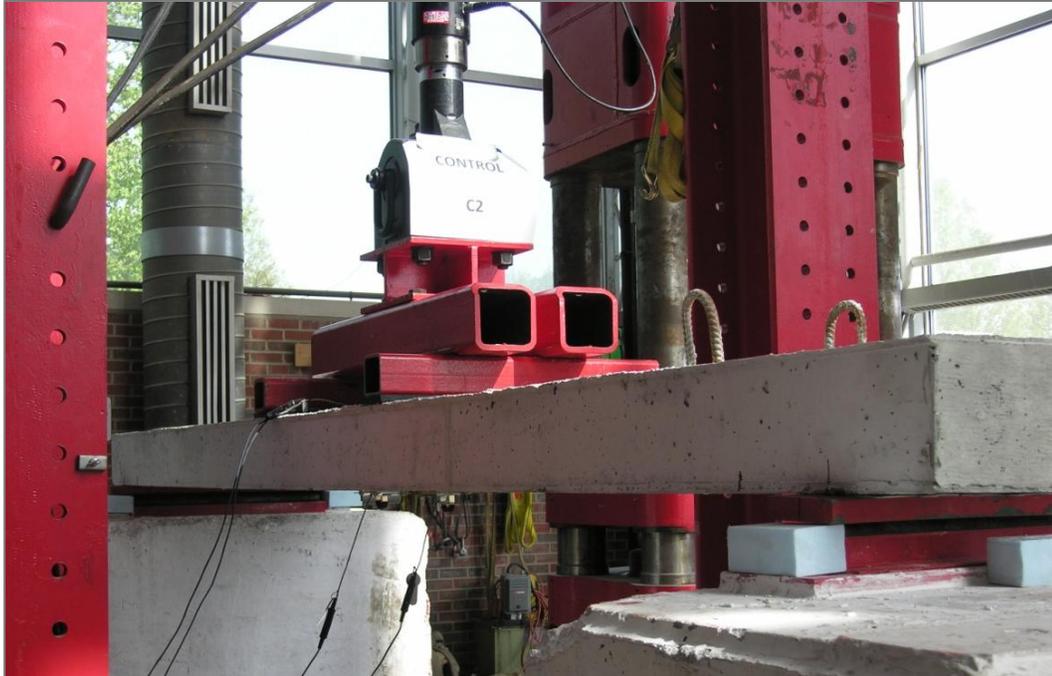
Figure 38: Test Set-Up

The flexural response of each slab was examined using a four-point loading configuration. A schematic of the test setup is shown in Figure 37. The test setup is shown in Figure 38. The slab was simply supported with a roller and pin configuration that provided a 10' clear span. A 55-kip MTS hydraulic actuator was used to apply the load to the slab which was tested up to failure. A spreader beam was used to distribute the load from the actuator to two HSS steel beams that produced two point loads that were 2' apart and distributed over the entire width of the slab. The load was applied at a controlled rate of 0.10 in/min until failure occurred.

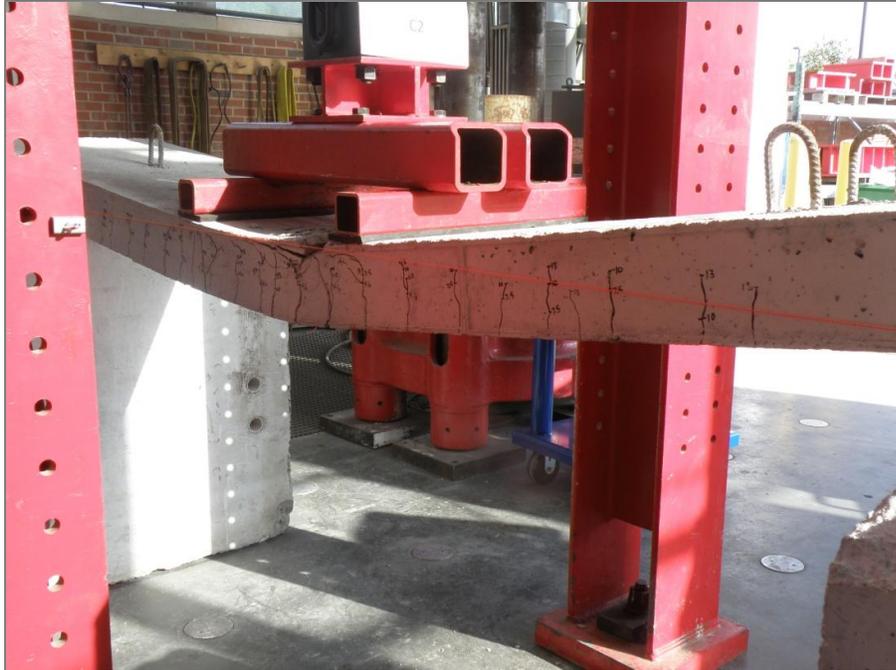
Figure 43: Deflected Shape of the Control Slab at Failure

The control slab was reinforced with the same steel reinforcement and was cast using the same concrete batch as the other slabs in Phase I. The control specimen failed as expected due to crushing of concrete in the compression zone in the maximum moment region. The load–deflection behavior of the control specimen is shown in Figure 42. The behavior was linear up to the initiation of the first crack which occurred at load level of 3000 lbs. The behavior after cracking was non-linear up to yielding of the reinforcing steel at a load level of 12,767 lbs followed by a significant decrease of the stiffness up to failure due to crushing of the concrete at a load level of 14,678 lbs. Comparing the deflection at failure of 5.60 inches to the deflection at yielding of 1.00 inches, the ductility of the control specimen is estimated to be 5.60. The deflected shape of the control slab at failure is shown in Figure 43 and the crack pattern is shown in Figure 44. The failure was very ductile as evident by the large

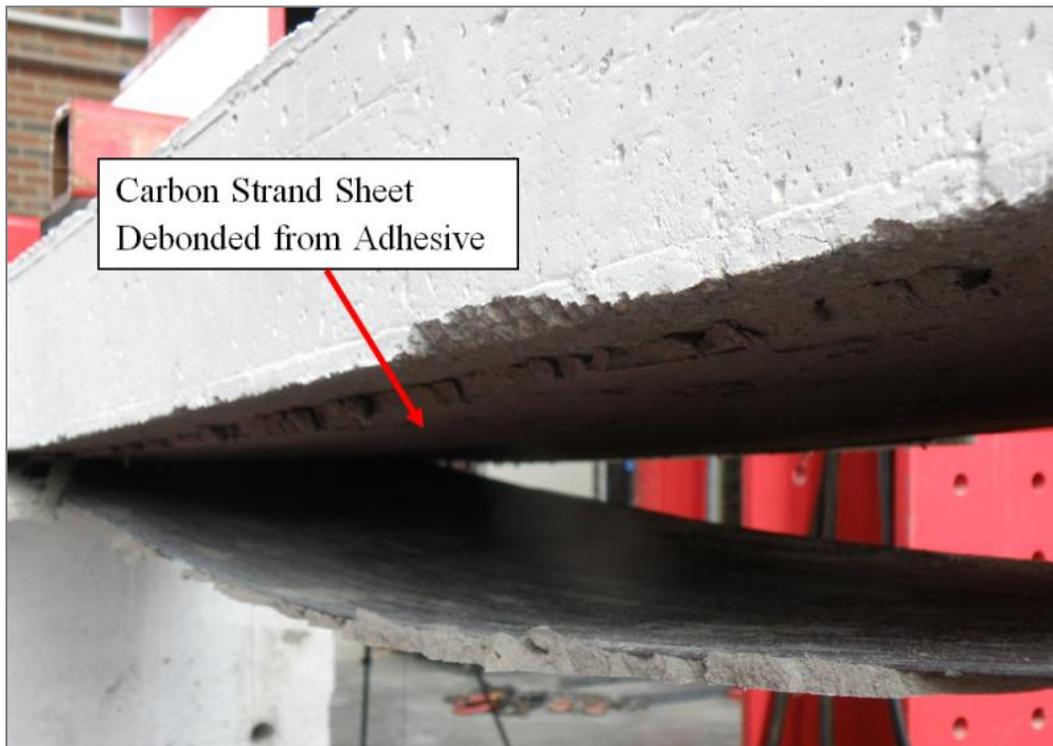
Failure of the strengthening system was due to debonding of the sheet within the shear span as shown clearly in Figure 46. The shear span is defined as the length of the slab between the support and the point of load application. It was observed that once both of the high strength and high modulus Carbon Strand Sheet – Type 1 strengthening systems failed, the slabs behaved as the control specimen until failure due to crushing of concrete as shown in Figure 45. A typical pattern of this crack propagation after debonding of the Carbon Strand Sheet is shown in Figure 47. Test results indicate that using high modulus carbon strands, as expected, increases the stiffness of the strengthened slab as shown in Figure 45. Both slabs strengthened with high modulus and high tensile carbon strands achieved the same increase in ultimate load carrying capacity since the failure for both of these slabs was due to delaminating of the fibers and did not fully utilize the characteristics of the fibers.

Figure 46 : Typical Failure of Carbon Strand Sheet – Type 1 Sheet

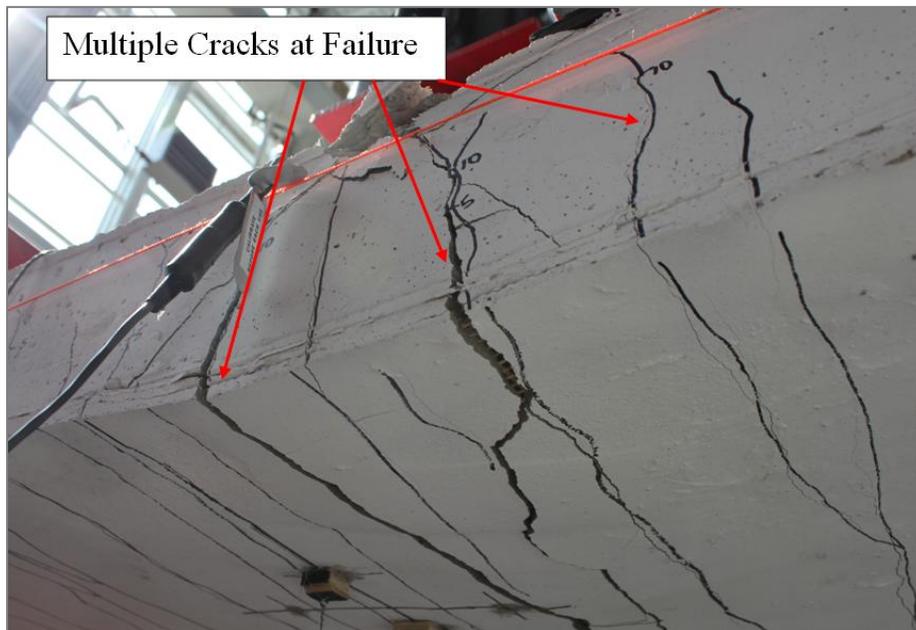
Figure 49: Typical Failure of Glass Grid Strengthened Specimens

Two slabs that were strengthened with Glass Grid were tested in Phase I. Test results indicate that the Glass Grid strengthening system increased the load required to initiate cracking and yield of the reinforcement when compared to the control slab. However, it did not increase the ultimate load carrying capacity when compared to the control specimen as shown in Figure 48. It was also observed that once the Glass Grid strengthening system failed, the slab followed the same behavior of the control specimen until failure occurred due to crushing of concrete as also shown in Figure 48. The behavior of the strengthened slab under the load was characterized by significant cracking and propagation of these cracks. This behavior can be characterized as a ductile failure. The typical crack pattern and crack propagation observed are shown in Figure 49. Test results also indicate reduction of the ductility for all tested slabs strengthened with the Glass Grid in comparison to the control slab. Test results suggest also that the reinforcement ratio used was insufficient to increase the overall load carrying capacity. Failure of the strengthening system was due to Intermediate Crack (IC) debonding as expected for most of the externally bonded sheets. Inspection of the test specimen after failure showed that the glass grid had debonded and ruptured in the region of maximum moment. Pull-off test were performed and the results indicate that the bond strength for the 1 inch grid was adequate to meet the ACI 440.2R-08 requirement of 200 psi whereas the bond strength for the 0.25 inch grid was not due to the small opening between the strands. Test results are given in detail in A.5 and A.6.

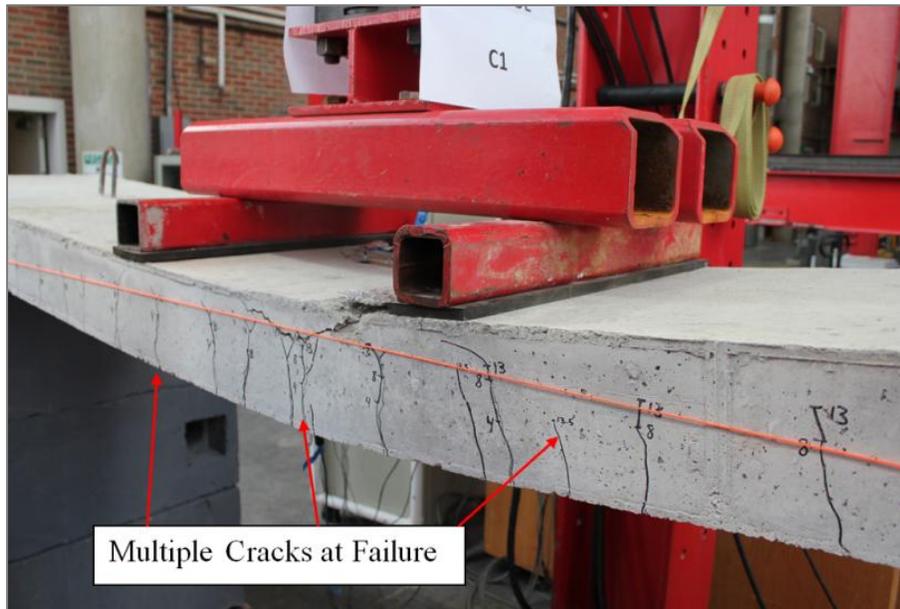
Figure 63: Crack Pattern of Control Slab at Failure

The control slab was reinforced with the same steel reinforcement and was cast using the same concrete batch as the other slabs in Phase II. The control specimen failed as expected due to crushing of concrete in the compression zone in the maximum moment region. The load –deflection behavior of the control specimen is shown in Figure 42. The behavior was linear up to the initiation of the first crack which occurred at load level of 3000 lbs. The behavior after cracking was non-linear up to yielding of the reinforcing steel at a load level of 12,814 lbs followed by a significant decrease of the stiffness up to failure due to crushing of the concrete at a load level of 13,751 lbs. Comparing the deflection at failure of 4.35 inches to the deflection at yielding of 1.10 inches, the ductility of the control specimen is estimated to be 3.95. The deflected shape of the control slab at failure is shown in Figure 43 and the crack pattern is shown in Figure 44. The failure was very ductile as evident by the large deflection and the propagation of a significant number of cracks before failure. Test results are given in detail in A.10.

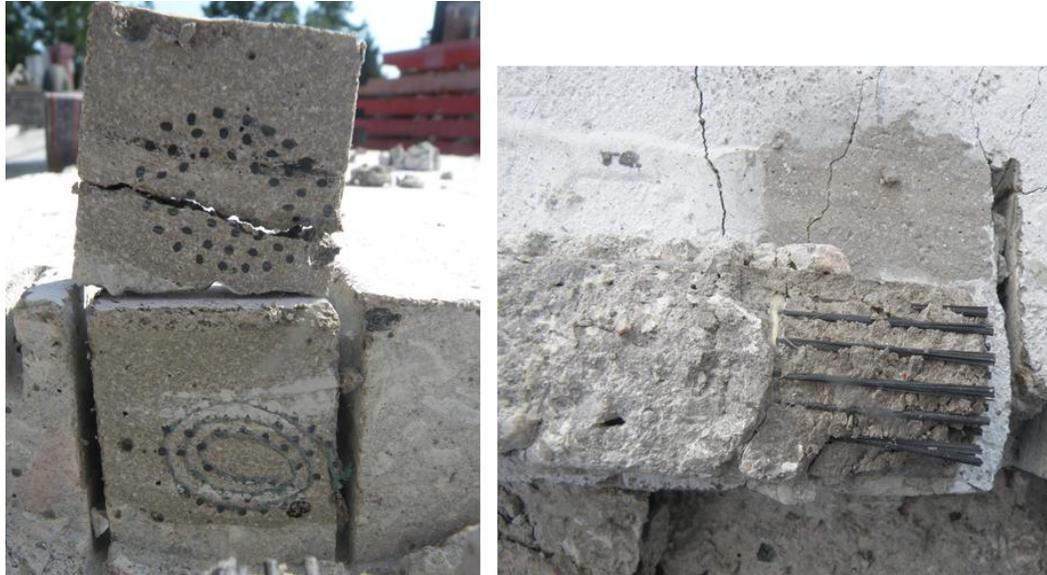
Figure 75: Exposed NSM Carbon Strand Fibers

The spacing of fibers was also closely looked at during Phase II of the experimental program. The spacing between the fibers is very important because if the spacing between the fibers is not sufficient for the cementitious material to penetrate between the fibers and achieve the proper bond. Weak bond leads to a premature failure due to debonding of the strengthening system. The bond strength for each of the strengthened slabs was determined using a standard pull off test. Results of the pull off test of specimens that were strengthened with the externally bonded technique are shown in Figure 74. This figure indicates that the Type 3 spacing for both the High Tensile and High Modulus was large enough to allow for full penetration of the cementitious material. This is confirmed as the fibers for the near surface mounted and the externally bonded were exposed as shown in Figure 75 and Figure 76, respectively. It was therefore recommend that the Type 3 spacing be used for both the High Tensile and High Modulus Carbon Strand.

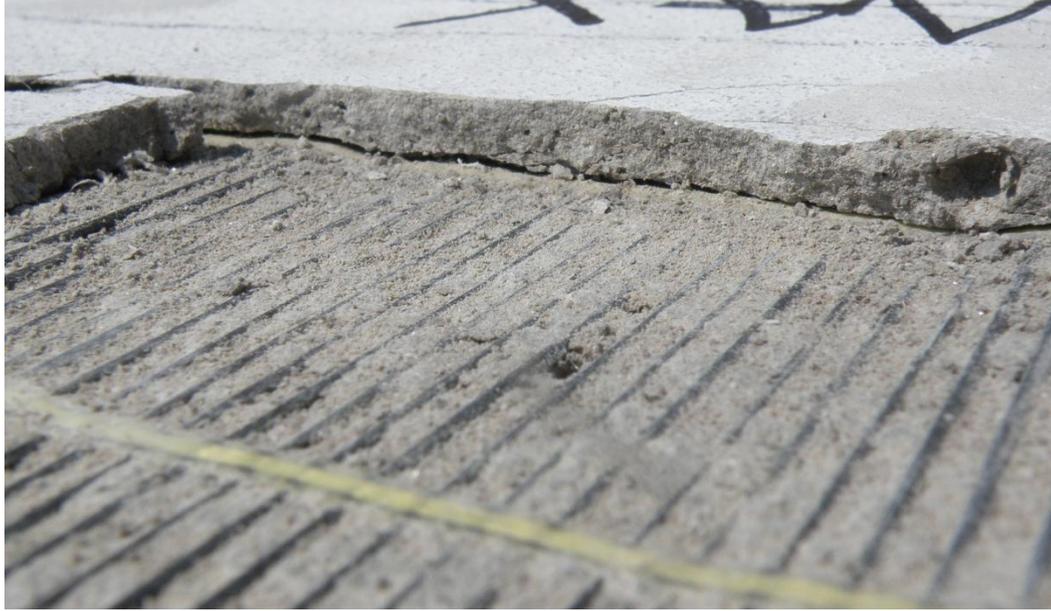
Figure 76: Exposed EB Carbon Strand Fibers

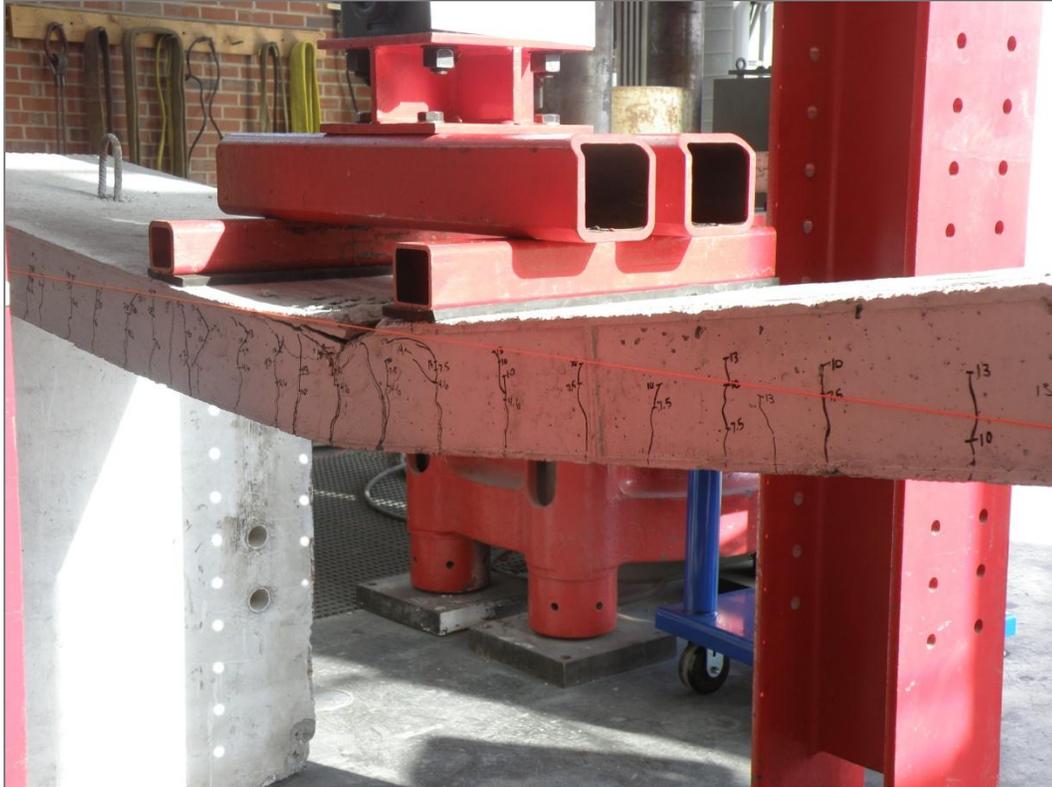
Figure A-1: Control Specimen – Phase I under four-point bending

The unstrengthened control specimen tested in Phase I was used as a benchmark to measure the effectiveness of the various FRP strengthened slabs explored in Phase I. The control specimen, as well as the strengthened slabs, was subjected to a four-point bending test as shown in Figure A-1.

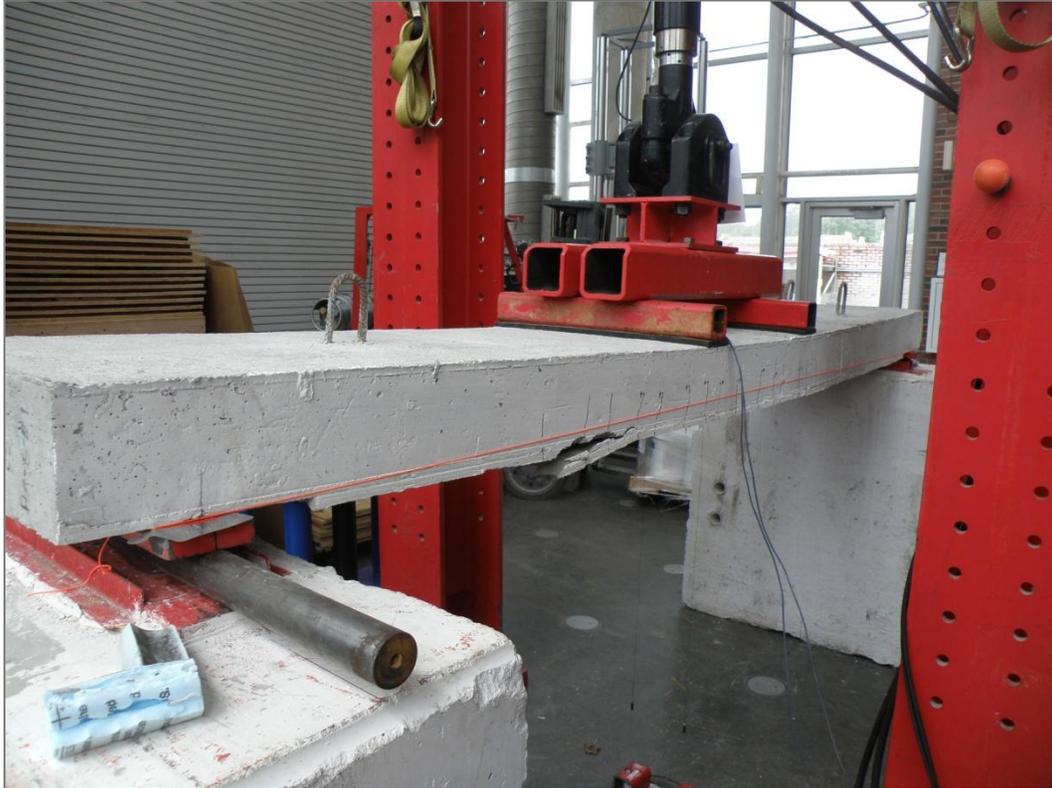
Figure A-4: HM-G-E-1 specimen under four-point bending

This slab was strengthened with an externally bonded High Modulus Carbon Strand Sheet – Type I, commercially referred to as FORCA Carbon Strands, and bonded with Grancrete PCW. This specimen was subject to a four-point bending test as shown in Figure A-4.

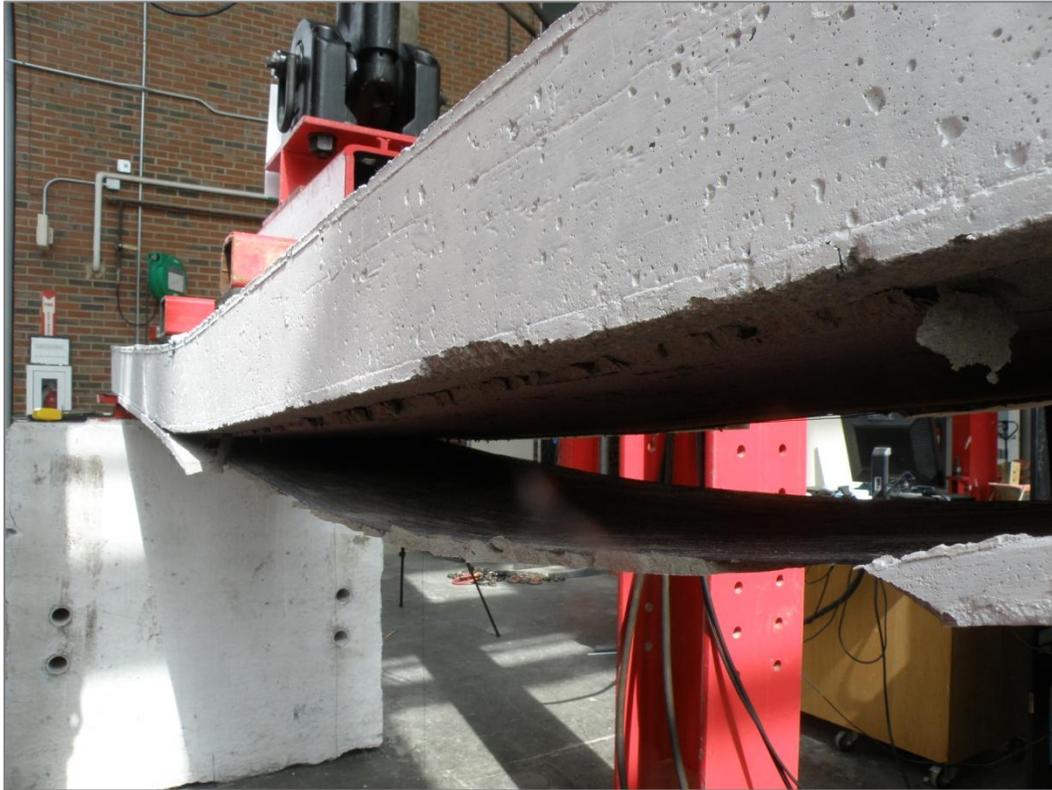
adhesive through the carbon strands to the sub-strata is needed so that a strong bond can be achieved.

Figure A-7: Debonding within the shear span of the FORCA Carbon Sheet – Type I

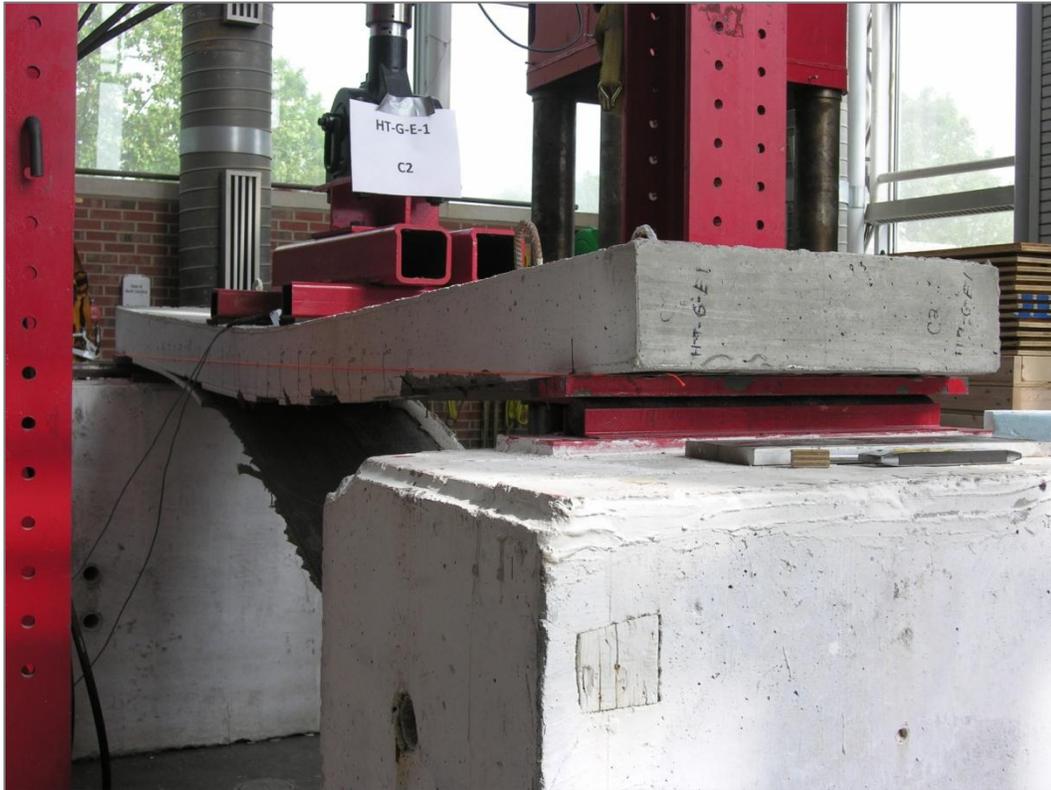
Figure A-9: HT-G-E-1 specimen under four-point bending

This slab was strengthened with an externally bonded High Tensile Carbon Strand Sheet – Type I, commercially referred to as FORCA Carbon Strands, and was bonded with Grancrete PCW. This specimen was subject to a four-point bending test and is shown in Figure A-9.

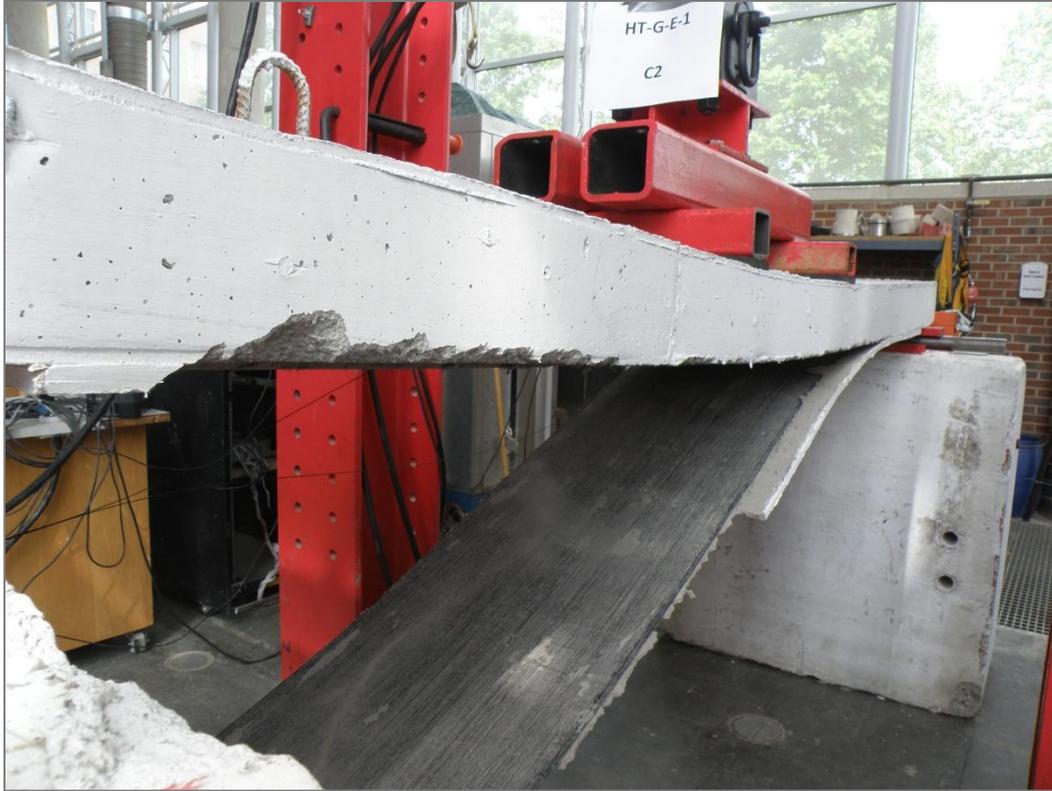
Failure of the strengthening system was sudden and occurred within the shear span of the slab. Failure of the strengthening system was due to debonding of the sheet within the shear span of the slab. This failure is shown in Figure A-12. Once failure of the strengthening system occurred, the specimen followed the same behavior of the control specimen overall until failure due to crushing of concrete, as shown in Figure A-10. Inspection of the test specimen after failure showed that the FORCA carbon strand sheet had debonded from the slab along most of the span length. It was also observed that very little adhesive penetrated through the FORCA carbon strands causing a weak bond to form below and above the strands. Penetration of the adhesive through the carbon strands to the sub-strata is needed so that a strong bond can be achieved.

Figure A-12: Debonding within the shear span of the FORCA Carbon Sheet – Type I

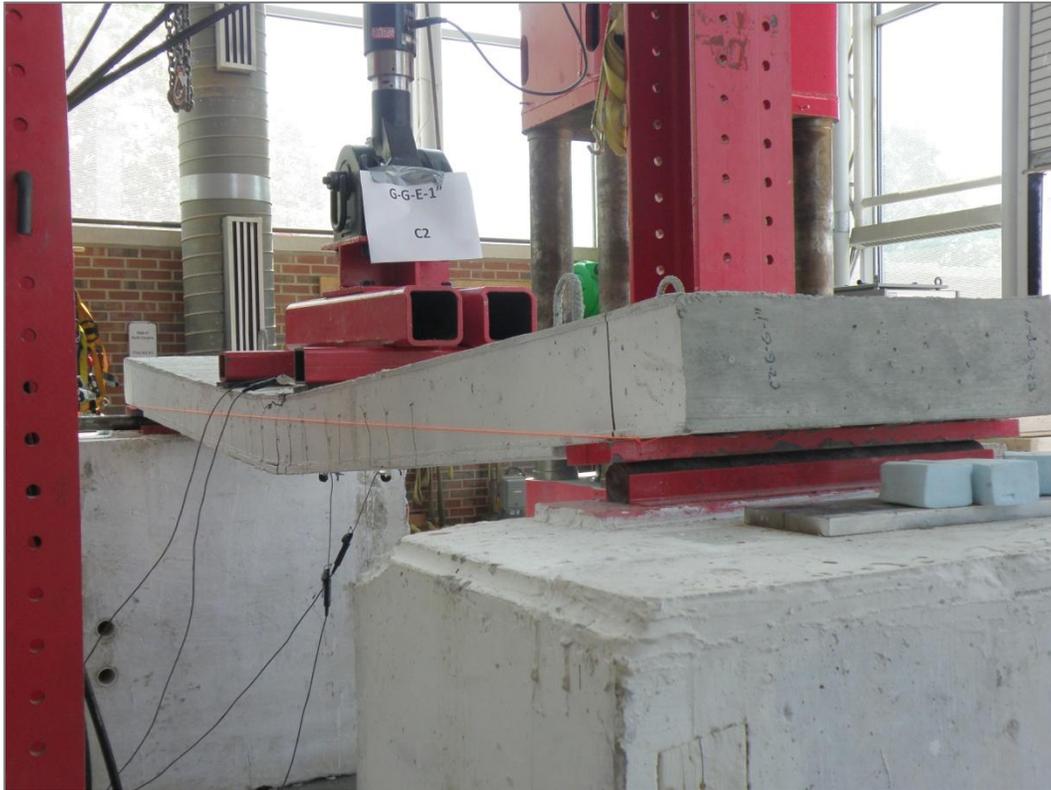
Figure A-14: G-G-E-1" specimen under four-point bending

This slab was strengthened with an externally bonded glass fiber grid with a 1" grid spacing, provided by PPG Company, and was bonded with Grancrete PCW. This specimen was subject to a four-point bending test and is shown in Figure A-14.

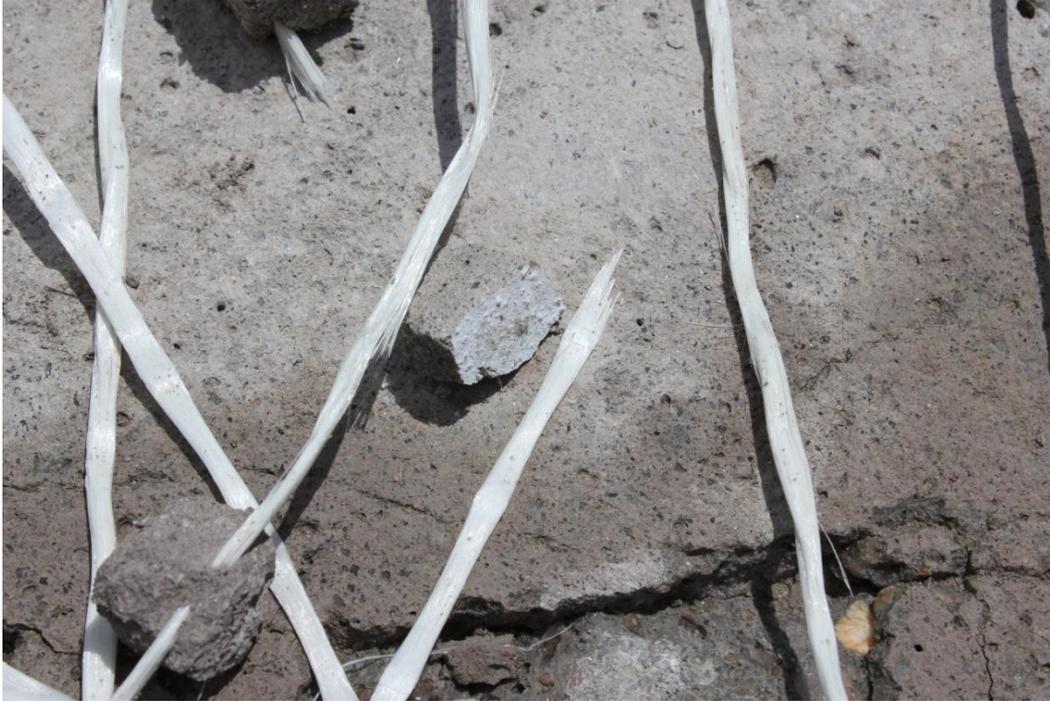
Inspection of the test specimen after failure showed that the 1 inch glass grid had debonded and ruptured in the region of maximum moment region. It was also observed that very large crack widths had formed in the region of maximum moment, where failure occurred. The widths of some of these cracks were 4-5mm. Figure A-17 shows the debonded and ruptured grid once the slab had been turned over for inspection of the fibers. It should be noted that the glass grid achieved a very good bond by using the Grancrete PCW, evident by rupture of the fibers that were observed during the inspection process as shown Figure A-17.

Figure A-17: Ruptured and Debonded Fibers from G-G-E-1” specimen

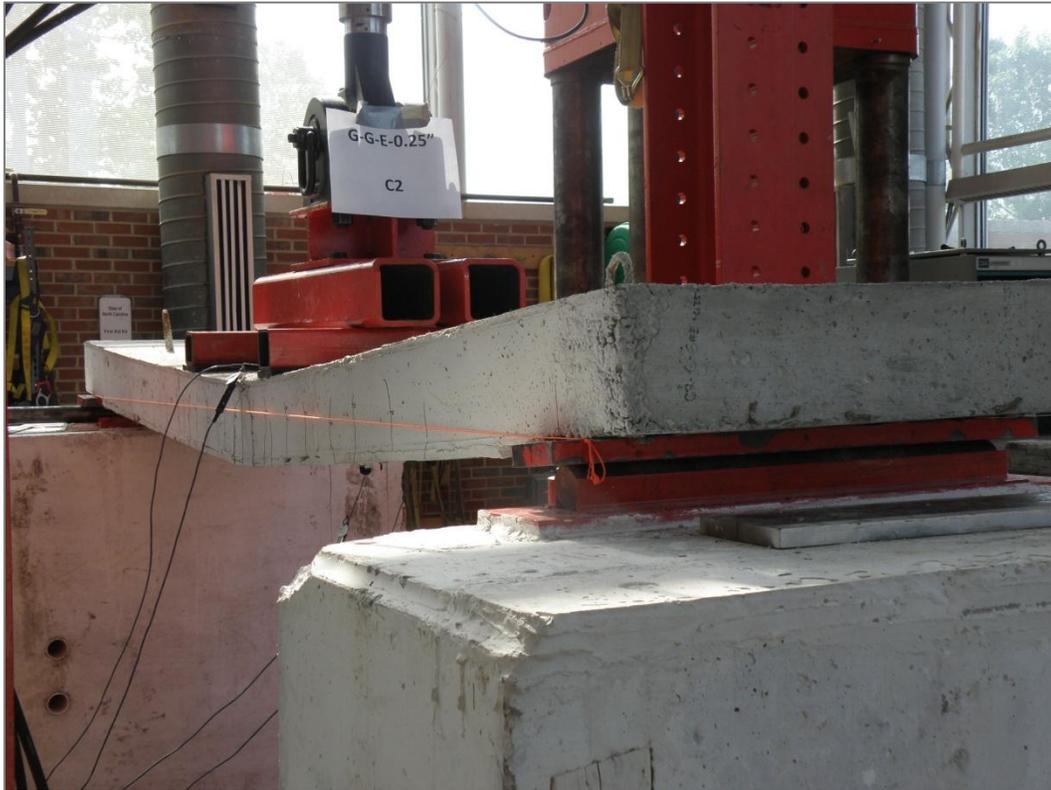
Figure A-19: G-G-E-0.25" specimen under four-point bending

This slab was strengthened with an externally bonded glass fiber grid with a 0.25" grid spacing, provided by PPG Company, and was bonded with Gracrete PCW. This specimen was subject to a four-point bending test and is shown in Figure A-19.

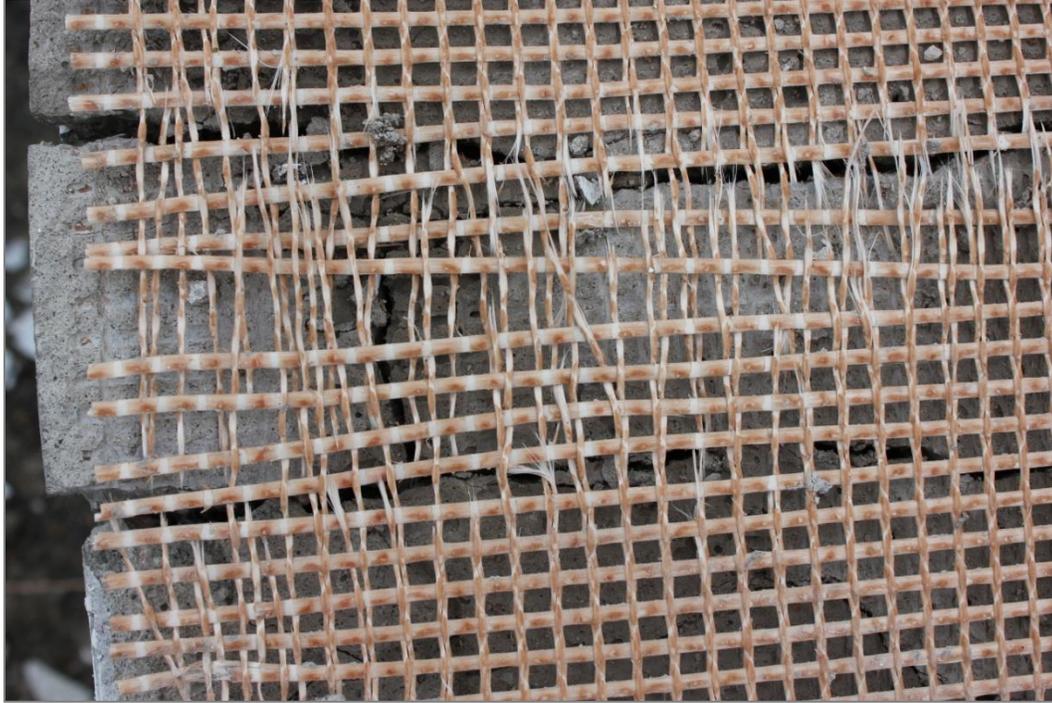
Inspection of the test specimen after failure showed that the 0.25'' glass grid had debonded and ruptured in the region of maximum moment region. It was also observed that a very large crack had formed in the region of maximum moment, where failure occurred. Figure A-22 shows the debonded and ruptured grid once the slab had been turned over for inspection of the fibers. It should be noted that the glass grid achieved a very good bond by using the Grancrete PCW, evident by rupture of the fibers that were observed during the inspection process as shown in Figure A-22.

Figure A-22: Ruptured and Debonded fibers of G-G-E-0.25” specimen
