Advanced Fiber Strengthening Systems for Concrete Structures

by
Benjamin Thomas Mielke

A thesis submitted to the Graduate Faculty of
North Carolina State University
in partial fulfillment of the
requirements for the degree of
Master of Science

Civil Engineering

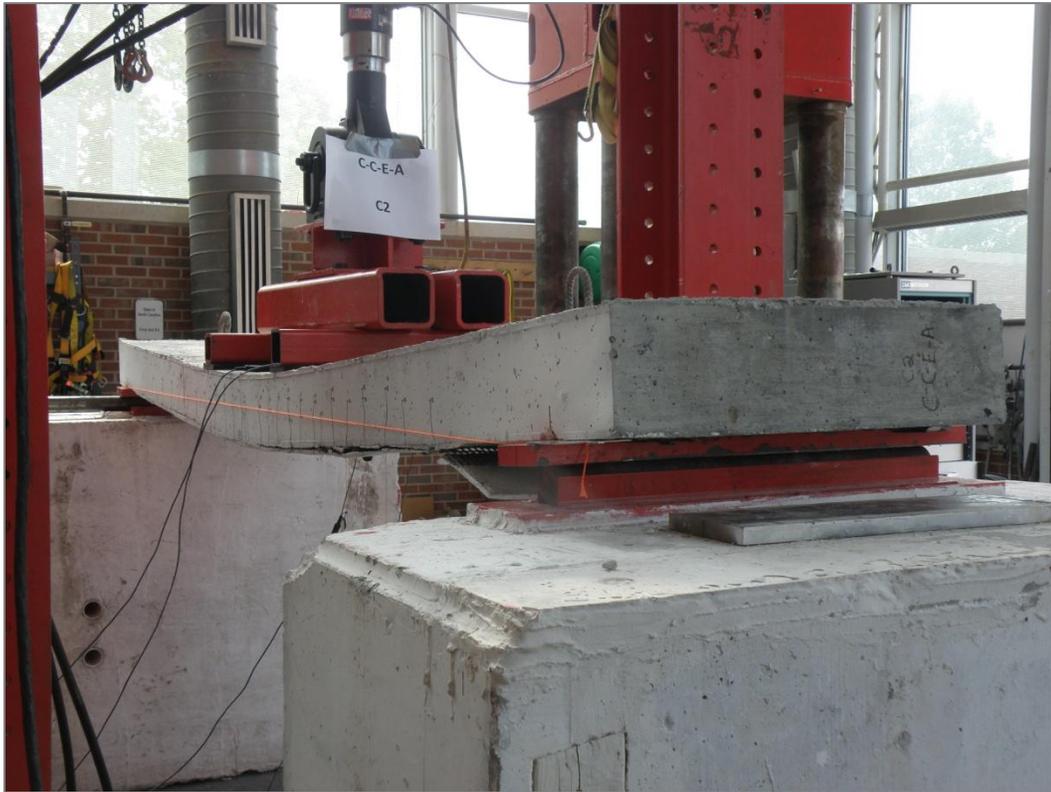
Figure A-29: C-C-E-A specimen under four-point bending

This slab was strengthened with an externally bonded carbon fiber grid, provided by the Fyfe Company, that has a spacing of 9.5mm center to center of the longitudinal fibers and a 19.5mm center to center spacing of the transverse strands and bonded with a cementitious material provided by the Fyfe Company, commercially referred to as Tyfo C-Matrix. This specimen was subject to a four-point bending test as is shown in Figure A-29.

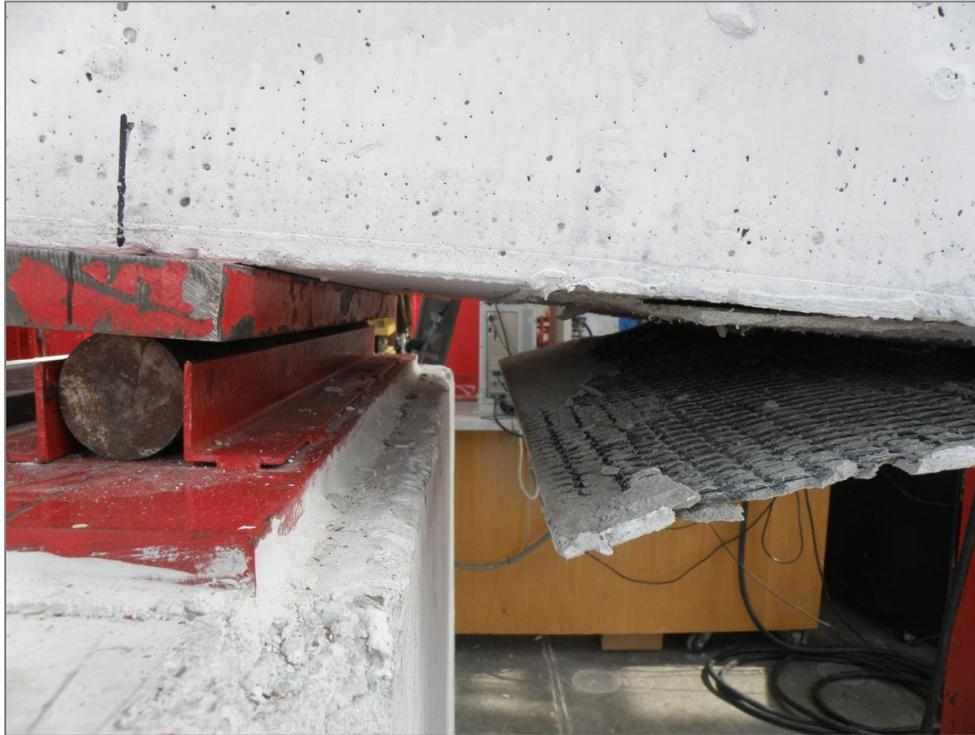
Failure of the strengthening system occurred due to debonding of the strengthening system as shown in Figure A-31. One unique event that was observed was that the overlaying layer of cementitious material on the fibers crushed in the shear zone of the strengthening system. This is shown in Figure A-32. The failure due to debonding was characterized also by crushing of the cementitious material as shown in Figure A-32 and may suggest that the recommended water/material ratio of the cementitious material may not be adequate to

Figure A-31: Debonding of C-C-E-A specimen

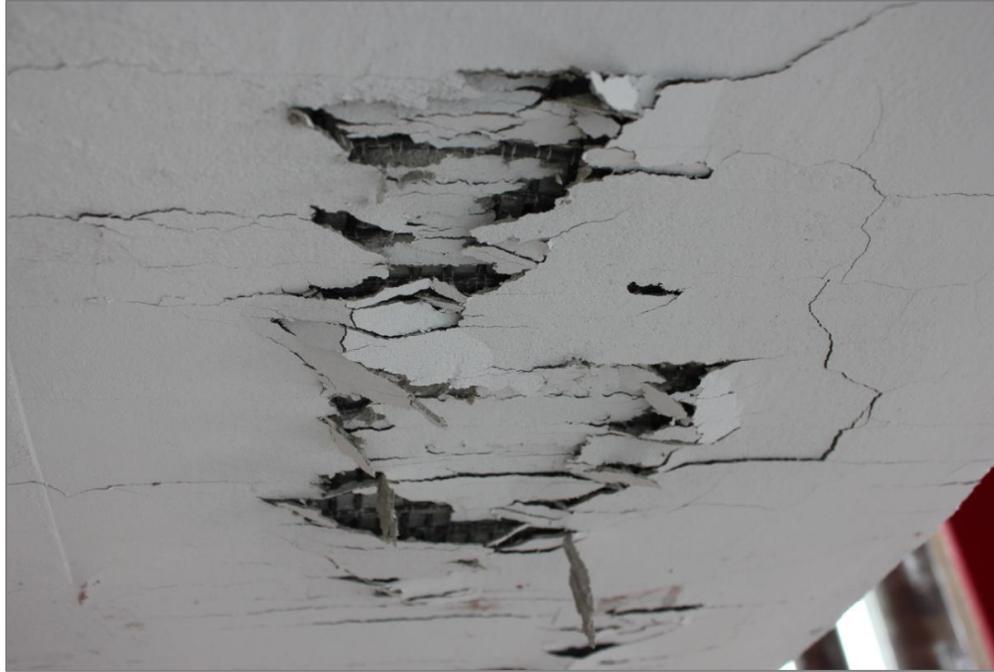
achieve the full bond characteristics of the material. The behavior suggests that there is a need to adjust the water/material ratio. It was also very dry during application and hardened in a very short time.

Figure A-32: Crushed Overlaying Layer of Cementitious Material of C-C-E-A specimen

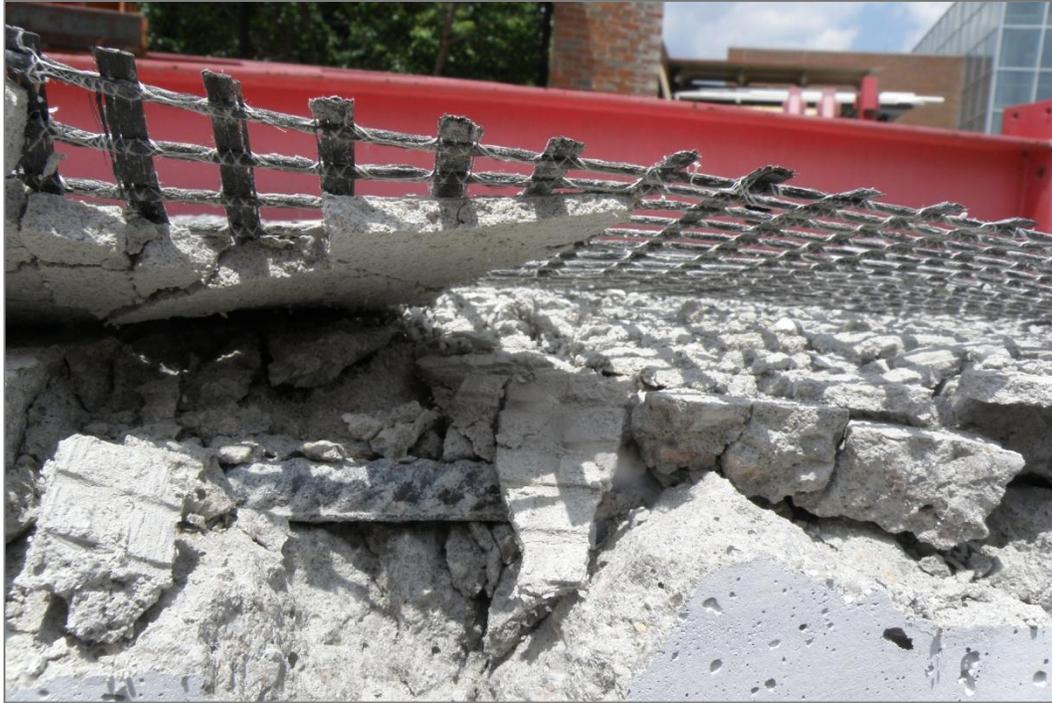
Inspection of the test specimen after failure showed that the carbon grid was debonded without rupture of the fibers in the region of maximum moment region. Figure A-34 shows that the debonded grid when the slab had been turned over for inspection of the fibers.

Figure A-34: Debonded fibers in region of maximum moment of C-C-E-A specimen

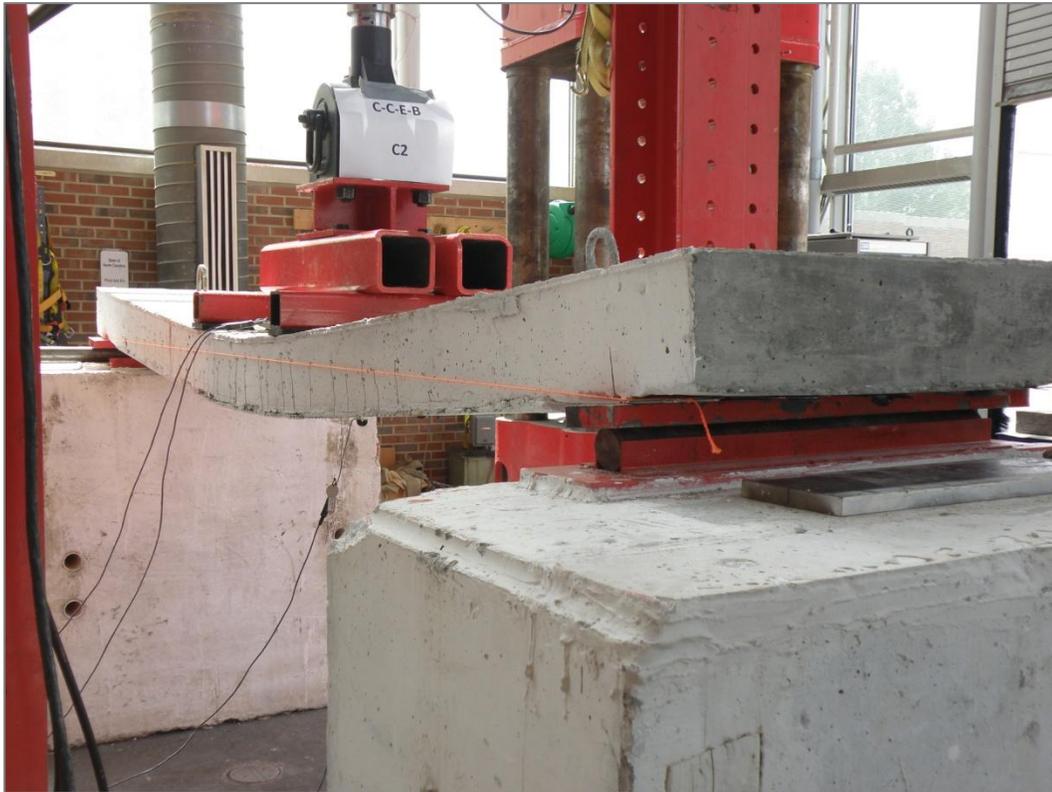
Figure A-36: C-C-E-B specimen under four-point bending

This slab was strengthened with an externally bonded carbon fiber grid, provided by the Fyfe Company, that has a spacing of 9.5mm center to center of the longitudinal fibers and a 19.5mm center to center spacing of the transverse strands and bonded with a cementitious material provided by the Fyfe Company, commercially referred to as Tyfo C-Matrix. This specimen was subject to a four-point bending test and is shown Figure A-36.

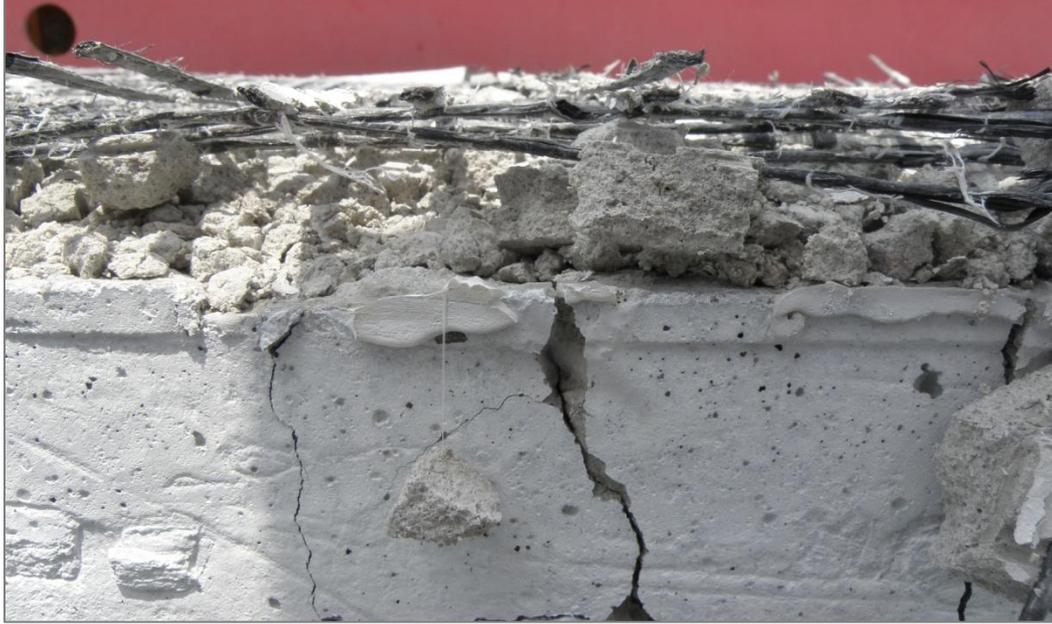
Inspection of the test specimen after failure showed that the carbon grid was debonded without rupture of the fibers in the region of maximum moment. Figure A-39 shows the debonded grid when the slab had been turned over for inspection of the fibers. It should be noted that the top layer of adhesive on the fibers was very thin, and therefore it was difficult to remove during the inspection. The fibers were not ruptured during the testing of the specimen, and the failure occurred mainly due to debonding of the strengthening system.

Figure A-39: Debonded fibers of C-C-E-B specimen

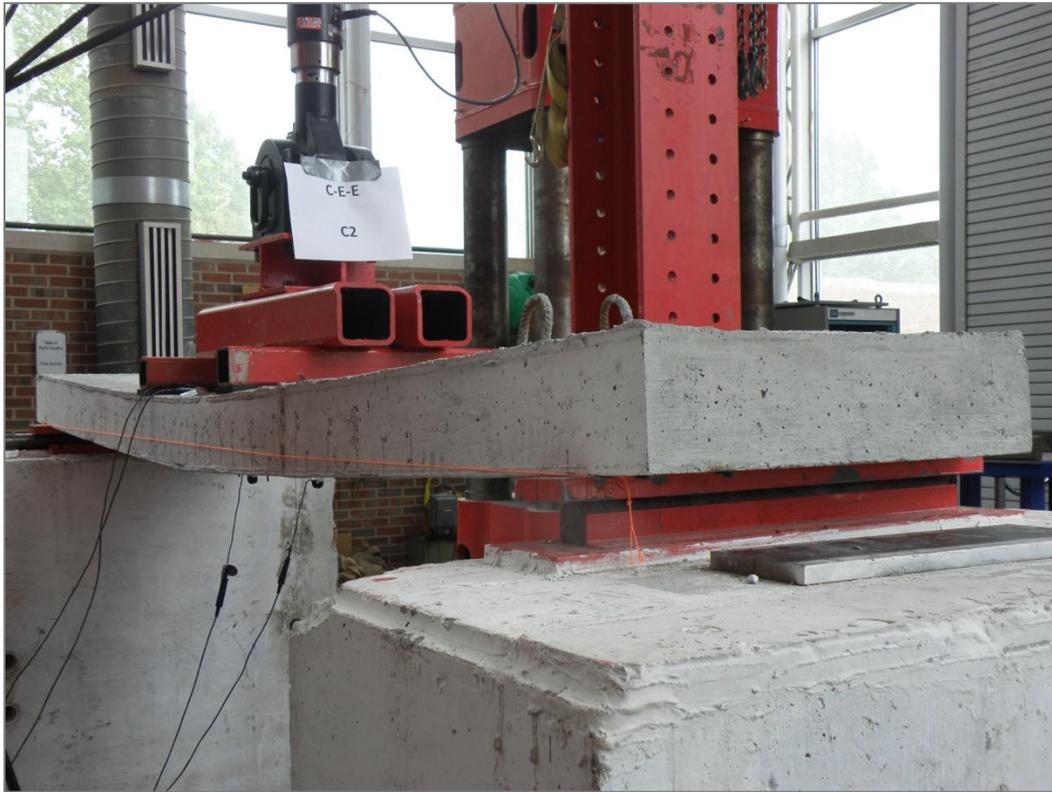
Figure A-41: C-E-E specimen under four-point bending

This slab was strengthened with an externally bonded carbon fiber grid, provided by the Fyfe Company that has a spacing of 9.5mm center to center of the longitudinal fibers and a 19.5mm center to center spacing between the transverse strands and was bonded with an epoxy adhesive, commercially known as Tyfo TC, provided by the Fyfe Company. This specimen was subject to a four-point bending test as shown in Figure A-41.

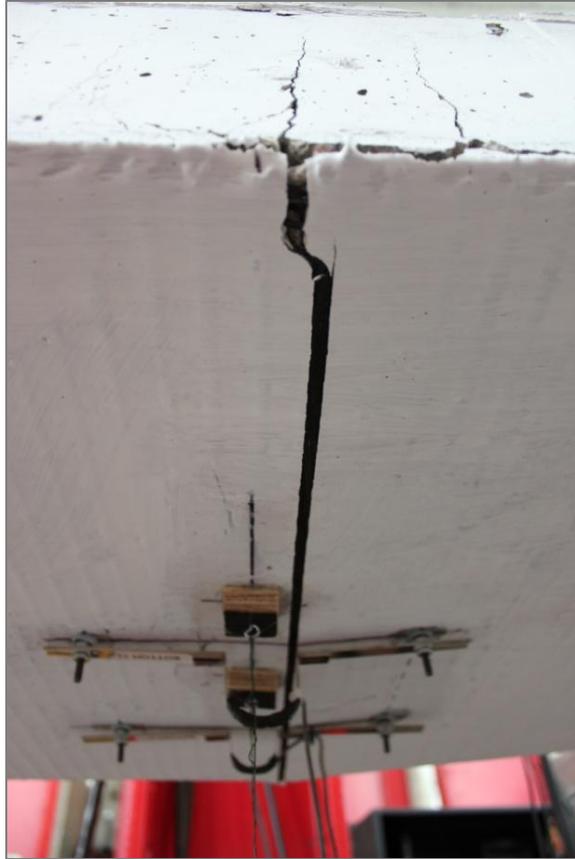
Figure A-43: Sudden Rupture of Epoxy Strengthening System on C-E-E specimen

reinforcement and then a sudden drop in load due to failure which occurred due to rupture of the fibers. The cracking load and yielding load was 4,245 lbs and 16,102 lbs, in comparison to 3,000 lbs and 12,767 lbs measured for the control slab, respectively. It should be noted that the load at yielding was much higher than the load at yielding for the other slabs that were strengthened by the same fiber but bonded by the cementitious adhesives. Ductility of the strengthened specimen was 2.22 and was determined based on the comparing the mid-span deflection at failure of the strengthened system to the mid-span deflection at yielding of the longitudinal reinforcements. Figure A-42 shows a sudden drop in load and consequential failure of the strengthened slab due to a sudden rupture of the strengthening system. The failure shown in Figure A-43 indicates formation of one single large width crack which is believed to be the main reason for rupture of the fibers.

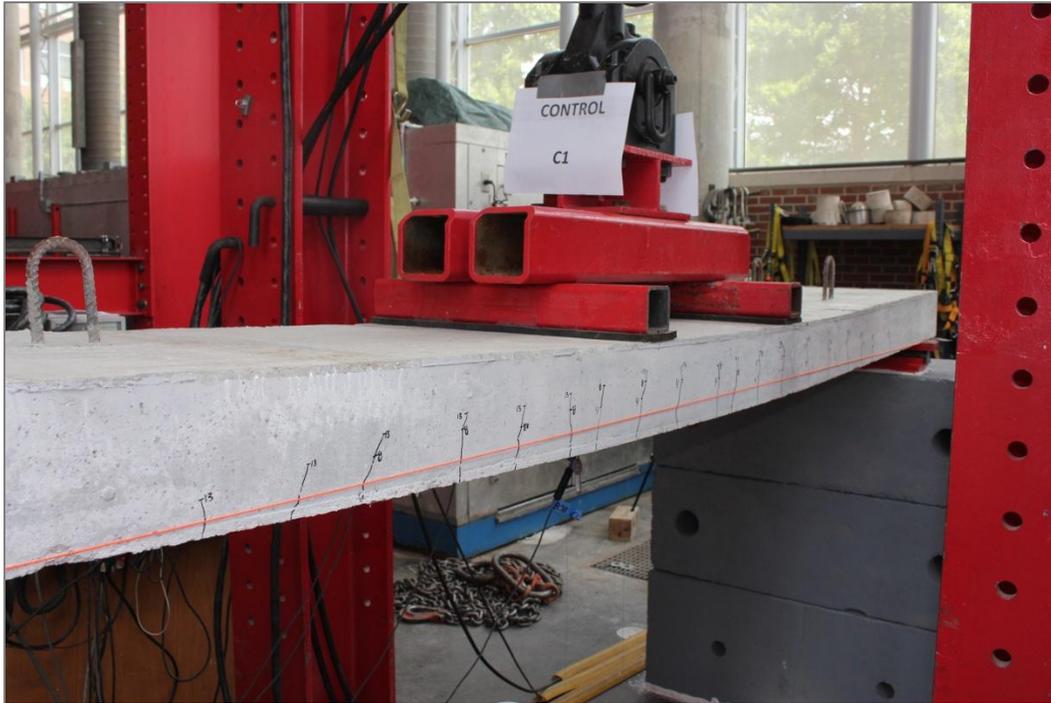
Figure A-47: Control Specimen – Phase II under four-point bending

The unstrengthened control specimen tested in Phase II was used as a benchmark to measure the effectiveness of the various FRP strengthened slabs explored in Phase II. The control specimen, as well as the strengthened slabs, was subjected to a four-point bending test as shown in Figure A-47.

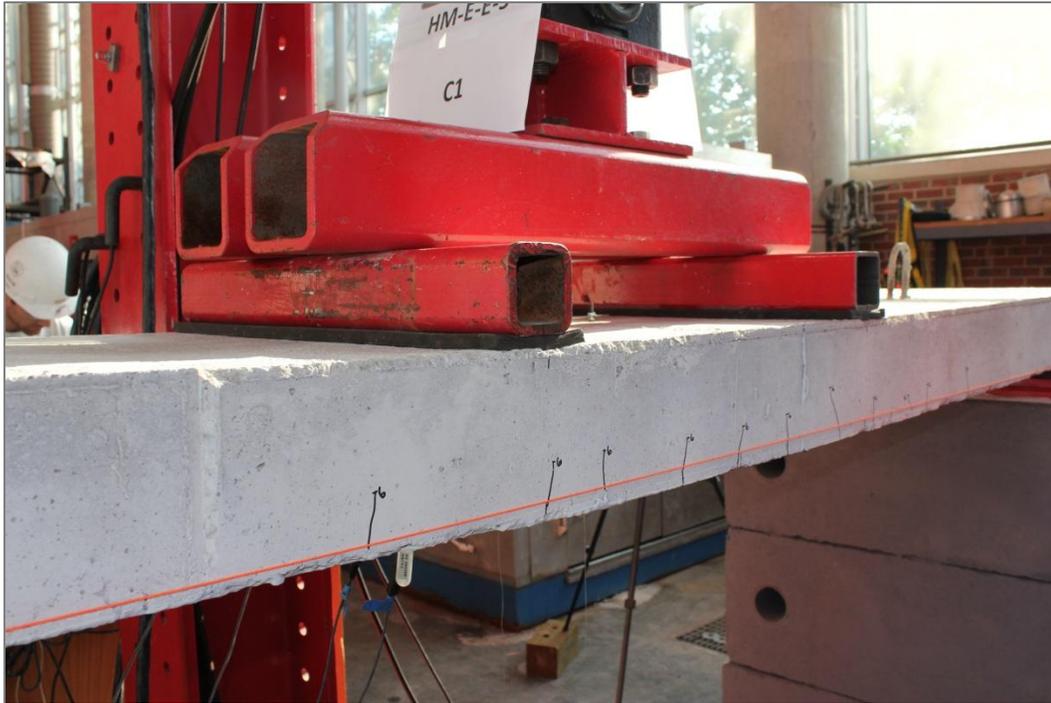
Figure A-50: HM-E-E-3 specimen under four-point bending

This slab was strengthened with an externally bonded High Modulus Carbon Strand Sheet – Type 3, commercially referred to as FORCA Carbon Strands, and bonded with an epoxy supplied by Nippon Steel Company using the externally bonded technique. This specimen was subject to a four-point bending test as shown in Figure A-50.

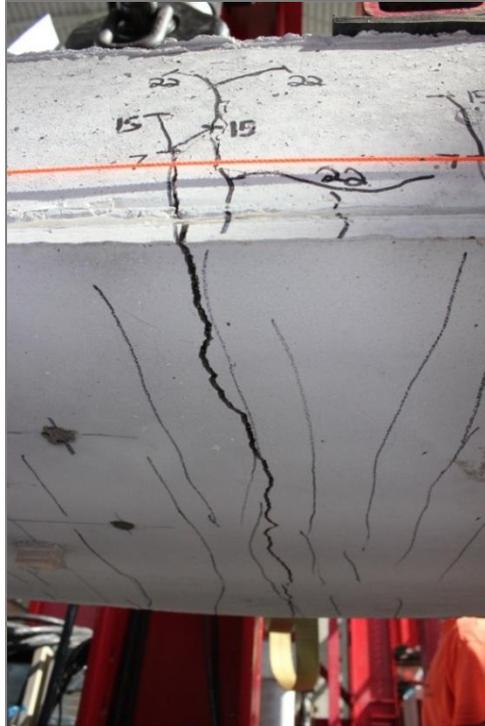
Figure A-59: Rupture of the of the FORCA High Modulus Carbon Sheet – Type 3

Failure of the strengthening system was sudden and occurred within the maximum moment region of the slab. Failure of the strengthening system was due to rupture of the fiber within the maximum moment region of the slab. This failure is shown in Figure A-59. Inspection of the test specimen after failure showed that the FORCA carbon strand sheet had ruptured. The ruptured fibers are shown in Figure A-60.

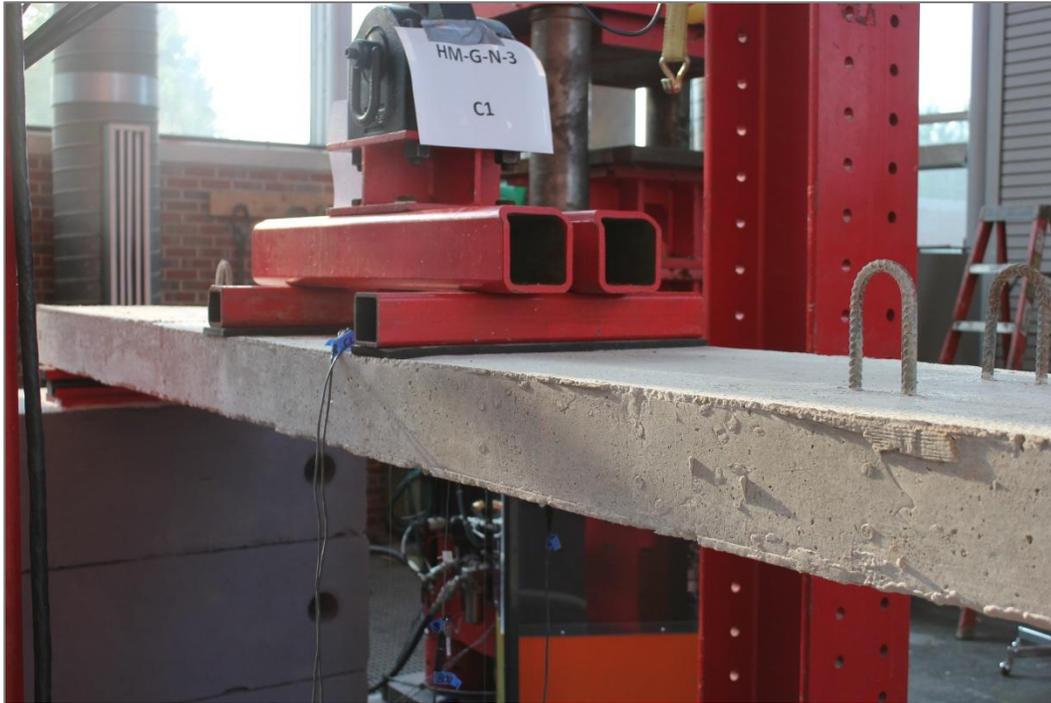
Figure A-62: HM-G-N-3 specimen under four-point bending

This slab was strengthened with High Modulus Carbon Strand Sheet – Type 3, commercially referred to as FORCA Carbon Strands, and bonded with Grancrete PCW using the near surface mounted application. This specimen was subject to a four-point bending test as shown in Figure A-62.

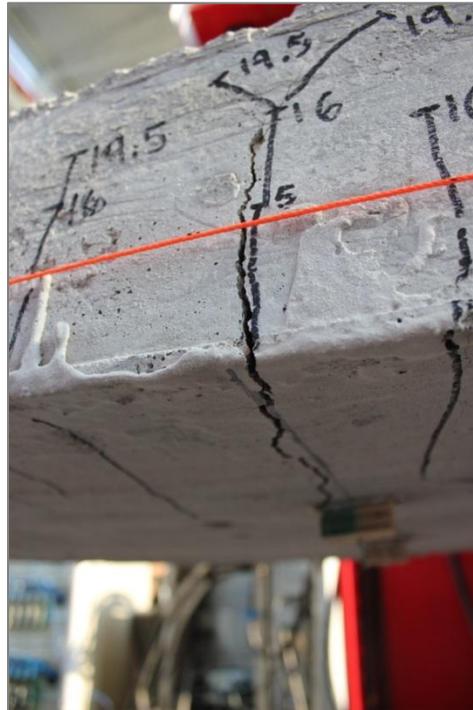
Figure A-65: Rupture of the of the FORCA High Modulus Carbon Sheet – Type 3

Failure of the strengthening system was sudden and occurred within the maximum moment region of the slab. Failure of the strengthening system was due to rupture of the fiber within the maximum moment region of the slab. This failure is shown Figure A-65. Inspection of

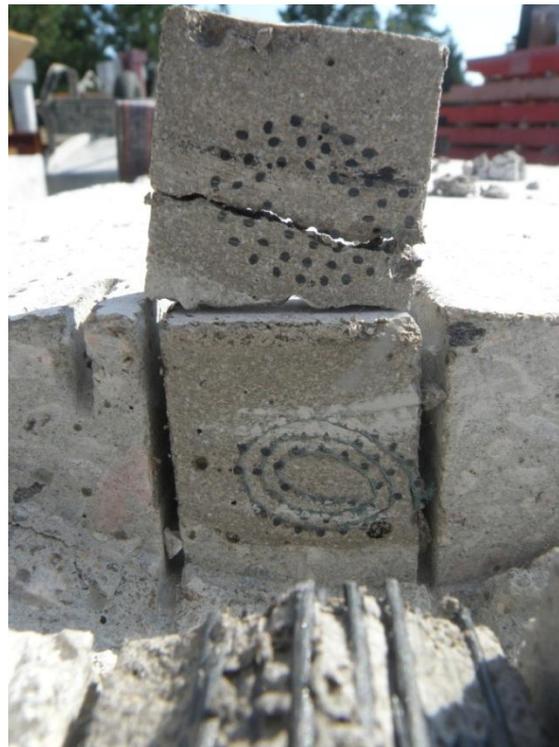
Figure A-67: Total Encasement of FRP Bundle by Grancrete

the test specimen after failure showed that the FORCA carbon strand sheet had ruptured. The ruptured fibers are shown in Figure A-66. It was also observed that the adhesive was able to completely surround the bundle of carbon strands as shown in Figure A-67. This is very important because in order to achieve a strong bond, the adhesive must be able to completely surround the FRP carbon strand bundle so that a cohesive layer of adhesive may be achieved throughout the NSM groove. Failure of the adhesive to completely encase the FRP can lead to bond problems which can lead to premature debonding failures.

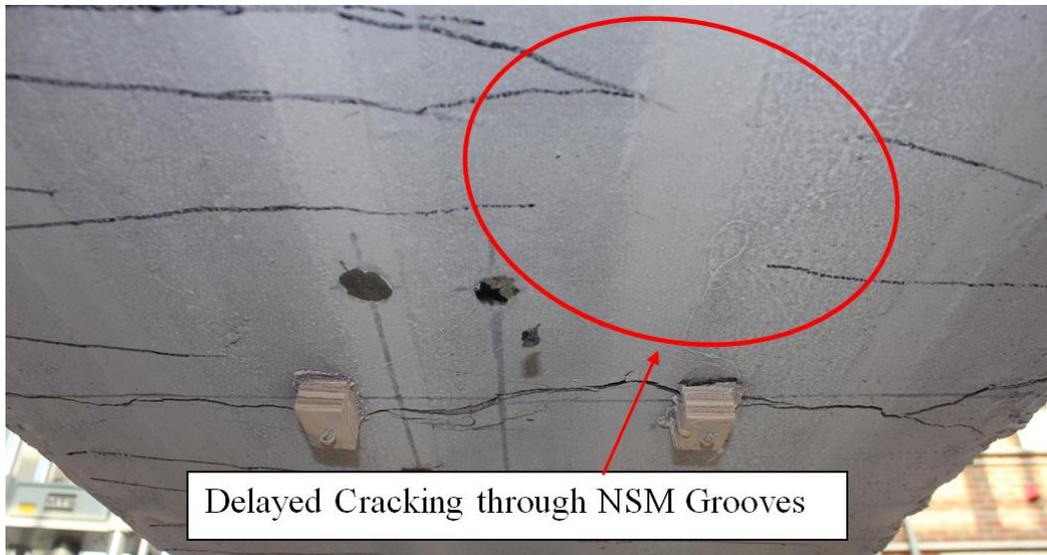
Figure A-68: Delayed Cracking through NSM Grooves

It was observed that the load carrying capacity was increased by 42% when compared to the unstrengthened control specimen. There was no measured ductility due to the sudden and brittle failure of the strengthening system before yielding of the reinforcement. During the testing, it was observed that the flexural cracks were not propagating through the Gracrete PCW in the NSM grooves as quickly as they were propagating through the concrete on the bottom the slab. The reason for this is that the Gracrete PCW/Carbon fiber system is a much stiffer system than the concrete surrounding it. This results in a greater tensile strength in the grooves, which resists cracking of the system. This delay in cracking of the NSM grooves can be seen in Figure A-68. The failure occurred due to rupture of the FRP Sheet within the maximum moment region caused by the small rupture strain of the High Modulus fibers. The strengthening system did not allow the slab to be fully utilized due to failure of the slab before yielding of the reinforcing steel. It is recommended that fibers with a higher rupture strain be used to strengthen reinforced concrete structures to help prevent failure due to rupture of the fibers before yielding of the steel reinforcement.

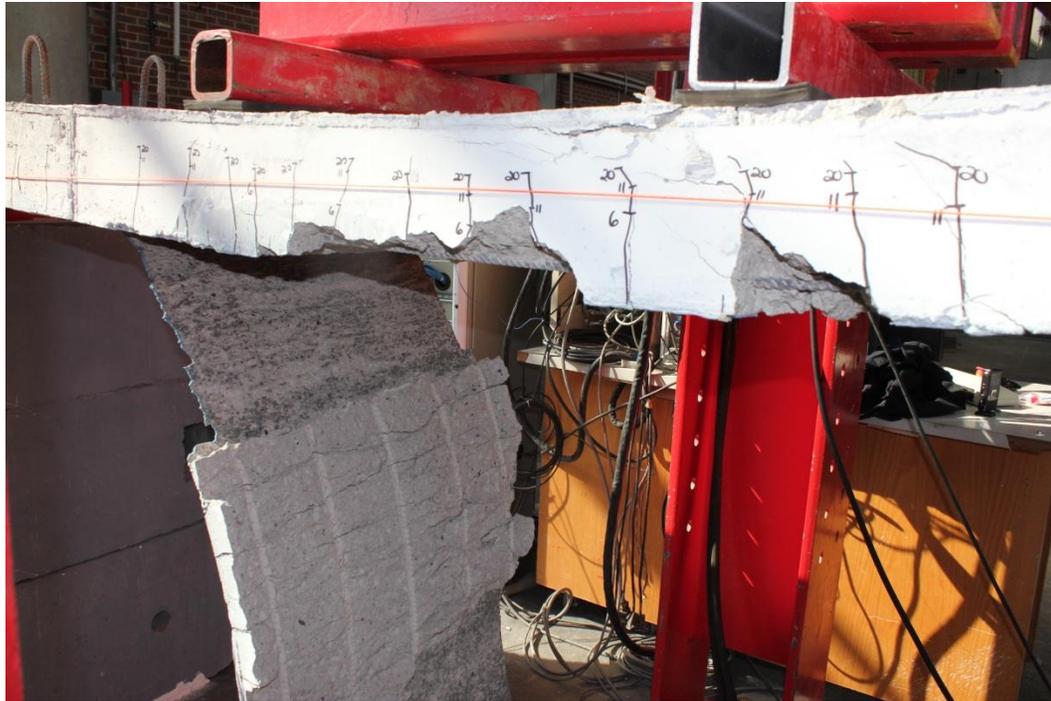
Figure 80: Failure due Debonding of Fibers in specimen HT-E-E-3

The second failure occurred when the strengthening system debonded from the slab. This was followed by a significant decrease in load as seen in Figure A-70. The debonding failure can be seen in Figure 80.

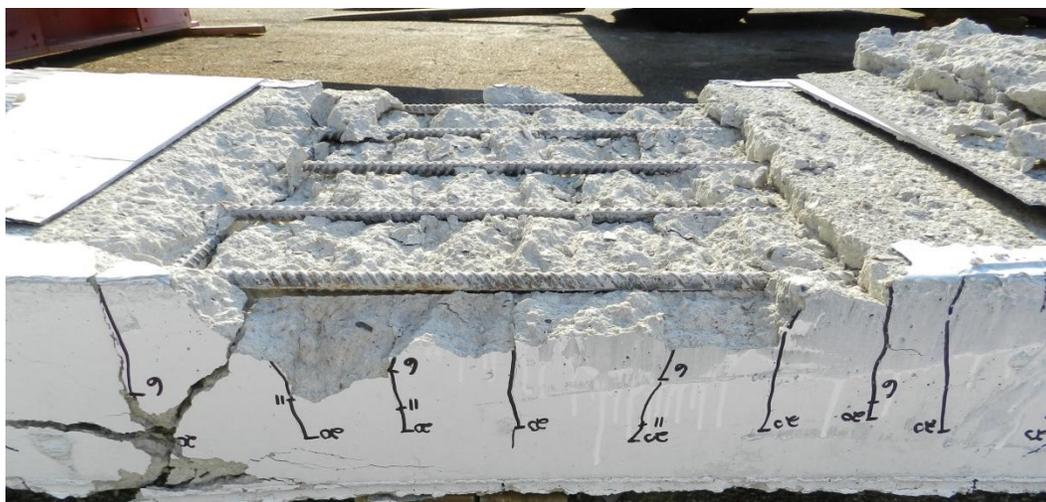
Figure A-73: Debonded Fibers from HT-E-E-3 specimen

Inspection of the test specimen after failure showed that the High Tensile Carbon Strand Sheet had debonded from one support to the maximum moment region. It was also observed that many flexural cracks had formed in the region of maximum moment, where debonding occurred after crushing of the concrete. Figure A-73 shows the debonded carbon strand sheet once the slab had been turned over for inspection of the fibers. It should be noted that the High Tensile Carbon Grid Strand Sheet-Type 3 achieved a very good bond when using the epoxy as the adhesive as evident by concrete cover that peeled away with the strengthening system when the system debonded as shown in Figure A-73 that shows the exposed reinforcing steel of the specimen.

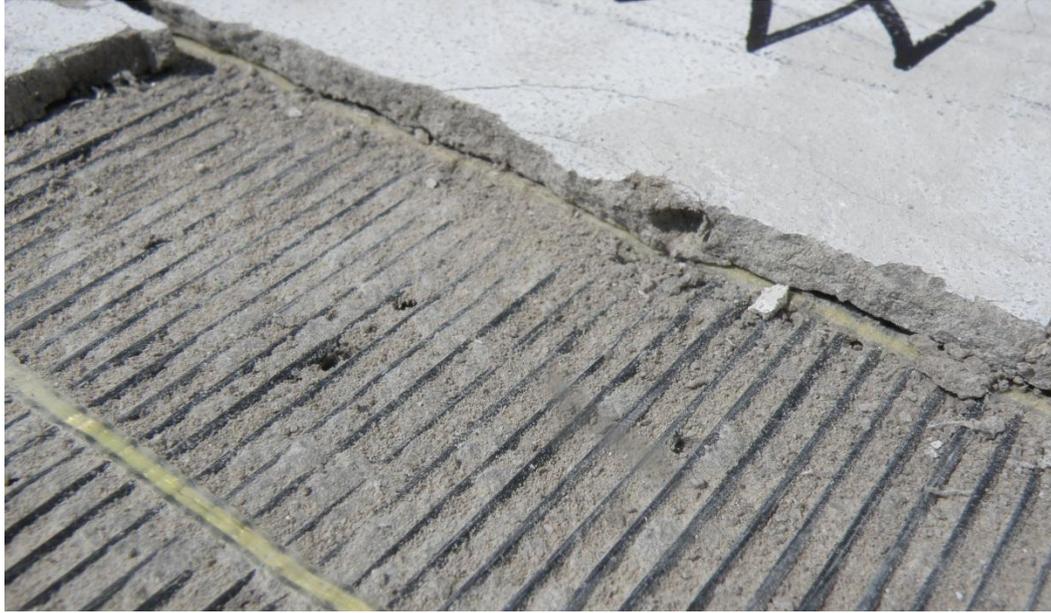
Figure A-78: Grancrete penetrating between the Type 3 Carbon Strands

Inspection of the test specimen after failure showed that the High Tensile Carbon Strand Sheet had not debonded and that failure was due to concrete crushing. It should be noted that the High Tensile Carbon Grid Strand Sheet-Type 3 achieved a very good bond when using Grancrete PCW as the adhesive as shown in Figure A-78 that shows the fibers had not debonded and that the Grancrete PCW had complete penetrated between the High Tensile Type 3 Carbon Strands. This penetration is important because it give a cohesive layer of adhesive and bond between the top layer of Grancrete PCW and the concrete surface.

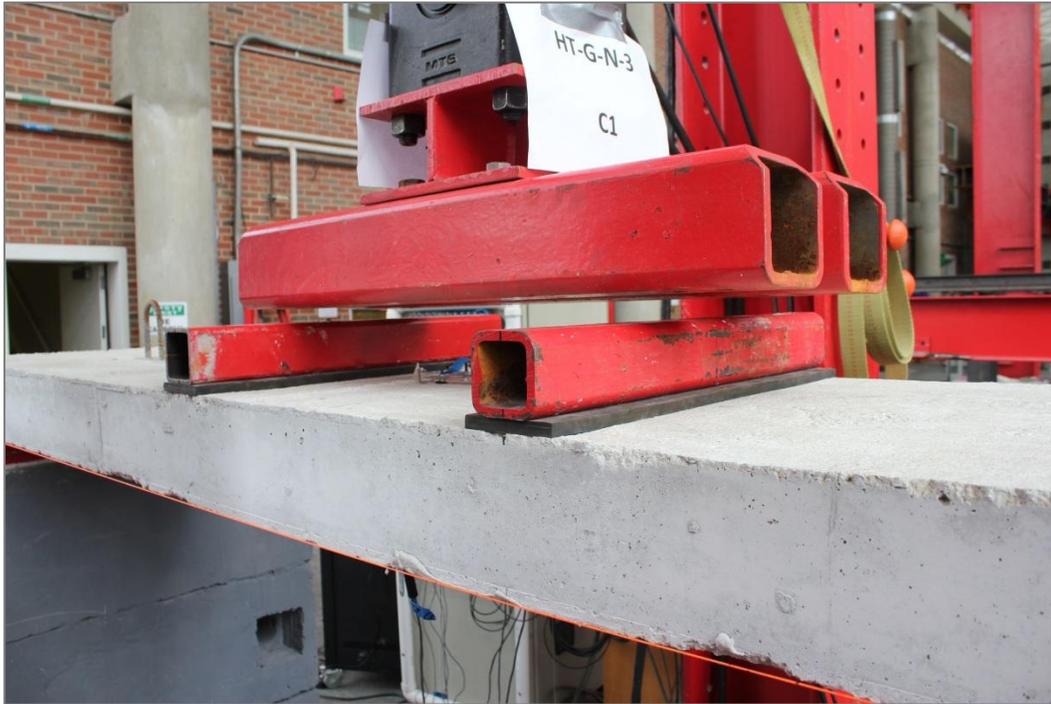
Figure A-80: HT-G-N-3 specimen under four-point bending

This slab was strengthened with a High Tensile Carbon Strand with Type 3 spacing and Grancrete PCW using the near surface mounted technique. This specimen was subject to a four-point bending test and is shown in Figure A-80.

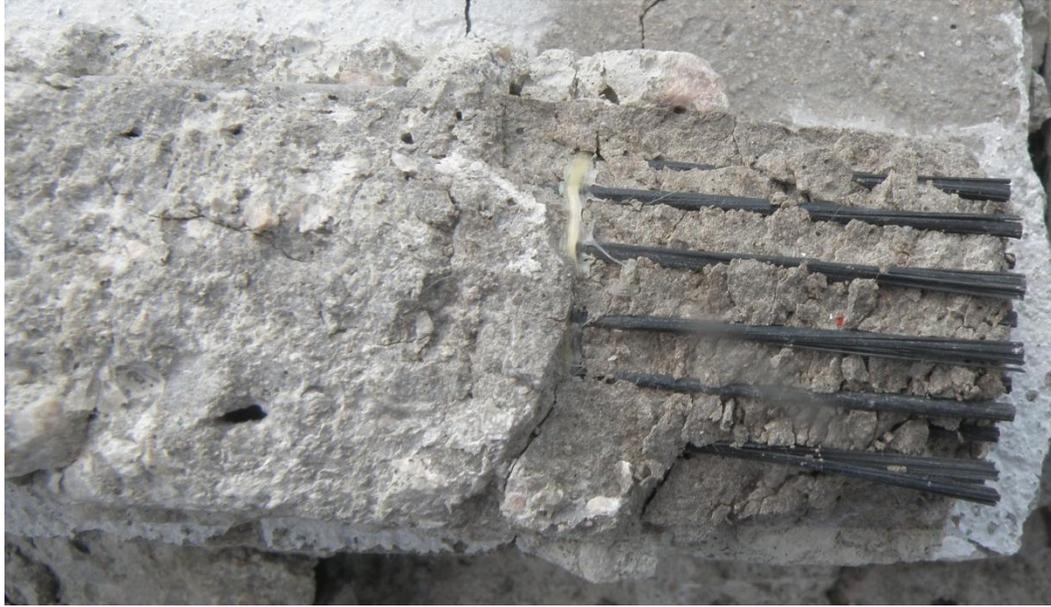
Figure A-83: Fibers encased by Grancrete in HT-G-E-3 specimen

Inspection of the test specimen after failure showed that the High Tensile Carbon Strand Sheet had not debonded and that failure was due to concrete crushing. It should be noted that the High Tensile Carbon Grid Strand Sheet-Type 3 achieved a very good bond when using Grancrete PCW as the adhesive as shown in Figure A-83 that shows the fibers had not debonded and that the adhesive had completely encased the carbon strand bundle. The figure also shows that the concrete substrata has formed a strong enough bond with the adhesive that it detaches with carbon strand bundle when the groove was removed for inspection.
