Field Implementation and Comparative Performance Assessment of
Undercut Stabilization Measures

by
Timothy David Cowell

A thesis submitted to the Graduate Faculty of
North Carolina State University
in partial fulfillment of the
requirements for the degree of
Master of Science

Civil Engineering

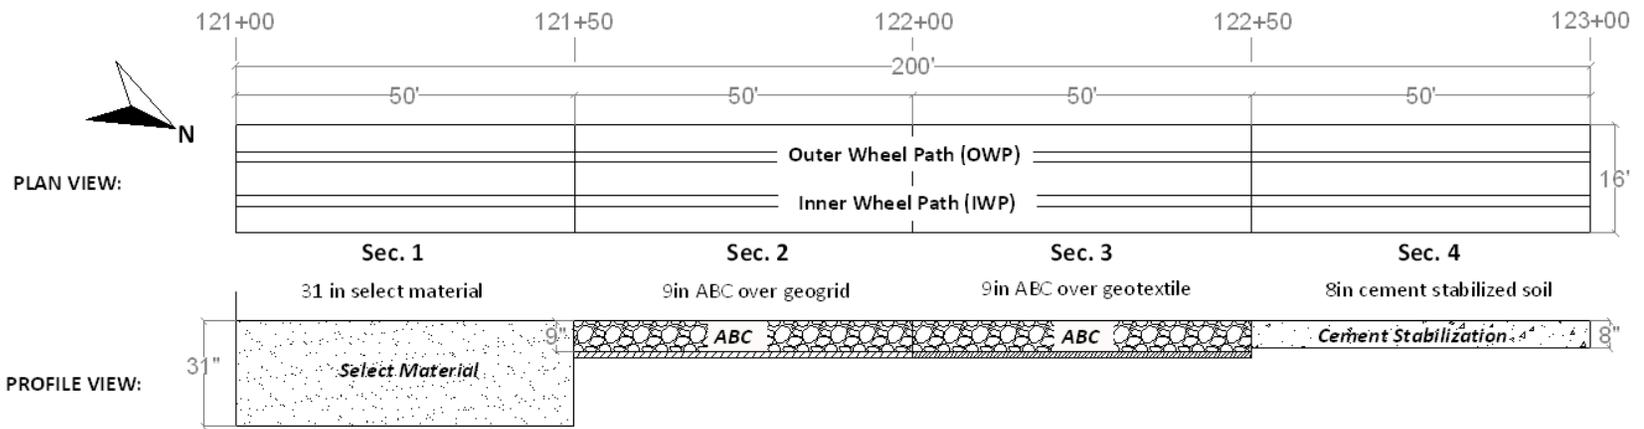
Figure 4: Plan and profile views of the full-scale test pad

It is worth noting that the original design thickness of the stabilized layer for Test Sections 1, 2, and 3 was 36 inches, 15 inches, and 12 inches, respectively. However, after testing was completed it was realized that based on surveying measurements the contractor failed to undercut to the prescribed depths. As result, all analyses within this study are based on the measured thicknesses of each test section.

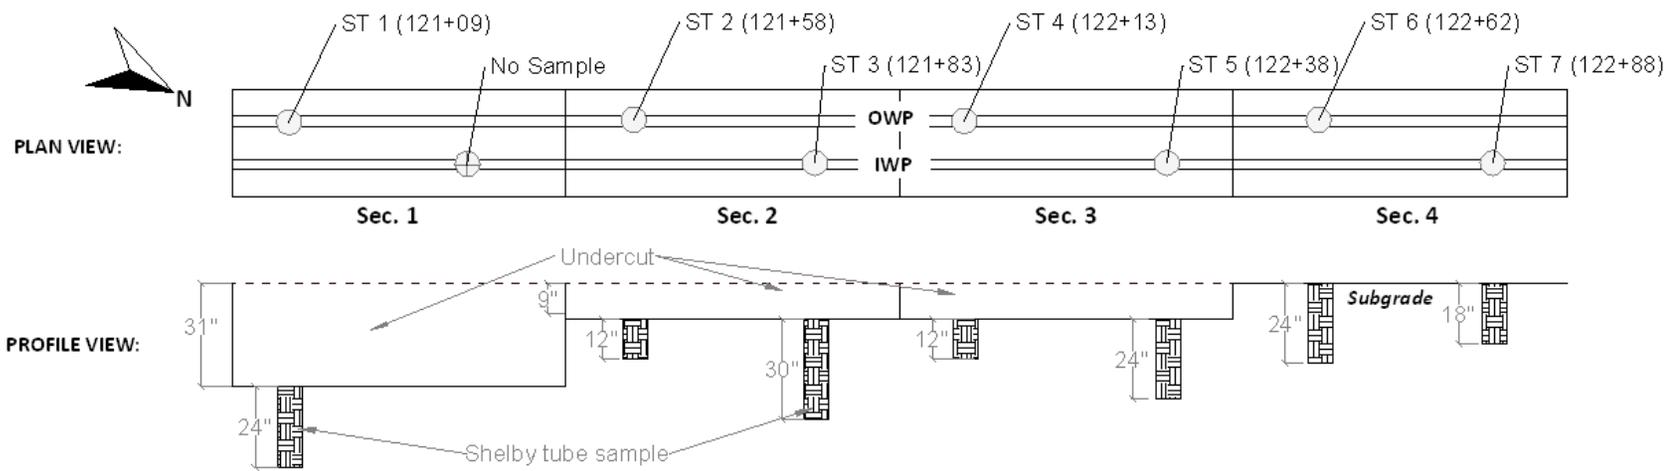
Figure 5: Shelby tube sample layout

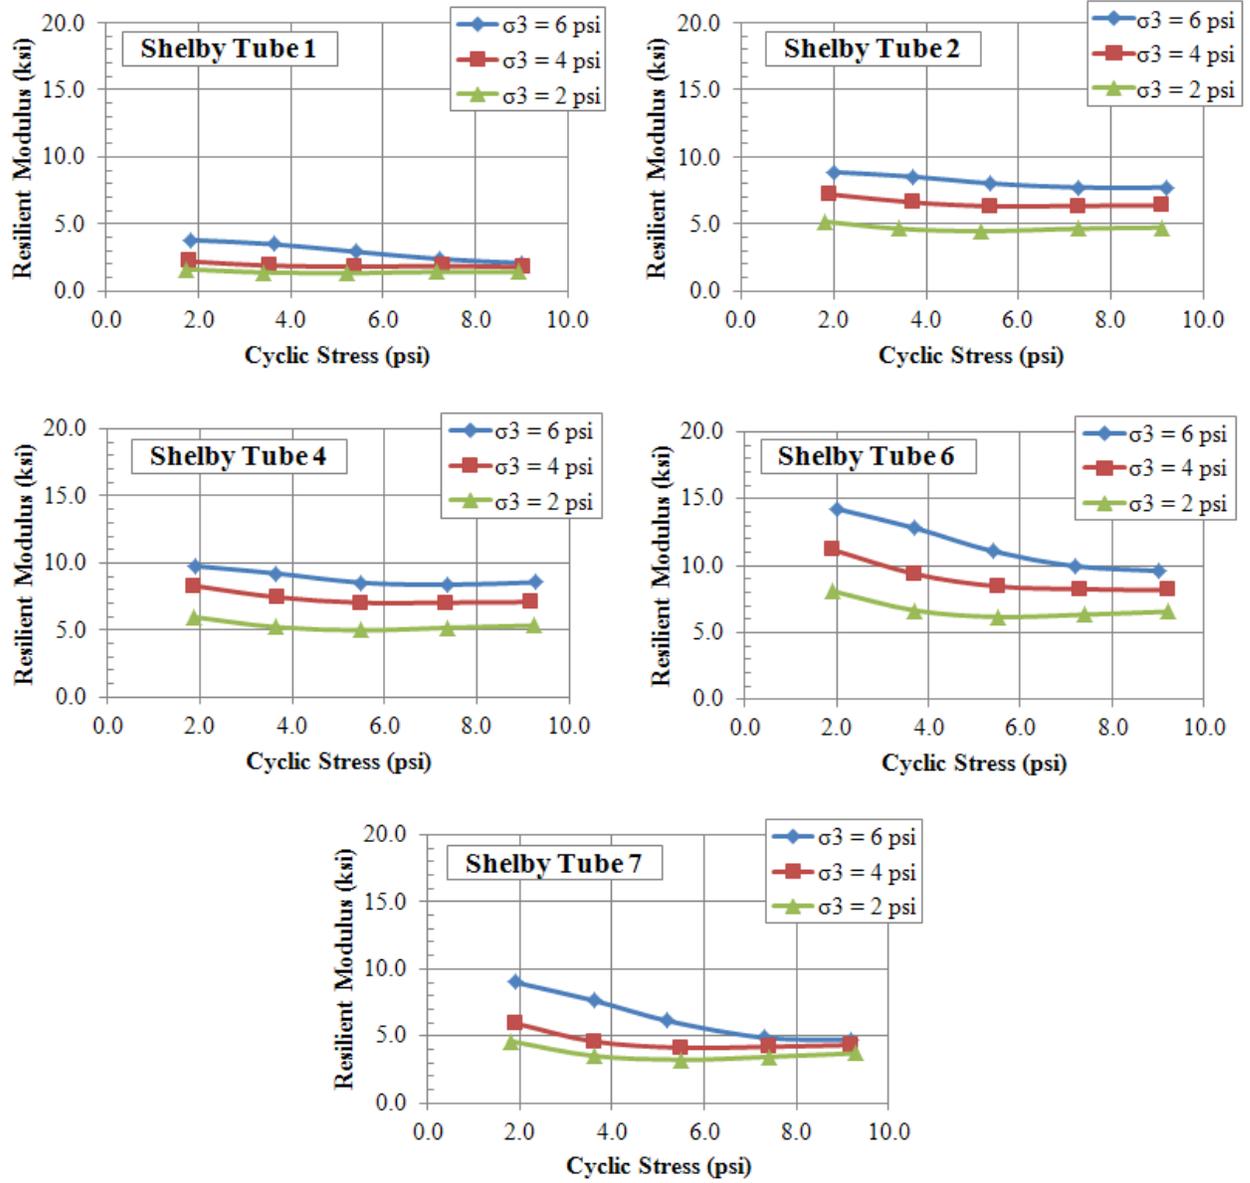
Figure 7: Resilient modulus test results on the subgrade Shelby tube samples

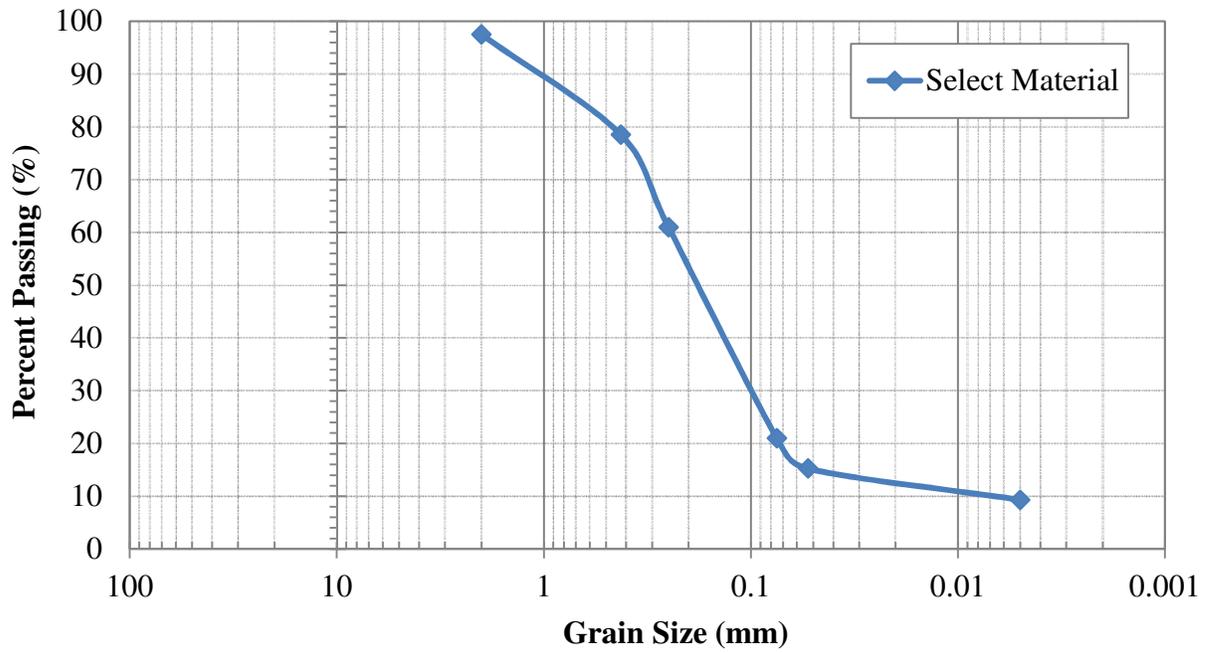
Figure 10: Grain size distribution curve for the select material

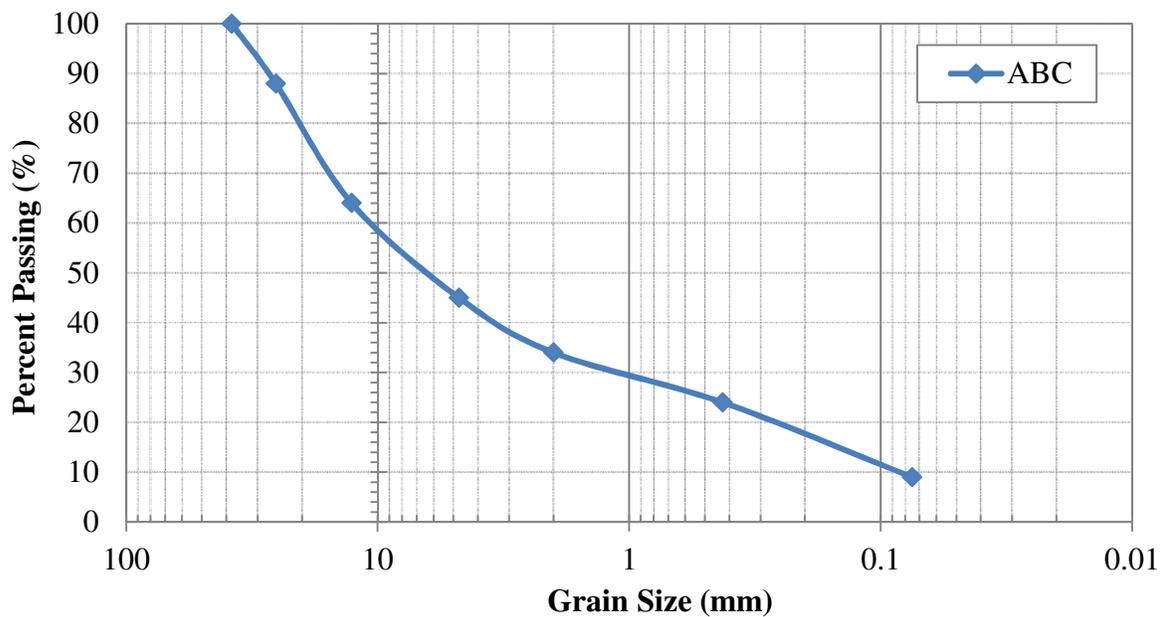
Figure 13: Grain size distribution curve for the ABC

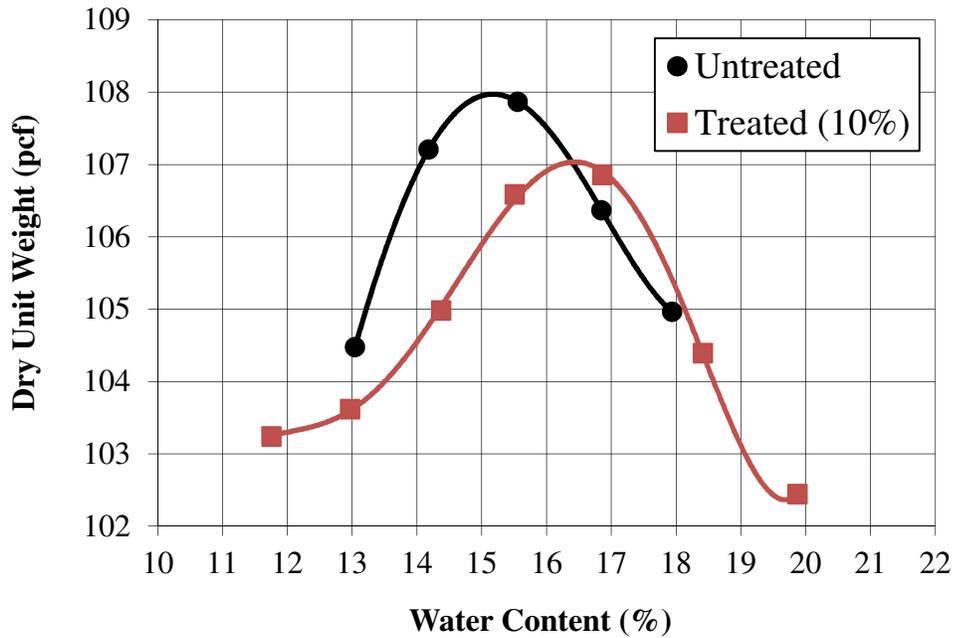
Figure 16: Untreated and cement treated subgrade soil standard proctor compaction test results

The moisture-density relationship of the soil-cement mixture was determined by performing standard proctor tests according to ASTM D558. Portland cement type I was added to bulk subgrade samples to simulate the construction of cement stabilized subgrade (CSS) in the field. The subgrade samples were taken from the top 12 inches from grade during a preliminary site visit in March, 2011. First, a single set of standard proctor compaction tests were performed on an untreated sample of the subgrade. Based on a measured maximum dry density of 108 pcf, another round of standard proctor compaction tests were performed, this time adding cement at a dosage rate of 10%. After mixing, the soil-cement mixture was immediately compacted at various water contents to assess the moisture content and dry unit weight relationship. The results are presented in Figure 16. Compared with the untreated sample the 10% cement treated sample exhibited a slight increase in optimum moisture content and decrease in maximum dry unit weight. This is consistent with the observations made by Sariosseiri and Muhunthan on cement-treated subgrade soils in Washington state (2009).

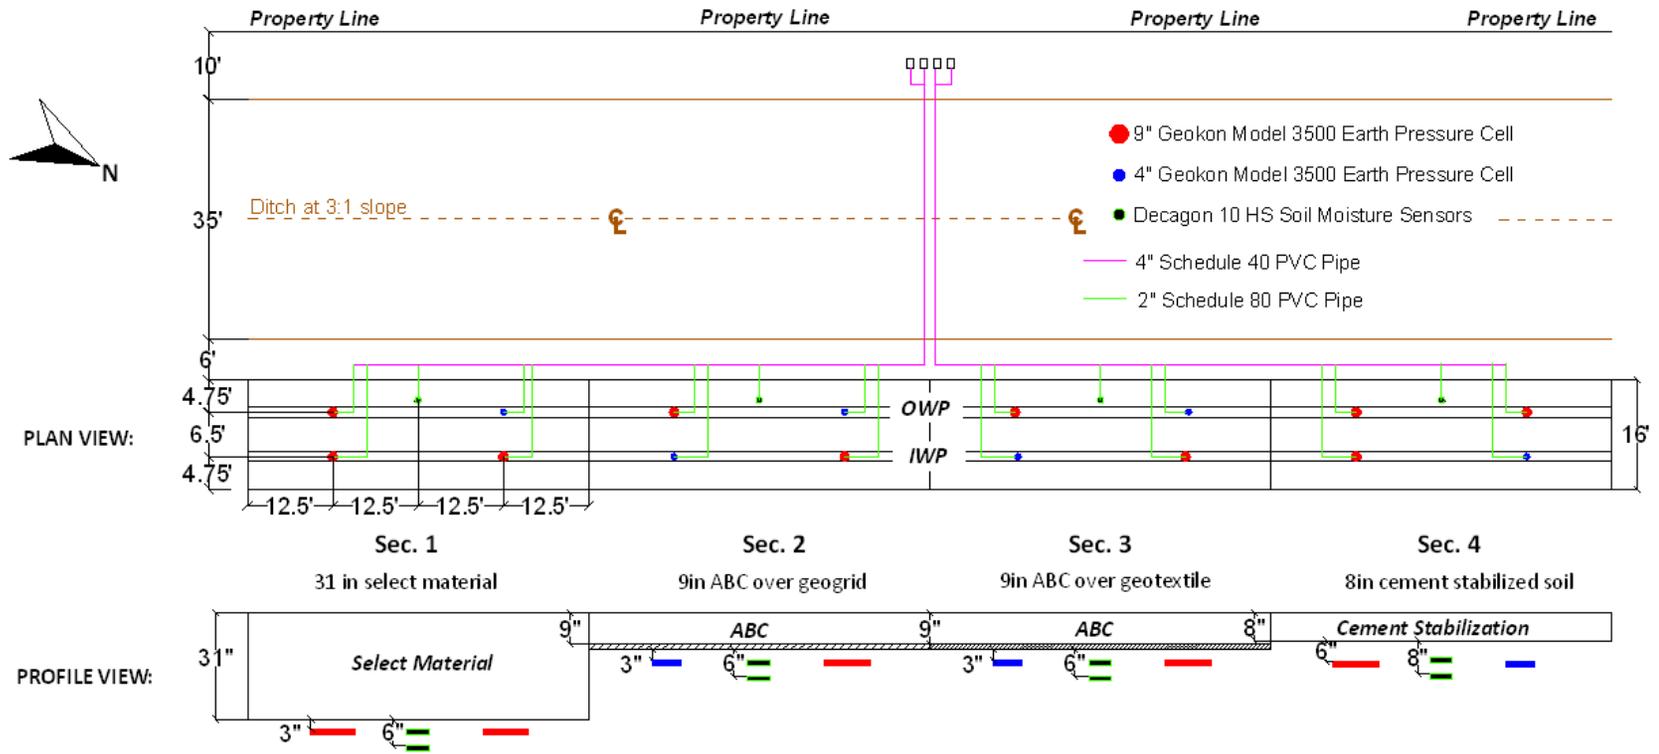
Figure 17: Sensor layout for the full-scale test pad

Before performance testing the reading from EPC #3 (see Appendix B for location in the test pad) became sporadic and was eventually lost. The reason for the loss is unknown but it is believed to be random based on the fact that the 15 other EPCs worked properly throughout the duration of testing.

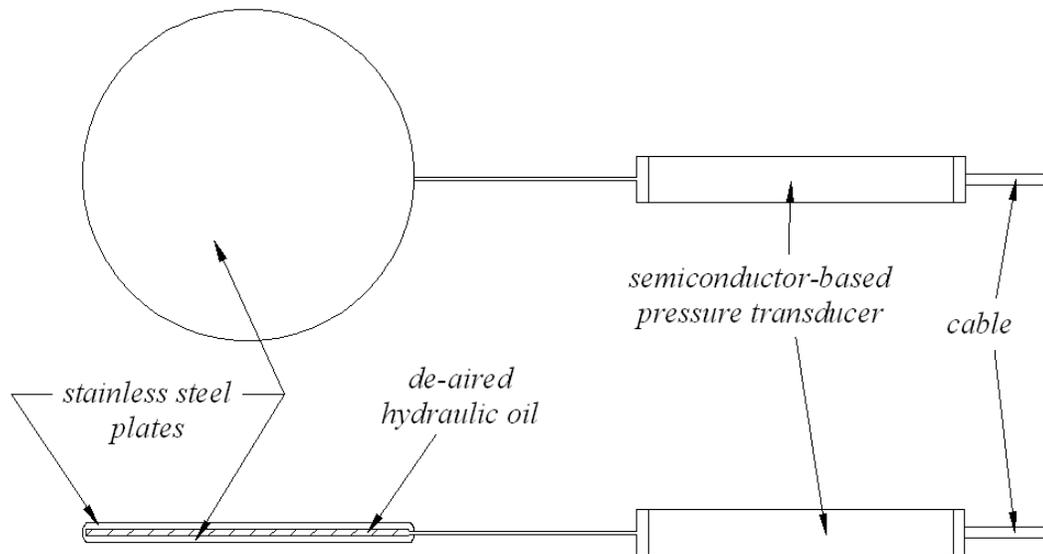
Figure 18: Geokon-Model 3500 Earth Pressure Cells

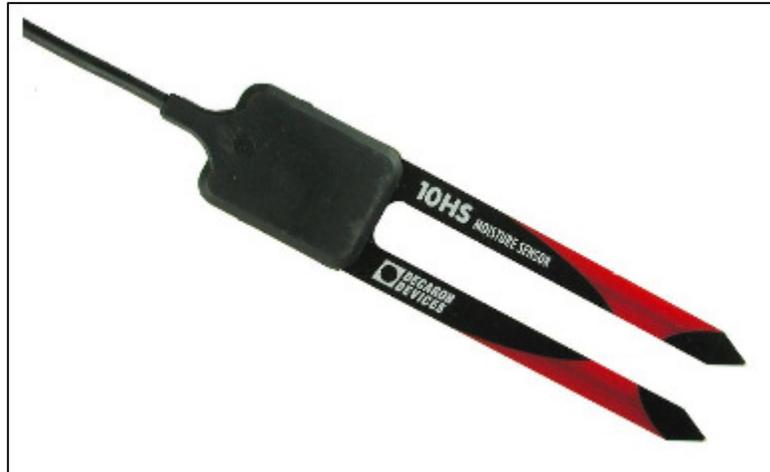
Figure 19: Decagon 10HS Soil Moisture sensor (Decagon Devices, Inc., 2012)

The volumetric water content (VWC) of the subgrade at each test section was measured using two Decagon 10HS Soil Moisture sensors (Figure 19). Each sensor was 10 centimeters long with an 1100 cubic centimeter volume of influence. When the two probes are inserted into a mass of soil the sensor measures the dielectric permittivity of the soil using capacitance/frequency domain technology (Decagon Devices, Inc., 2010). Based on the dielectric permittivity the VWC can be determined using a manufacture provided calibration equation. However, the manufacturer notes that different soils have different soil properties (Cobos & Chambers, 2010). Thus, for the most precise results the manufacturer recommends calibrating the sensors in the lab using the soil specific to the project. Following their recommendation, the sensors were calibrated in the lab using the subgrade soil obtained from the field. A summary of the lab calibration procedure and the results is provided in Appendix D. A detailed discussion of the soil moisture sensor installation is provided later in this chapter.

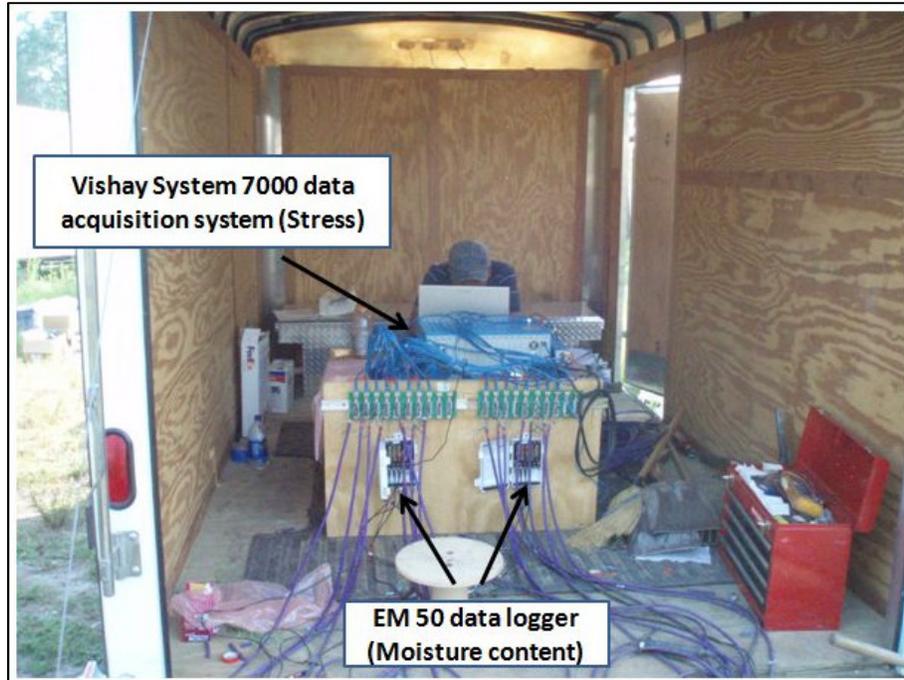
Figure 20: Data acquisition systems used to measure stress and moisture content

The volumetric water content of the subgrade at each test pad was monitored using two EM 50 data loggers. Each data logger was a self-contained unit that provided five ports of which four were used (two ports per test section). During performance testing the soil moisture sensors were set to record the volumetric water content of the subgrade every five minutes. Prior to and after performance testing the number of measurements was scaled back to every two hours. After testing was complete the data were downloaded using a laptop computer with Decagon's ECH₂O Utility software. A picture of the data acquisition systems used at the field site is shown in Figure 20.

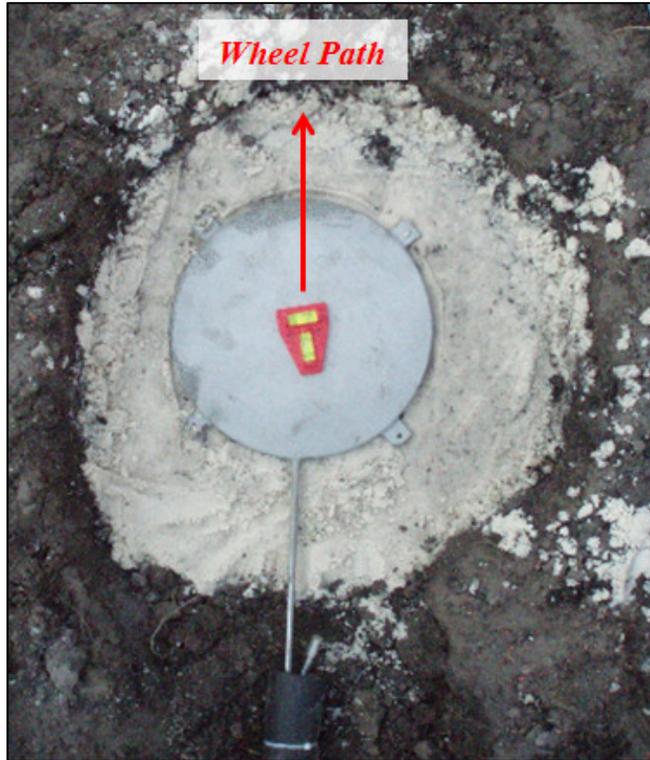
Figure 23: EPC installation in Test Section 1

Once the trenches were completed a hole 15 inches in diameter by 6 inches deep was excavated at the location of each EPC. The center of the hole was aligned directly with the centerline of the wheel path. Inside the hole a three inch thick layer of compacted ASTM fine-graded silica sand was placed and compacted to avoid damaging the EPC from aggregate and roots in the immediate vicinity. Once the sand was in place, the EPCs were positioned parallel to the wheel path and leveled, as shown in Figure 23. After checking each EPC for functionality, an additional two inch layer of sand and one inch layer of subgrade material was hand compacted on top of the EPC to prevent damage from above. After this was completed in Test Section 4, the hole was backfilled using a shovel with the same material that was dug out to install the EPCs. It is important to note that in Test Sections 1, 2, and 3 the EPCs were installed approximately 3 inches below the base/subgrade interface. However, in Section 4 the EPC's were installed approximately 6 inches below the base/subgrade interface to avoid damage from the rotating mixers when constructing the cement-stabilized layer.

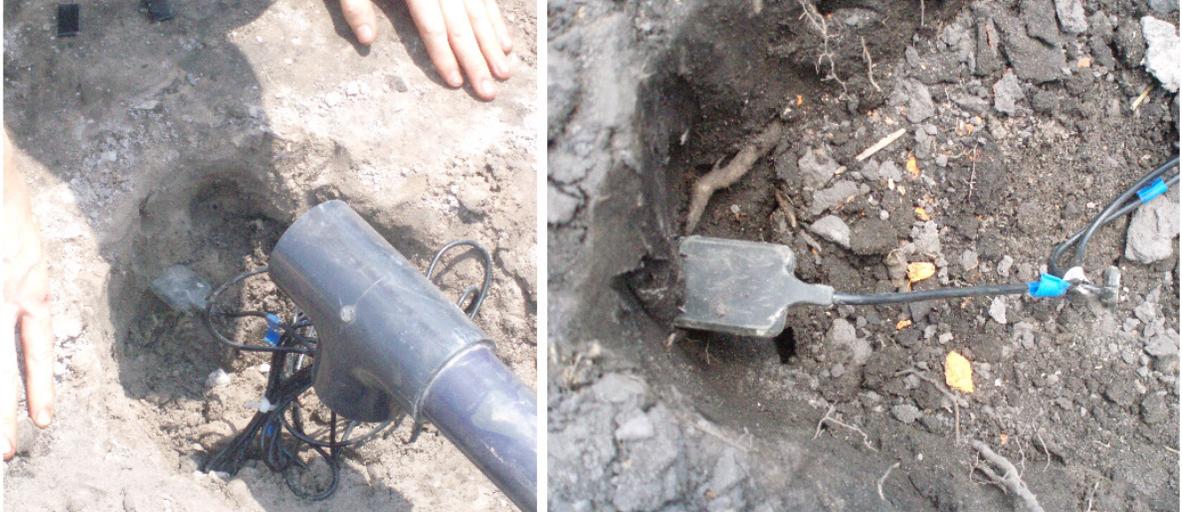
Figure 24: Moisture sensors installed (left) in Test Section 1 and (right) in Test Section 2

Two Decagon 10HS Soil Moisture sensors were installed in the center of each test section near the outer wheel path. To prevent damaging the sensors during installation, a blade slightly thinner than the moisture sensor was pushed into the undisturbed subgrade to create a small opening. After removing the blade the sensor was carefully inserted making sure that the probes were in direct contact with the soil. In Test Sections 1, 2, and 3 the first sensor was installed horizontally into the sidewall of the undisturbed subgrade at a depth of three inches below the undercut elevation. The second sensor was installed vertically into the undisturbed subgrade at a depth of six inches below the undercut elevation. Like the EPCs, the moisture sensors in Test Section 4 were installed six inches horizontally and eight inches vertically below the base/subgrade interface out of precaution from damage during the cement-stabilized layer construction. Shown in Figure 24 is the installation of the soil moisture sensors for Test Sections 1 and 2.

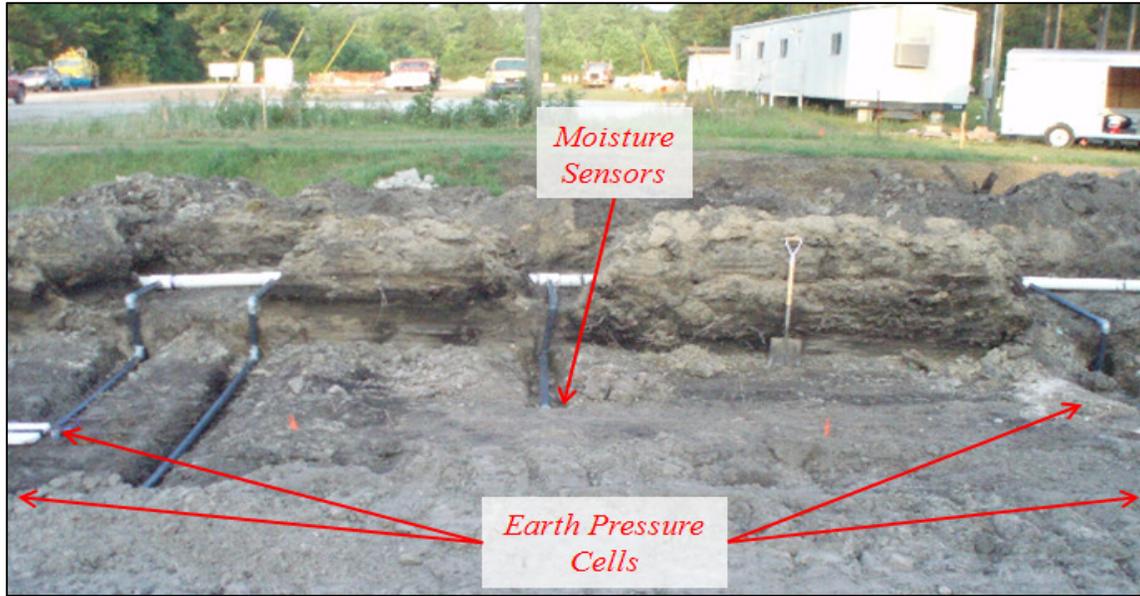
Figure 25: Sensor and PVC installation

To protect the sensor cables located in the roadway each cable was enclosed in a two inch diameter schedule 80 PVC pipe. Once reaching the shoulder the cables were joined together within a four inch diameter schedule 40 PVC pipe that ran parallel to the roadway and to the center of the test area (see Figure 25). At the center of the test area the PVC and enclosed sensor cables were routed across the ditch to allow for safe access away from the road. In addition, four vault boxes were installed on the opposite side of the ditch to provide storage for all sensor cables when not in use. The EM 50 data loggers were also installed in the vault boxes and connected to the soil moisture sensor cables to collect the volumetric water content data.

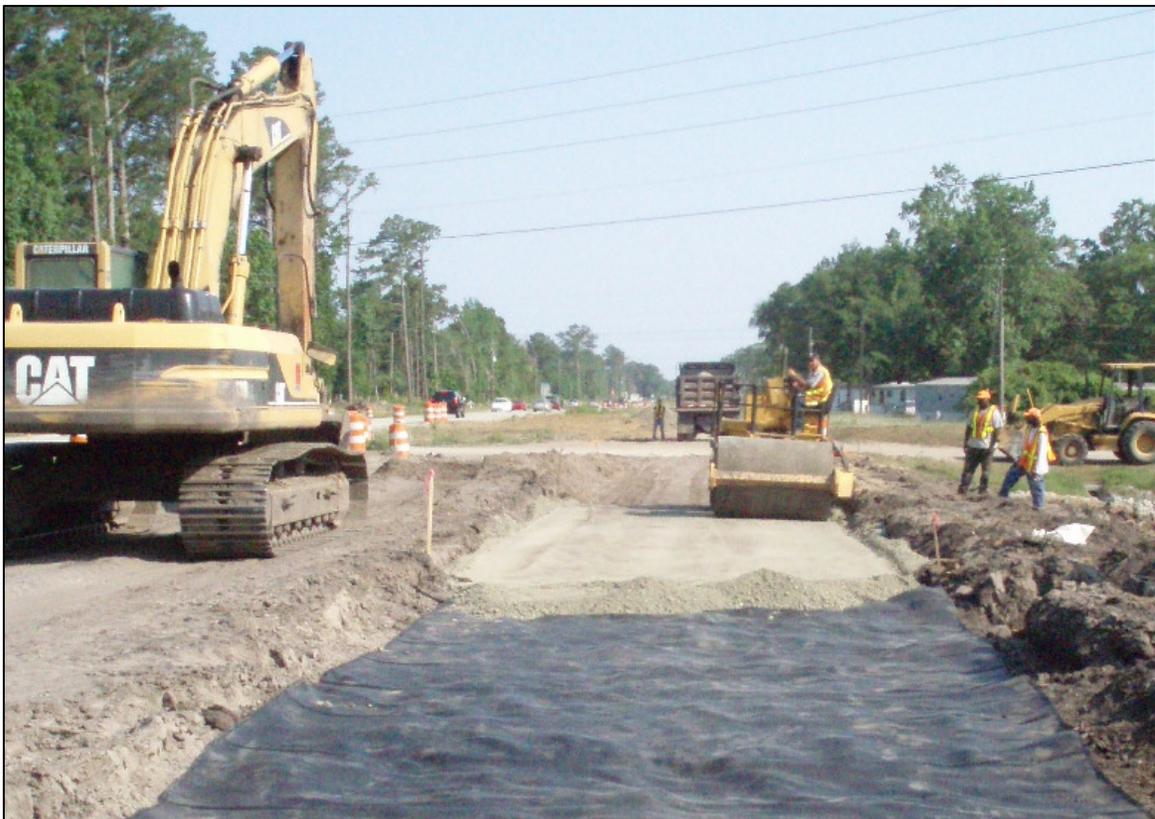
Figure 27: Compacting Test Sections 1 and 2 using a steel drum vibratory roller

vibratory roller progressively moved forward over the test pad to compact the stone and provide a platform for the dump trucks to drive on (see Figure 27). Rather than dumping the backfill material from the side of the test pad, it was recommended by the TenCate™ representative to slowly back the dump trucks over the areas with sufficient cover in order to unload the backfill material onto the exposed geosynthetics (Dull, 2011). This allows the geosynthetics to be pre-tensioned prior to trafficking in order to reduce the amount of initial rutting needed to mobilize their tensile strength. Due to a lack of time at the end of the work week, the test sections were only partially backfilled on May 26, 2011. The remaining backfill was placed on June 8, 2011 under the supervision of the NCDOT inspectors. After the last lift had been placed a series of quality control tests were performed on the each test section. A discussion of these tests is provided later in the chapter.

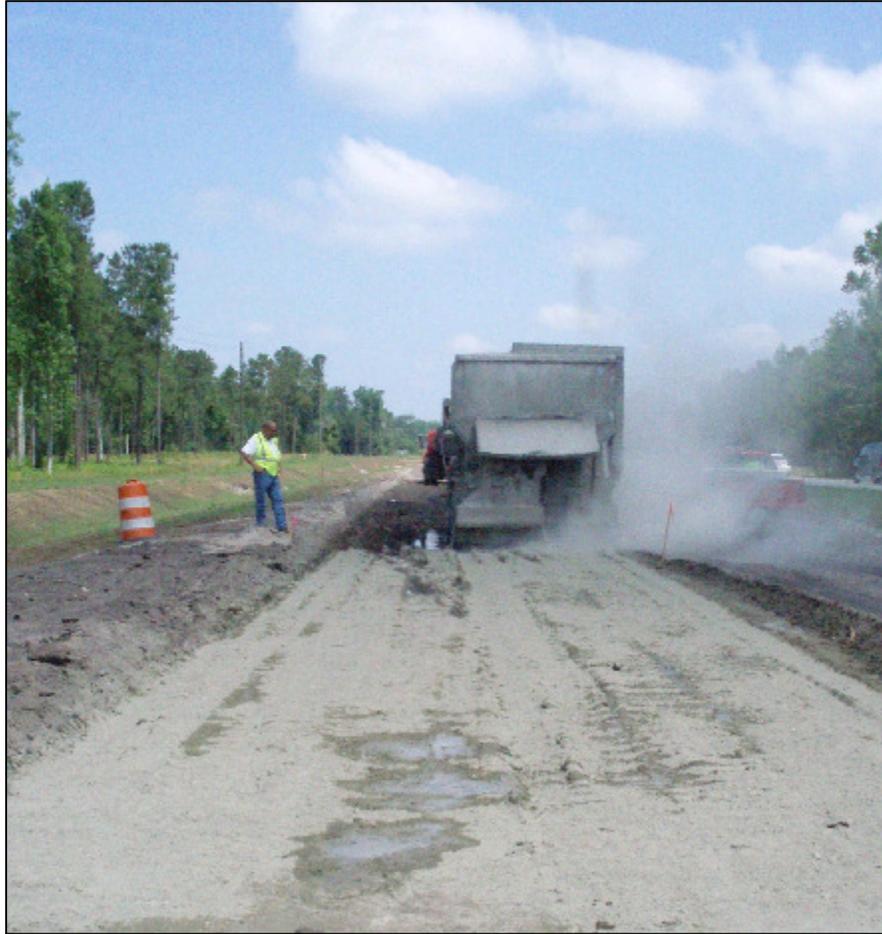
Figure 28: Spreading the cement in Test Section 4

On June 1, 2011 Site-Prep, Inc. of North Carolina constructed Test Section 4 in accordance with Section 542 of the NCDOT *Standard Specifications* (2012). Portland Type I/II cement (ASTM C150) provided by Lehigh Hanson was used to construct the test section. The area was first prepared by grading, leveling, and wetting the subgrade soil. Afterwards, the cement coverage area was marked off based on a 12% cement content or 77 pounds per square yard to a depth of 8 inches. As previously mentioned, this mix design was selected by the NCDOT using the UCS lab results on the cement-subgrade specimens. It is important to note that the dry cement was spread using a tanker truck equipped with a deflector that drops the cement out of the back and onto the ground (see Figure 28). This method of spreading does not allow the operator to adjust the rate of flow. Consequently, the area of the cement coverage must be pre-determined and monitored in conjunction with emptying the truck in order to verify uniformity. Based on a total cement weight in the tanker of approximately 8100 lbs. it was determined that a coverage area of 946.8 square feet was required to provide a cement content of 12% within the top 8 inches of subgrade soil. Since the test section was 16 feet wide, the cement was spread over 59.2 linear feet of roadway starting at the interface of Test Section 3 and 4 (Station 122+50) and ending 9.2 feet past the designated end of Test Section 4 (Station 123+9.2). In order to spread the cement evenly throughout the test section the operator made two consecutive passes with the first pass running alongside the shoulder of the roadway and the second pass running adjacent to the centerline of the roadway.

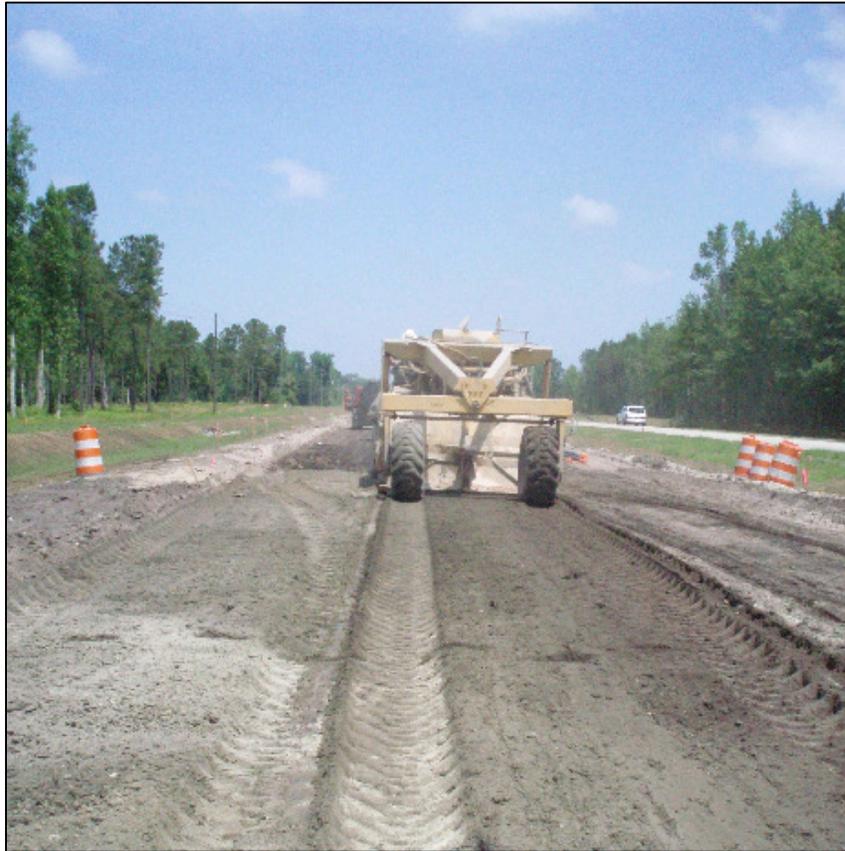
Figure 29: The soil stabilizer mixing the cement into the top 8 inches of subgrade soil

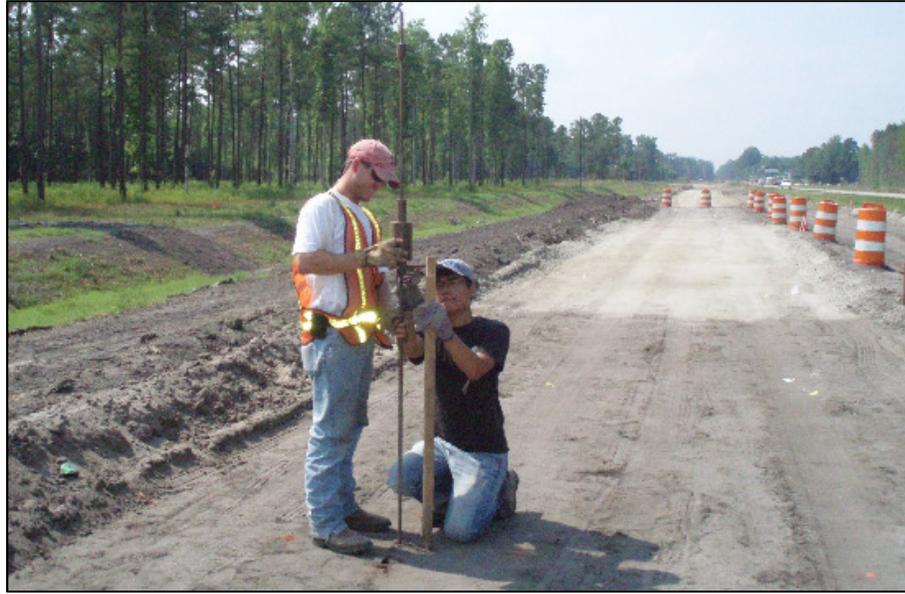
Figure 31: DCP testing prior to performance testing

The DCP is used by lifting and releasing a hammer from a standard drop height onto an anvil which drives a cone tipped rod into the ground. Prior to beginning the test a wooden stake is positioned next to the DCP and a mark is made where the stake crosses the DCPs horizontal handle. After each drop of the hammer another mark is made on the wooden stake using the same horizontal handle as the point of reference. After the test is completed the distance between marks can be measured to determine the distance of penetration per blow (mm/blow) or DCP Index (DCPI). Testing was performed according to ASTM D6951 using a hammer weight of 8 kg (17.6 lbs.), a drop height of 576 mm (22.6 inches), a drive rod with a diameter of 16 mm (5/8 inch), and a cone tip angle of 60 degrees. A typical test is shown in Figure 31.

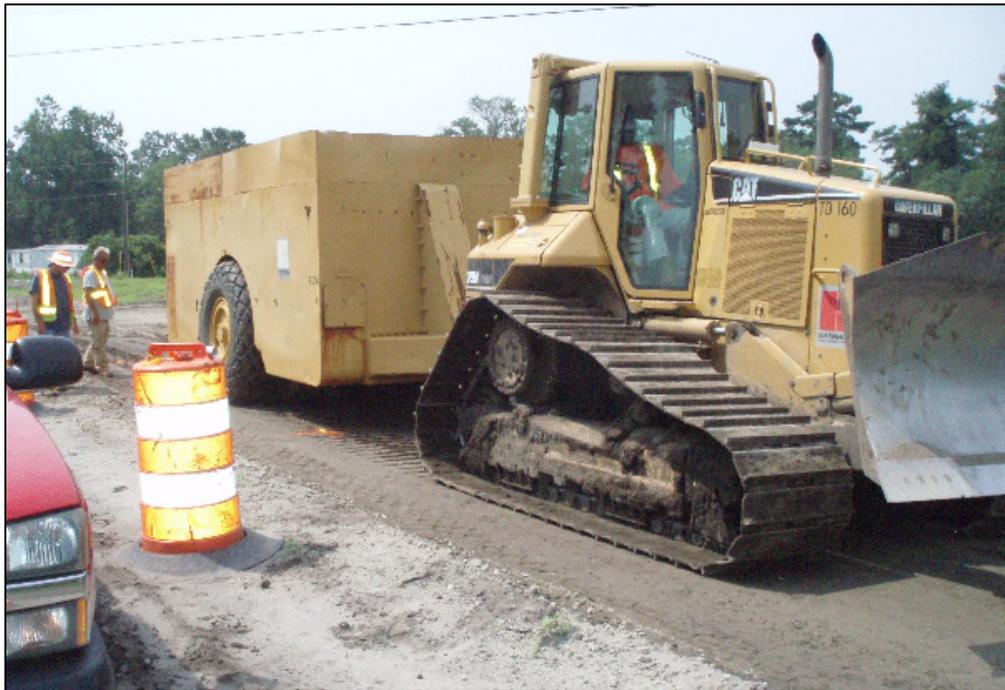
Figure 35: Proof rolling performed with 35 ton proof roller

After performance testing was completed, each section was leveled and lightly re-compacted, under the guidance of the NCDOT, with approximately one to two passes using a vibratory steel drum roller (Simmons, 2011). A month later on August 4, 2011 proof rolling was performed on the repaired test sections in accordance with Section 260 of the NCDOT *Standard Specifications* (2012). A bulldozer pulling a loaded single axle, four wheeled proof roll trailer conforming to the NCDOT specifications was used to perform two proof rolling tests at gross loaded weights of approximately 35 and 50 tons, respectively (see Figure 35). For each gross loaded weight the proof roll trailer was towed twice, once in each direction, in the wheel paths at a speed of approximately 1 to 2.5 miles per hour. As the tires traveled over each section, two NCDOT inspectors visually monitored each wheel path for signs of recovered (pumping) and permanent (rutting) deformation. A profile survey was performed prior to proof-rolling, after the 35 ton proof roll, and after the 50 ton proof-roll.

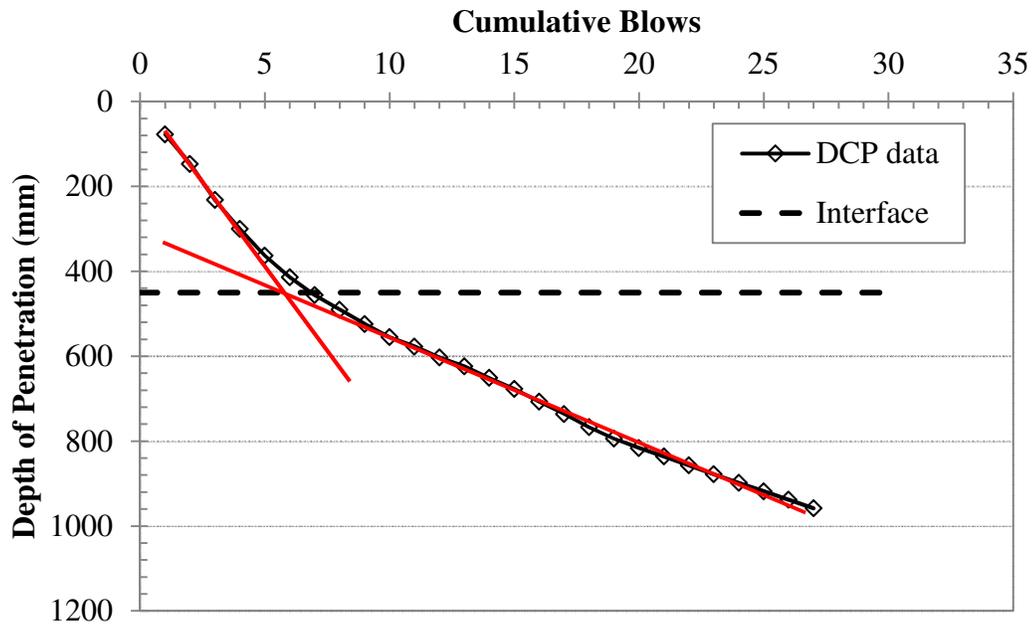
Figure 36: An illustration of how the interface of adjacent soil layers was defined

station 121+50 prior to undercutting. Based on the results, there is a layer interface located at approximately 450 mm (18 inches) below the ground surface.

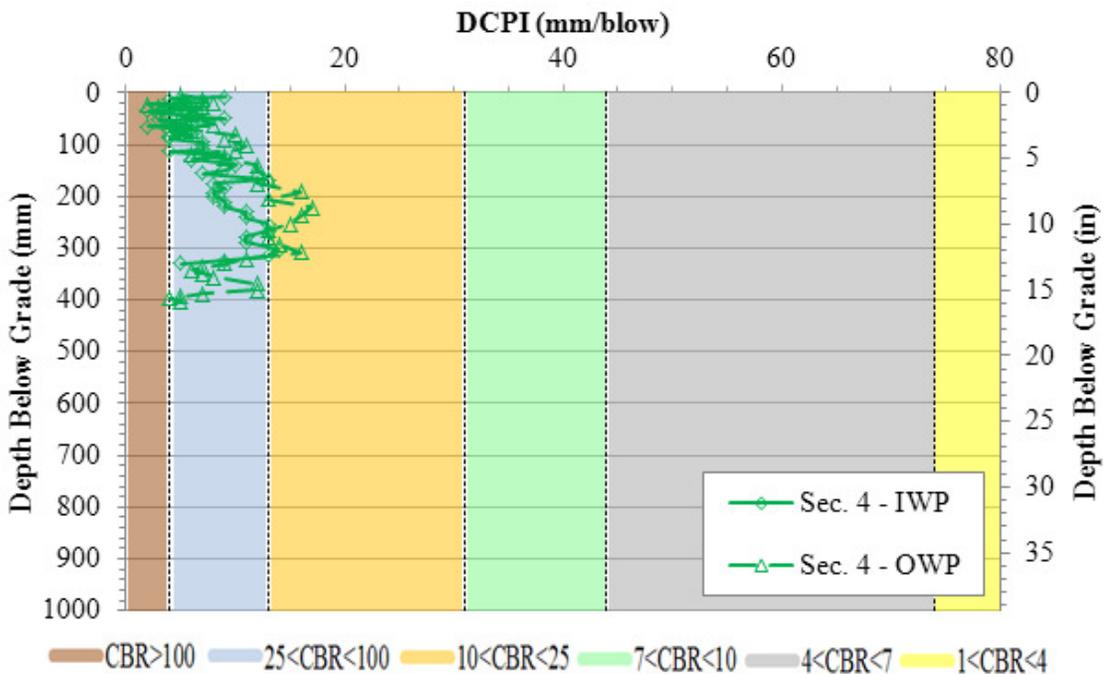
Figure 48: DCP results for tests performed in Section 4 prior to performance testing

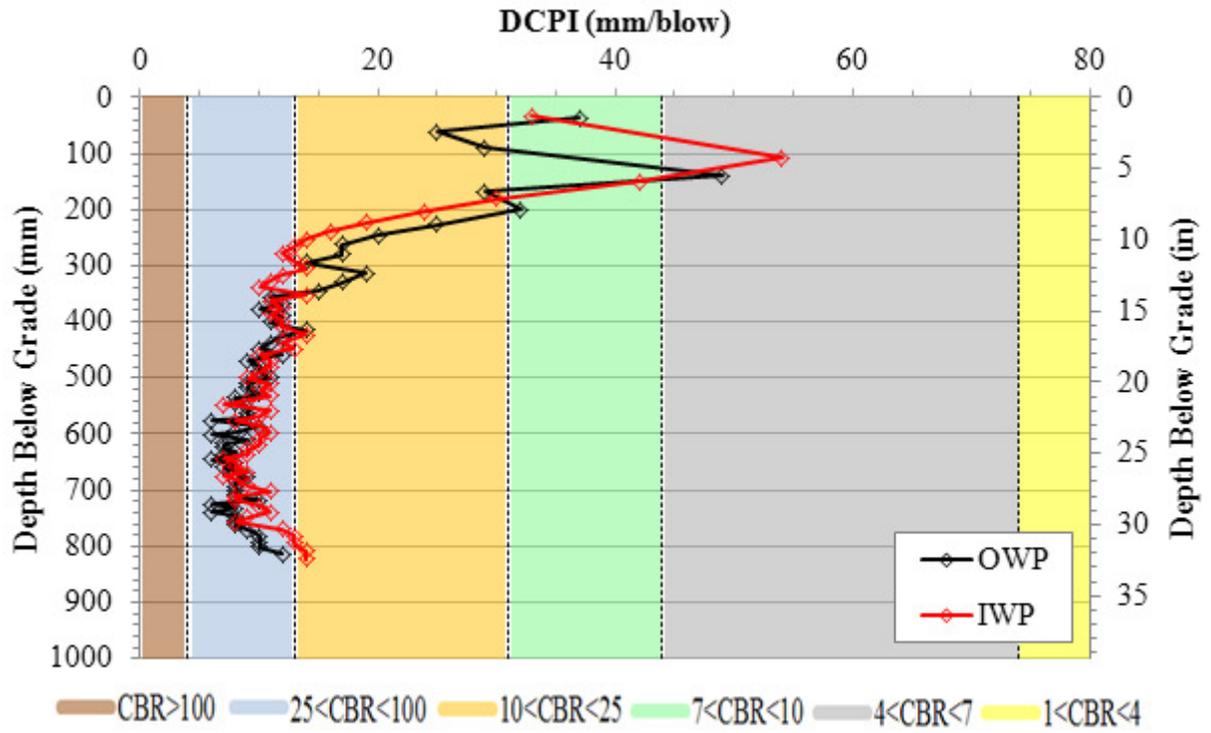
Figure 49: DCP results for tests performed in Section 1 after repair

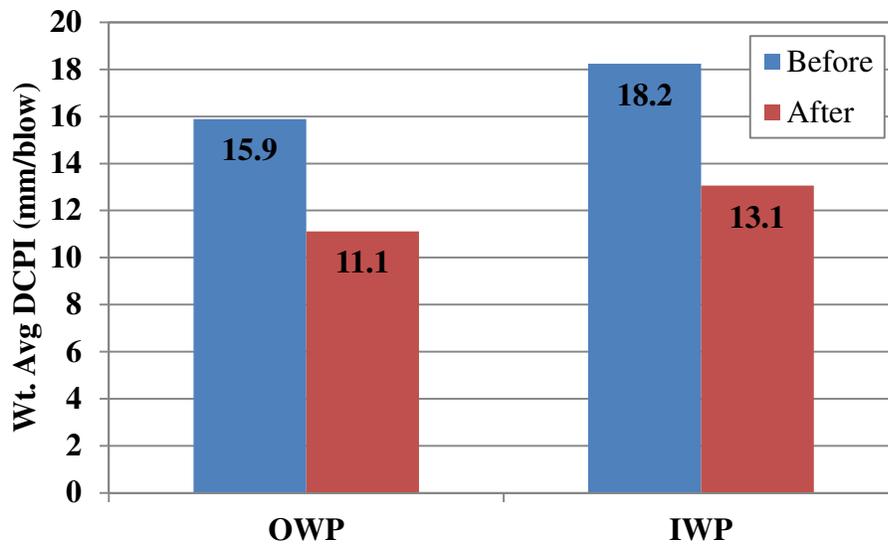
Figure 55: Weighted average DCPI in Section 1 before and after performance testing

To evaluate the change in the stiffness of each section due to repeated truck loading, weighted average DCPI values for tests performed in the center of the wheel paths for each test section are presented in Figure 55 through Figure 58. Generally, a decrease in DCPI (increase in stiffness) is observed in Test Sections 1, 2, and 3 presumably due to the densification of the base layer material during performance testing. In addition, the mobilization of the geosynthetic tensile strength within Test Sections 2 and 3 may have also contributed to the increase in stiffness; however, this cannot be validated due to the absence of an unreinforced ABC section. One exception is at the inner wheel path of Test Section 3. A possible explanation for the softening behavior may be due to geotextile damage possibly during construction (i.e. backfilling and compaction) or during truck loading. A softer subgrade may also be the culprit; however, DCPI tests performed after undercutting did not indicate any major difference in strength in that area of the subgrade versus elsewhere in the test pad.

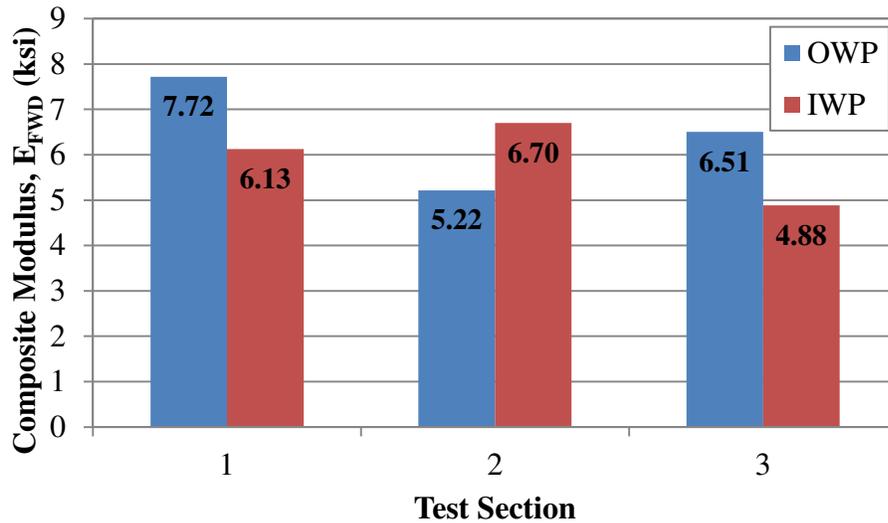
Figure 59: Composite modulus based on FWD tests performed prior to performance testing

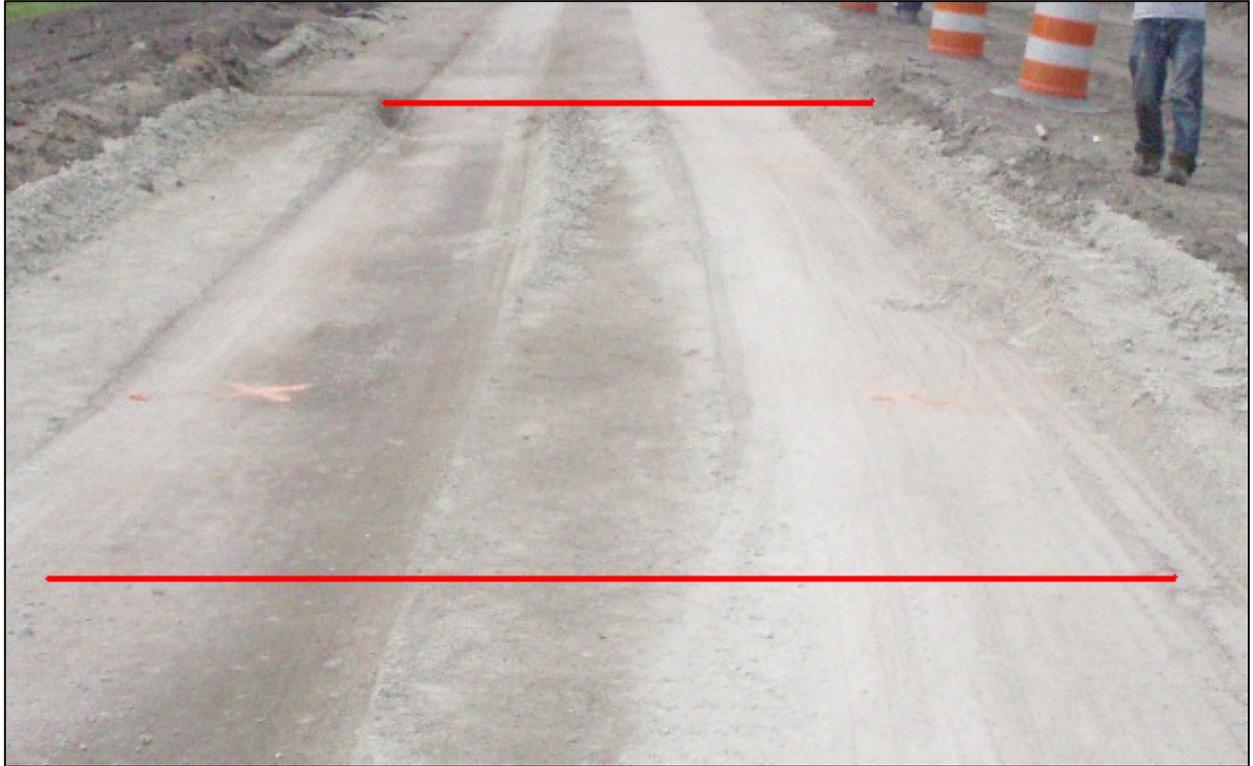
Figure 74: Test Section 1 after 1000 truck passes

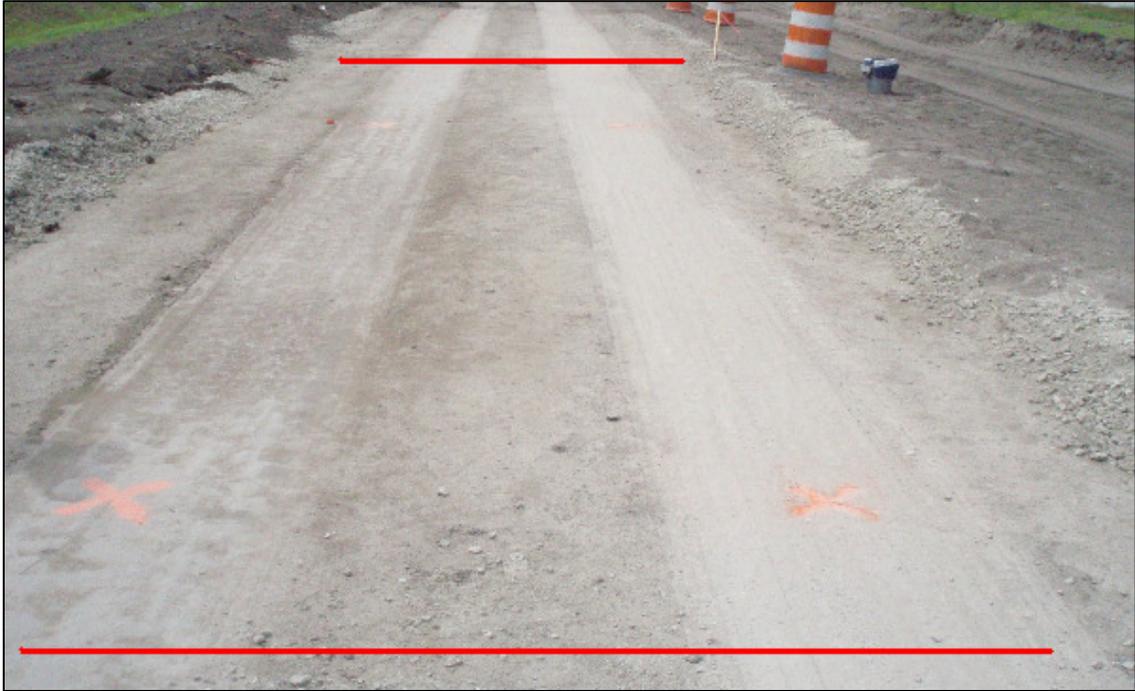
Figure 75: Test Section 2 after 1000 truck passes

In terms of rutting, Test Sections 2 and 3 performed significantly better than the other two test sections. Shown in Figure 75 and Figure 76 is an image of Test Sections 2 and 3 after 1000 truck passes. With the exception of periodic wetting for dust control (which was also needed everywhere else at the field site) neither geosynthetically reinforced section required any maintenance or repair during the truck trafficking period. In terms of visible deterioration, alligator cracking, shown Figure 77, became prevalent throughout both sections after approximately 100 truck passes. A considerable amount of rutting did develop at the interface of adjacent test sections (Stations 121+50, 122+00, and 122+50); however, these areas were neglected from the analysis due to the overlapping stabilization measures.
