Field Implementation and Comparative Performance Assessment of
Undercut Stabilization Measures

by
Timothy David Cowell

A thesis submitted to the Graduate Faculty of
North Carolina State University
in partial fulfillment of the
requirements for the degree of
Master of Science

Civil Engineering

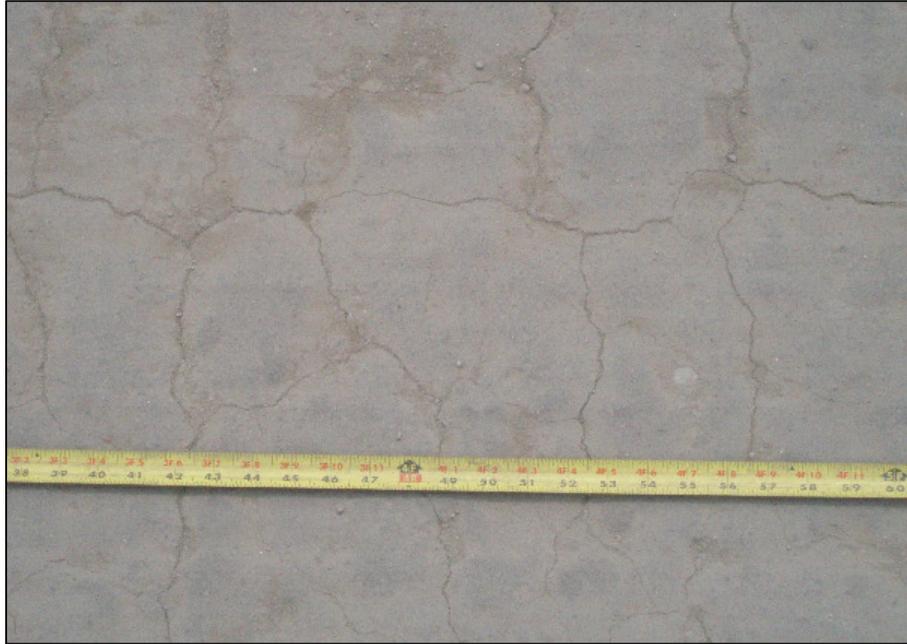
Figure 77: Image of the OWP in Test Section 3 after 1000 passes. Note the alligator cracking which was prevalent in Test Sections 2 and 3.

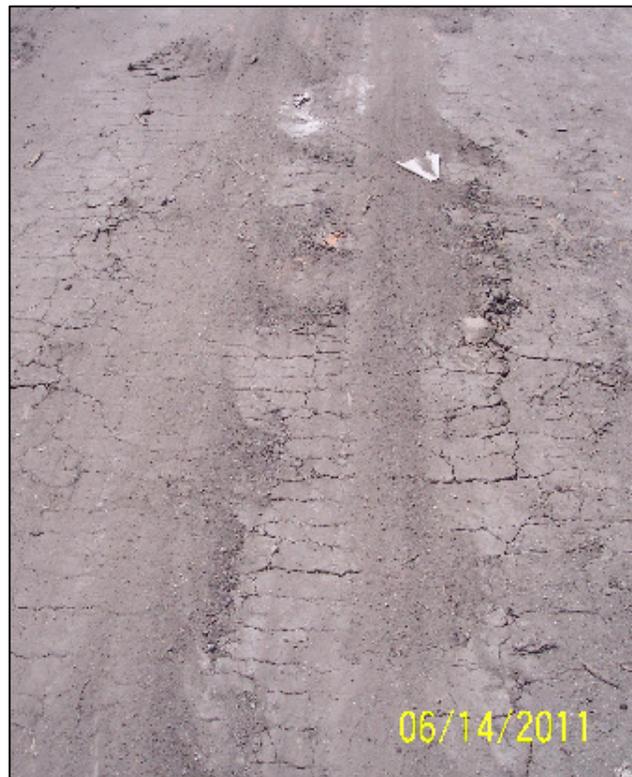
Figure 78: Cracks developing along the IWP in Test Section 4 after 10 truck passes

addition, a significant amount of rutting also occurred at the first EPC along the outer wheel path (OWP) of Test Section 4. The rut depth for this area, however, did not reach the same magnitude as measured in the other area of the test section and the complete 1000 passes were able to be conducted without any repair. An image of Test Section 4 after 1000 truck passes is shown in Figure 79.

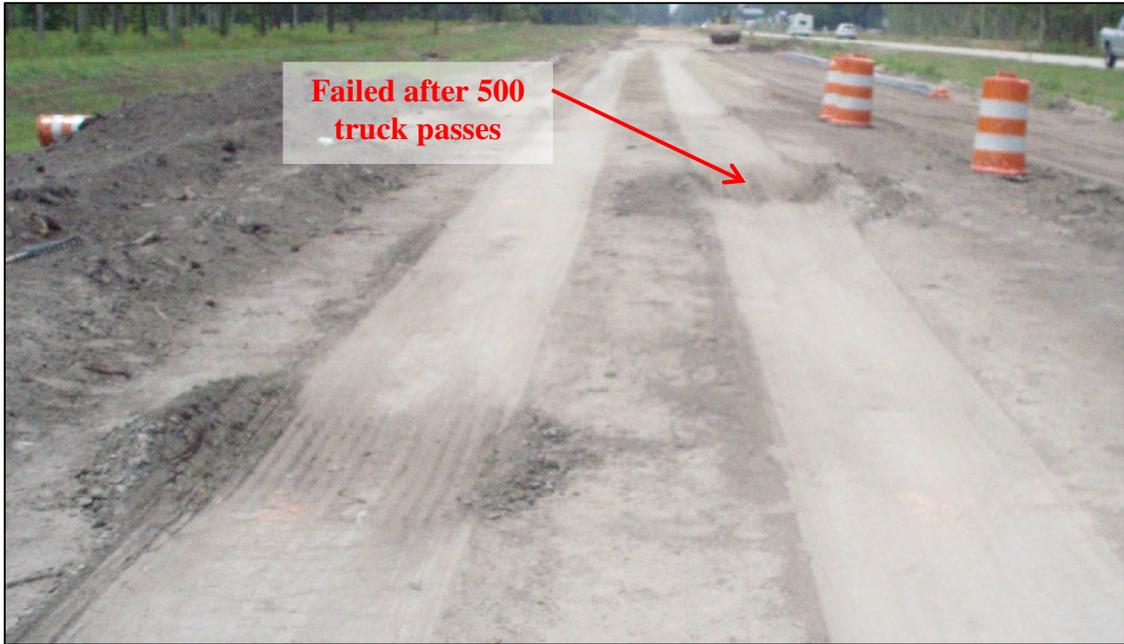
Figure 79: Test Section 4 after 1000 truck passes

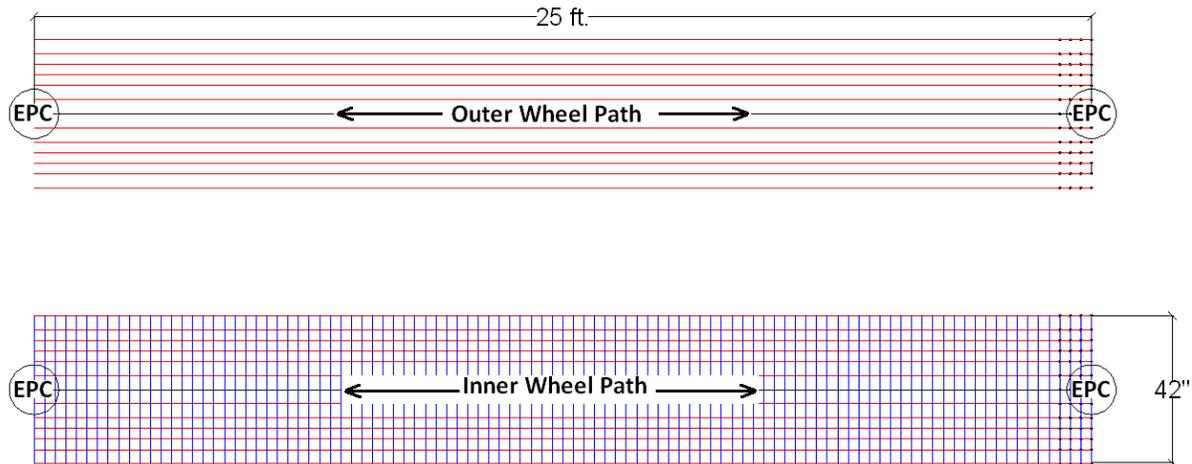
Figure 80: An illustration of the alignment (red lines) and stationing (blue lines) used to capture the elevation from the LIDAR data

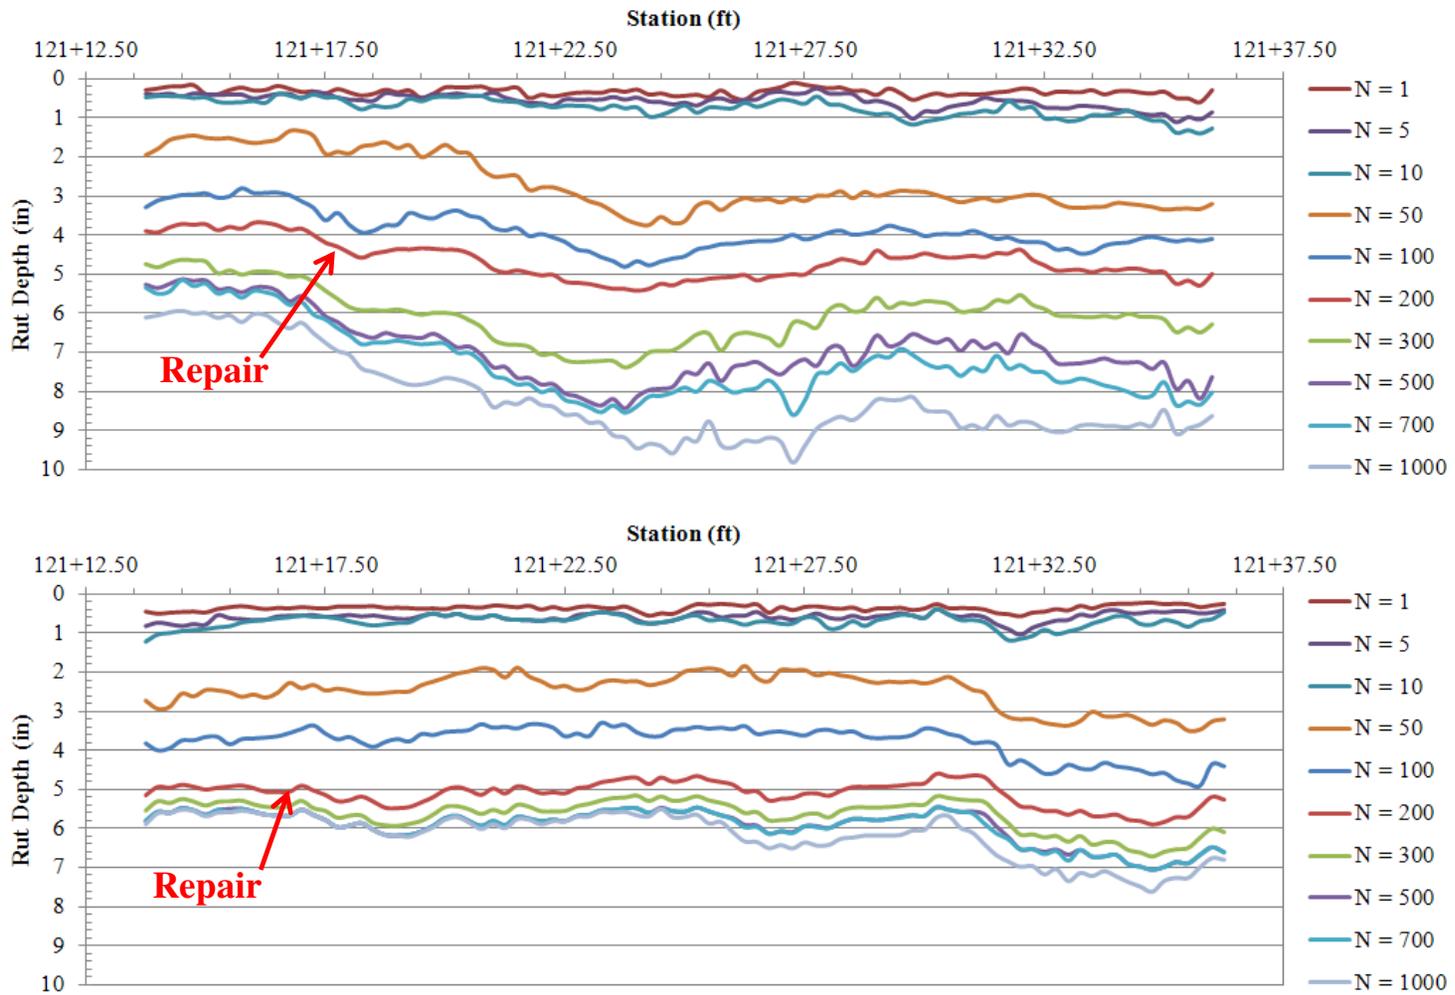
Figure 82: Permanent deformation along the IWP (top) and OWP (bottom) in Test Section 1

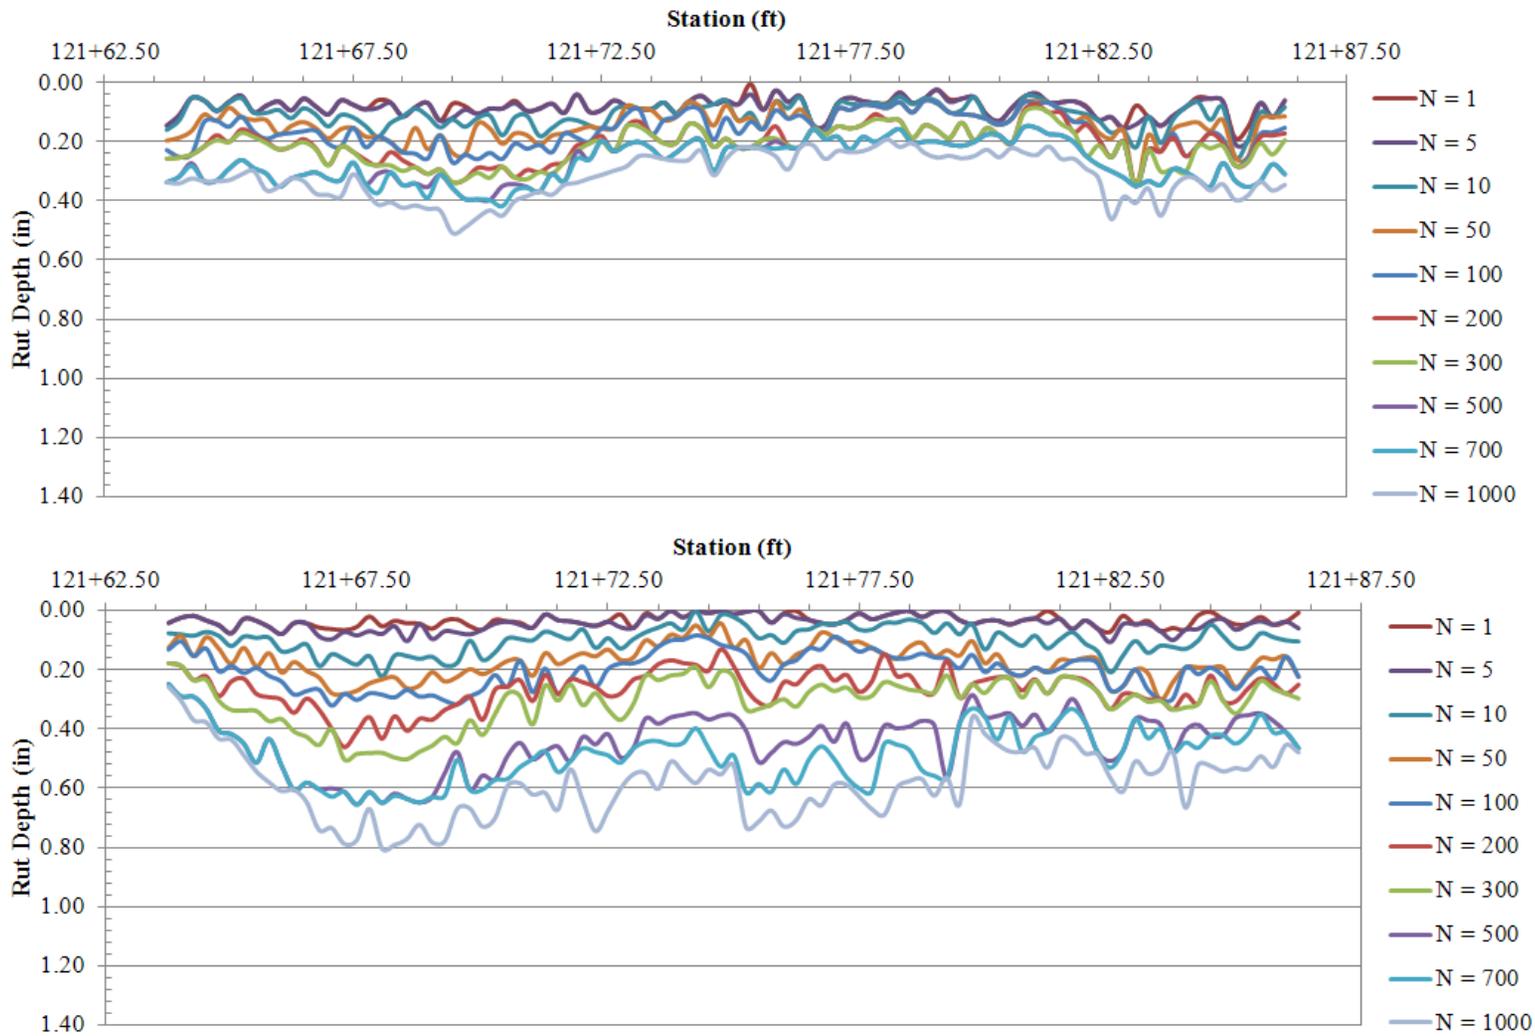
Figure 83: Permanent deformation along the IWP (top) and OWP (bottom) in Test Section 2

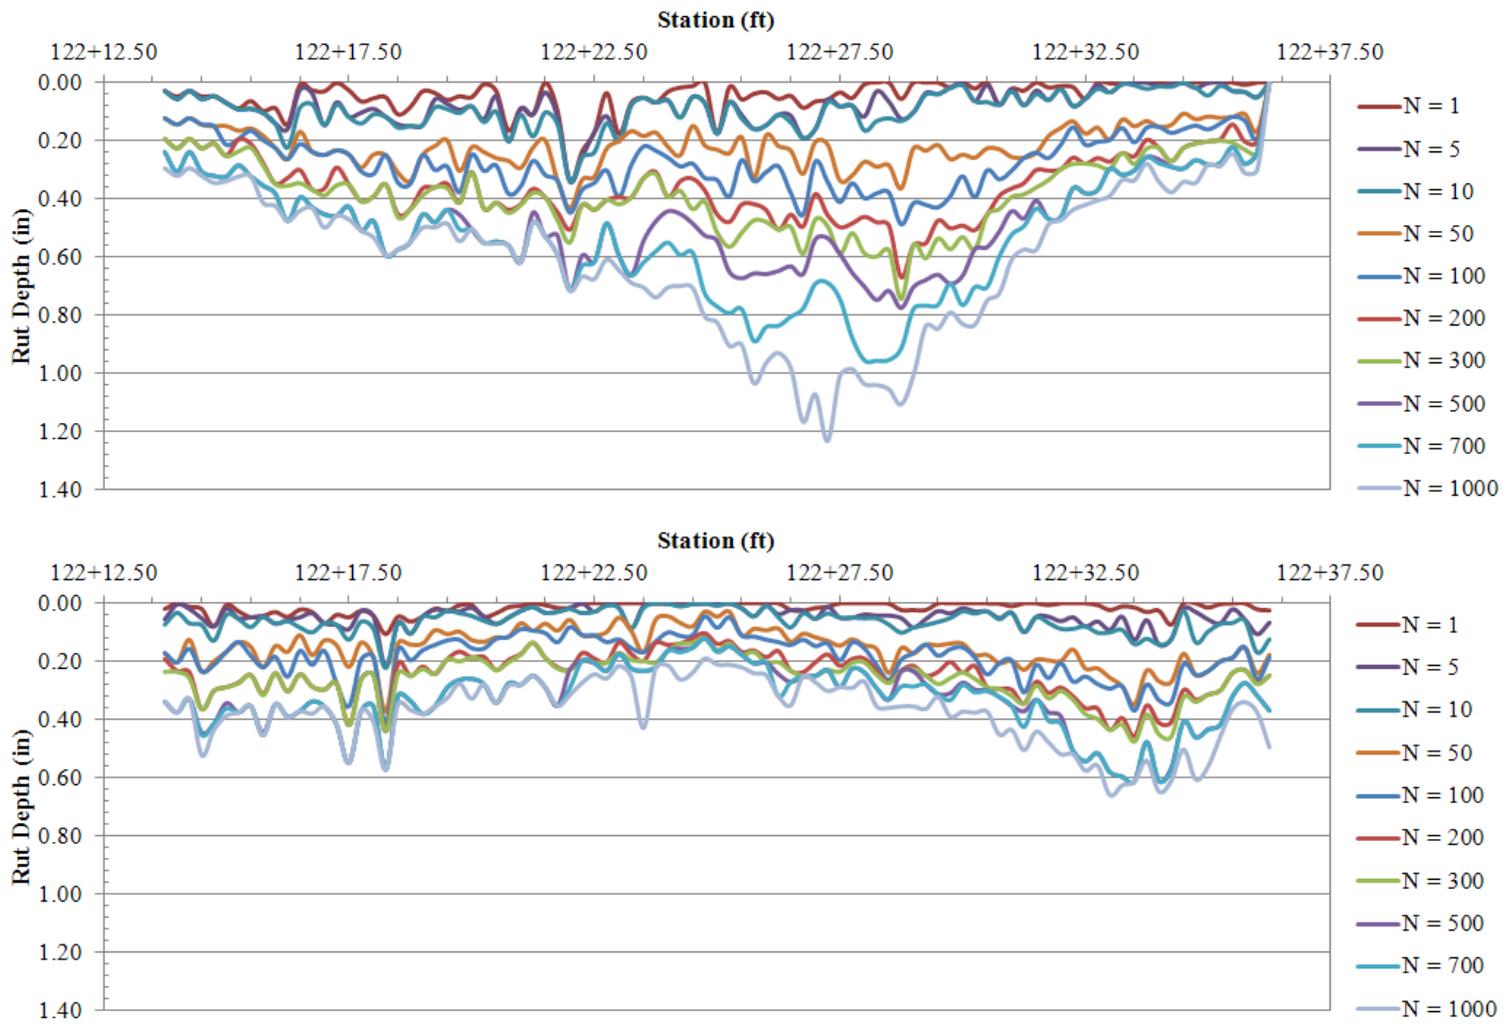
Figure 84: Permanent deformation along the IWP (top) and OWP (bottom) in Test Section 3

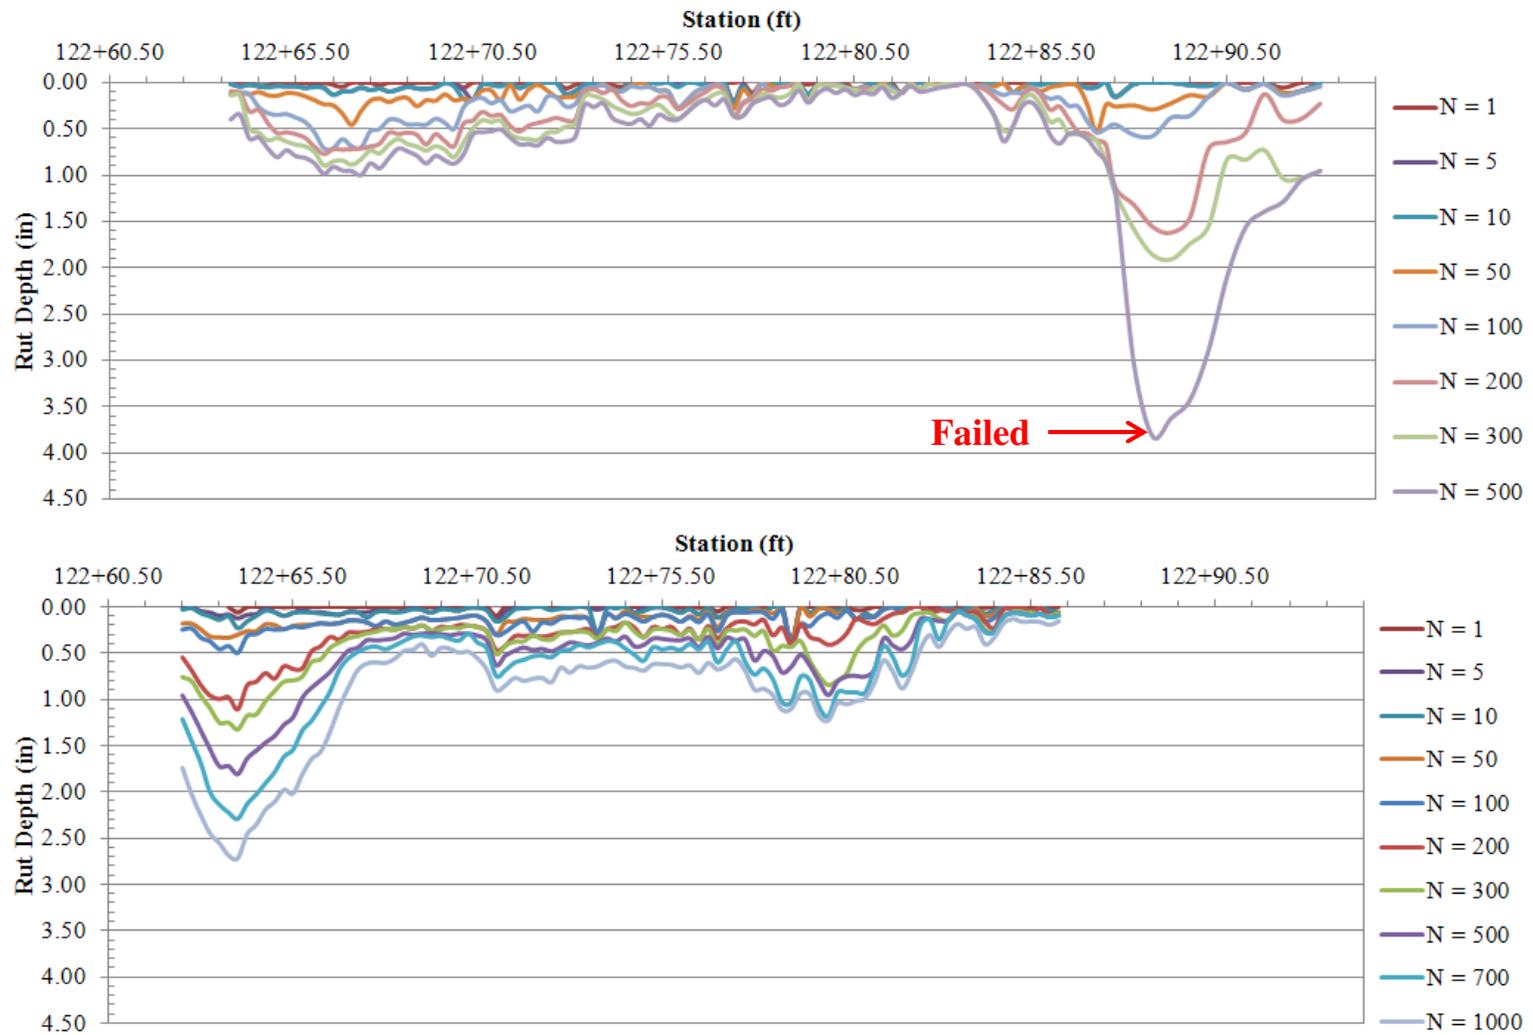
Figure 85: Permanent deformation along the IWP (top) and OWP (bottom) in Test Section 4

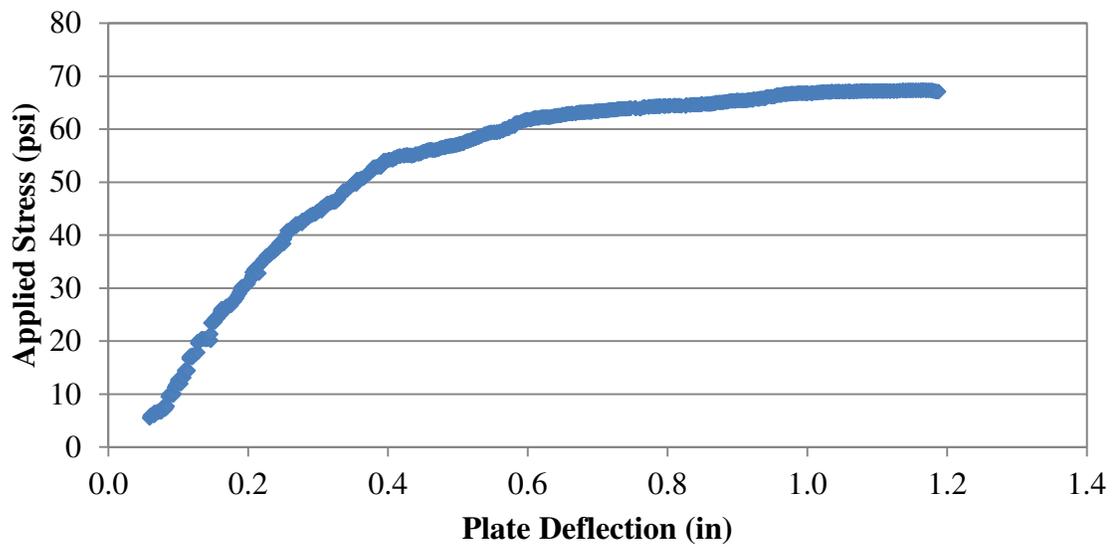
Figure 87: Plate load results performed using a 4 inch diameter plate in Test Section 4

constructing the section in the field based on an average lab UCS of 137 psi. However, during plate load testing the base layer begins to reach an asymptotic value of approximately 70 psi, indicating that soil-cement has reached its performance capacity well below what should be expected based on lab results. Although this observation is limited to the area around the plate load test location, it does facilitate the inclination that other areas in Test Section 4 were more than likely much weaker than expected.

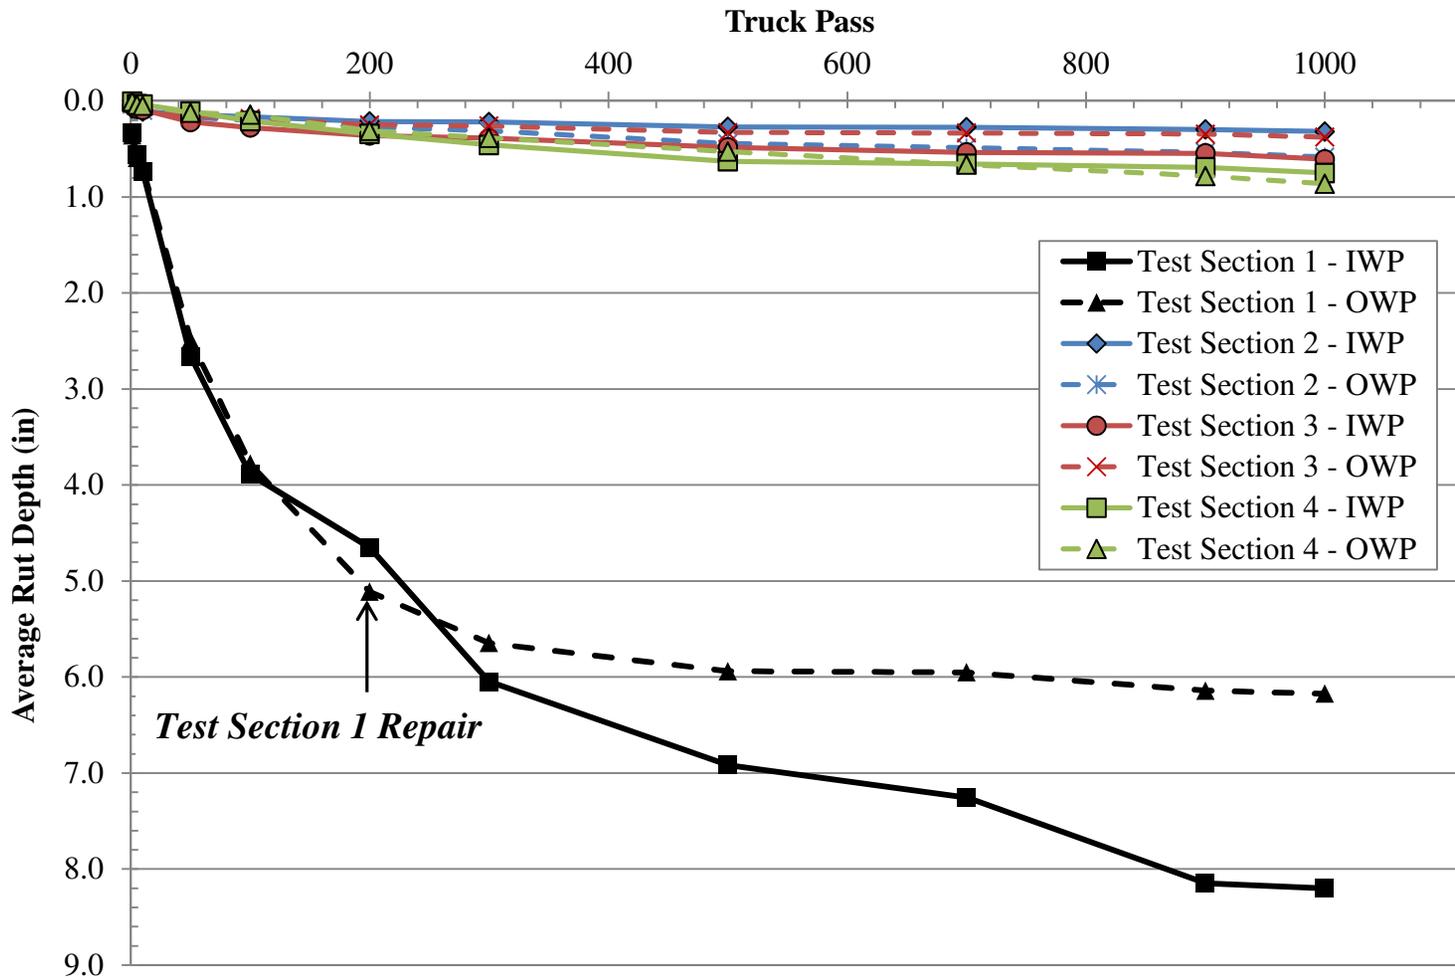
Figure 88: Average rut depth versus number of truck passes for all test sections

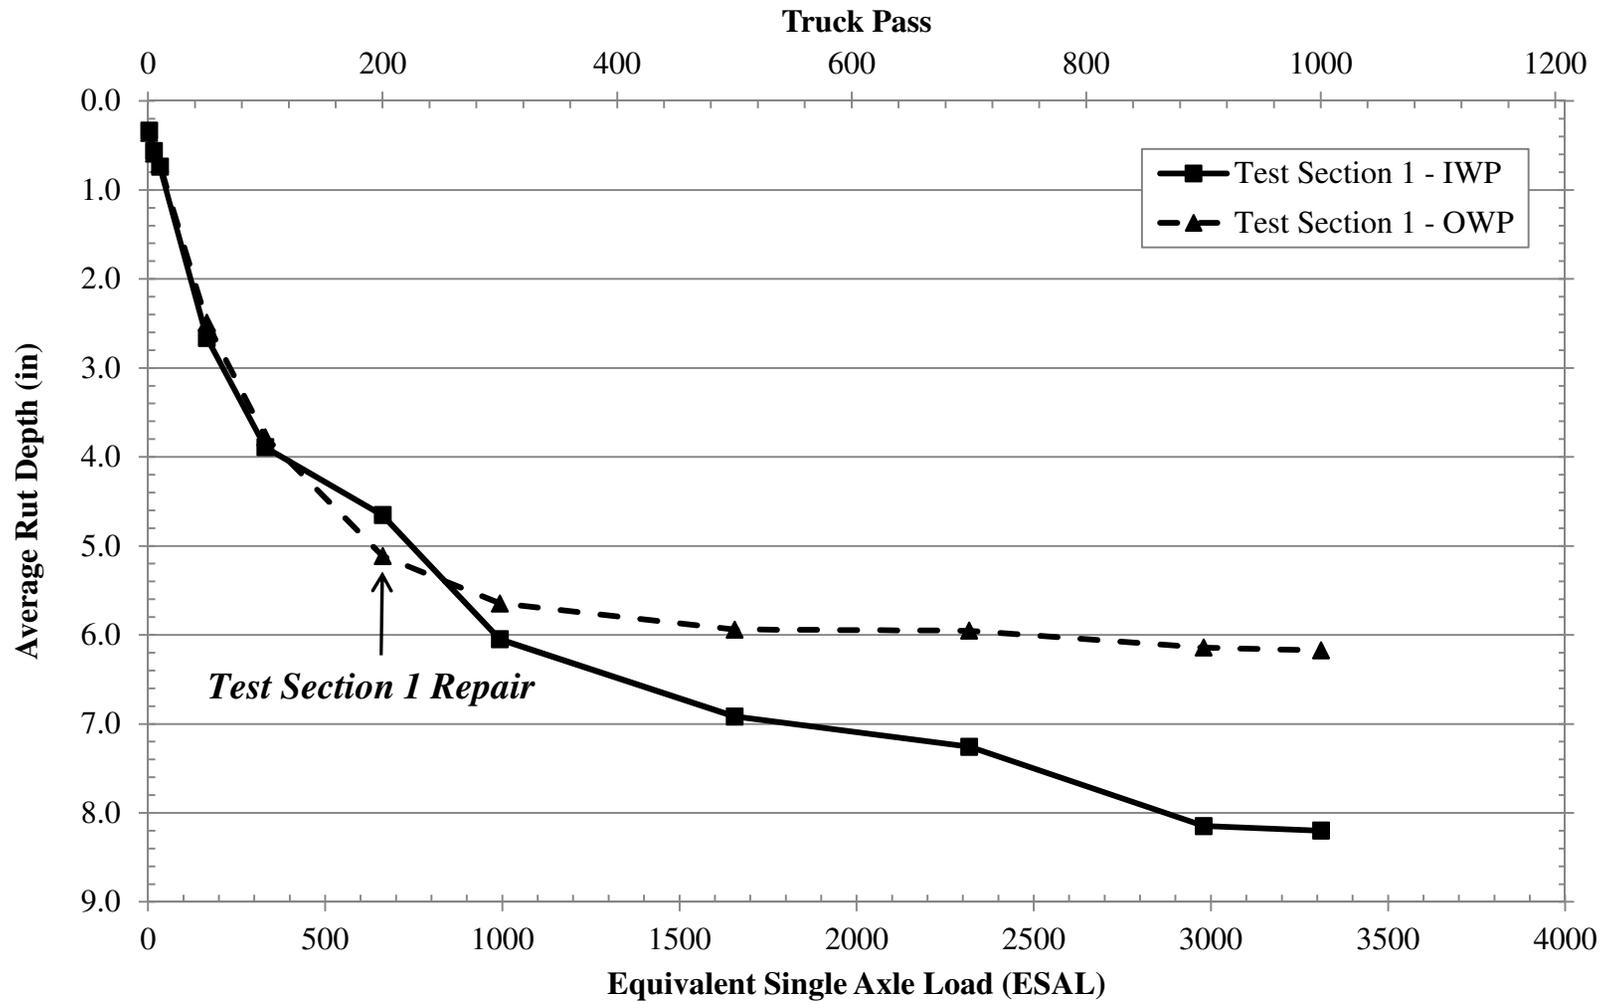
Figure 89: Average rut depth versus number of truck passes and ESAL for Test Section 1

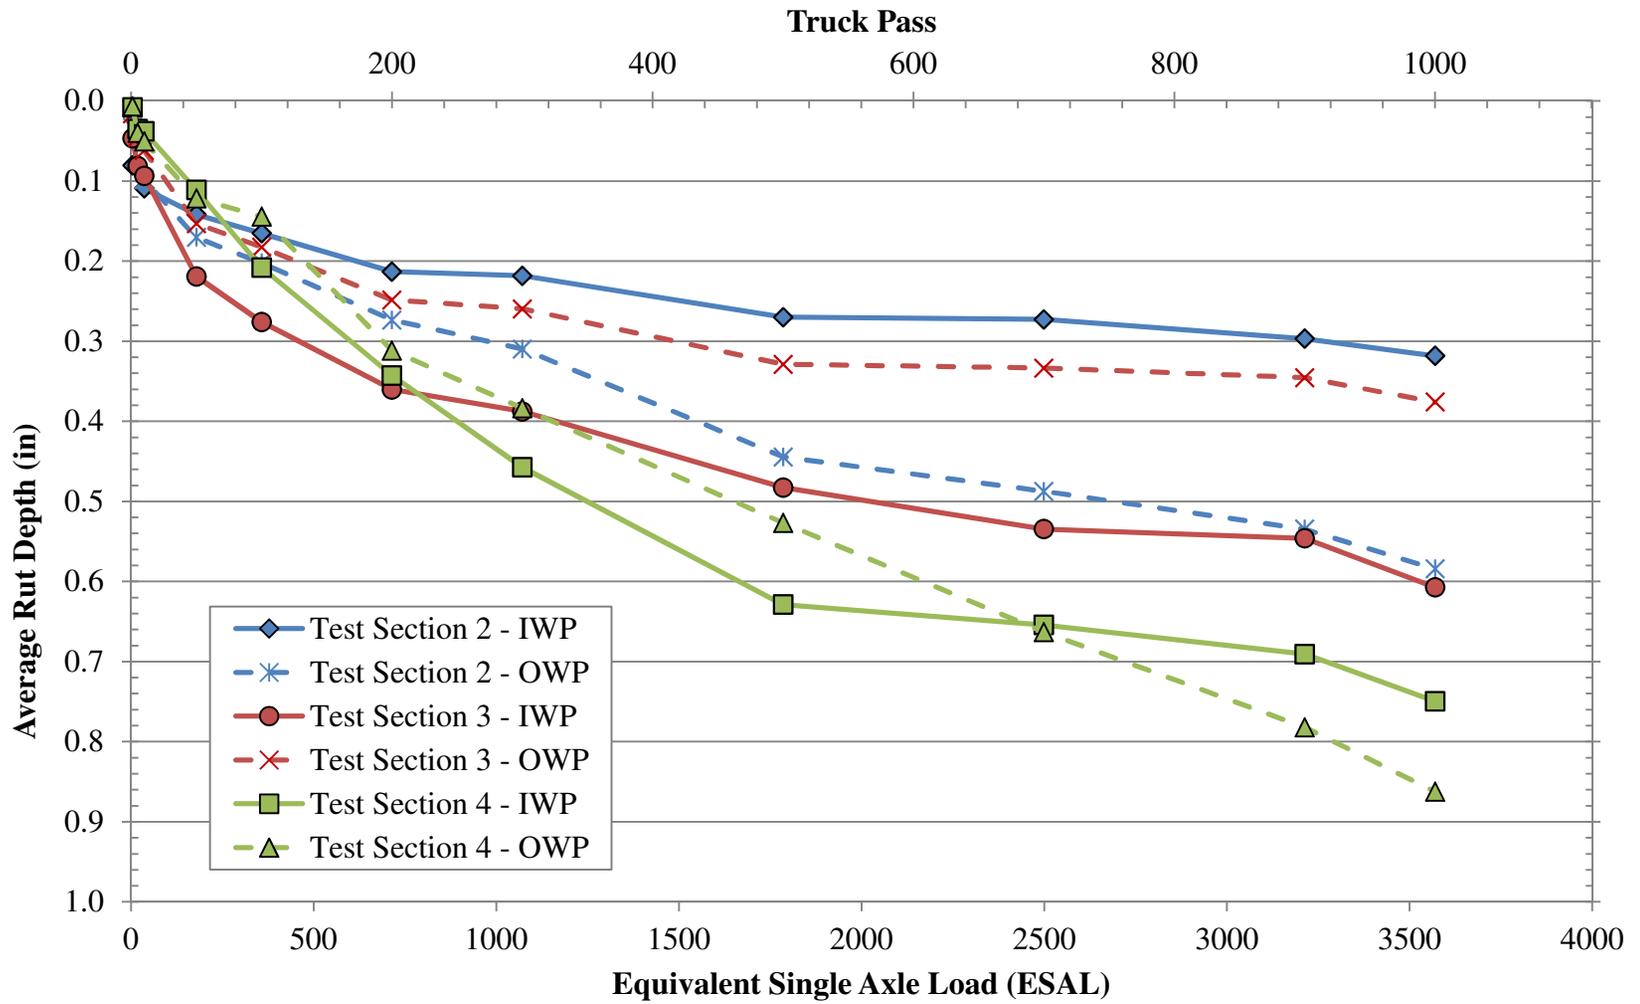
Figure 90: Average rut depth versus number of truck passes and ESAL for Test Sections 2, 3, and 4 (note the change in scale)

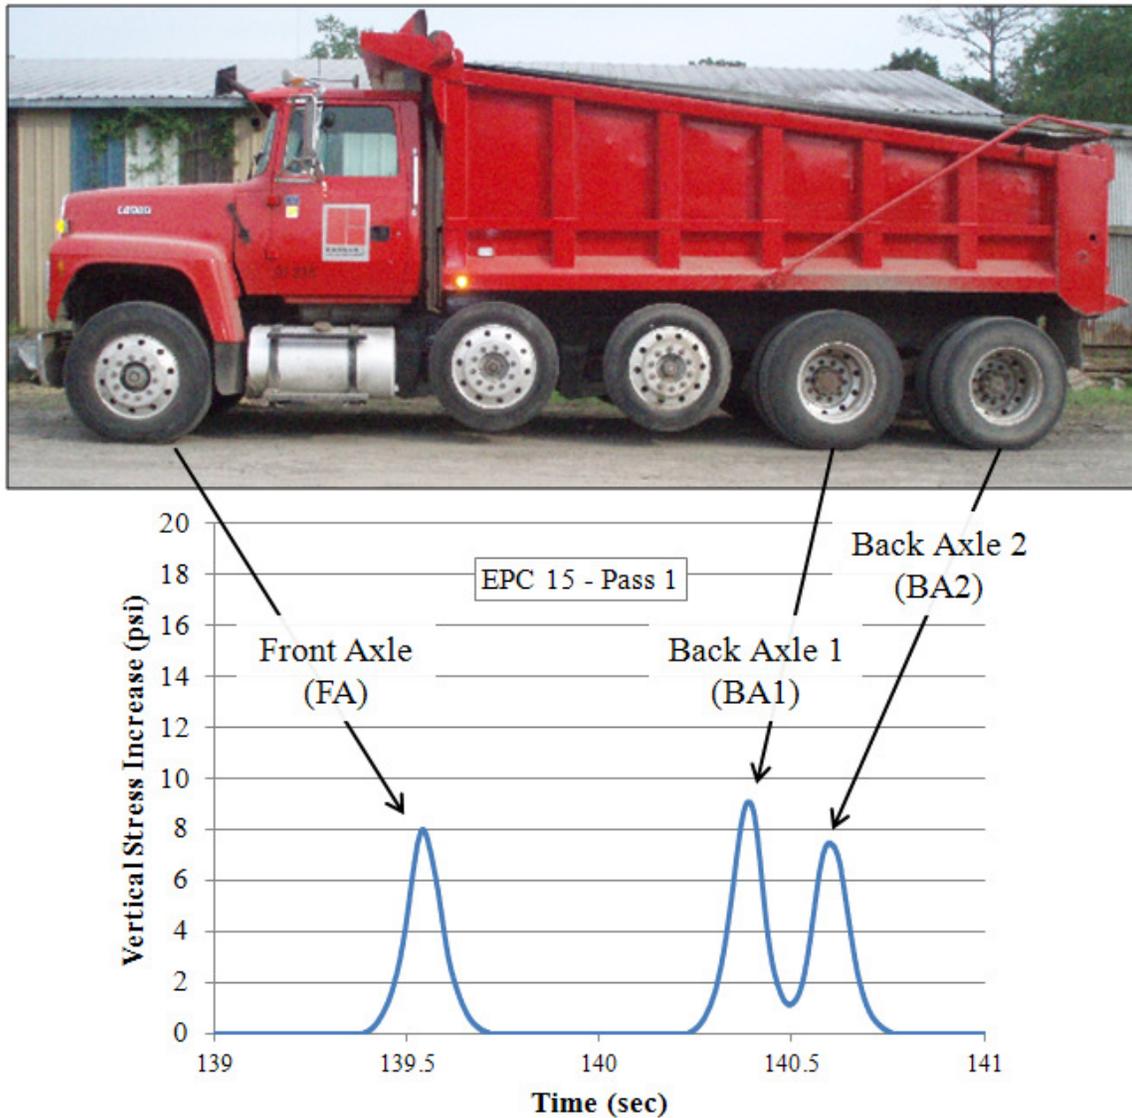
Figure 91: Truck used for loading and the EPC output during the first pass from EPC 15

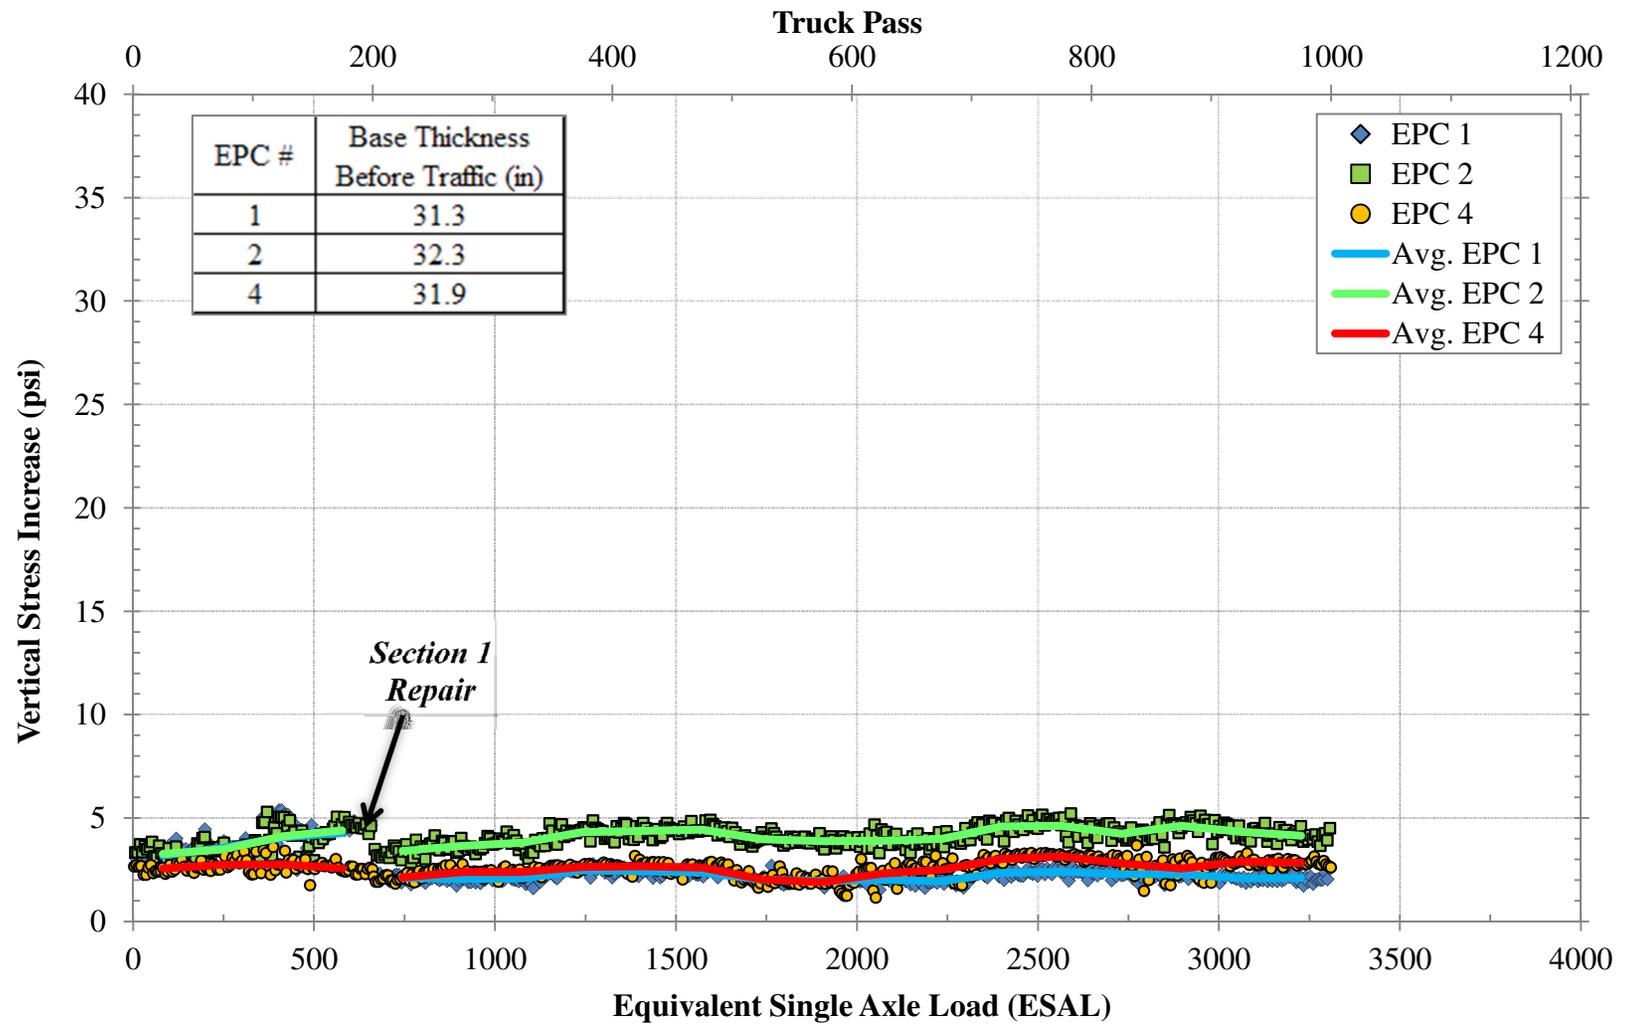
Figure 96: Vertical stress increase three inches below the base/subgrade interface for Test Section 1

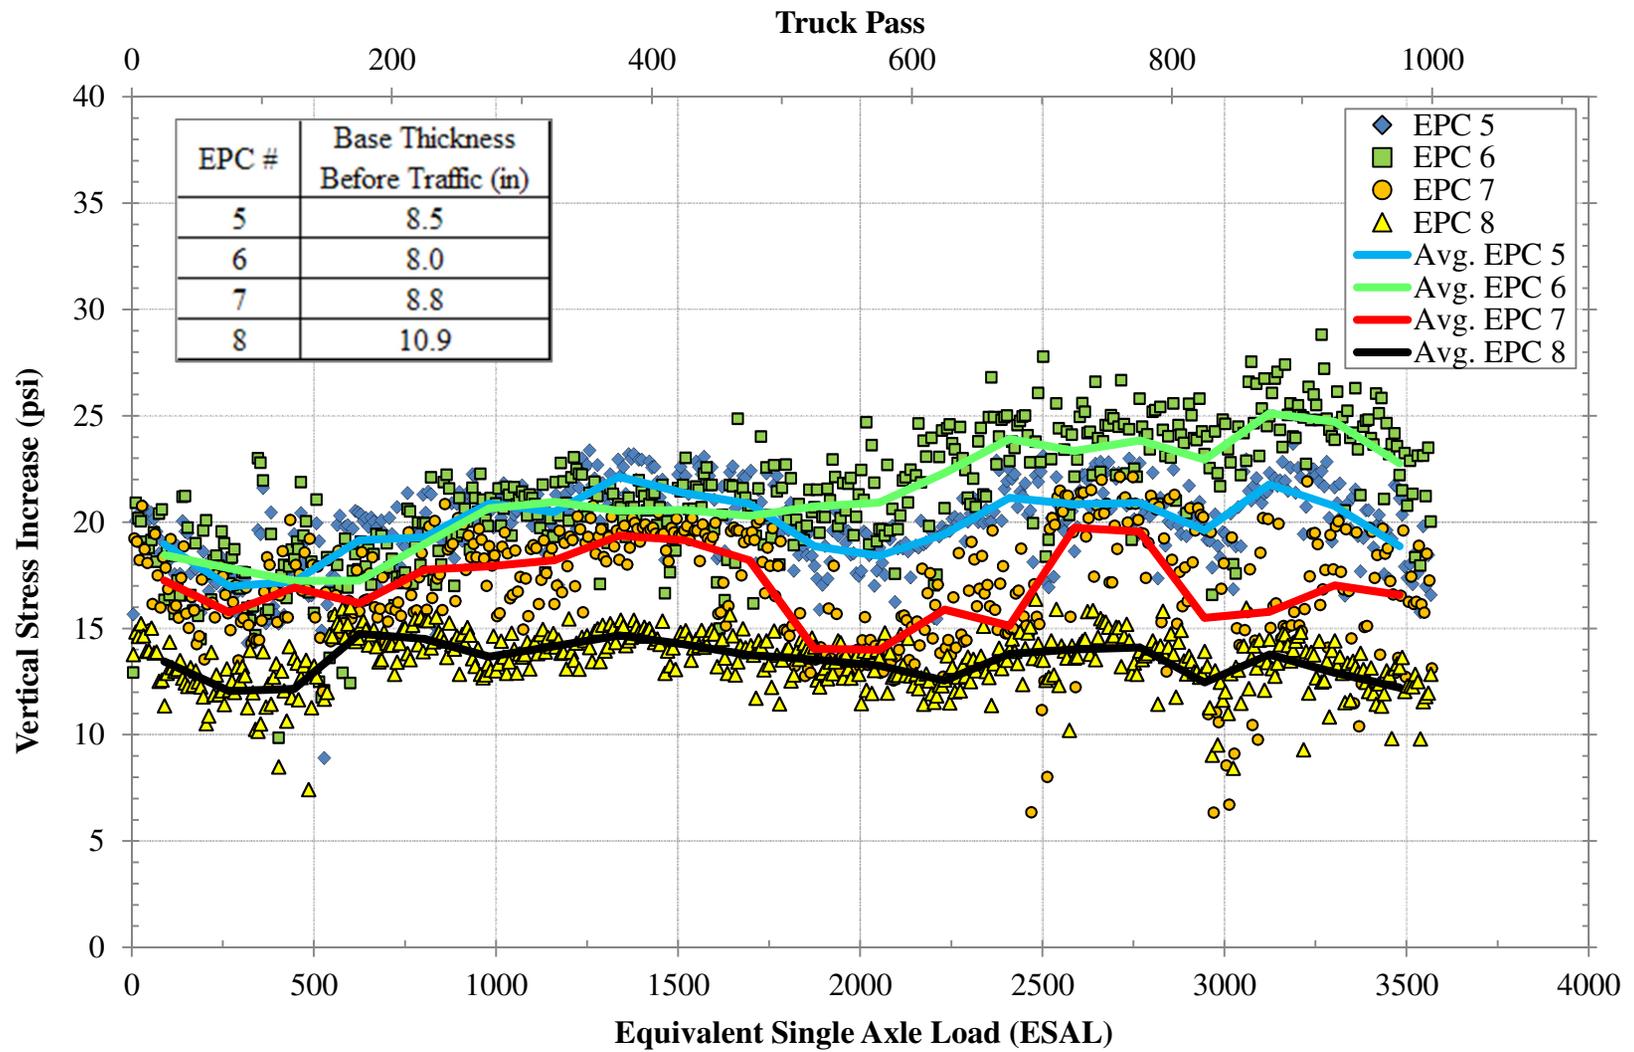
Figure 97: Vertical stress increase three inches below the base/subgrade interface for Test Section 2

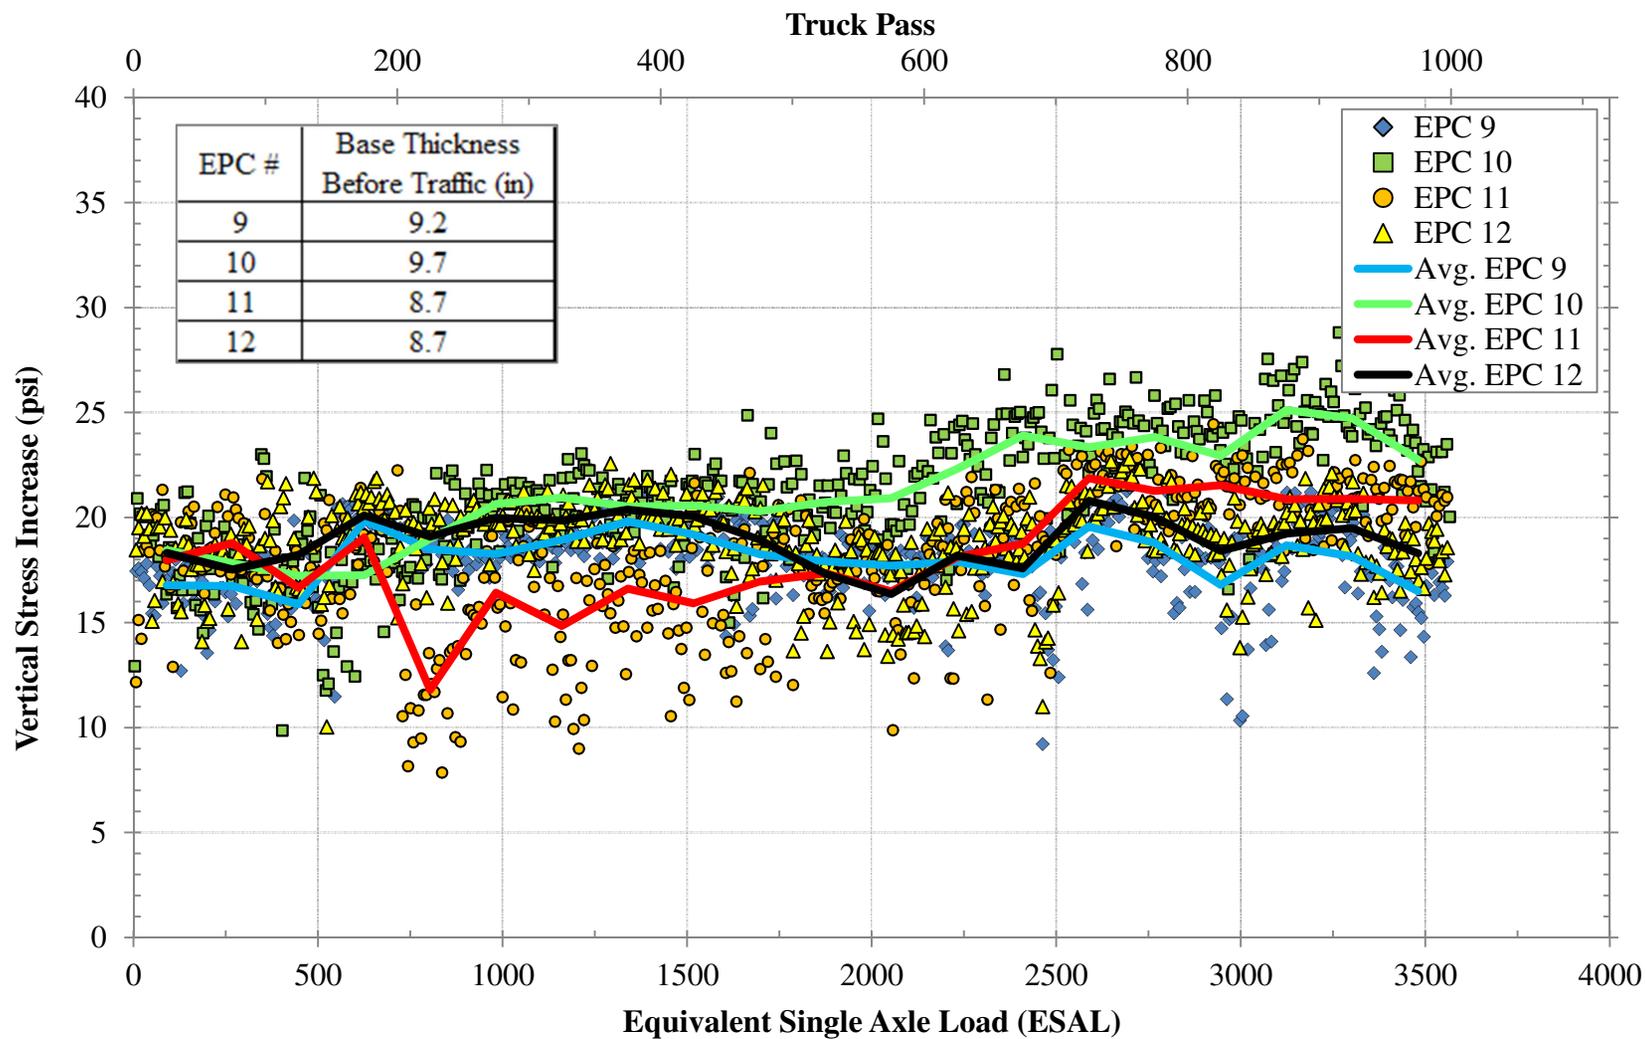
Figure 98: Vertical stress increase three inches below the base/subgrade interface for Test Section 3

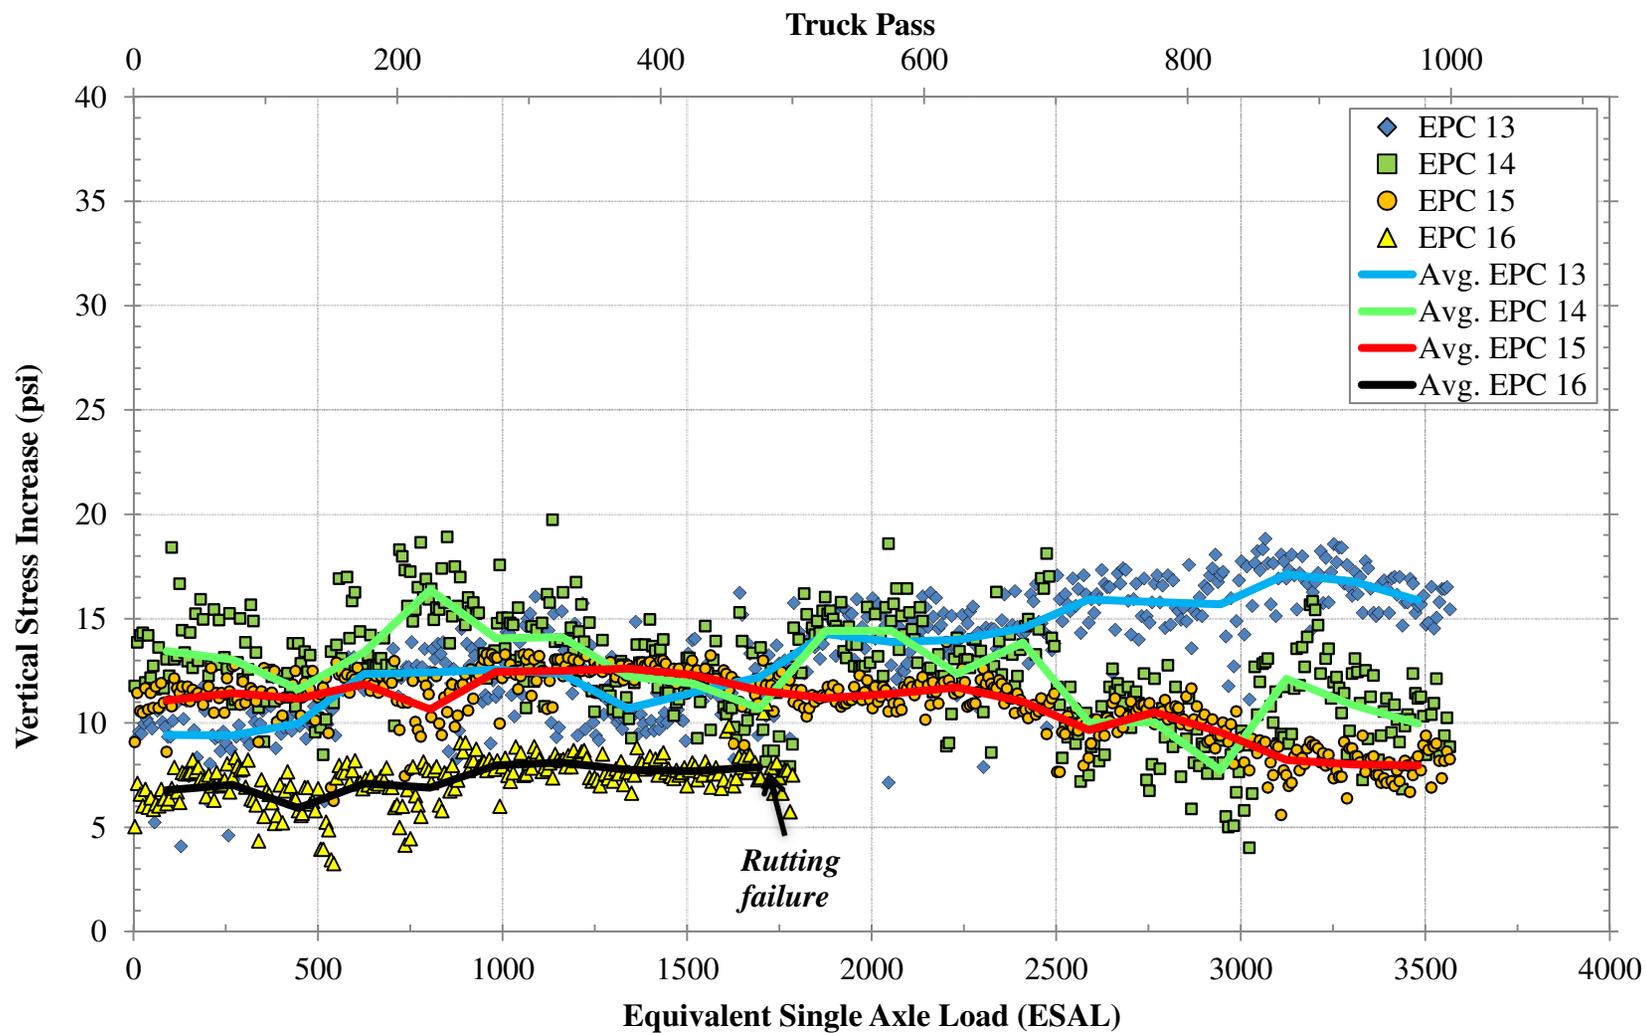
Figure 99: Vertical stress increase six inches below the base/subgrade interface for Test Section 4

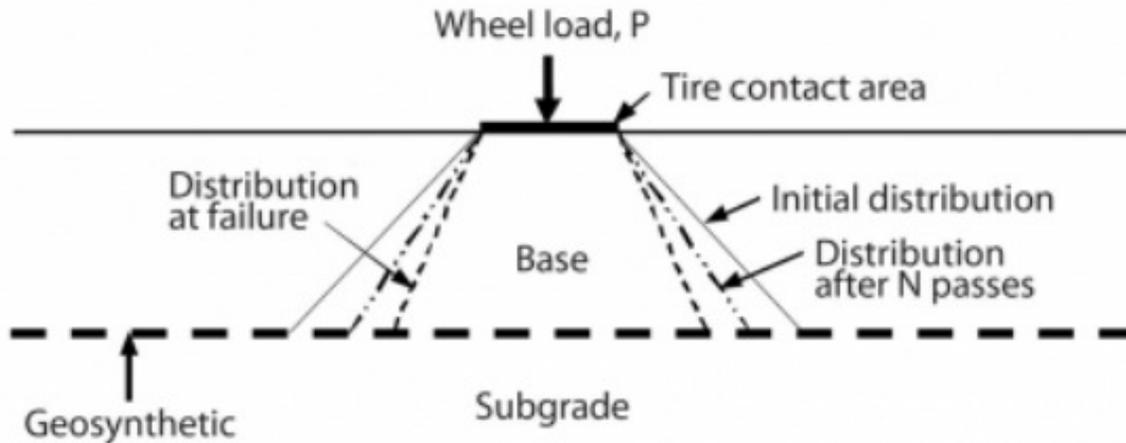
Figure 101: Giroud and Han (2004) stress distribution solution for unreinforced and reinforced unpaved roads (image obtained from Giroud and Han (2012))
