Field Implementation and Comparative Performance Assessment of
Undercut Stabilization Measures

by
Timothy David Cowell

A thesis submitted to the Graduate Faculty of
North Carolina State University
in partial fulfillment of the
requirements for the degree of
Master of Science

Civil Engineering

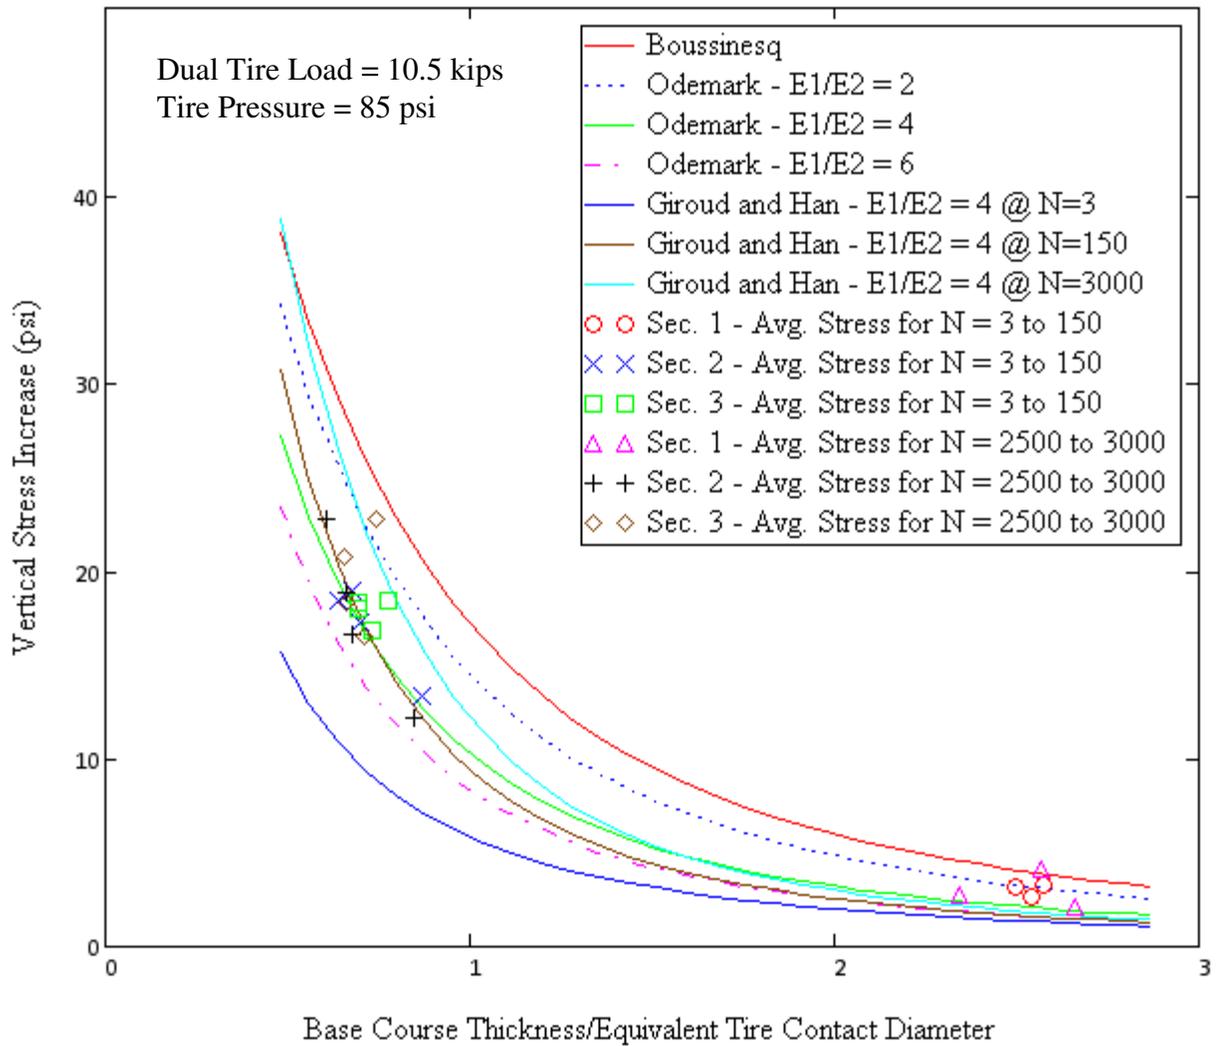
Figure 102: Vertical stress increase three inches below the base/subgrade interface

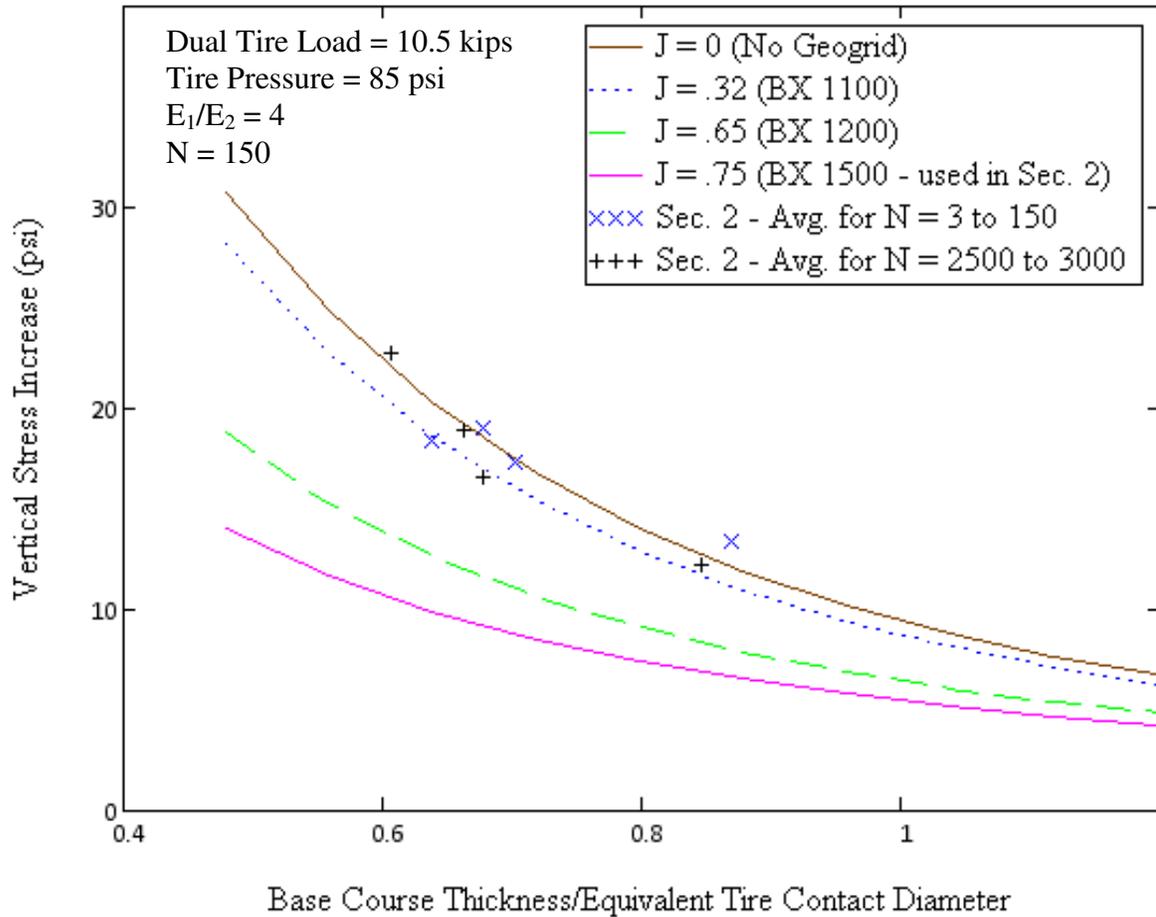
Figure 103: Vertical stress increase three inches below the base/subgrade interface for various geogrid aperture stability modulus values

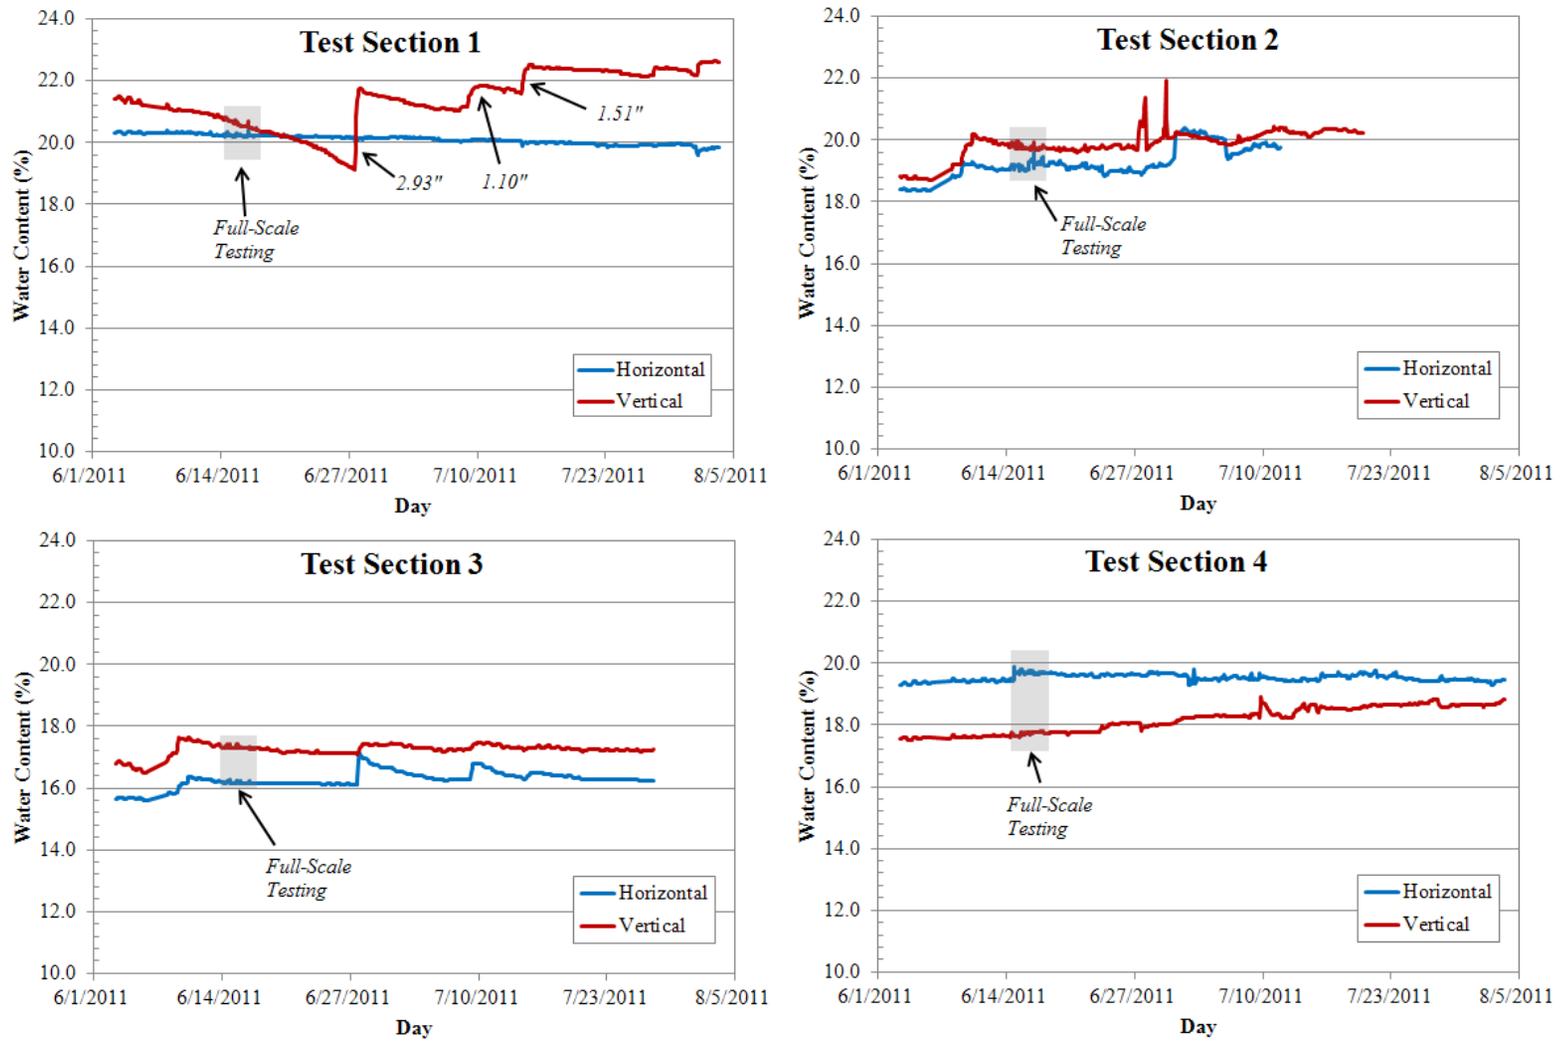
Figure 105: Measured water content at the base/subgrade interface throughout the duration of the project (about 2 months)

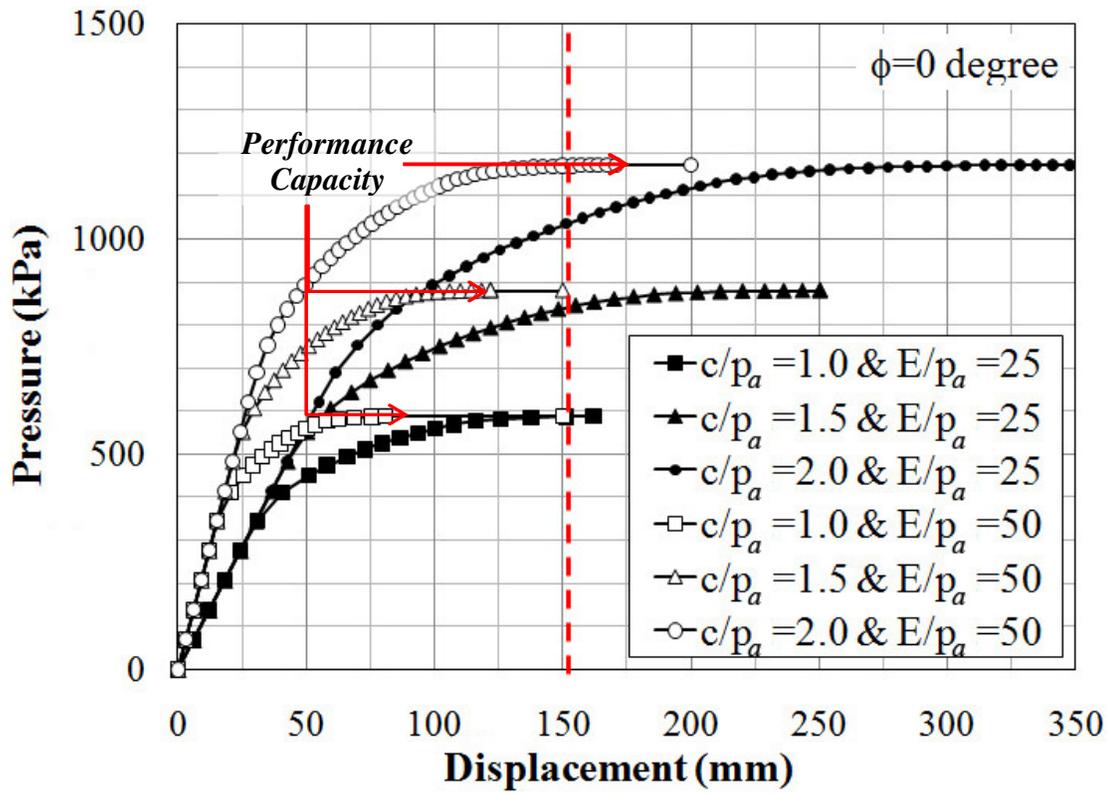
Figure 109: Pressure and displacement plots dependent on strength and stiffness

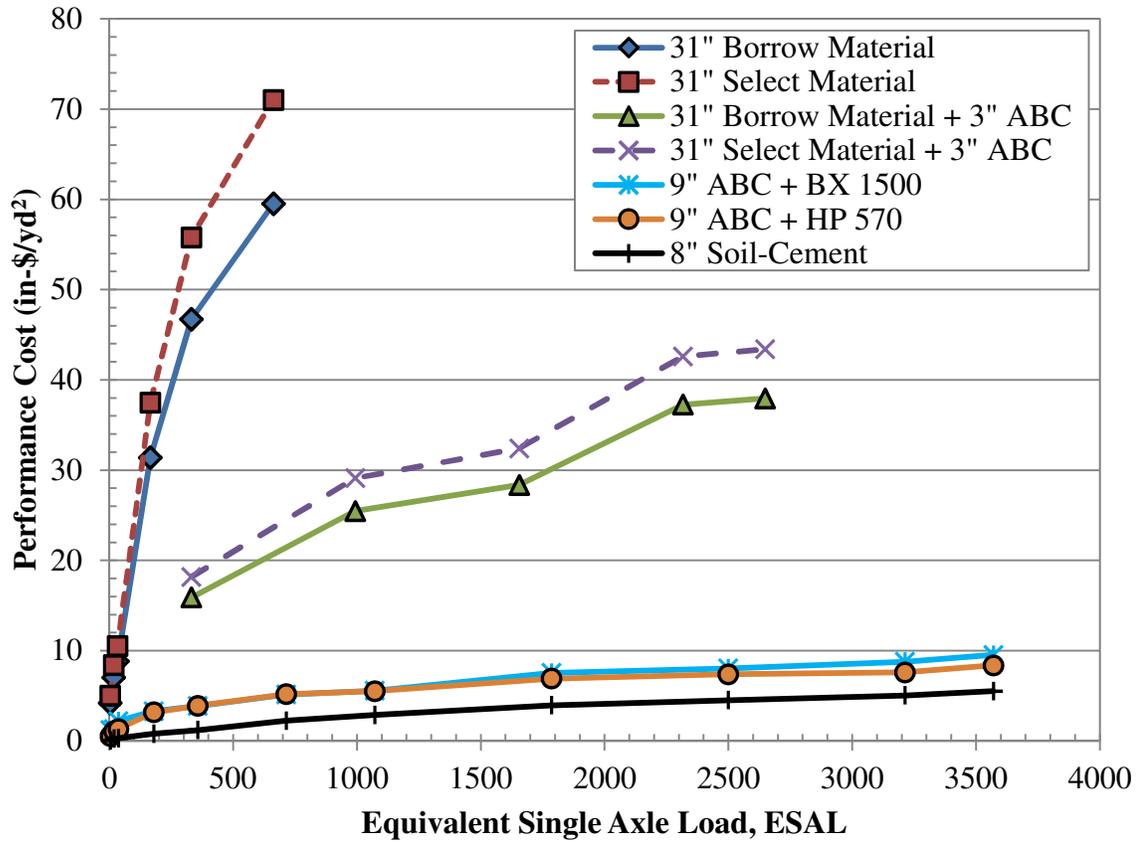
Figure 114: Average performance cost of stabilization measures based on unit costs from the 2011 statewide bid average

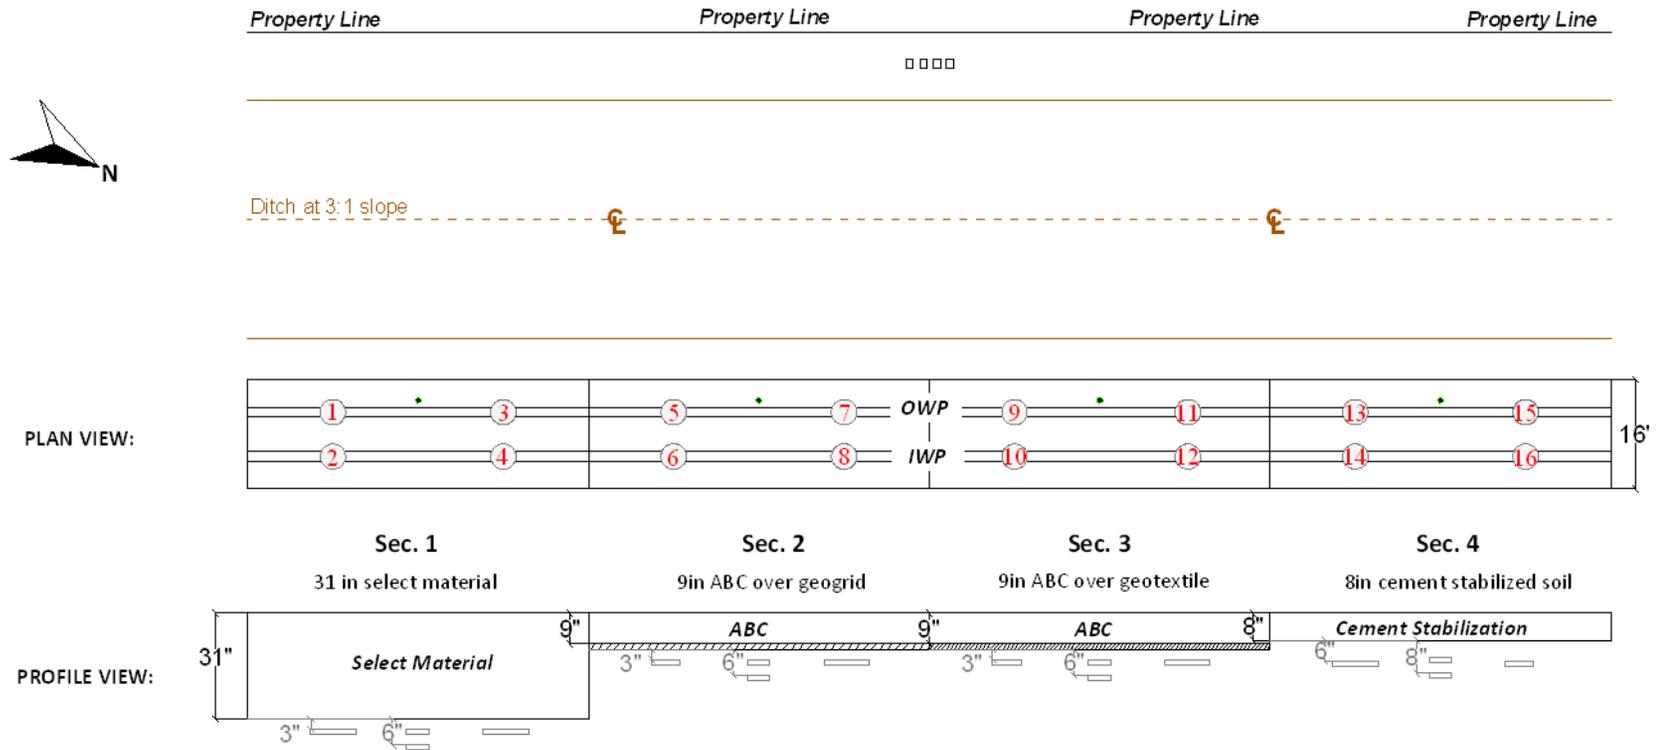
Figure B.124: EPC location and identification number

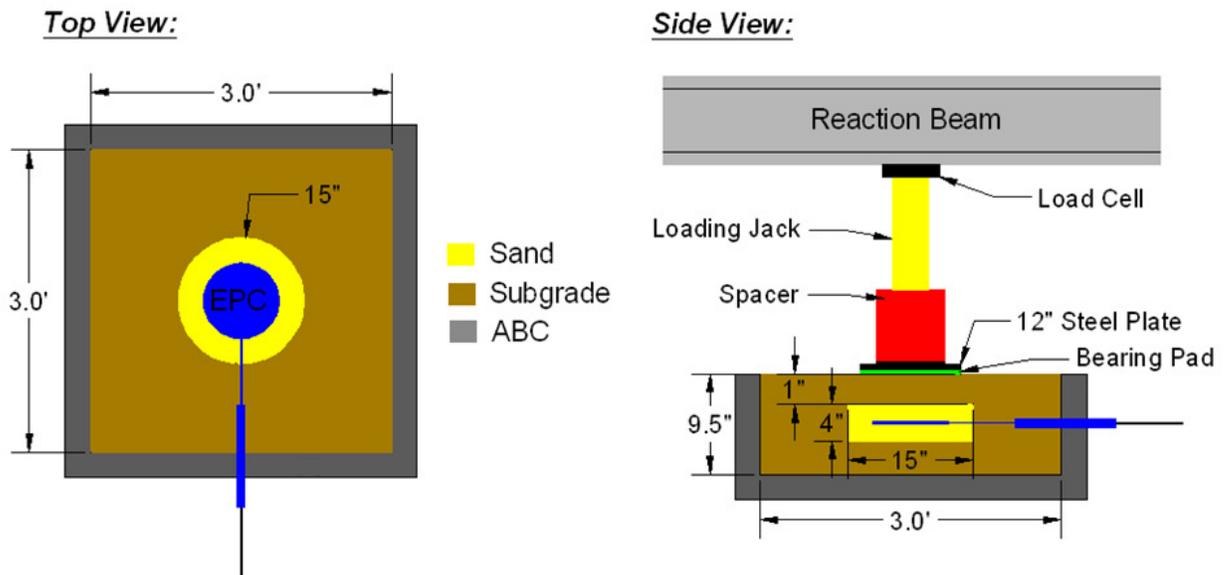
Figure C.125: Diagram of the EPC laboratory calibration test setup

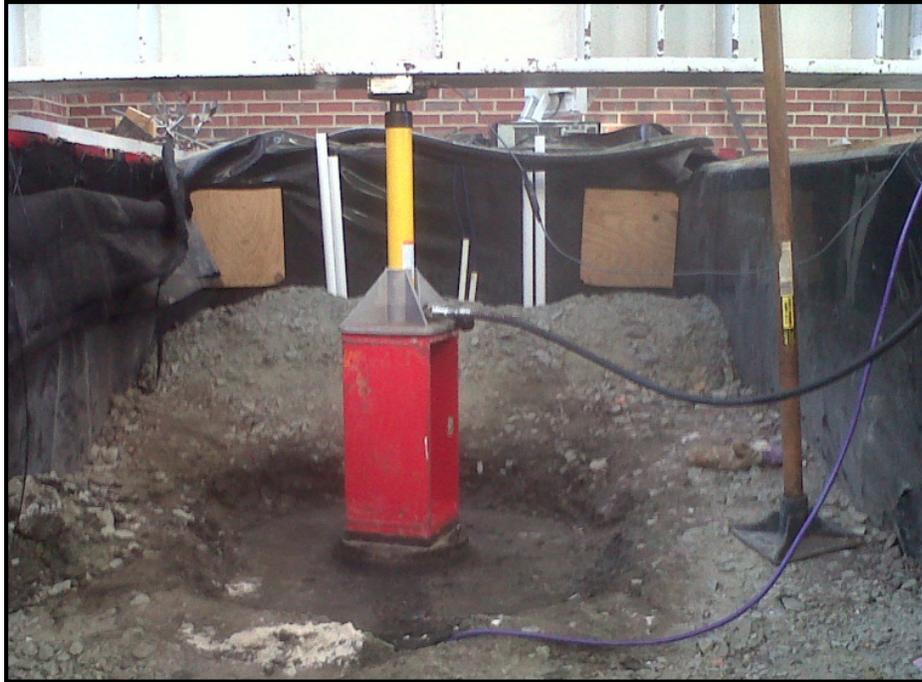
Figure C.126: EPC laboratory calibration test setup

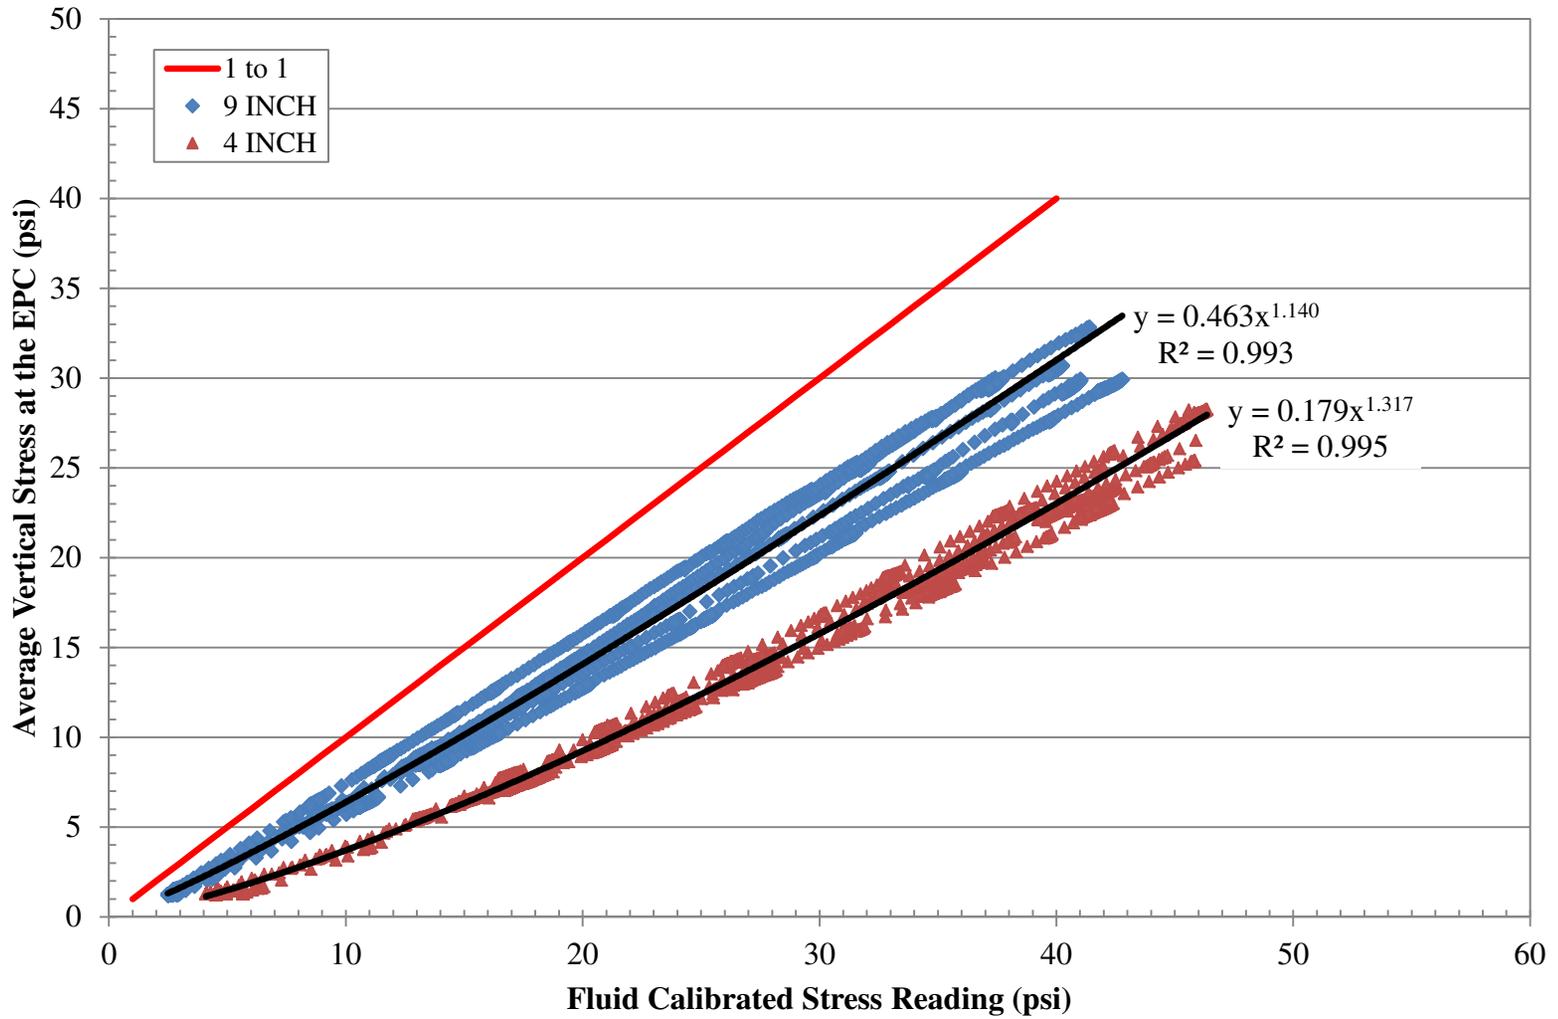
Figure C.129: EPC calibration results from lab testing

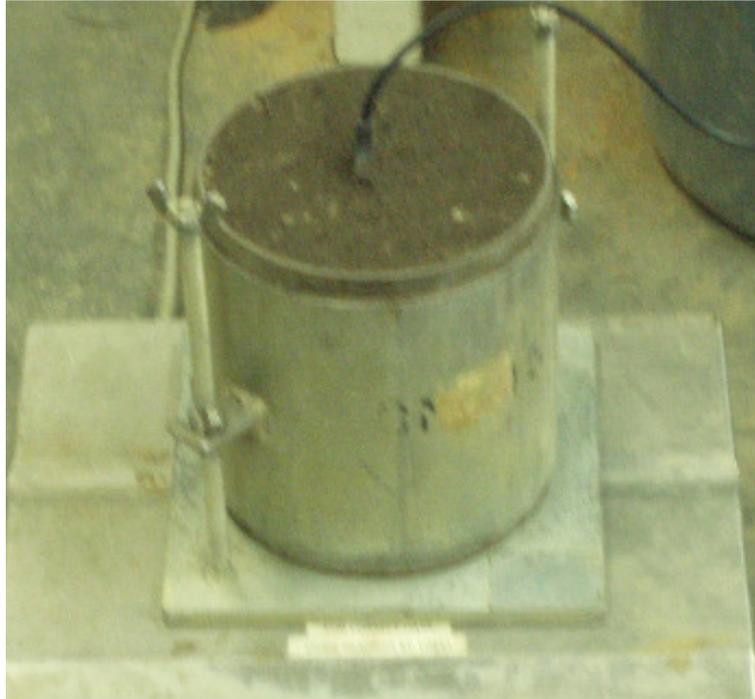
Figure D.131: Soil moisture sensor calibration setup

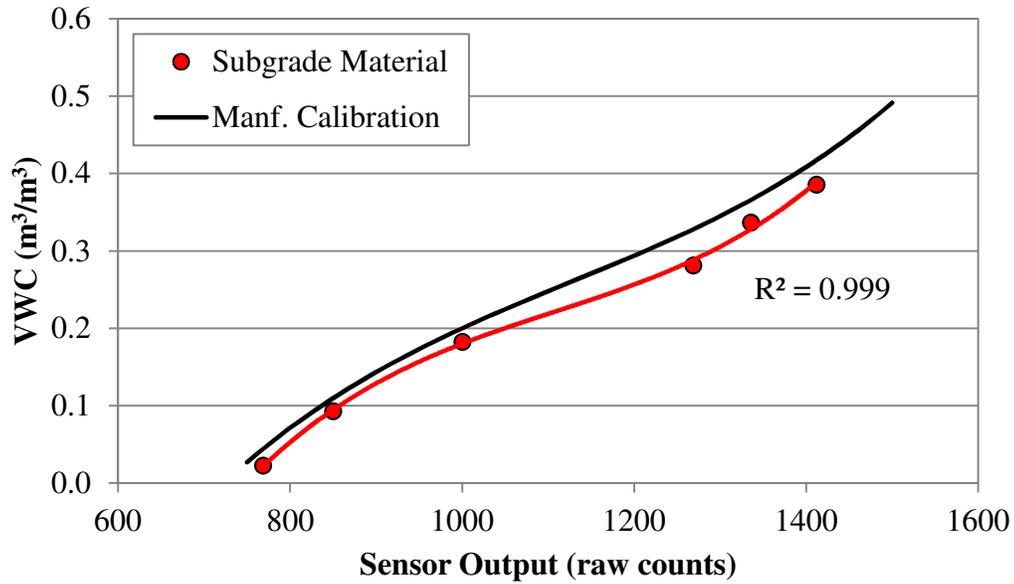
Figure D.132: The results from the lab calibration of the soil moisture sensors

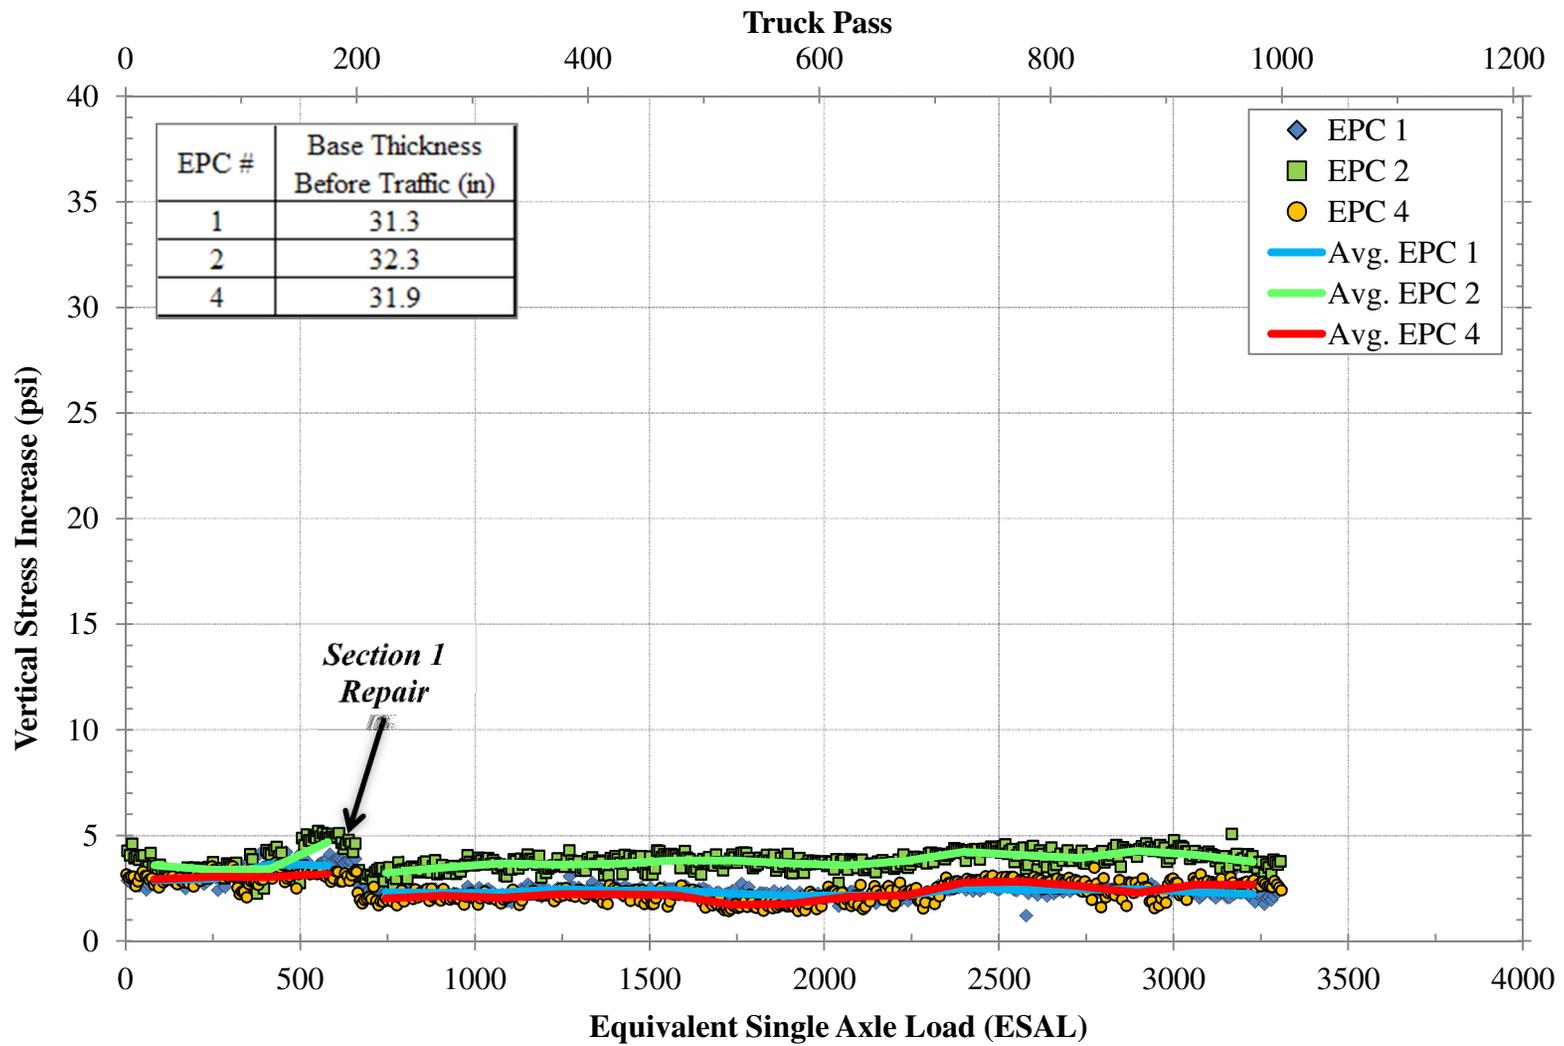
Figure G.134: Vertical stress increase three inches below the base/subgrade interface for Test Section 1

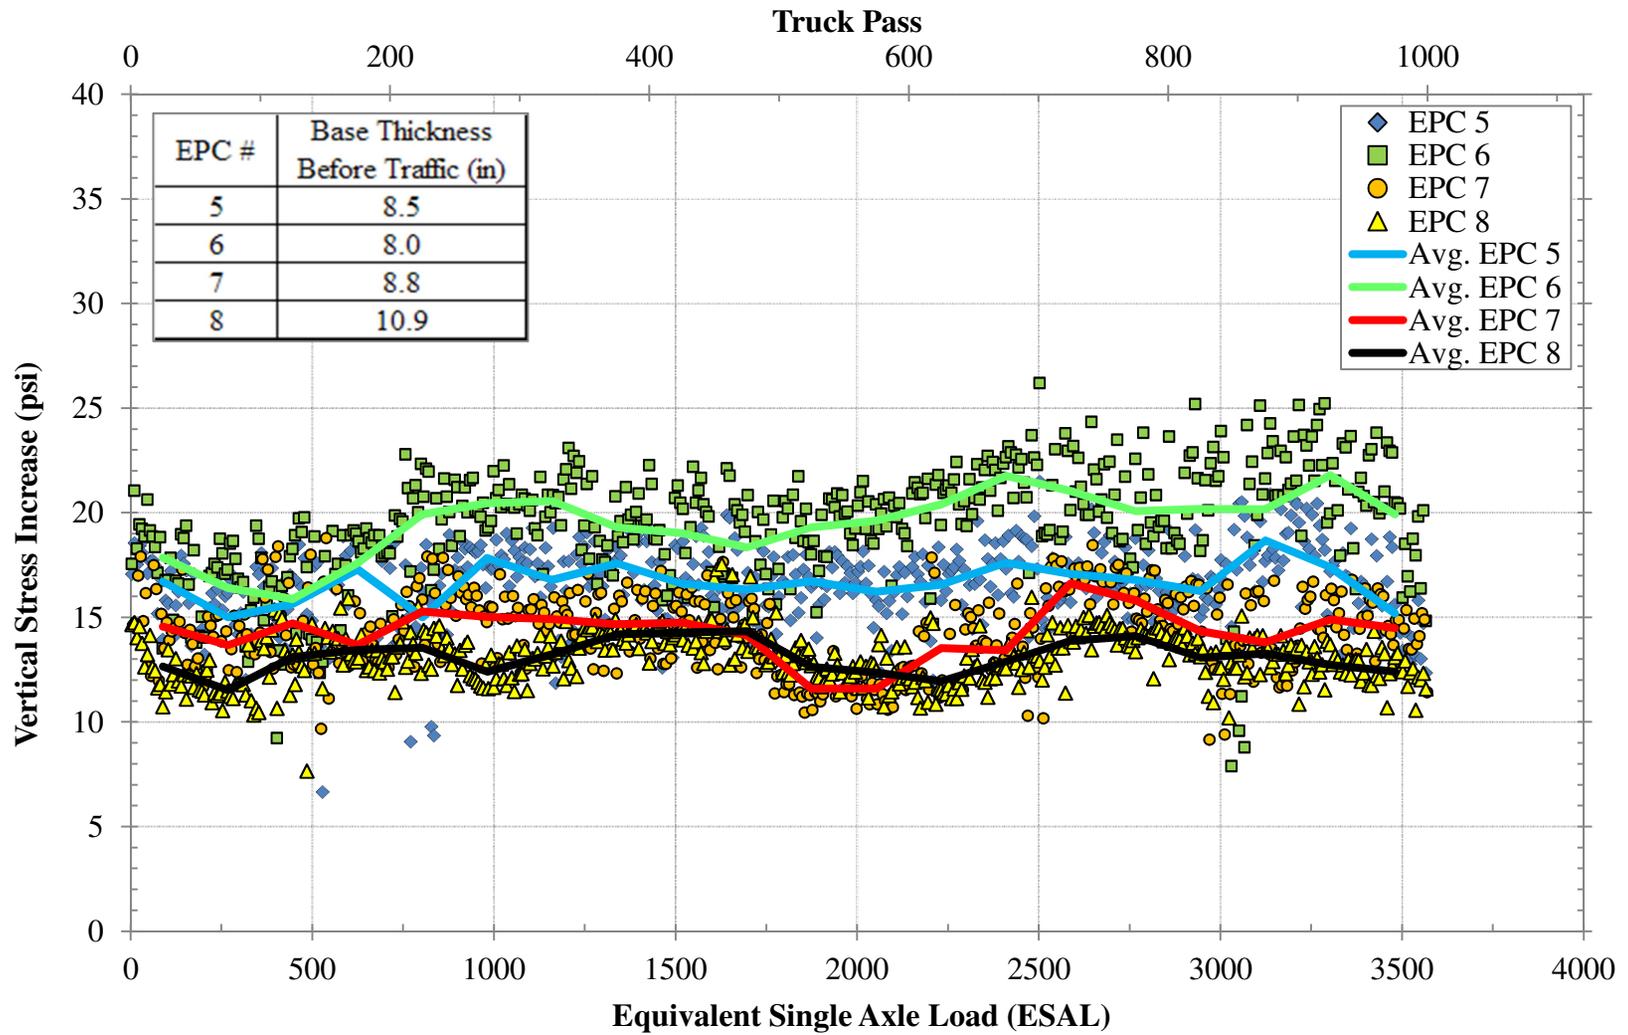
Figure G.135: Vertical stress increase three inches below the base/subgrade interface for Test Section 2

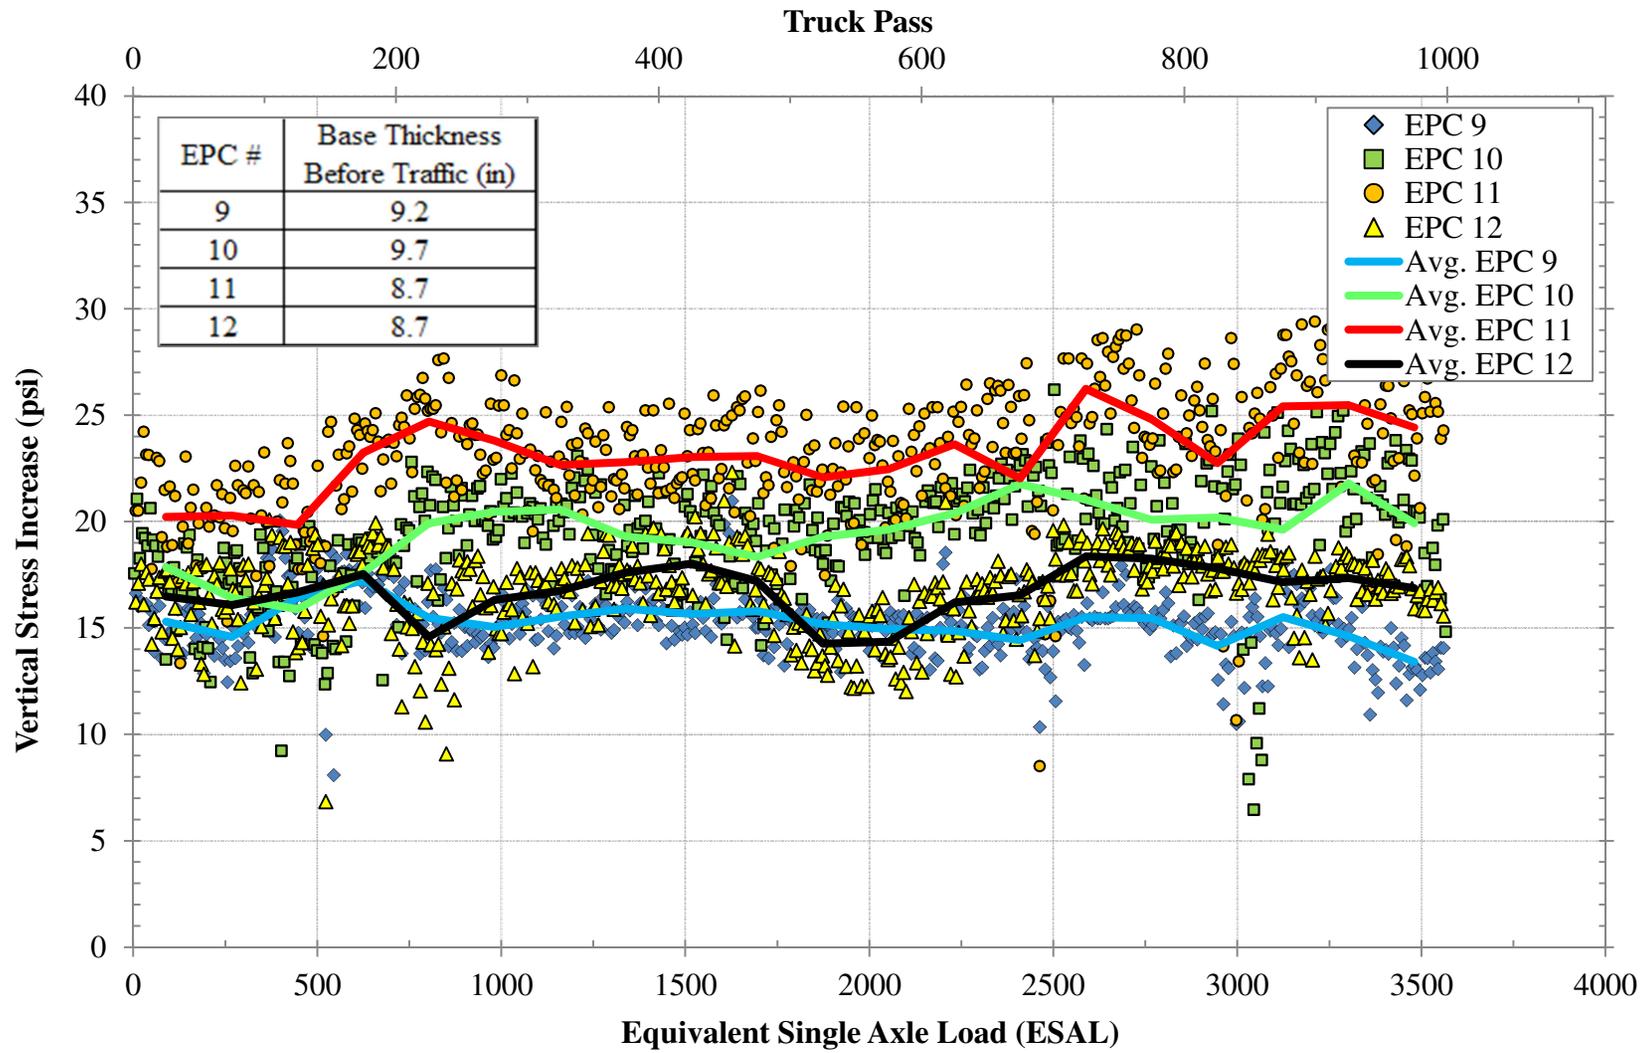
Figure G.136: Vertical stress increase three inches below the base/subgrade interface for Test Section 3

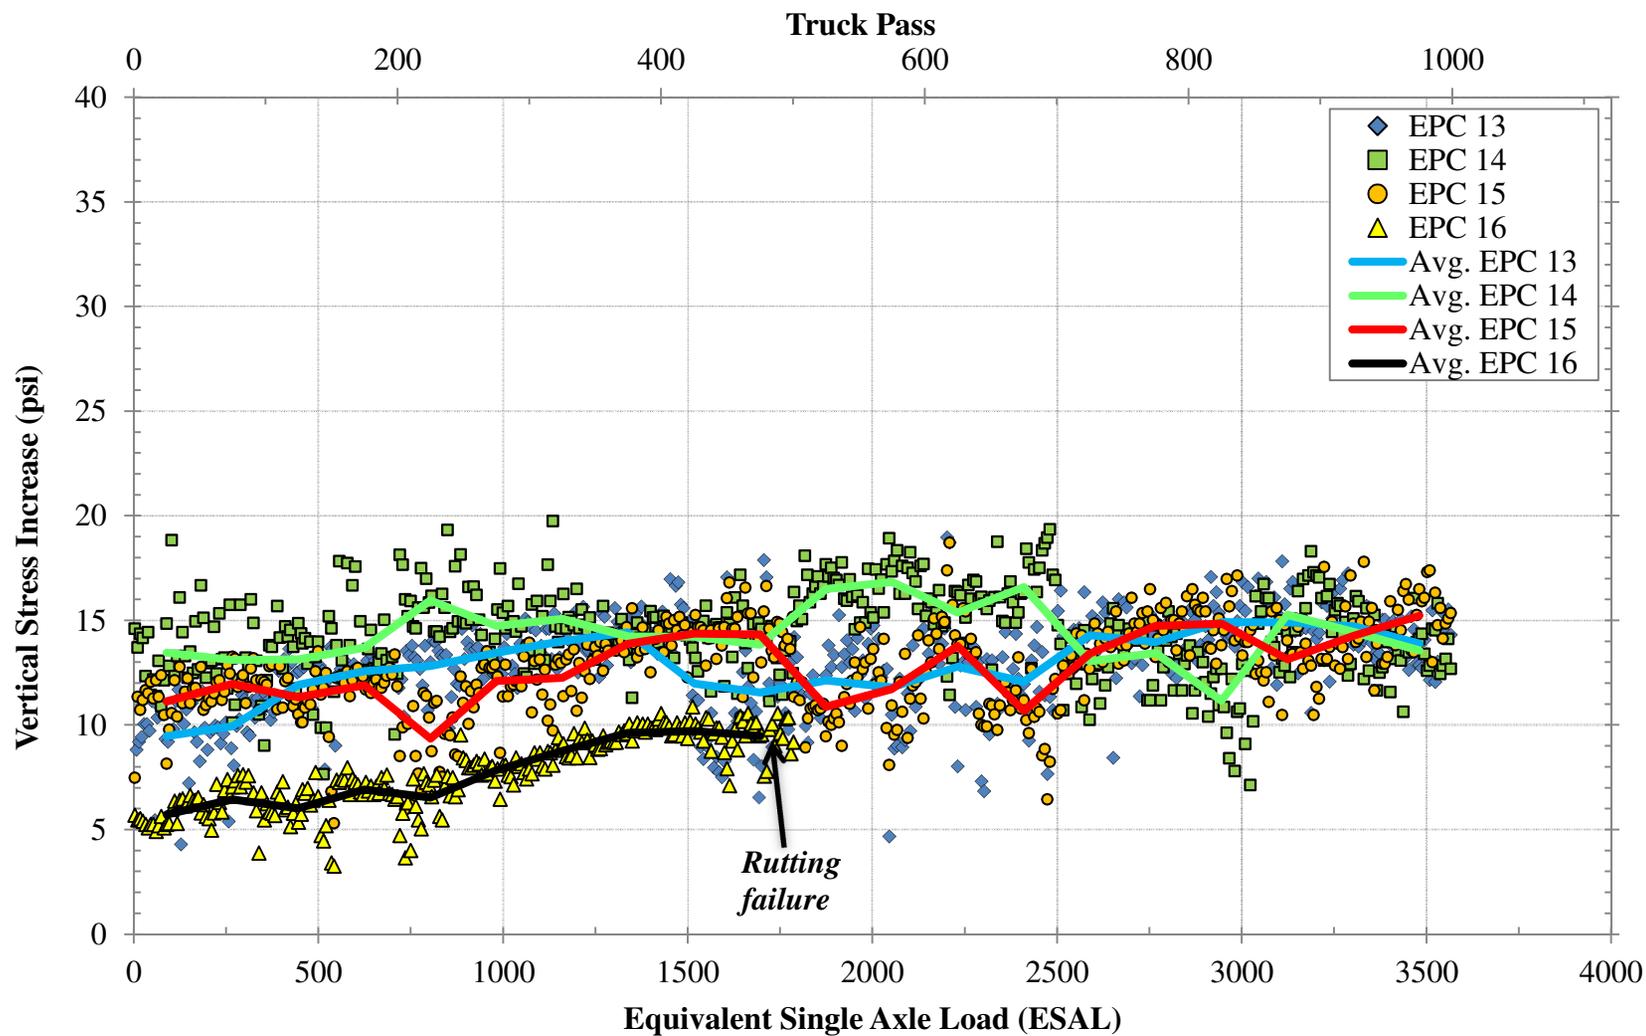
Figure G.137: Vertical stress increase six inches below the base/subgrade interface for Test Section 4
