**IMPROVING THE ASSESSMENT OF IN SITU TIMBER MEMBERS WITH
THE USE OF NONDESTRUCTIVE AND SEMI-DESTRUCTIVE TESTING
TECHNIQUES**

A thesis submitted to the Graduate Faculty of
North Carolina State University
in partial fulfillment of the
requirements for the Degree of
Master of Science

CIVIL ENGINEERING

2005

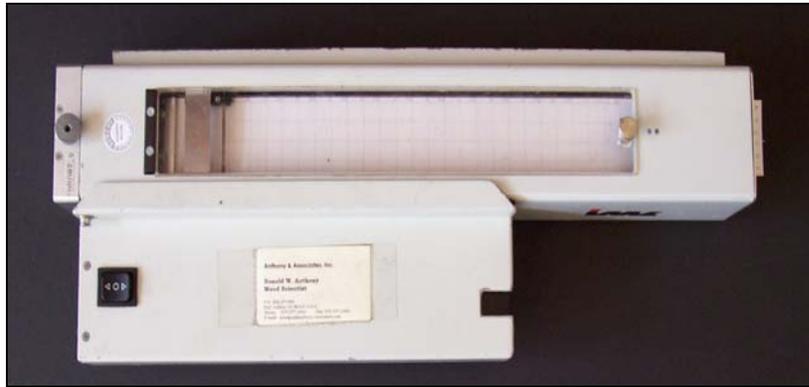
Resistance drilling offers a non-destructive means of analyzing the quality of the interior material in wood members. Resistance drills use small diameter (1.5-3.0 mm [0.6-0.12 in]) needle-like drills to bore into timber members and measures the resistance the drill bit encounters as a function of the penetrated depth. Resistance drills have electric motors and are battery operated, offering portability for field investigations. Drill bits are flexible, tungsten steel-tipped needles that will vary in length depending on manufacturer. Drill weight will also vary with manufacturer but will typically be close to three kilograms [6.6 pounds]; equipment shown in Figure 2.16 and Figure 2.17.

Figure 2.16: Resistance Drill

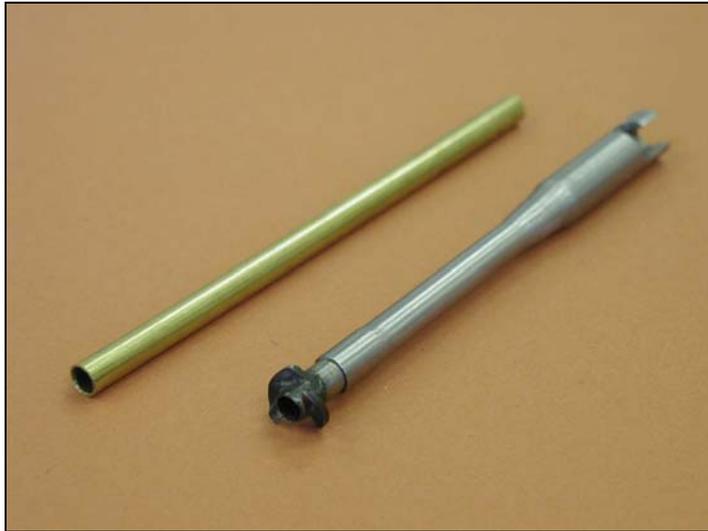
Figure 2.21: Mechanical core drill bit.

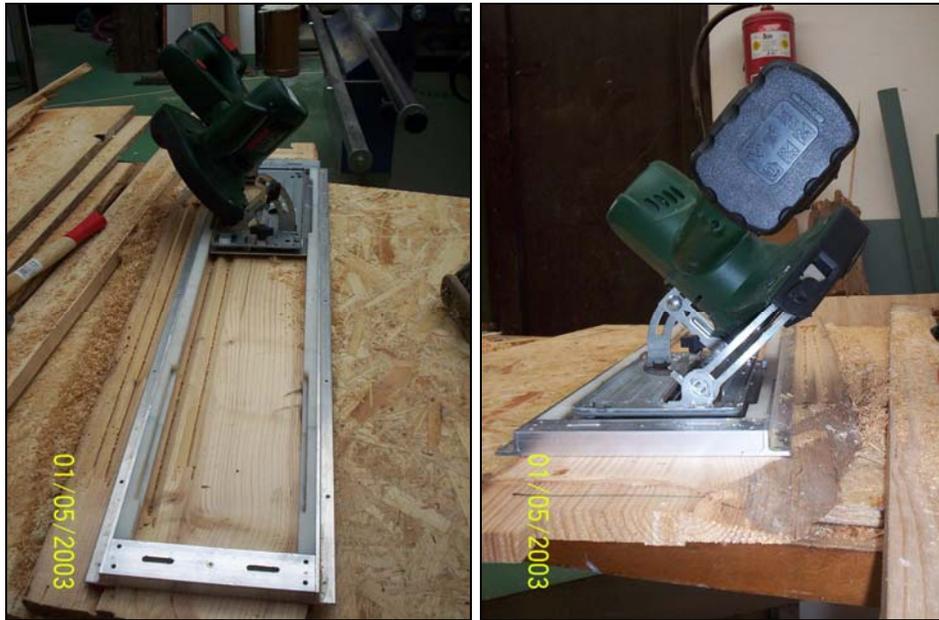
Figure 2.29: Tension micro-specimen equipment, kerf saw and guiding track

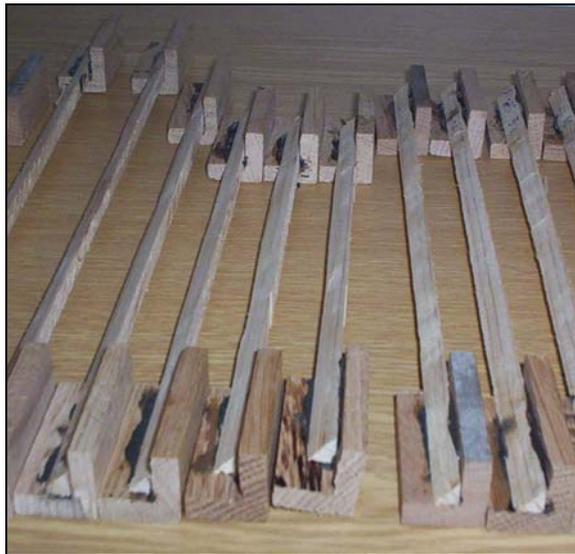
**Figure 2.30: Tension micro-specimens
(mounted in grips for testing)**

After sample extraction and preparation through sizing, sanding and mounting for experimentation, as discussed above and shown in Figure 2.30, the samples are tested under tensile loading to find the ultimate tensile strength along the grain as well as the modulus of elasticity. A schematic of testing set up is shown below in Figure 2.33.

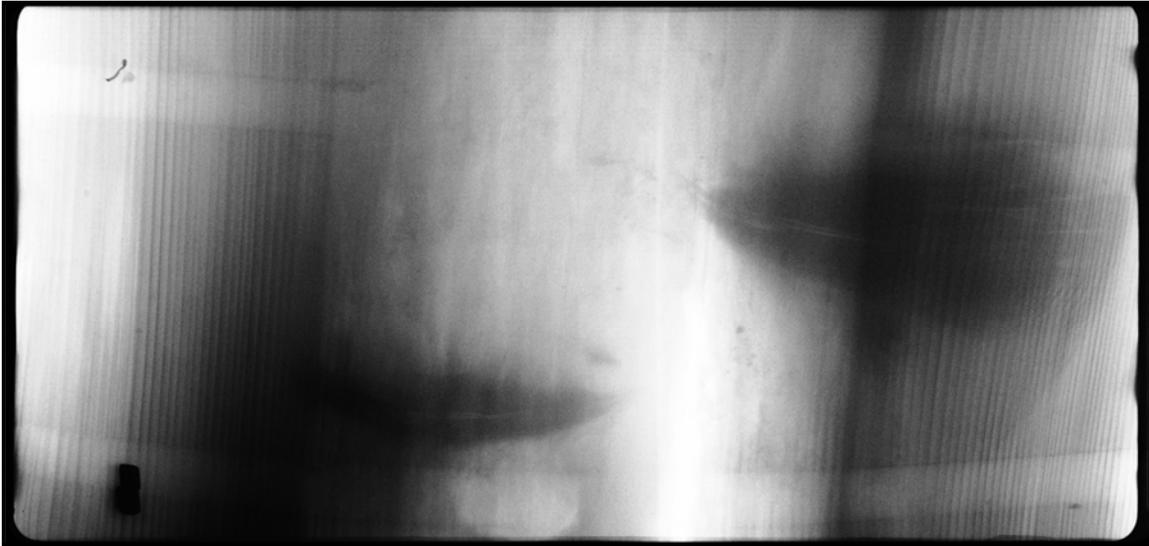
Figure 4.7: X-ray image of level 1

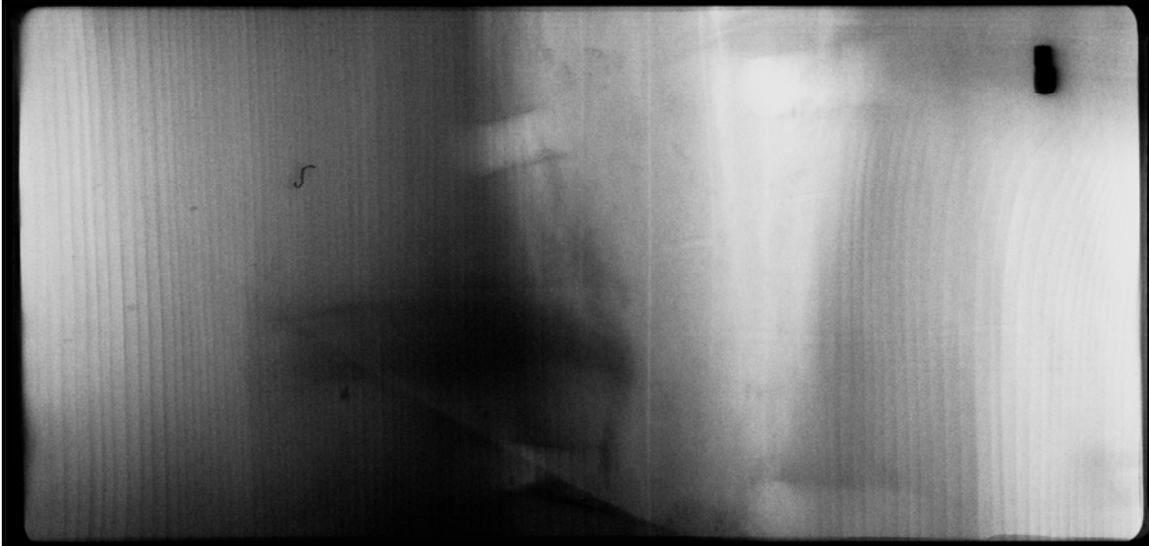
Figure 4.8: X-ray image of level 2

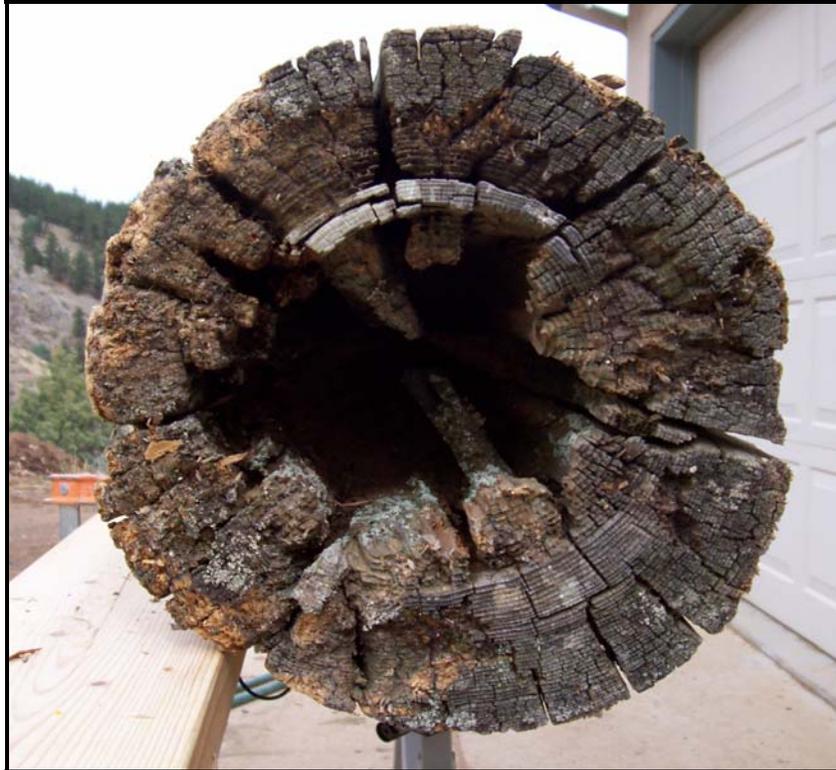
Figure 4.15: Photograph of level one cross-section

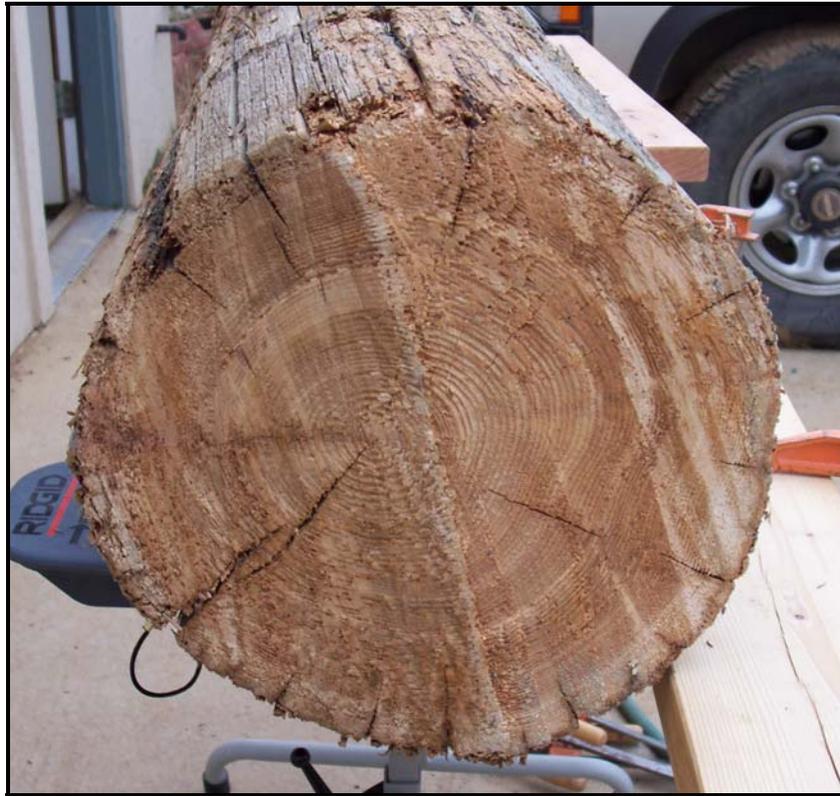
Figure 4.18: Photographs of pole cross-section near level 4.

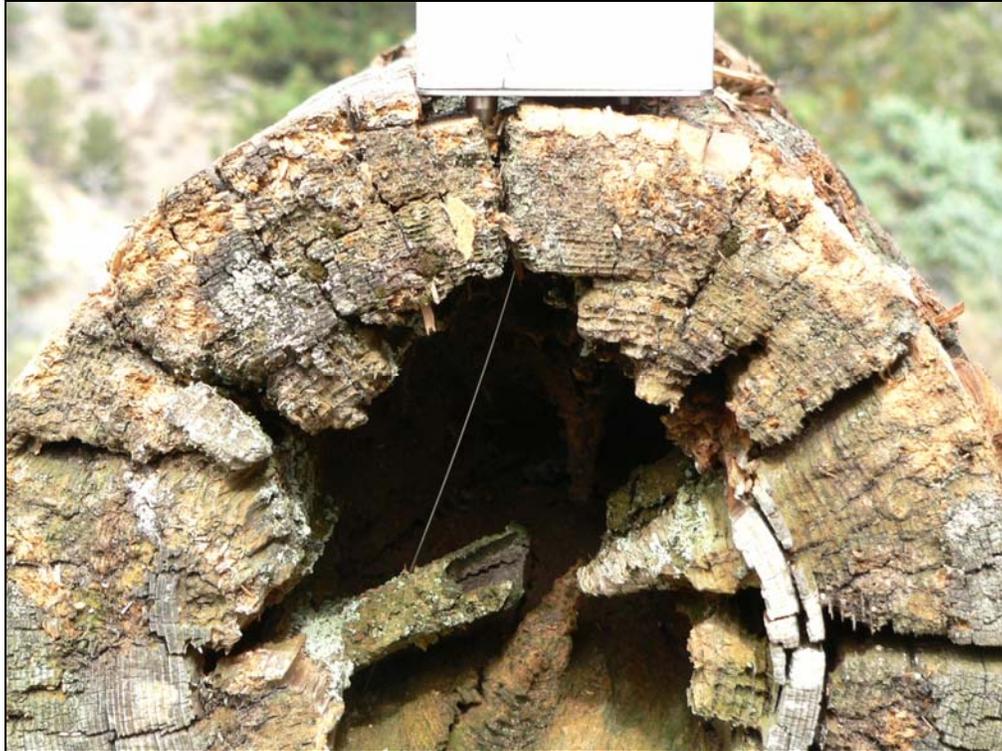
Figure 4.19: Deviation of resistance drill needle from intended straight path, level one.
