## Verification test for integrity of equipment foundations affected by dynamic load

**Keywords:** Concrete equipment base, Anchor bolt, Dynamic load, Seismic test

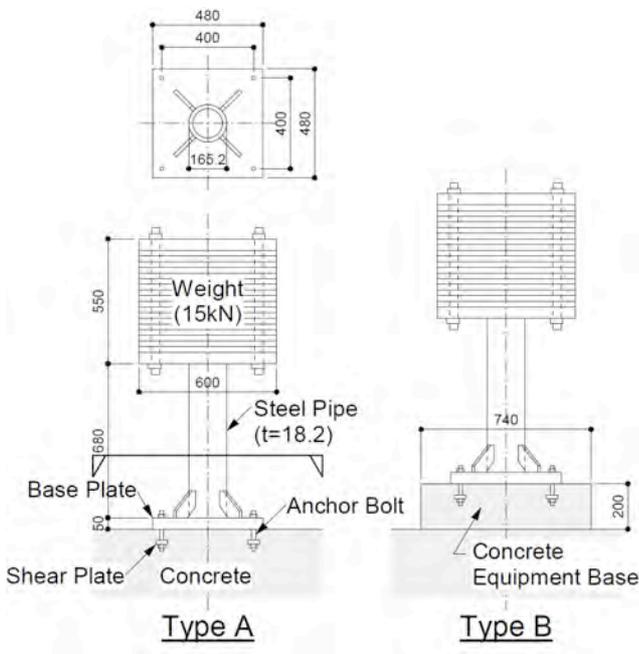
Figure 1. Test model for pull-out loading

Table 1 and Figure 1 through 2 show the specifications of test models. The models consist of base plate with anchor bolts and heavy weight connected with the base plate by a steel pipe. They were designed so that pull-out force worked on anchor bolts by horizontal excitation. Major parameters of the models were anchor bolt diameter and embedment depth. The other parameters were the existence of an additional sleeve for construction use and concrete equipment base of 200mm high. Anchor bolts were installed in concrete foundation of 1m thick, and no rebar was installed around anchor bolts except for those in equipment bases. The material of anchor bolt was SS400 of Japanese Industrial Standard (specified minimum yield stress is 235 N/mm<sup>2</sup>). Initial fastening force was loaded to each bolt by torque (M16:100N-m, M36:1200N-m). Natural frequencies of models were around 15Hz. Two models with the same parameters were prepared. One was used for pull-out test and another for internal crack investigation after seismic tests.

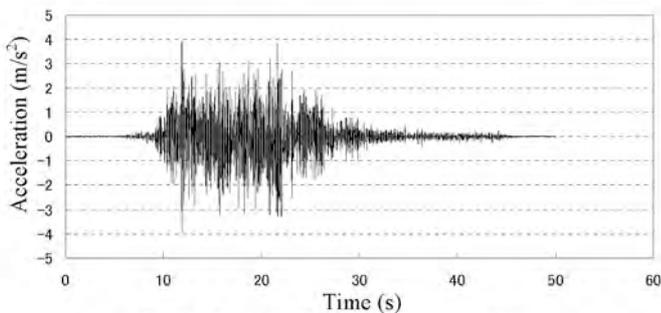
Figure 3. Acceleration time history

Input motion was an artificial seismic wave which causes high acceleration response. The time history and response spectrum of the input motion are shown in Fig. 3 and 4.

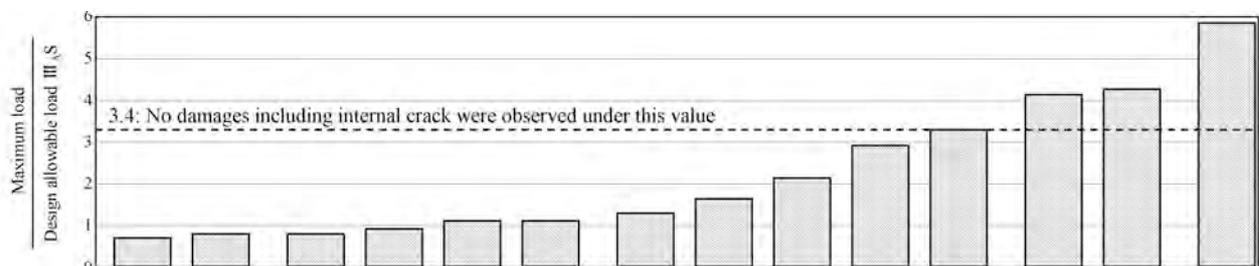
**Figure 5.** Comparison of maximum pull-out force in seismic test and design allowable value

Although internal cracks were found in a few models after the seismic test as described in the later section, no surface cracks appeared in any models. Figure 5 shows the ratios of bolt pull-out forces to short term design allowable values ( $III_{AS}: 0.45A_c\sqrt{F_c}$ ,  $A_c$ : Effective shear cone area,  $F_c$ : Specified compressive strength of concrete). Even though the pull-out forces loaded to many models beyond the design allowable values, no model collapsed by dynamic loads.

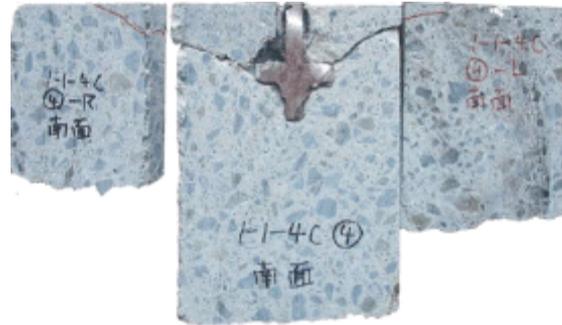
Figure 6. Internal crack (Model I-1-4)

After the seismic test, concrete around the anchor bolts was cut by core drilling, and their surfaces were visually observed to find internal cracks. A sample of observed internal crack is shown in Fig. 6. Investigation results are summarized in Table 1. It can be found that internal cracks were generated in the models whose ratios of the loaded pull-out forces to the design allowable values were relatively larger. According to the results, the internal crack was found in the model whose pull-out force ratio was 4.1, and no damage could be observed in the model whose ratio did not exceed 3.4.

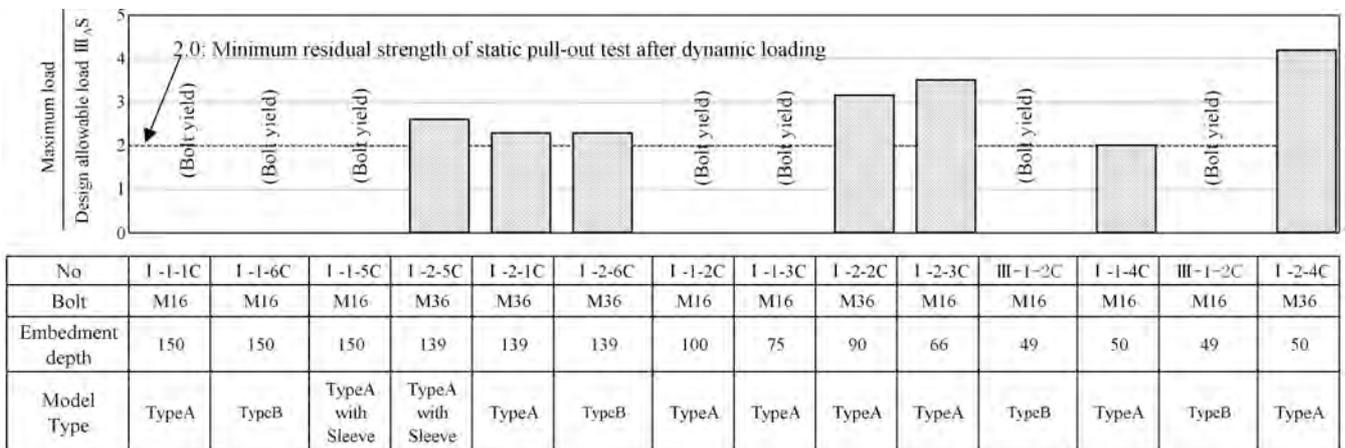
Figure 7. Comparison of static pull-out strength and design allowable value

Residual pull-out strength was statically tested after seismic test for every model. The test results are listed in Table 1. Major failure mode was the concrete shear cone failure excluding the models which used M16 bolts and had relatively deep embedment depths. The ratios of the residual pull-out strengths to the design allowable values are shown in Figure 7. It can be confirmed that the residual strength satisfactorily exceeds the design allowable value even for the model with internal crack.

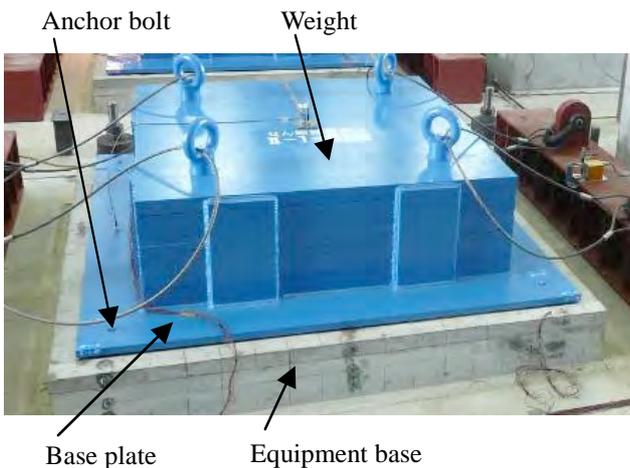
**Figure 8.** Test model for shear loading (Type B)

Table 2 and Figure 8 through 9 show the specifications of test models. Anchor bolts were 4-M8(SS400). Major parameter of the models was the shear force loaded to the anchor bolts. Loaded shear forces were settled as the ratios to the design allowable value, i.e., 1.0, 0.5, and 2.0, and weights of models were determined on the basis of these values. The other parameters were the existences of the initial fastening force, sleeve for construction use and concrete equipment base. Anchor bolts were fixed to the base plates of 1600x1600x25mm, and weights were welded on the base plates. Greased stainless steel plates were inserted

between the base plates and concrete surfaces to reduce friction and to load shear force from weights to anchor bolts directly. Initial fastening force of each bolt was 12 N-m.

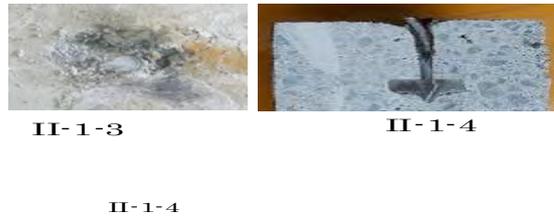
**Figure 10.** Damage of bolt and concrete

Figure 10 shows the damages of the model II-1-4 in which anchor bolts were failed in shear. It was observed that the upper half of the anchor bolts were bent and concrete around the bolts was crushed. No internal damages were found in the other models.

Test results are listed in Table 2. Cut off of the anchor bolt was occurred in the model, II-1-4, to which the twice of design allowable shear force was loaded. Although slight pull-out of anchor bolts and flaking of concrete were occurred in tests for pull-out loading, no significant damage which affects the capacities of anchorage could be observed in tests for shear loading.

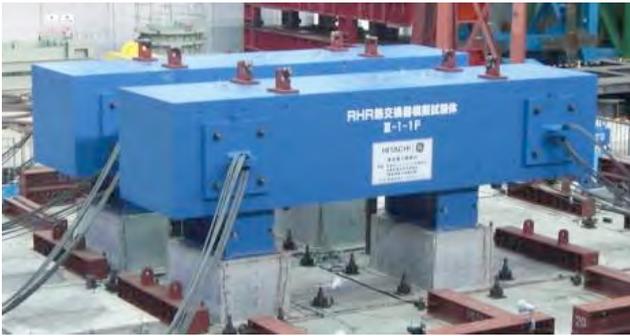
Figure 11. RHR Heat Exchanger model

Representative foundation type was selected among those installed in Kashiwazaki-Kariwa nuclear power plant unit 7 (KK-7: ABWR, 1356MWe) operated by Tokyo Electric Power Company. RHR (Residual Heat Removal System) heat exchanger, which is one of the most important systems, was chosen as the representative model. Figure 11 through 12 show the models fixed on the shaking table. The reinforced concrete block, which has the same weight (about 330 kN) and length with the actual RHR heat exchanger, was installed on two concrete equipment bases by steel supports. One of the steel supports was fixed to the concrete equipment base, and another was connected by the manner that it could be slid in the longitudinal direction. Four M48 anchor bolts were used to fix RHR heat exchanger model to each equipment base. Initial fastening force of anchor bolts was 3 kN-m.

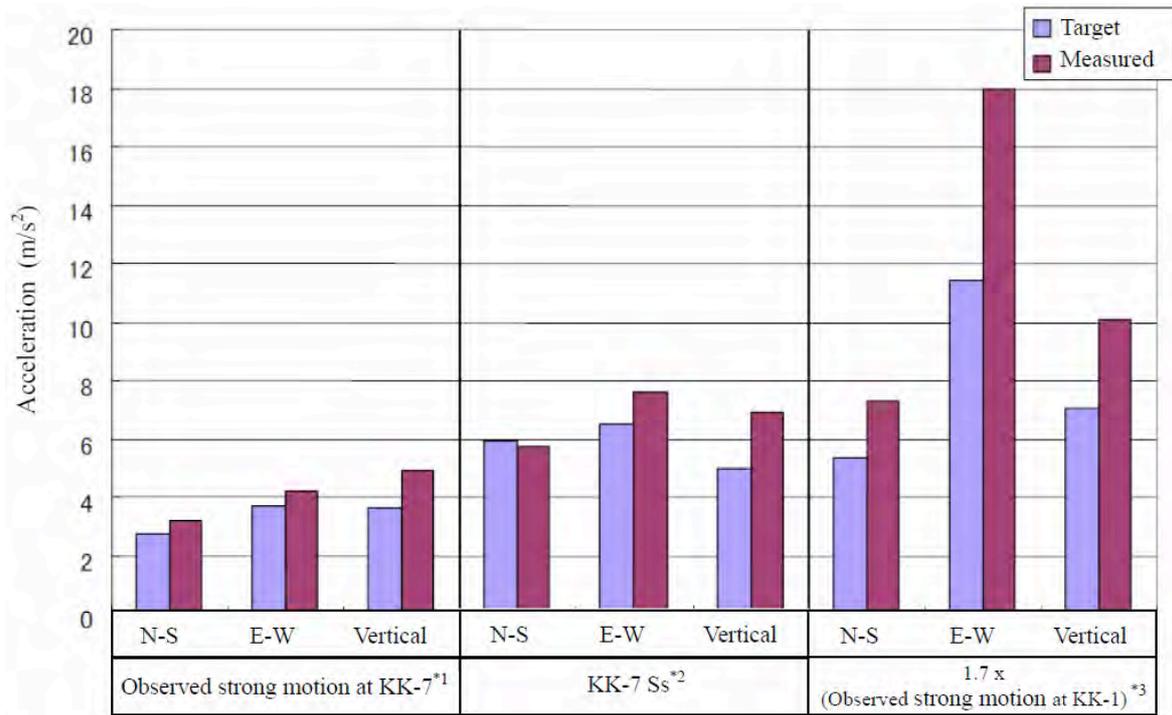
Figure 13. Maximum acceleration of input motions

Figure 13 compares the maximum accelerations observed at the reinforced concrete slab of the test models with the target values of each input motion. It shows that three motions were applied successfully as planned acceleration level. The maximum acceleration reached to  $18 \text{ m/s}^2$  which is 2.6 times of the actually observed strong motion at KK-1 in the Niigataken Chuetsu-oki Earthquake in 2007. However, no visual damage could be found on the surfaces of concrete bases and anchor bolts.

- \*1: Observed strong motion at KK-7 R/B basemat during the Niigata ken Chuetsu-oki Earthquake
- \*2: Response at KK-7 R/B basemat for Design Basis Earthquake Ground Motion, Ss declared on May 22, 2008 by Tokyo Electric Power Company
- \*3: 1.7 x (Observed strong motion at KK-1 R/B basemat during the Niigataken Chuetsu-oki Earthquake)

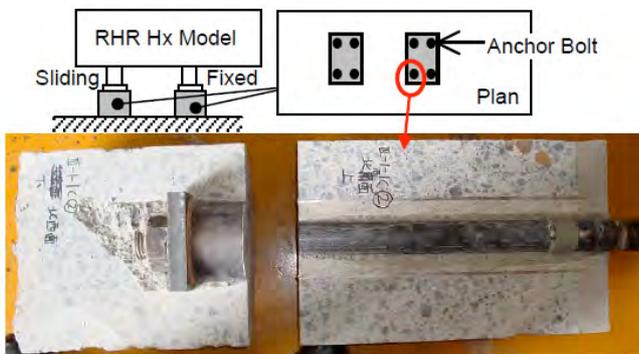
Figure 14. Concrete section around anchor bolt

Figure 14 shows the concrete around an anchor bolt cut after three seismic tests. As a result of visual inspections, no significant damage of bolts and surrounding concrete was observed.

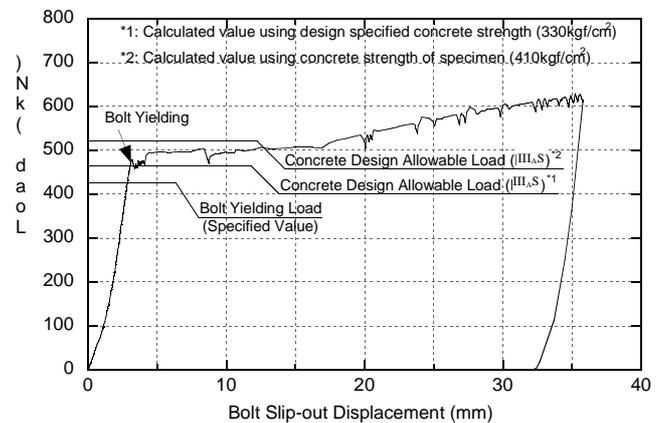
Figure 15. Load – Displacement relationship in static pull-out test

Figure 15 shows the load – bolt pull-out displacement relationship obtained from the static pull-out test. Anchor bolts yielded and extended, and it was confirmed that the concrete anchoring portion maintained pull-resistance beyond the design allowable value even after three times of shaking tests.
