Preliminary Results of a 1:4-Scale Prestressed Concrete Containment Vessel Model Test^a

M. F. Hessheimer¹⁾, E. W. Klamerus¹⁾, G. S. Rightley¹⁾, R. A Dameron²⁾, S. Shibata³⁾, S. Mitsugi³⁾ and J. F. Costello⁴⁾

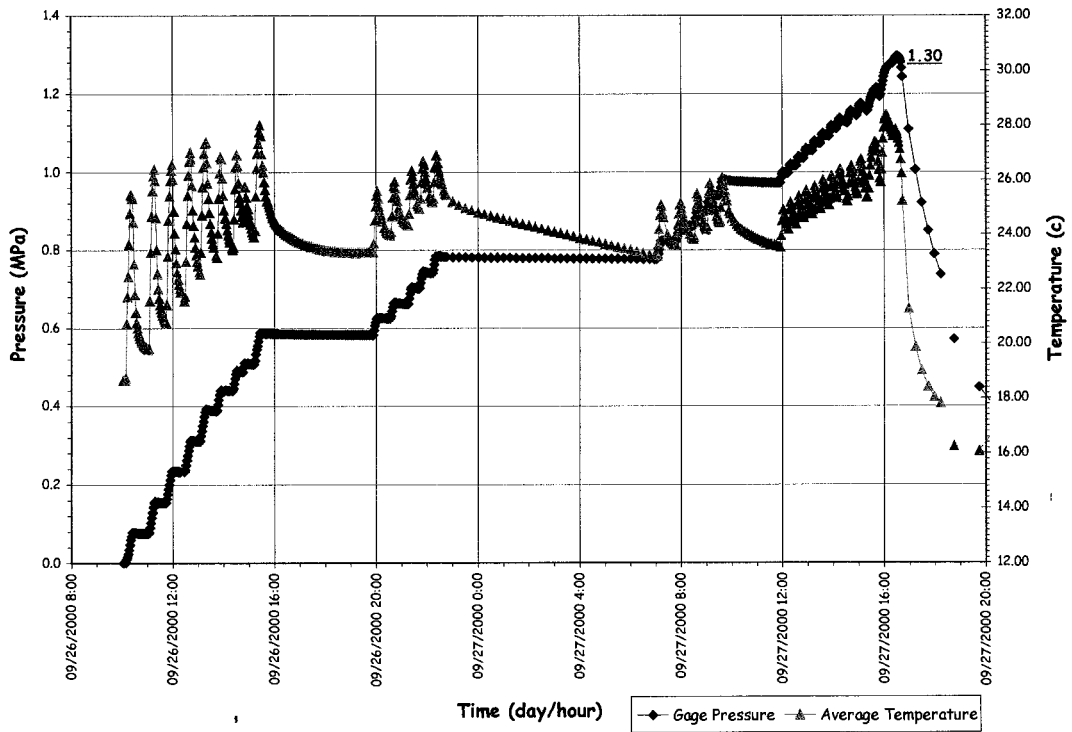
Figure 4 Limit State Test Pressure and Temperature Time History

The Limit State Test (LST), conducted on September 26 & 27, 2000, fulfilled the primary objectives of the PCCV test program, i.e., to investigate the response of representative models of nuclear containment structures to pressure loading beyond the design basis accident and to compare analytical predictions to measured behavior. Figure 4 shows the average temperature and pressure time history inside the model during the LST. As the model was pressurized, periodic leak checks were conducted by holding pressure and monitoring pressure and temperature and calculating the apparent leak rate. Figure 5 shows the calculated leak rates at 1.5, 2.0 and 2.5 Pd. At 2.5 Pd a calculated leak rate of 1.6% mass/day gave the first evidence that the pressure boundary had been breached and subsequent analysis of the acoustic data indicated that a leak in the liner had occurred during pressurization from 2.4 to 2.5 Pd. At this time, the data showed high strains (> 2%) in the liner at the edge of the equipment hatch embossment.

At this point, the model was pressurized in rapid incremental steps to approximately 3Pd, with increasing evidence of leakage and increasing liner strains. At 3Pd, it became difficult to increase pressure so the nitrogen flow rate was increased to 3500 scfm. The pressure was increased to 3.1Pd however, the pressure dropped steadily after reaching this level. The leak rate at this point was estimated to be approximately 100% mass/day. The nitrogen flow rate was then increased to the maximum capacity of the pressurization system (142 std m³/min) and the pressure was increased to slightly over 3.3Pd before the leak rate exceeded the capacity to pressurize the model. Since the pressure could no longer be increased and the supply of nitrogen was exhausted, the decision was made to begin terminating the test. The isolation valve was closed and the model was allowed to depressurize on it's own. The initial terminal leak rate was estimated to be on the order of 900% mass/day. (The maximum flow rate of nitrogen, 142 std m³/min is equivalent to 1000% mass/day.) As the model depressurized, a steadily decreasing leak rate was observed (initially decaying at 250% mass/day per hour).

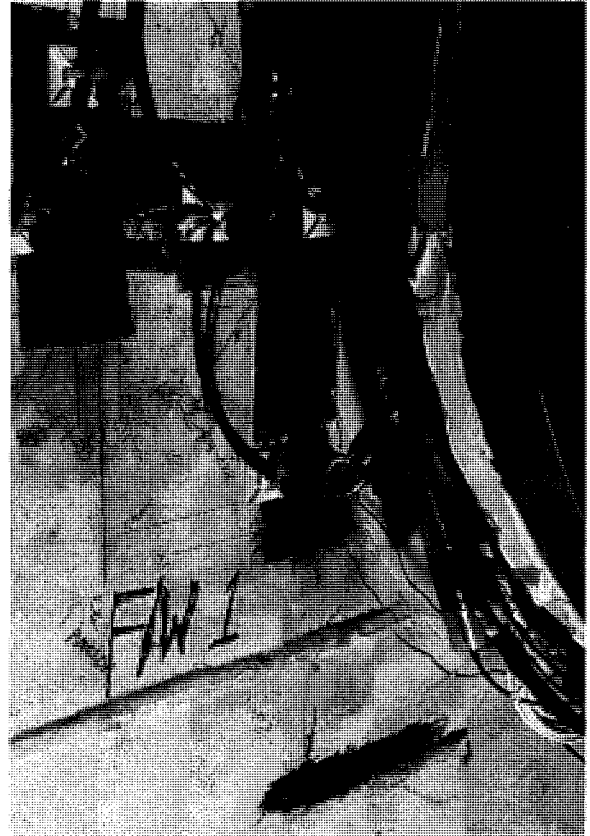
Figure 9 Liner Tear at Locations 15 (Equipment Hatch) and 3 (Feedwater Penetration)

After the PCCV model was depressurized and the pure nitrogen atmosphere was purged with fresh air, the equipment hatch cover was removed to allow personnel to enter the model and inspect the interior surface of the liner. After a thorough visual inspection, a total of 24 distinct tears at 17 different locations were discovered. (A few locations that appeared to have a tear were checked by local vacuum box testing.) Figure 8 is a developed elevation of the PCCV model showing the location of the liner tears. All of the liner tears run more or less vertically (i.e. driven by the hoop strain) appear to be associated with a field weld, i.e. none of the tears occurred in the main body of the individual liner panels. A series of acoustic events, keyed to the pressure levels at which they were observed are also shown in the figure. The acoustic data, along with the liner strain data, strongly suggests that the liner first tore at the edge of the equipment hatch embossment at approximately 2.5Pd, while the tears at either end of the Feedwater penetration insert plate occurred very near the end of the LST around 3.0Pd.

While the tears at these locations appear to be associated with major geometric discontinuities, the remainder of the tears appear to be randomly distributed around the middle of the cylinder wall where, as noted previously, the global hoop strains were only on the order of 0.4%. Figure 9 shows a tear at the edge of the equipment hatch embossment (#15) and at the edge of the feedwater penetration insert plate (#3). Figure 10 shows a typical 'free-field' liner tear (#2). Further investigation gives evidence that every tear location was also subject to some post-weld repair work, i.e. that the weld was ground or that the initial weld was removed and replaced. This suggests that local geometric discontinuities associated with the repair of the weld, such as local thinning or removal/replacement of the back-up bars, may have made a significant contribution to the initiation of any specific liner tear. Further metallographic examination of individual tears may provide further insight into the mechanism(s) that led to the formation of the liner tears.
