## Assessing and Managing Aging of Nuclear Safety-Related Concrete Structures – Recent AECL Experiences

1) CANDU Services Civil Engineering, Atomic Energy of Canada Limited, Mississauga, ON, Canada

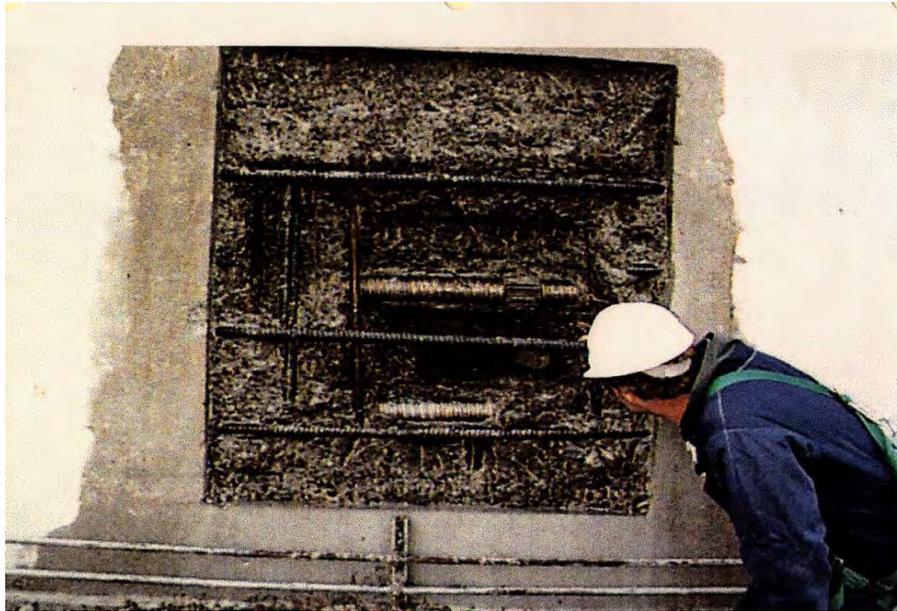
**Figure 3 In-situ Stress Measurements**

- Non-destructive tests and laboratory analysis of concrete cores;
- Overcore concrete stress measurements;
- In-situ stress measurement (Figure 3) and inspection of post tensioned cables for signs of corrosion (Figure 4).

In the areas of post-tensioning anchorages, concrete serves mainly a secondary function of protecting anchorage heads from corrosion. Despite the very poor concrete quality of the concrete in the post-tensioned recesses (Figure 5), the anchorage heads were in a reasonably good condition. Exposed rebar and post-tensioned tendons in the wall did not reveal any significant signs of corrosion. Deterioration was mainly due to Alkali Aggregate Reaction (AAR). All measured stresses were compressive as expected, generally in the design range.

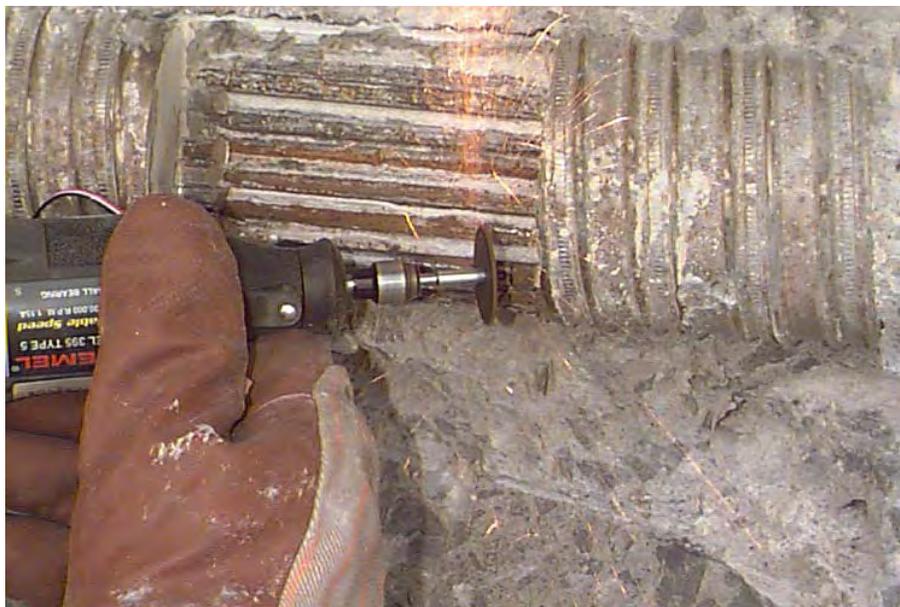
**Figure 4 Inspection of Prestressing Cables**

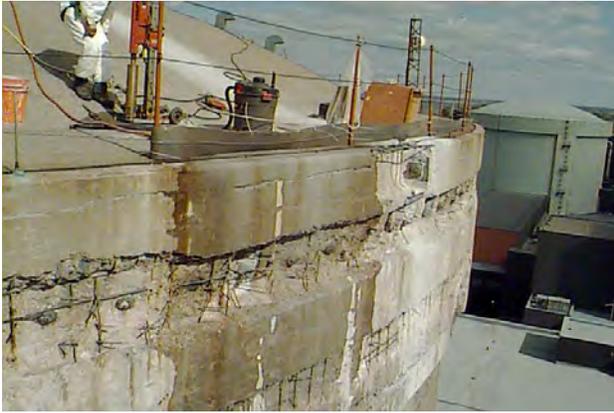
**Figure 5 Condition of the Ring Beam Before Repair**

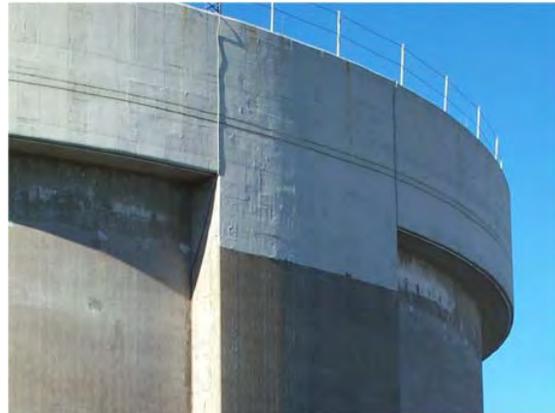
**Figure 6 Condition of the Ring Beam After Repair**

To minimize future expansion due to AAR and to protect reinforcing and prestressing steel from corrosion, the water ingress had to be prevented. Deteriorated concrete of the ring beam was replaced using cement based grout material. Subsequently, Glass Fiber Reinforced Polymer (GFRP) sheets were applied. Prequalifying work was carried out to test the repair method prior to application. Figure 6 shows the ring beam after repair.

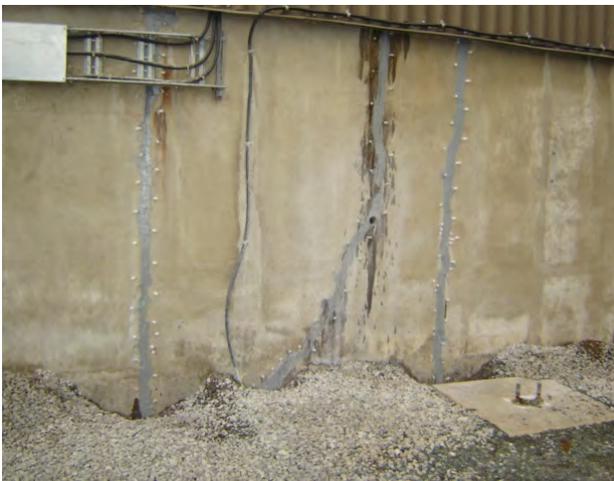
**Figure 7 Epoxy Injection of Cracks in T/B Walls**

Repair work was conducted. Cracks in concrete walls were repaired using epoxy injection (Figure 7). The quality of repair was assured based on the inspection of extracted cores over a few repaired cracks. The penetration of epoxy into the crack was examined using measurement microscope. Subsequently, the core was broken by hitting with the hammer in vertical direction to ensure that it would not break along the line of repaired crack. One joint in the concrete wall, where a leakage was suspected, was repaired using polyurethane injection.

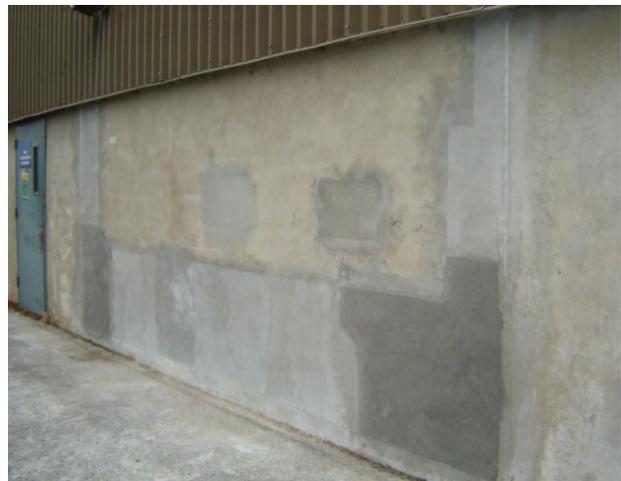
**Figure 8 Repaired T/B Walls**

Areas of delaminated mortar on the block wall were removed using saw cut and repaired using repair mortar (Figure 8). After repair of delaminations was completed, joints between the block wall and concrete wall were redefined and filled with polyurethane sealant.

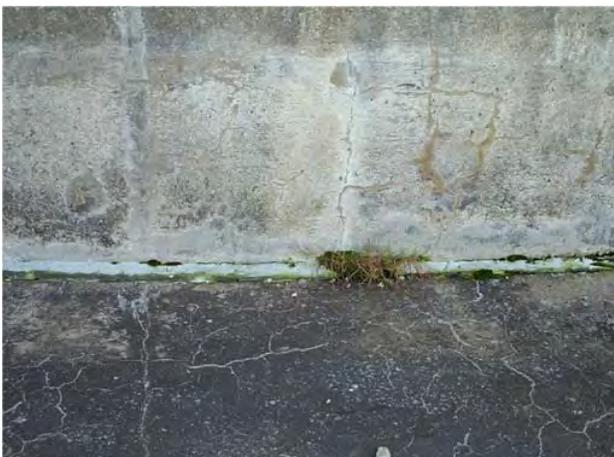
**Figure 9 Deterioration of Sealant at the Bottom of R/B**

During the spring of 2005, the leakage of water had been noticed at the bottom of the Gentilly 1 Reactor Building perimeter wall adjacent to the top slab of the North tunnel. The condition of the joint on the outside of the R/B was inspected. Although the sealant did not seem to become brittle, the bond between the sealant and the concrete had deteriorated (Figure 9).

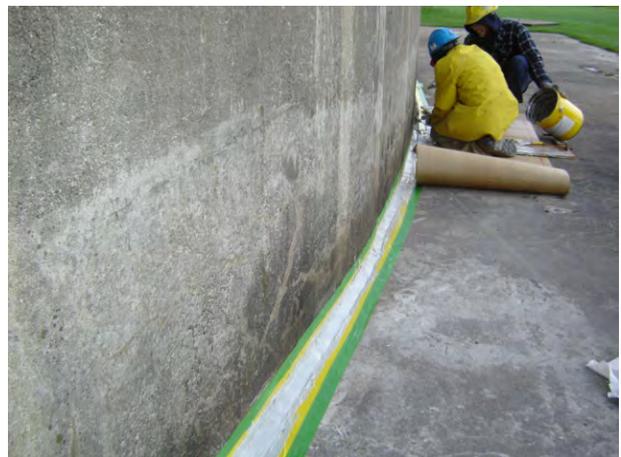
**Figure 10 R/B Bottom Joint Sealant Repair**

Repair work to replace the joint was carried out (Figure 10). Prior to repair of the joint around the R/B wall, the old joint material was removed and the joint was cleaned and then sealed using urethane based joint sealant material.
