INVESTIGATION ON IMPACT RESISTANCE OF STEEL PLATE REINFORCED CONCRETE BARRIERS AGAINST AIRCRAFT IMPACT PART 1: TEST PROGRAM AND RESULTS

Keywords: Steel Plate Reinforced Concrete Structure, protective capability against aircraft impact, impact test

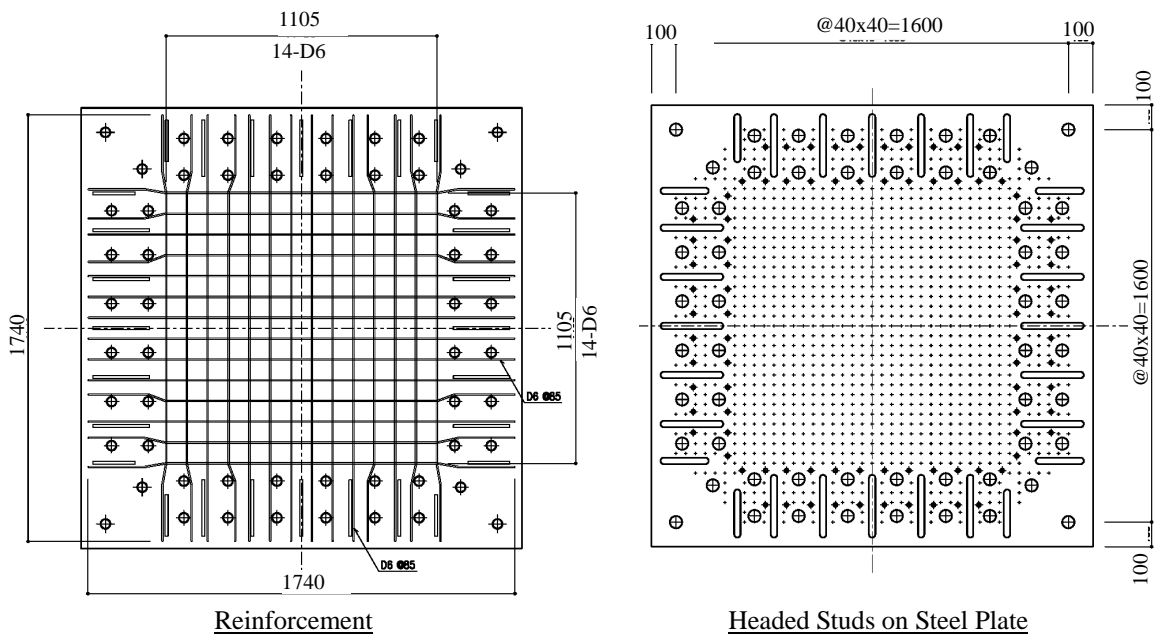
Fig.2 SC Panel (HSC-80)

The SC panels were 1.7m square with a parameter of panel thicknesses of 6, 8, and 12cm. The panel thicknesses were determined from preliminary analyses by a discrete element method (DEM) (Sawamoto et al. 1998), to obtain test data of typical failure modes such as perforation and non-perforation. The thickness of the steel plate was about 1/70 to 1/100 of the panel thickness, decided in accordance with the thickness of the SC panel. In the tests, the SC panels were mounted on a reaction frame at their four corners by tensioned bolts. In order to avoid unexpected damage near the support points, thick support beams were placed around the SC panel.

Figure 2 shows the details of the SC panel for test HSC-80 as a typical example. The results of material tests on the concrete, steel plates and reinforcing bars are summarized in Table 2.

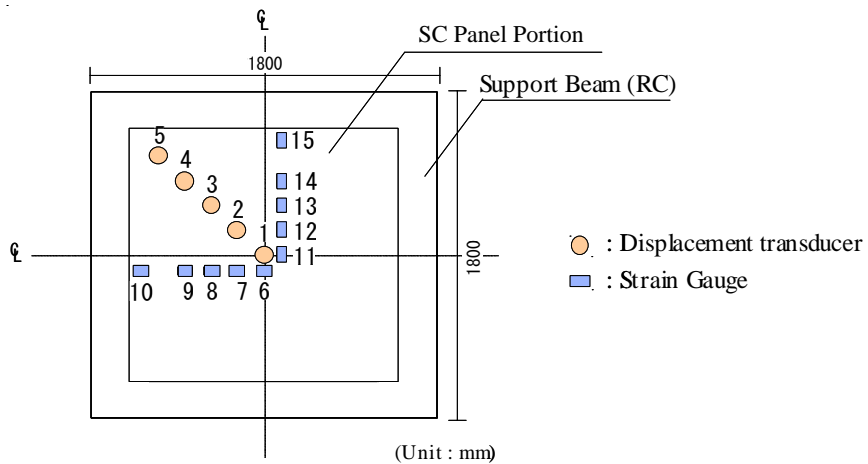
To evaluate the aircraft model's deceleration, one accelerometer was mounted on the fuselage and one on the engine, as shown in Figure 6. The SC panels of FSC-80 and HSC-120 were instrumented with displacement transducers and strain gauges on the rear-face steel plate, with the layout shown in Figure 6. Furthermore, high-speed video cameras were placed perpendicular to the flight trajectory on the front face of the SC panel to record the projectile's impact into the SC panel. Another high-speed video camera was placed on the back face of the SC panel to observe the failure mode on back surface, such as initiation of perforation and debris scattering after perforation.

(b) Displacement and Strain Measurement of FSC-80 and HSC-120
Fig.6 Measurement Plan

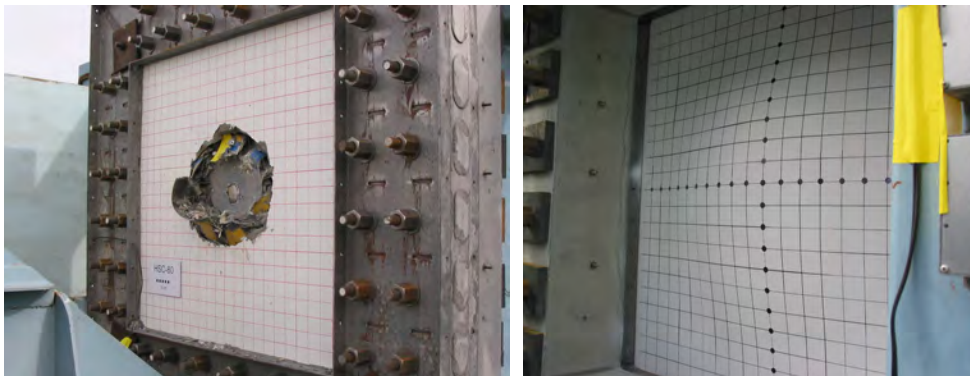
(b) HSC-80 panel

As shown in Figure 9(c) of test HSC-80, the front-face concrete suffered severe damage. Aircraft model penetration formed a shear cone in the SC panel with a 6.5cm depression at the center. The diameter of the damaged area on the front-face was about 45cm. The aircraft fuselage penetrated the damaged part into the internal concrete. The engine rebounded to front of the SC panel. No cracks were observed on the rear-face steel plate of the SC panel and no debris scattered backward.

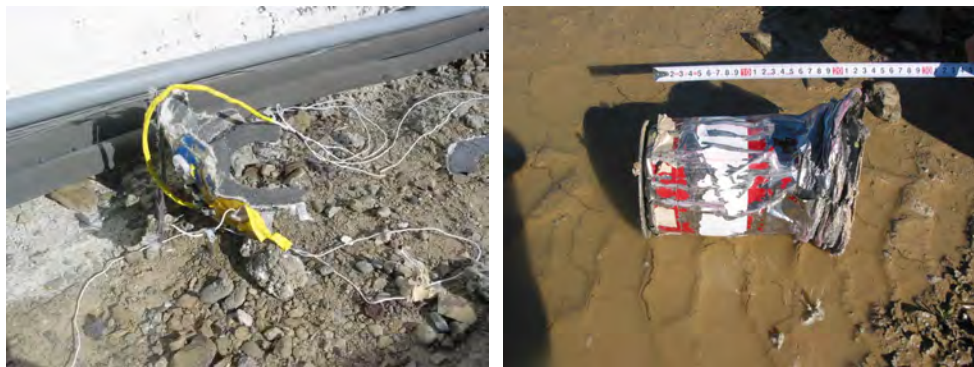
Fig.10 Damage to FSC-80 Aircraft Model

Figure 10 shows photos of the fuselage and the engine damaged during the impact test of FSC-80, as a typical example. It shows that the aircraft model was almost completely destroyed during the impact test, most of the fuselage turning into powder while only a small aft section on which the accelerometers were attached remaining intact. The engine was seriously deformed, with 15cm of the front section being crushed. The test results indicate that damage to the aircraft model increases with the thickness of the SC panels.

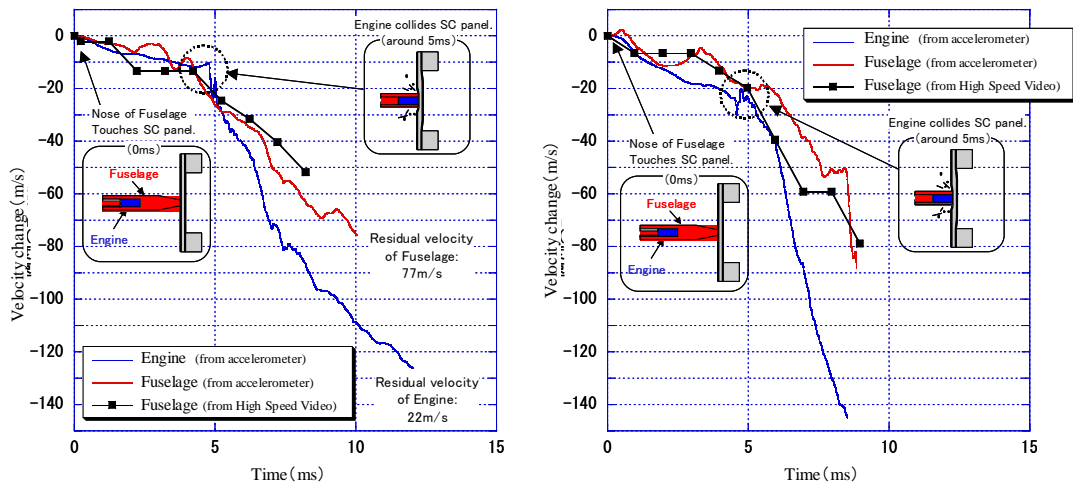
Fig.11 Deceleration Curves of Fuselage and Engine

Deceleration curves of FSC-60 and FSC-80 are shown in Figure 11. The velocity time histories of the engine were obtained from on-board accelerometers, while those of the fuselage were obtained from on-board accelerometers and a high-speed video camera that showed the motion of the aft portion of the aircraft model. The time 0ms on the time axis denotes the instant at which the projectile's nose touched the SC panel. According to the results, the decelerations of the fuselage and the engine were relatively gradual in both test cases until the collision of the front end of the engine. The velocity changes for the engines and fuselages were about 20m/s in the first 5ms. Thereafter, the engines decelerated more quickly, being separate from the fuselages. The velocity change for the engine of FSC-60 was about 90m/s over the following 5ms.

For FSC-60, the deceleration curves of the engine and fuselage where perforation occurred show that the change of speed becomes smaller, and after about 8ms cracks appeared on the rear-face steel plate of the SC panel. However, for FSC-80, where no perforation occurred, the engine kept decelerating and rapidly approached zero velocity.
