## DYNAMIC BEHAVIOR AND FUNCTIONAL RELIABILITY OF WWER 1000 TURBINE FOUNDATION

The presented paper shows a multidisciplinary study on the dynamic behaviour and functional reliability of WWER1000 turbine foundations built in NPP Kozloduy, Bulgaria.

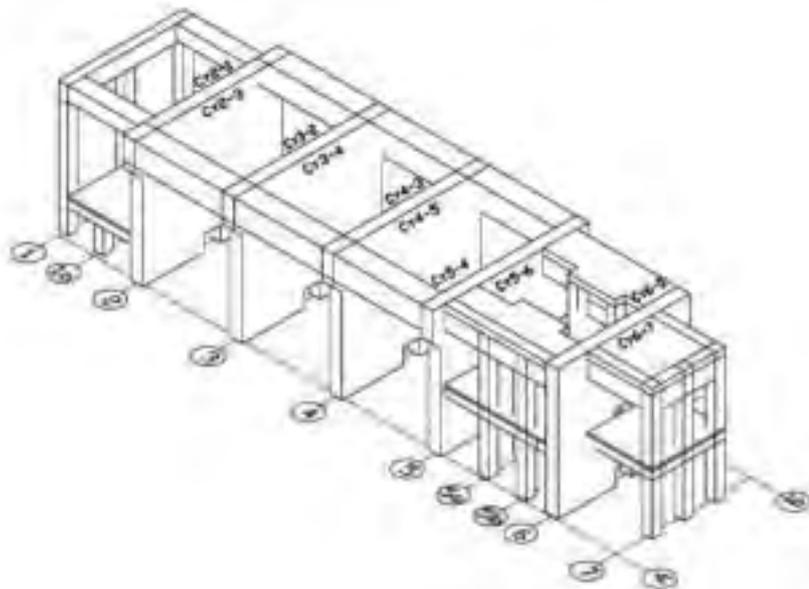
*Fig.1 – General view of the turbine foundation*

The turbine foundation is a complicated reinforced concrete consisting of bearing walls and frames. It is 86 m long, between 10 and 20 m wide and about 21.40 m high. The High pressured turbine is situated between the first and second transversal axis. The three Low pressure turbines are situated between the third, fourth and fifth axis. The Generator is situated between the fifth and sixth axis and the Exciter – between the sixth and seventh transversal axis.

The structure of the turbine foundations is of mixed type – part of it is cast in-situ reinforced concrete wall structure and the other part is assembled frames from prefabricated RC elements. The vertical bearing

Figure 1 shows a general view of the turbine foundation.

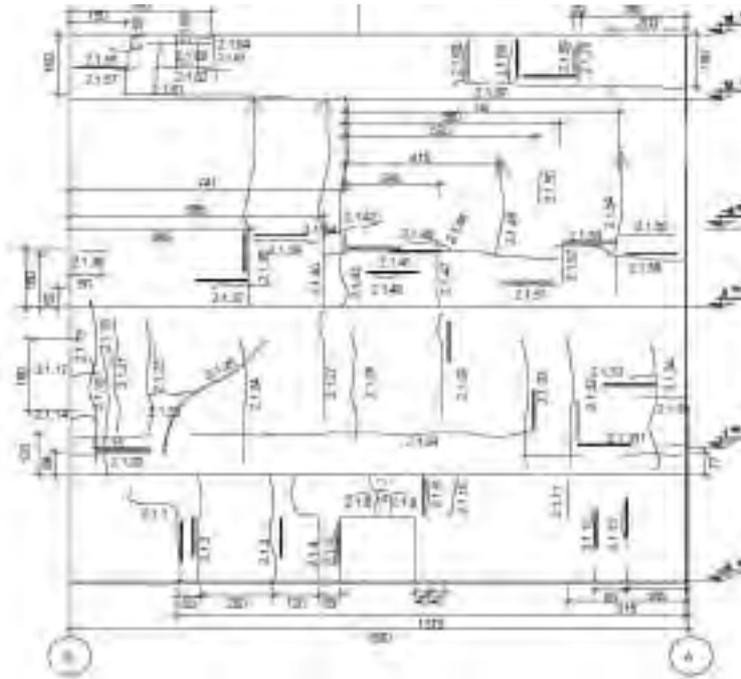
*Fig. 2 – Wall on axis 2 – map of the cracks*

- ❖ **Mapping of all available cracks**, including those, which appeared immediately after concreting of the foundation. On Fig. 2 is shown a typical picture of cracking of the transverse walls. For all cracks is measured width and length and for about 40% of them depth of crack is measured as well.

The main conclusion from the tests of the foundation in **stage 1** is that the most probable reason for the cracking is the temperature. This conclusion is based mainly on the observed positioning of the cracks and the depth of penetration. The intensive crack mapping of all surfaces is supporting this conclusion. The temperature distribution in the foundation structure, in the moment of concreting and concrete hardening, and during normal operation, is similar and lead to similar deformation in the structure. Therefore the old epoxy injected cracks open again and there is still development of new cracks. The main cracks are some kind of work joints, which allow the turbine foundation to expand and shrink and prevent the appearance of unfavorable structure stress fields. This is also confirmed by the fact that the more deformable parts of the construction are less cracked. Nevertheless the cracks should be repaired in a way that allows from the one side them to function as work joints and from the other side prevents the structure deterioration due to corrosion and carbonization. In the same time it is not necessary to recover the structure stiffness because the temperature processes in the foundation will lead to new opening and there is sufficient structure capacity (as estimated in stage 2).

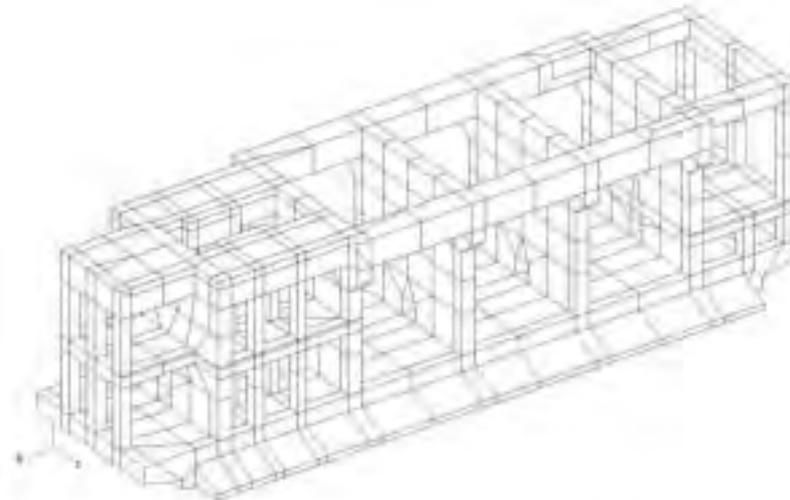
*Fig.3 – General view of the first model generated by solid elements*

Two 3D models are generated. The first one consists of solid elements. It is developed using FEMAP preprocessor and is analyzed with the program STARDYNE. The model consists of 919 solid elements, 61 mass elements and 1719 nodes each with three DOF. The aim of that model is to study the general dynamic behaviour and soil structure interaction as well as to create a reference for quality assurance purposes. The general view of the model is shown on Fig.3.

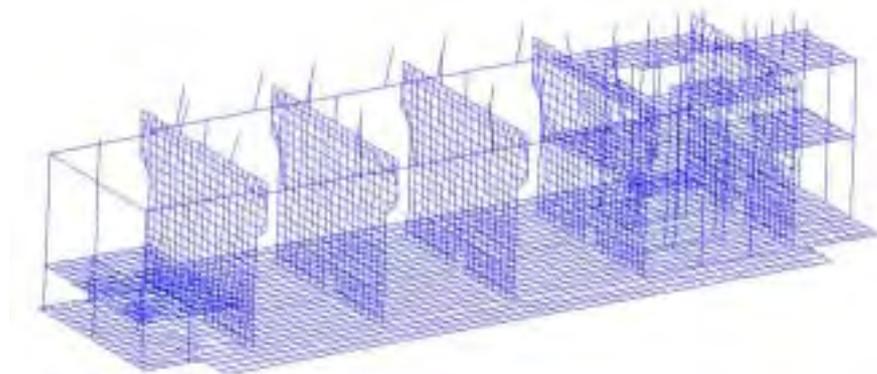
*Fig.4 – General view of the second model generated by beam and plate elements*

The second model is a refined 3D model with beam and plate elements. The modeling and analysis of this model is performed with software system STAAD III 23W. The model consist of 4056 nodes, 362 beam elements and 3741 plate elements. The beam elements are with 6 DOF in each node, and the plate ones – 5 DOF. The aim of the model is to study the stress and strain distribution within the structural elements. The general view of the second model is shown on Fig.4

As a referent model for static and dynamic analysis is used the second model, and the first - solid element model is used for verification.

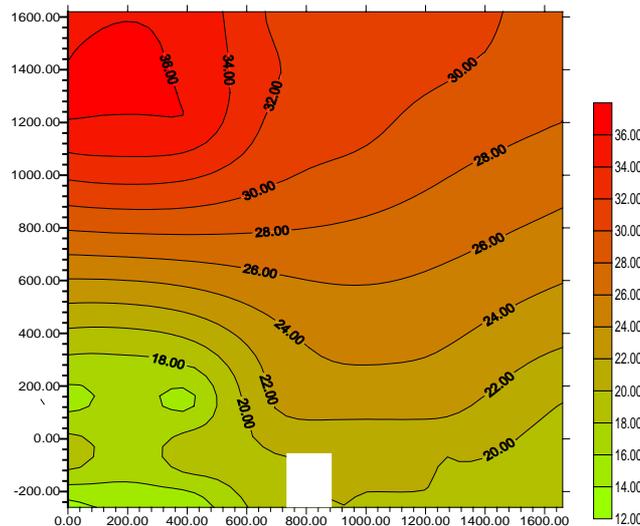
Fig. 5 Temperature field at the wall on axis 2, turbine normal operation

To define the tempered case, in-situ multiple measurements of temperature of the air and the concrete were conducted. The basic temperature of the turbine foundation elements is 20°C. On Fig. 5 a graphic illustration of the temperature distribution at a support wall is shown.

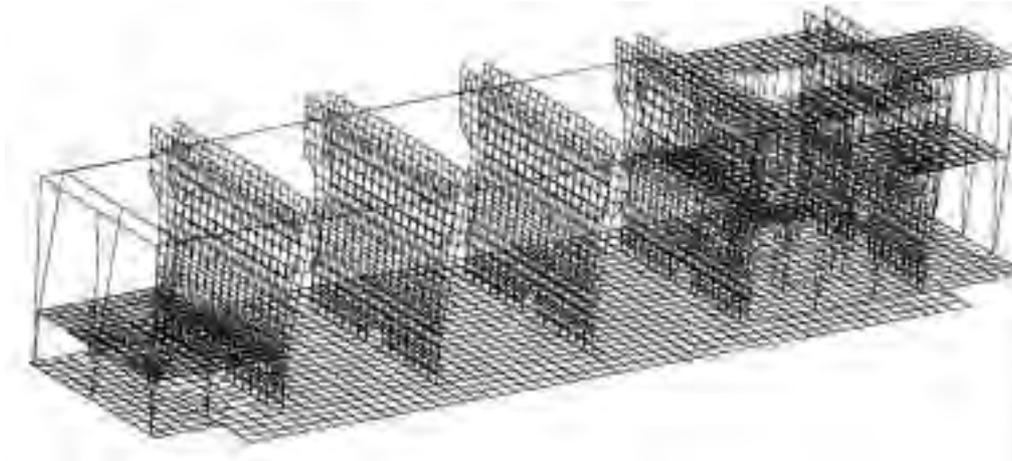
*Fig.6 – First mode of vibration (2,5 Hz)*

- ❖ The first mode of vibrations is characterized by predominantly longitudinal response at 2,5 Hz, i.e. the stiffness of the structure in longitudinal direction is lower than in transverse direction. The first mode of vibrations of the turbine foundation is shown in Fig.6.

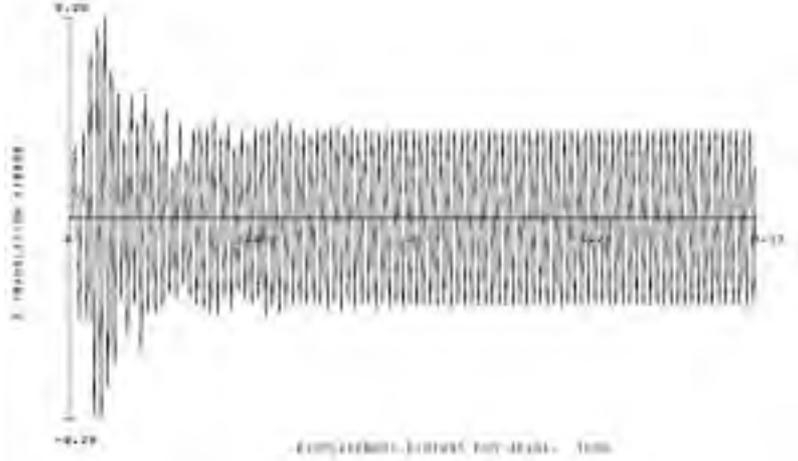
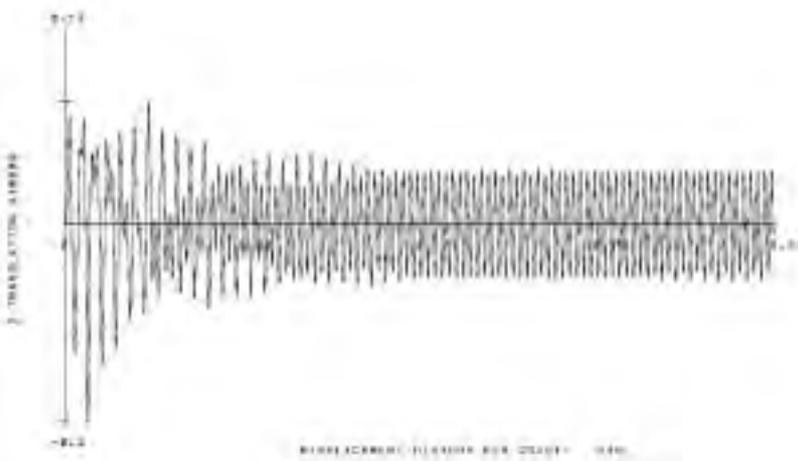
*Fig. 7 – Horizontal vibrations in transverse direction at axis 2 – 12 Hz transversal excitation of thrust bearing.*

*Fig. 8 – Horizontal vibrations in transverse direction at axis 7 - 12 Hz transversal excitation of thrust bearing*

*Table 1 – Comparison between calculated and measured horizontal amplitudes (mm), 12 Hz transverse harmonic excitation*

axis 1	axis 2	axis 3	axis 4	axis 5	axis 6	axis 7
Numerical analys at 12 Hz - transversal	0.0131	0.0124	0.007	0.016	0.0044	0.0031	0.006
Measurement at 810 rev/min –transversal	0.0072	0.0107	0.0089	0.0080	0.0037	0.0024	0.0077

The data in Table 1 show good coincidence between analytical results and measured data for all axis without axes 4 and 5. The reason for the observed differences most probably is due to the local natural mode close

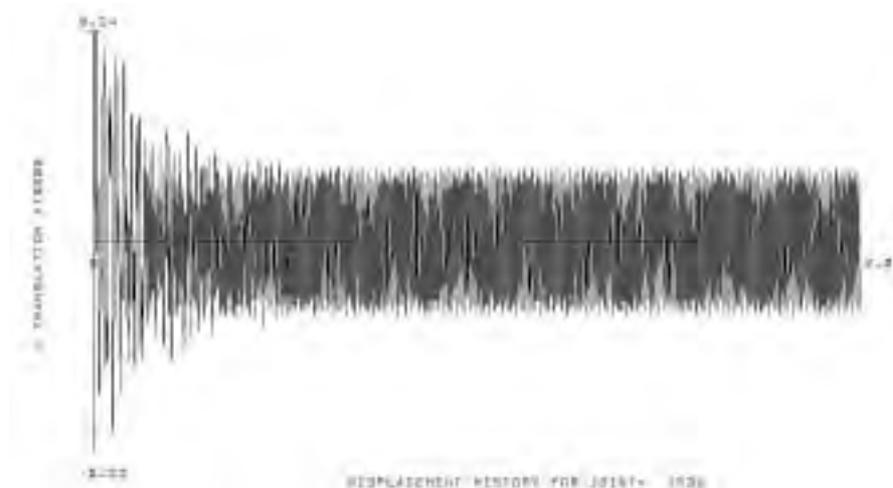
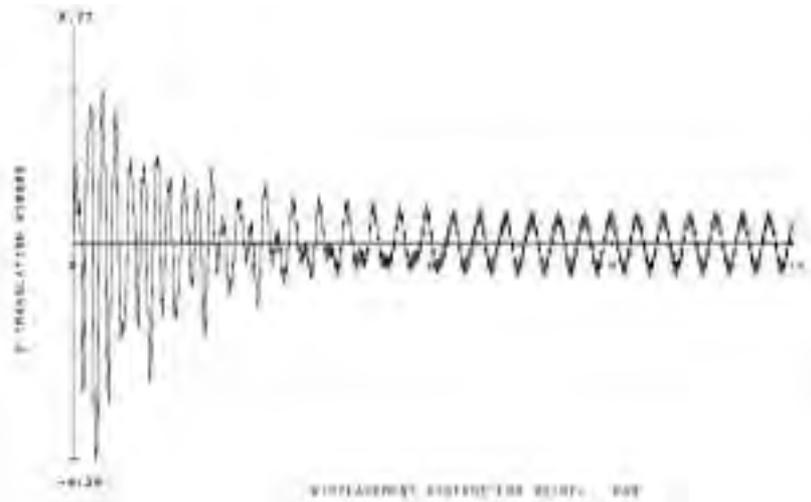
*Fig. 9 – Horizontal vibrations in transverse direction on axis 2 - 25 Hz transversal excitation on the thrust bearing*

Fig. 10 – Horizontal vibrations in transverse direction on axis 7 - 25 Hz transversal excitation on the thrust bearing

*Table 5 – Comparison between calculated and measured vertical amplitudes (mm), 25 Hz transverse harmonic excitation*

axis 1	axis 2	axis 3	axis 4	axis 5	axis 6	axis 7
Numerical analys при 25 Hz	0.0052	0.003	0.004	0.007	0.004	0.003	0.003
Measurement at 1500 rev/min	0.006	0.007	0.004	0.005	0.003	0.005	0.011

- The comparison between analytical and measured results shows that:
- ❖ The analytically determined amplitudes do not differ significantly from the measured ones in axes 1 to 5. There is some exception for axis 6.
  - ❖ The big difference between the analytical results and test is in axis 7 – thrust bearings of the exciter. Here the measured values differ almost 2 times from the analytical ones.

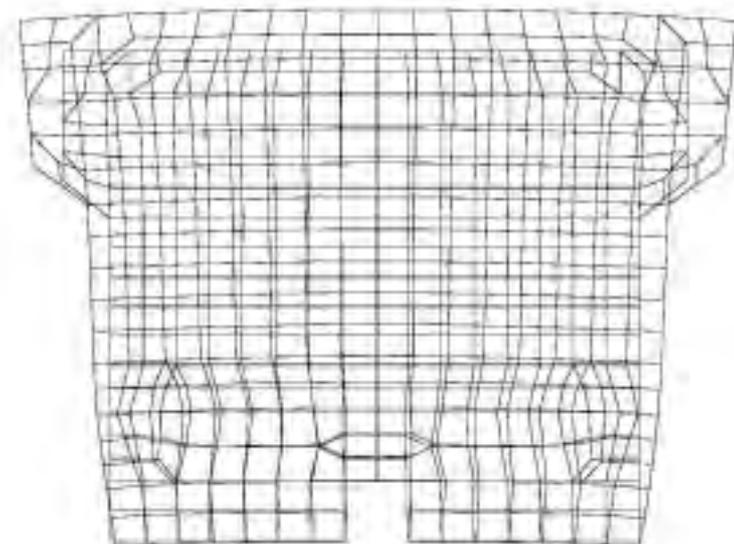
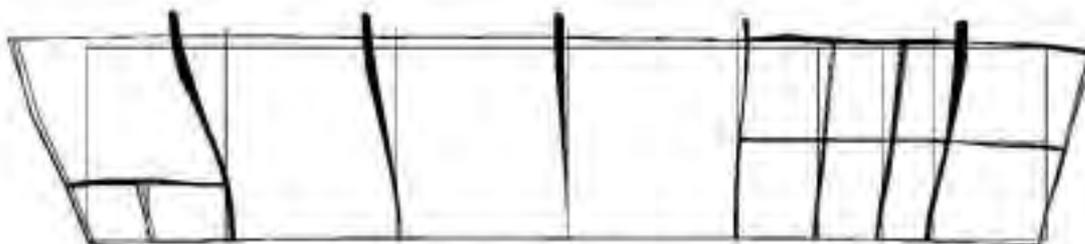
*Fig. 11 – Deformation of the wall in axis 2 due to temperature*

*Fig.12 – Deformation of the structure due to temperature effects.  
Longitudinal cross section.*

The adjustment of the turbine shaft is done in cold state and the deformations due to gravity loads should be constant. After starting of turbine operation, as a result of the foundation heating, deformations appear caused by differential temperature. Those deformations are determined separately and shown in Table 6 and in Figures 11 and 12..

Analyzing the deformed scheme of the foundations, it appears that the fundament “spreads” to the left and to the right, and the deformations of the first axes is larger than those on axes 5, 6 and 7. In vertical direction the foundation mat is declined to the right (Reactor department).

When the foundation is loaded only with temperature loads there is lowering of axes 1 and 7 and rising of axes 3 and 4.

In transversal direction for all axes there is “spreading” to the left and to the right from the thrust bearings supports, it is most strongly expressed in axes 1, 2, 3 and 4 (frames).

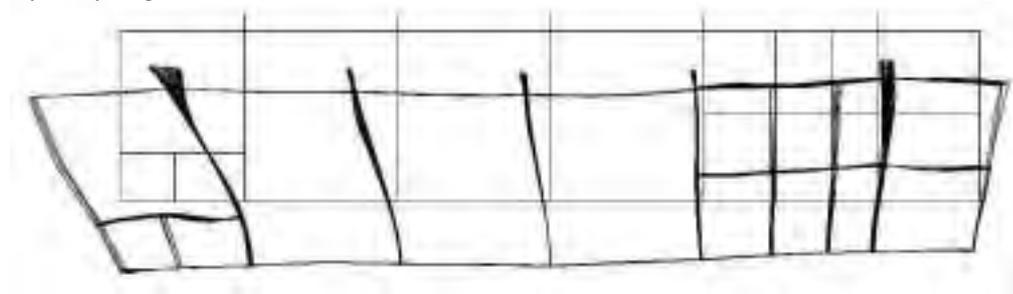
*Fig.13 – Deformed scheme for combined action of temperature and operation loads*

The picture of the deformations in transverse direction correlates with the picture of wall cracking. As mentioned, the first cracks in the walls appeared when the foundation was cast. They were results of exothermic process, which took place during the maturing of the concrete. The temperature distribution at that time was similar to the temperature distribution in operation state. The areas closer to the base mat are cooler than those at higher elevations. Because of this similarity the old cracks (that were injected) open again. The cracks act as work joints and allow the turbine foundation walls to expand. The cracking in horizontal direction depends on the temperature expansions in vertical and longitudinal direction, and the inclined cracks are because of the expansion in transverse direction.
