NDE STUDIES ON CRDMS REMOVED FROM SERVICE

ABSTRACT

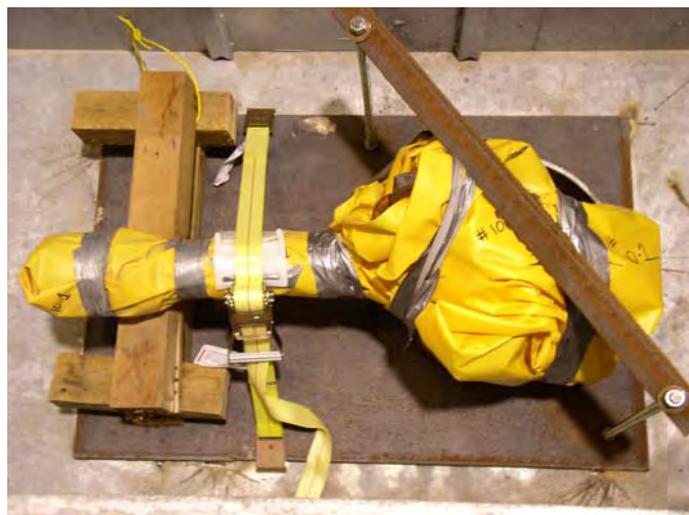
Fig. 2. A CRDM penetration-nozzle assembly as received by PNNL.

Figure 2 shows a CRDM penetration-nozzle assembly as received at PNNL from the North Anna 2 reactor. This work is being conducted as a collaborative effort between the U.S. NRC and the Electric Power Research Institute (EPRI). The North Anna 2 CRDMs were provided by EPRI for these studies. In the figure, a CRDM nozzle assembly is shown wrapped, bolted, and strapped to the bottom of a shipping container. The outer wrapper for the assembly is taped to help prevent the spreading of radioactive contamination. The portion of the CRDM nozzle assembly that would be above the vessel's top head is shown at the left and resting on the lumber (wooden) portion of the attachment fixture. In the figure on the right and beneath the wrapper is a portion of the vessel's top head, flame cut from its location and surrounding a degraded CRDM nozzle seal weld.

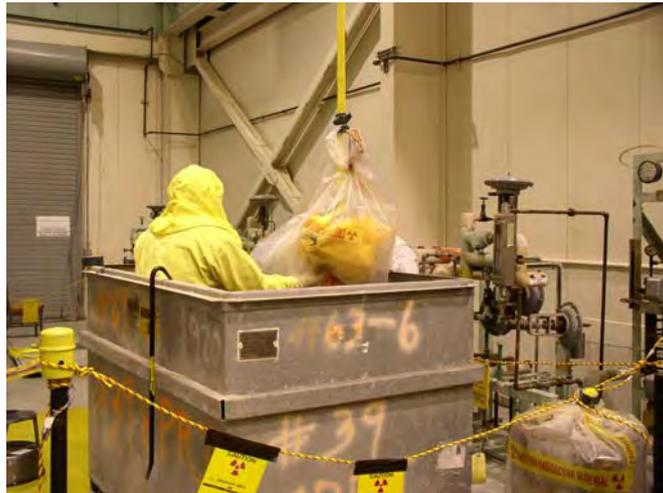
Fig. 3. CRDM muzzle assembly being removed from shipping container.

In Figure 3, a CRDM nozzle assembly is shown being lifted from the container in which it was sent to PNNL. The assembly is surrounded by wrapping additional to that shown in Figure 2 to prevent escape of radioactive contamination that may have spread during transport. The staff member shown is assisting by guiding the lift by an overhead crane (not shown).

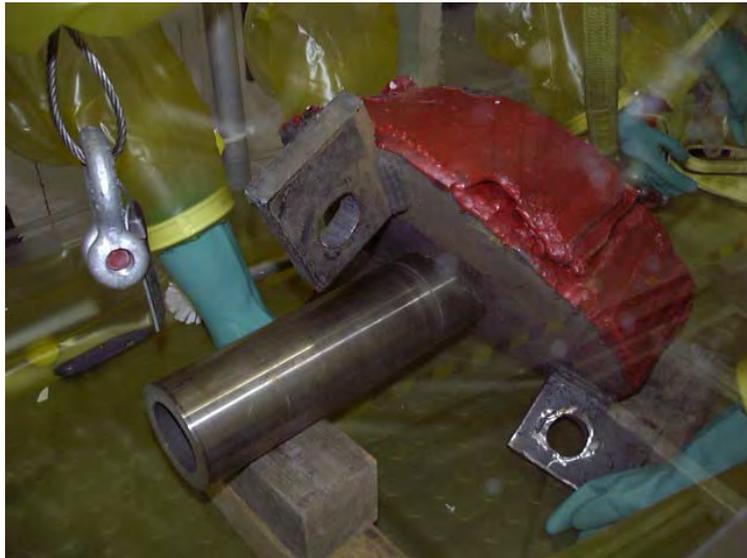
Fig. 4. CRDM penetration-nozzle assembly in glove box.

Figure 4 shows a CRDM penetration-nozzle assembly, which was removed from service, in a glove box. Before the CRDM penetration-nozzle assemblies can be inspected by the NDE techniques, the assemblies must be decontaminated in order to minimize the radiation exposure for PNNL personnel. In the figure, the flame cut surface of the vessel top head is shown after being painted to trap small amounts of contamination there. On the left in the figure is the CRDM penetration tube that extends above the vessel's top head. This portion of the assembly is not wetted by the reactor's coolant water and so is largely free of radioactive contamination. The wetted surfaces of both the top head and the penetration tube are coated with a highly radioactive, hard oxide layer. PNNL conducted decontamination of the CRDM using a CO₂ pellet blasting process and repeated application of replica material. These worked well for removing the loose contamination but did not reduce the dose level. Thus, it was concluded that the oxide layer must be removed in order to reduce the dose. The removal of this hard oxide layer is accomplished by repeated application of a commercially available etchant-gel. The gel dries after application in about 2 hours, and then the etched portion of the dissolved reactive oxide layer can be wiped away with a cloth.
