## ASSESSING PRIMARY WATER STRESS CORROSION CRACK MORPHOLOGY AND NONDESTRUCTIVE EVALUATION RELIABILITY

## **ABSTRACT**

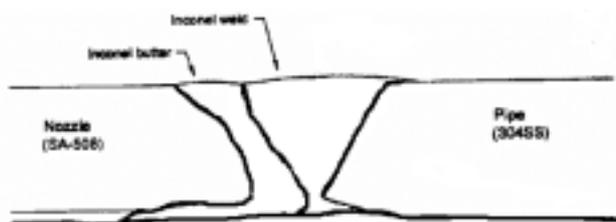
*Fig. 2. Product forms in dissimilar metal.*

Figure 2 shows the five product forms in the DMW in the 'A' hot leg nozzle to primary coolant pipe weld in the V.C. Summer Nuclear Station reactor coolant system (RCS). The nozzle is made of alloy 508, has a typical wall thickness of 5 cm, and is clad with 308 or 309 stainless steel that is typically 6 mm thick. The nozzle is buttered with alloy 182 to a thickness of approximately 1.5 cm on the weld preparation surface. Alloy 182 is used for the weld metal that joins the alloy 304 stainless steel pipe to the buttering. These product forms can vary; for example, the cold legs used at the V.C. Summer Nuclear Station have statically cast stainless steel elbows instead of alloy 304 safe-ends.

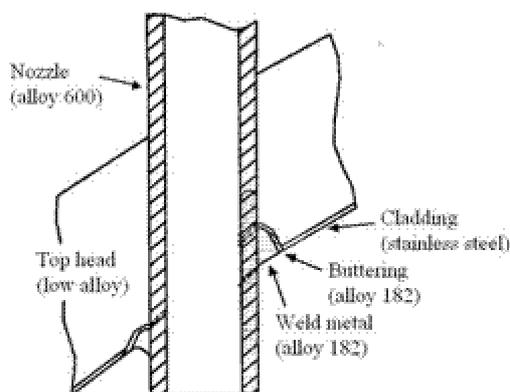
*Fig. 3. Product forms in CRDM penetration assembly.*

Figure 3 illustrates the product forms for the CRDM Nozzle. Five (5) product forms are shown in the figure. The alloy 600 tube (nozzle) has a typical outside diameter of 10 cm and a wall thickness of 1.5 cm. The tube is inserted into the carbon steel (low alloy) top head of the RPV. The top head is a welded assembly with 308 or 309 stainless steel cladding that is typically 6mm thick. Before the tube is inserted, the top head is buttered with alloy 182, to a thickness of approximately 1.2 cm, on the seal weld preparation surface. The seal weld (J-groove weld) joins the alloy 600 tube to the buttering with alloy 182 weld metal.

Within the product forms of the CRDM penetration assembly are important fabrication zones. Heat affected zones and re-heat zones are volumes of base metal or buttering that are changed by the heat of welding. Fusion zones are volumes of weld metal adjacent to the base metal or buttering.

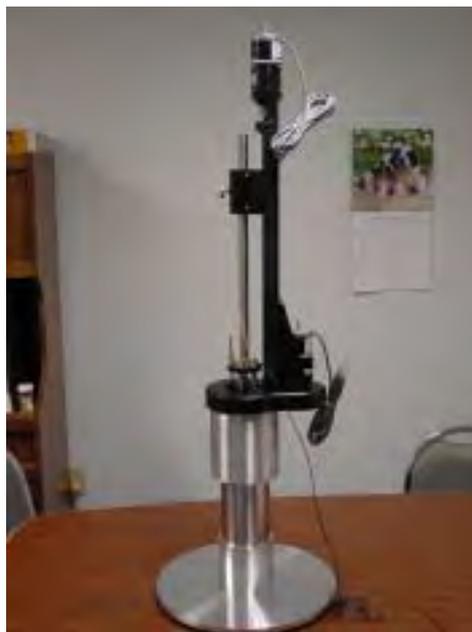
*Fig. 4. Laboratory scanner for NDE inspection from the inside of CRDM penetration tube.*

The objective for the study of NDE responses is to demonstrate and explain the performance of inspection for detecting degradation and preventing breaching of the reactor primary circuit at the welded assemblies that contain nickel-base alloys. It may not be possible to detect all degradation because of the inter-granular nature of the corrosive attack. Not all product forms and process zones are easy to inspect. NDE response information, gathered in this study, will be used to advance and quantify the characterization of welded assemblies that contain nickel-base alloys. Figure 4 shows the new PNNL scanner for inspecting the inside of the CRDM penetration assembly. Figure 5 show the focused ultrasonic probes, eddy current probe, and TODF probe for use with the new scanner.

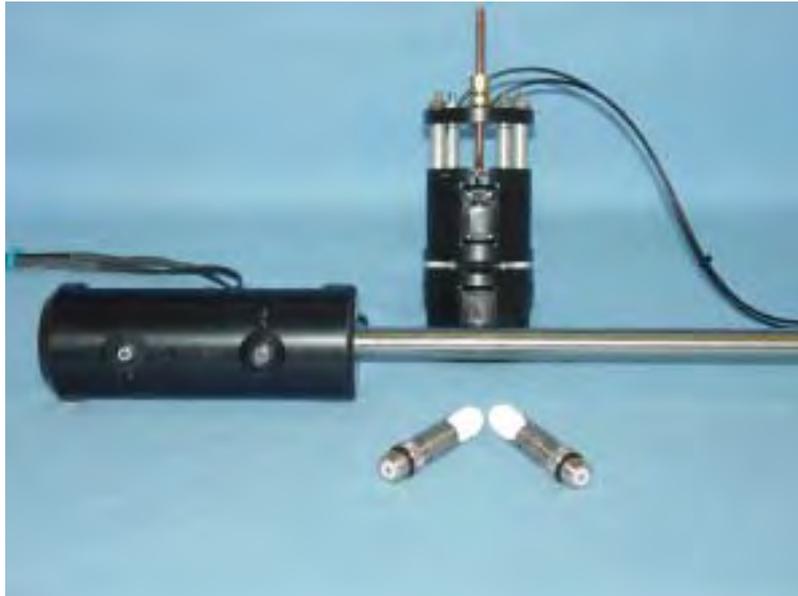
Fig. 5. Ultrasonic focused probes, Eddy Current probe, and TOFD probe for use in inspections from the inside of CRDM penetration tube.

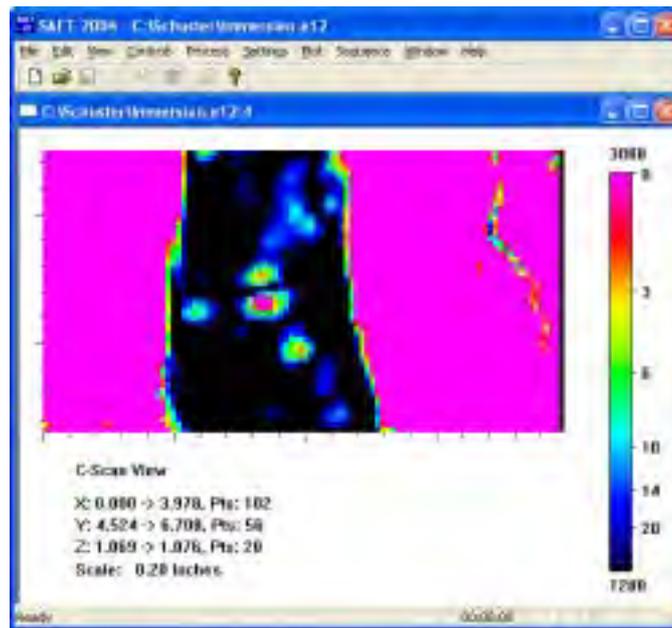
Fig. 6. Side view SAFT-UT image using 5 MHz ultrasound from the inside surface of CRDM penetration alloy 600 tube.

Normal incidence was also employed in scanning from the inside using an acoustic mirror to change the sound beam by 90°. Multiple reflections are observed except where the J-groove weld bonds the alloy 600 tube to the top head. In the region of this bond, ultrasound can be made to pass beyond the alloy 600 and into the alloy 182 weld metal. Small fabrication flaws have been found in the fusion zone of the alloy 182 weld with the alloy 600 tube. Figure 6 is a side view SAFT-UT image using a 10MHz ultrasonic, spherically focused probe from the inside of the CRDM penetration tube.

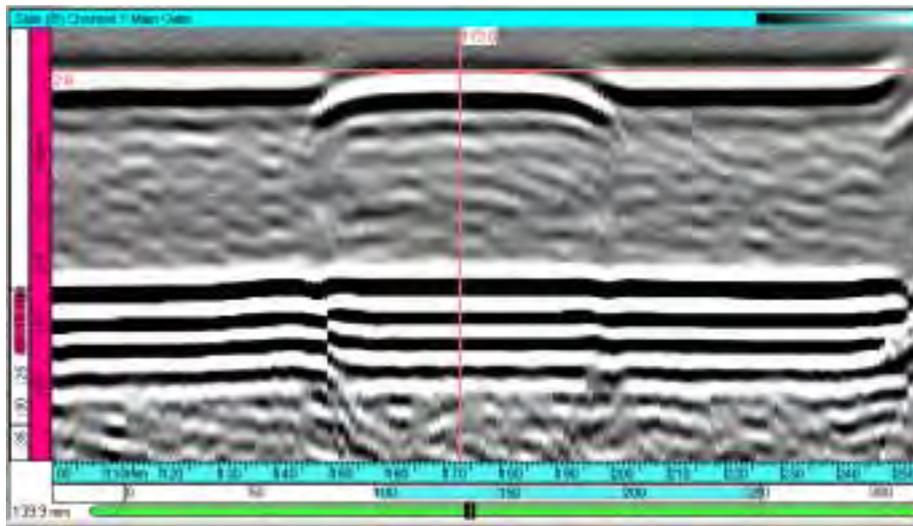
Fig. 7. TOFD data inside an alloy 600 tube from a circumferentially oriented EDM notch connected to the inside of the tube with a through wall dimension of 2 mm.

Test material in alloy 600 has been acquired in thickness representative of the CRDM penetration assembly's tube. Table 6 shows the EDM notches that were machined into an alloy 600 tube. Notches were placed on the inside and outside of the tube in axial and circumferential orientations. The through-wall dimensions of the notches are given in the table with the TOFD depth sizing results. Figure 7 shows TOFD data from the circumferentially oriented EDM notch connected to the inside of the tube with a through wall dimension of 2 mm.

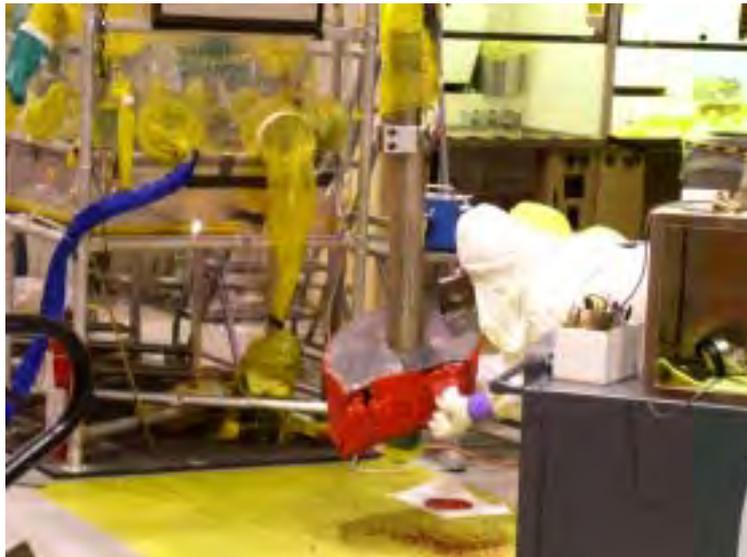
Fig. 8. CRDM penetration assembly being prepared for testing.

The components have been photographed, decontamination techniques have been established and evaluated, and progress on the decontamination has been made. The initial review of the components showed the splatter from the cutting of component from the RPV top head was prevent and would require removal as part of the decontamination process. Figure 8 shows one of the CRDM components after treatment of the flame cut surface with paint. After this treatment, a cutter was used to reduce the length of the penetration tube extending above the reactor vessel head.

A decontamination camber was designed and a lift fixture for gripping the CRDM tubes was put in place. It was decided that the areas of the wetted surface of the nickel-base alloys would be protected by the application of replica material and carbon dioxide ice crystal blasting would be used on the areas where replica material was not applied in order to remove surface contamination there. Once the carbon dioxide ice crystal basting was completed, removal and repeated reapplication/removal of the replica material was used for decontamination of the surface of the nickel-base alloys.
