INSPECTION AND MONITORING OF ASR-AFFECTED STRUCTURES AT SEABROOK STATION, NH

Liyang Jiang¹, Jesse L. Beaver², Matthew R. Sherman³, and Theodore Vassallo⁴

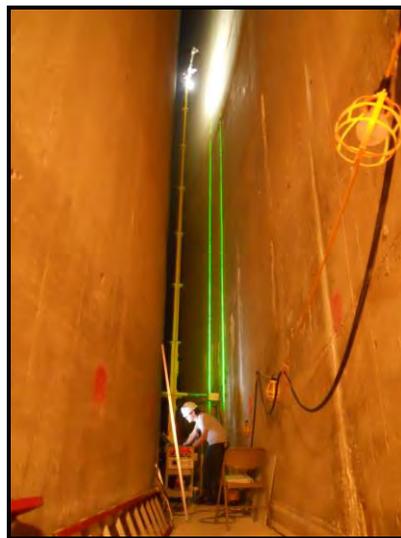
- *Digital Image Survey.* To survey the 50 ft high portion of the CEB wall, where installation of scaffolding was impractical, SGH designed a digital image system to capture features of interest (distresses and deterioration) on the concrete surface and to produce an overall image of the entire area over the full 50 ft height and the full circumference. This system included an extendable mast set on a mobile stand, a high-resolution digital SLR camera with an ultra-wide-angle lens, and compact fluorescent lights mounted on the top of the mast stand to image the interior face of the CEB wall. A system of linear lasers was used to project vertical lines on the CEB wall to allow the individual photos to be accurately “stitched” together during later post-processing to produce the overall image of the interior face of the CEB wall. Figure 2 shows the camera mast stand and linear lasers in use.

Figure 2. Digital Image System with Camera Mast Stand and Linear Lasers

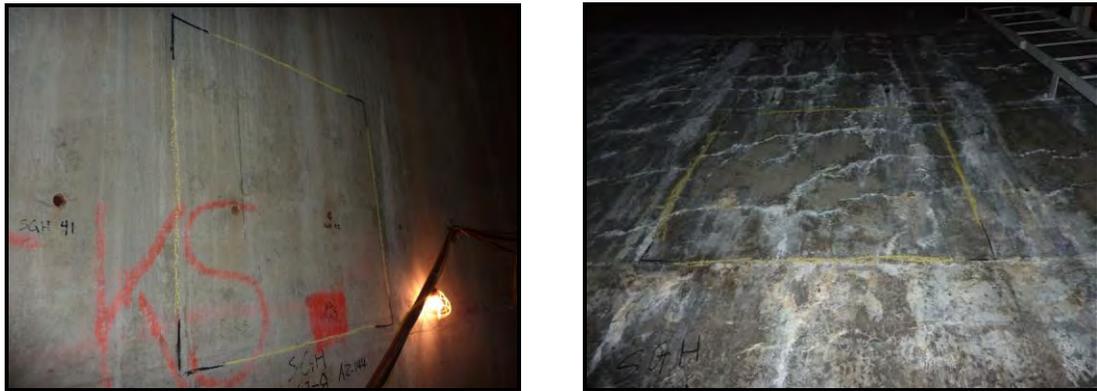
Based on overall condition of the CEB wall, SGH developed a five-tiered visual rating scale to classify the degree of visible distress in the surveyed areas. The scale includes elements of the classification system for “Low,” “Medium,” and “High” severity cracking, expansion, discoloration, and exudation as described in FHWA (2010). In the scale, Ratings 1 through 4 describe increasing levels of distress characteristic of ASR (cracking, efflorescence, and evidence of moisture/active leakage). Rating 5D is specified for areas with a diagonal cracking pattern that is likely unrelated to ASR. For illustration, examples of Visual Rating 1 and 4 are shown in Figure 4. SGH developed a map of the entire CEB wall that is categorized by visual ratings/zone, as shown in Figure 5.

Figure 4. Examples of visual rating of ASR distress on CEB Wall (Left: 1; Right: 4)

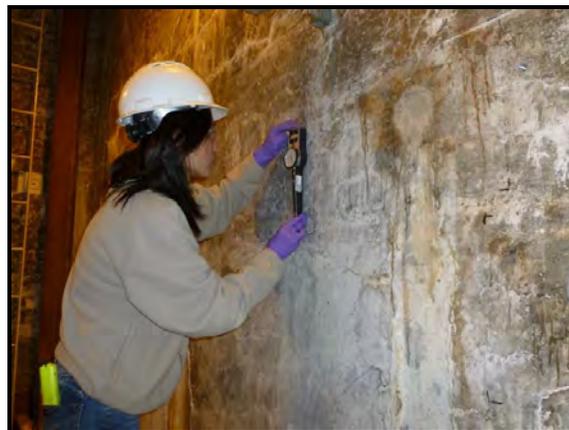
Figure 7 illustrates an example of the crack widths at an ASR Monitoring Location. Figure 8 shows the measurement of the distance between gage points using the mechanical strain gage.

Figure 8. Measurements with Mechanical Strain Gage
