## **COMPREHENSIVE ASSESSMENT AND IMPACT OF ALKALI-SILICA REACTION ON THE SEISMIC RESPONSE OF A NUCLEAR STRUCTURE**

**Said Bolourchi<sup>1</sup>, Jesse L. Beaver<sup>2</sup>, Theodore Vassallo<sup>3</sup>**

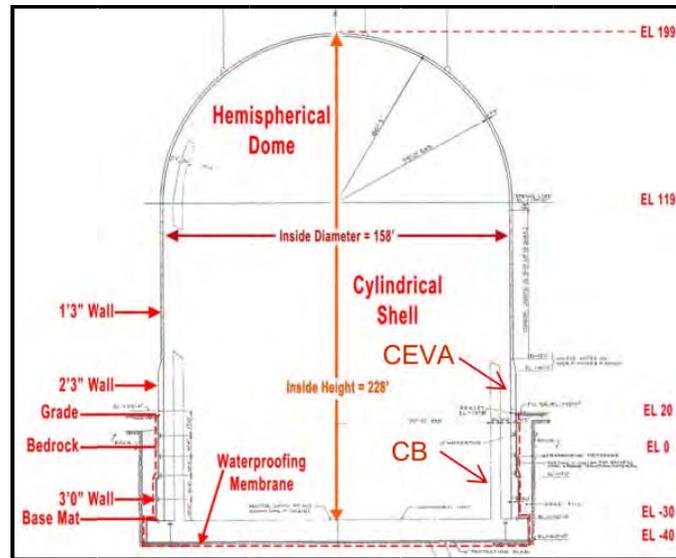
Figure 1. Seabrook Station Containment Enclosure Building - Cross-Section

CEB is a cylindrical reinforced concrete wall, 228 ft tall, with an inside diameter of 158 ft and closed at the top with a 1 ft-3 in. thick hemispherical concrete dome (Figure 1). The wall thickness varies from 3 ft-0 in. at the base to 2 ft-3 in. from EL -11 ft to EL 40 ft, and 1 ft-3 in. above EL 40 ft. The wall is supported on a 10 ft thick concrete base slab. The top of the base slab is at EL -30 ft, 50 ft below finished grade, which is at approximately EL 20 ft. The bedrock surface is at EL 0. The lower portion of the CEB structure is below the exterior grade and was constructed in an excavation into granite bedrock. The structure was not cast directly against the granite, but was instead formed on both surfaces. A butyl rubber waterproofing membrane system was installed on the exterior of the CEB concrete walls at the time of construction and the exterior portions of the below-grade structure were backfilled with nonstructural concrete fill. The structure consists of conventionally reinforced concrete with very close spacing and layout of reinforcing bars (two to three layers of #9 to #14 at 6 to 12 in.), which is significantly more reinforced as compared to typical building or bridge structures.

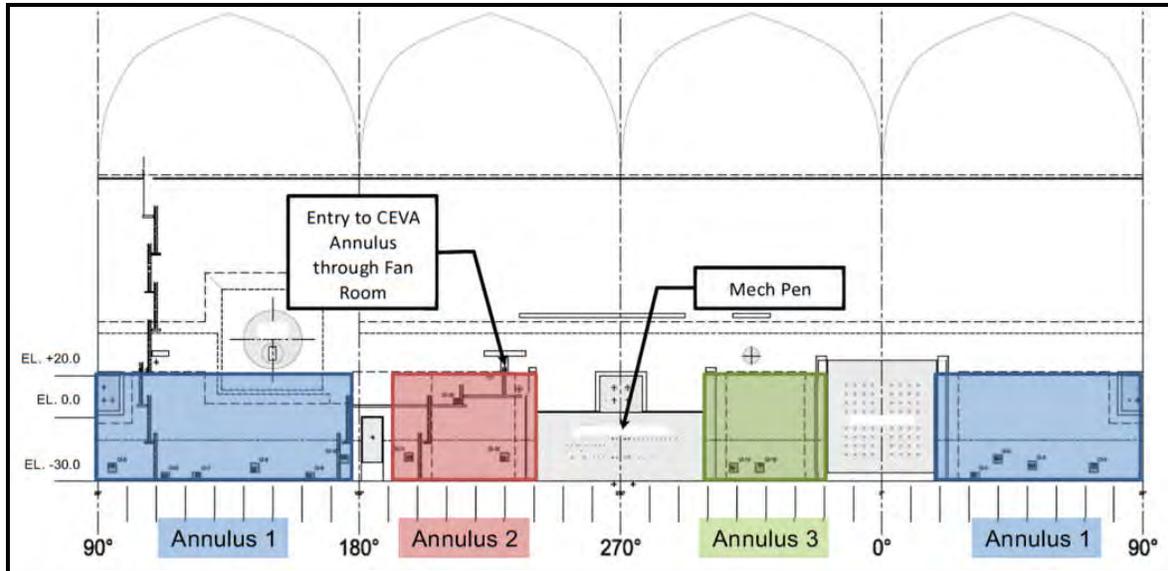
Figure 2. Seabrook Station Containment Enclosure Building - Exploded View

The CEB has several large openings (penetrations) through the lower elevations of the cylindrical wall. Access into the CEVA is available into three annuli between the penetrations. Figure 2 shows an exploded view of the CEB with the three annulus locations along with the significant penetrations, such as the mechanical penetration that is called out.

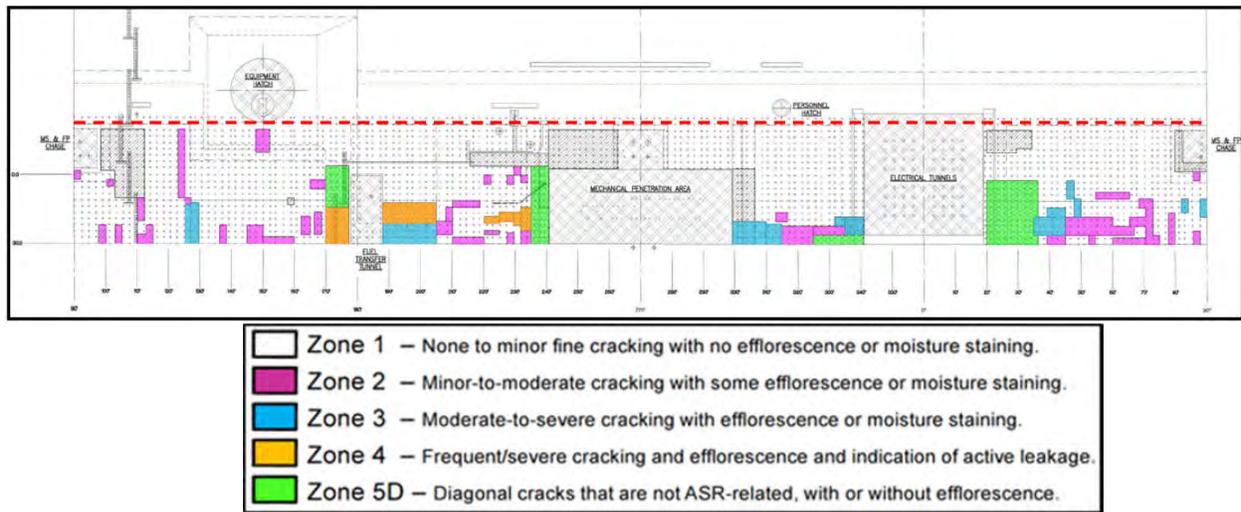
Figure 3. Visual Rating Map – CEB Wall Full Circumference

Visual inspection included overall visual assessment of the CEB, digital image survey of the full internal surface of the CEB wall located below grade (over a 50 ft height), and detailed visual survey with cracking index (CI) measurements on the portion of the CEB wall located below grade, as well as on four additional concrete structures at Seabrook Station. The inspection process is described in a companion paper also submitted to SMiRT-22, Jiang et al (2013). The surveyed surface of the CEB was categorized into five zones of visual distress ratings as shown in Figure 3. Zones 1 through 4 reflected ASR distress, while Zone 5 included distress primarily unrelated to ASR. Representative photographs of concrete representing Zones 1 through 4 are shown in Figure 4.

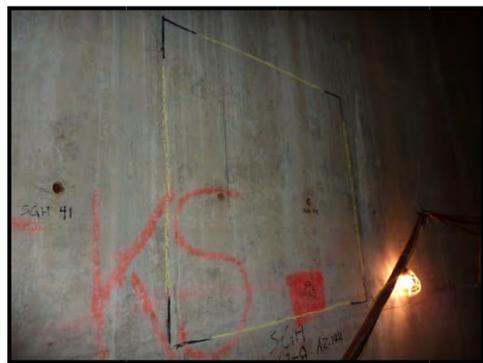
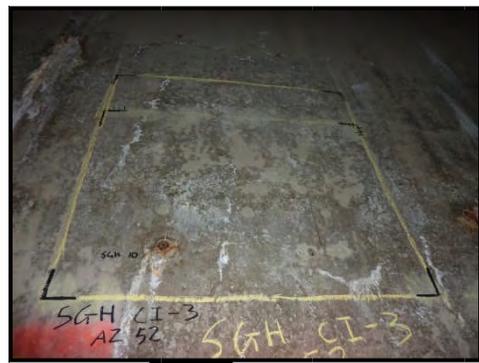
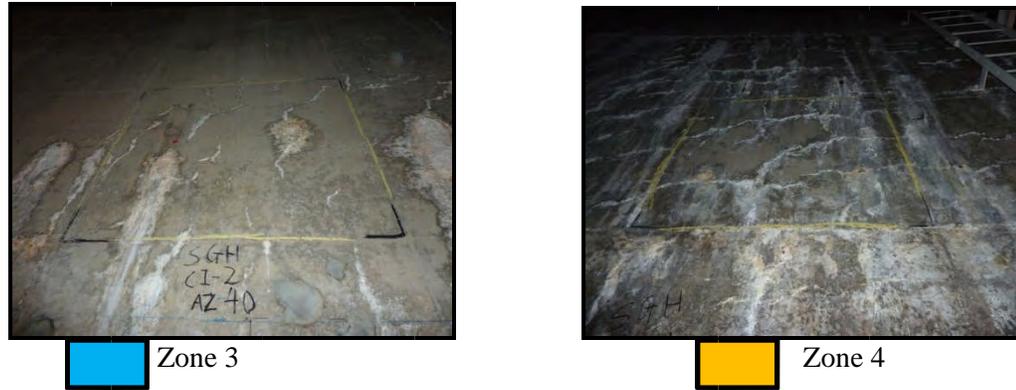
Figure 4. Photographs of ASR Visual Rating Zones

Zone 1

Zone 2

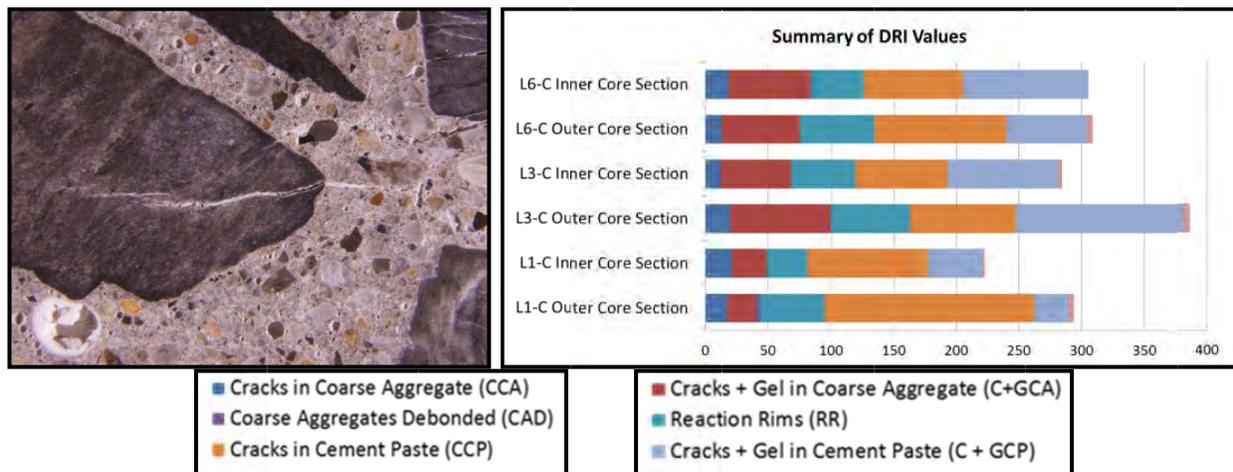
Figure 5. Illustration of Cracks and Gel in a Coarse Aggregate Sample and DRI Summary based on petrographic examination of concrete Cores from Seabrook Station

The petrographic examination showed that the coarse aggregates used for Seabrook Station concrete were reactive and that some of the aggregates used in other concrete structures were similar to those used in the CEB concrete, and had the same potential, but variable degrees of ASR. The fine aggregate was determined to be non-reactive. The examination also evaluated the level of ASR distress at the exposed surface, as compared to the level of ASR distress within the wall thickness. This evaluation demonstrated that the damage, as quantified using a damage rating index (DRI), is greatest at the exposed surface. The petrographic examinations confirmed the presence of ASR and justified use of a surface visual distress rating as a valid indicator of ASR distress levels in nuclear structures. Figure 5 shows a photograph of a Seabrook Station concrete aggregate with ASR related distress features and a DRI plot of ASR features for a set of three core samples removed from the CEB. The DRI plot shows greater ASR damage at the exposed (outer) surfaces within the CEVA.

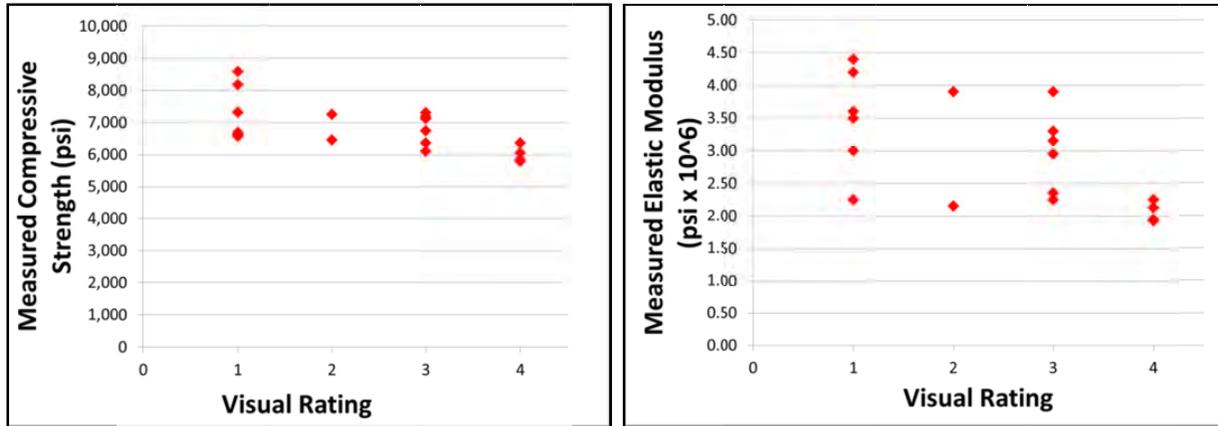
Figure 6. Correlations between SGH Visual Rating and Laboratory Test Results

ASR damage has been shown to reduce the concrete tensile strength, concrete compressive strength, and concrete stiffness, and negatively impact the quality of bond between reinforcement bars and the surrounding paste structure. ISE (1992) published physical properties measured on unrestrained concrete specimens for various amounts of free expansion that showed a reduction in mechanical properties with increasing ASR damage. Laboratory testing on Seabrook Station cores included compressive strength and modulus of elasticity testing. Figure 6 provides the tested strength and stiffness versus the visually rated concrete surface condition that illustrates good correlation between the visual rating and the mechanical properties. These findings justify the use of visual rating to estimate reduced mechanical properties for the CEB concrete.

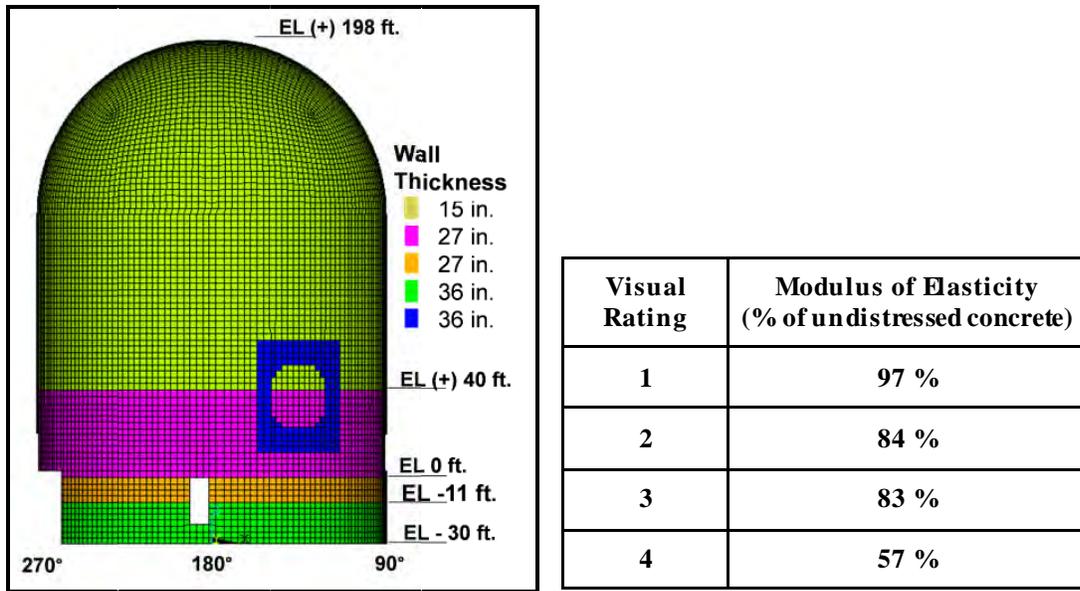
Figure 7. 3D Finite Element Model and Ratio of ASR Distress Relative to Undistressed Specimens

A detailed three-dimensional finite element model (3D FEM) of the CEB was prepared using the ANSYS program. The wall and dome were modeled by element SHELL181, which has in-plane extension, out-of-plane bending stiffness, and allows section offsets. Shell elements had average size of 3 ft and an overall thickness matching the design concrete wall in the CEB. All penetrations were included in the model, as shown in Figure 7. Two 3D models are used including a undistressed condition where the design properties are used for elements representing concrete areas, and a distressed condition which includes areas with different severity of ASR impacts that were mapped into the 3D FEM. The reduction in elastic modulus,  $E$ , with increasing levels of ASR distress, based on visual ratings, for the distressed condition model, are shown in Figure 7.

Stick models were used for calculating overall seismic behavior of CEB. Detailed 3D models were used to calculate the properties and offsets for beam elements representing different elevations of the overall structural model. Two sets of stick models were prepared: one based on undistressed 3D FEM and other based on the distressed 3D FEM. The offsets, as well as the beam model properties, for the distressed stick model were different, as compared to the corresponding properties for the undistressed model.

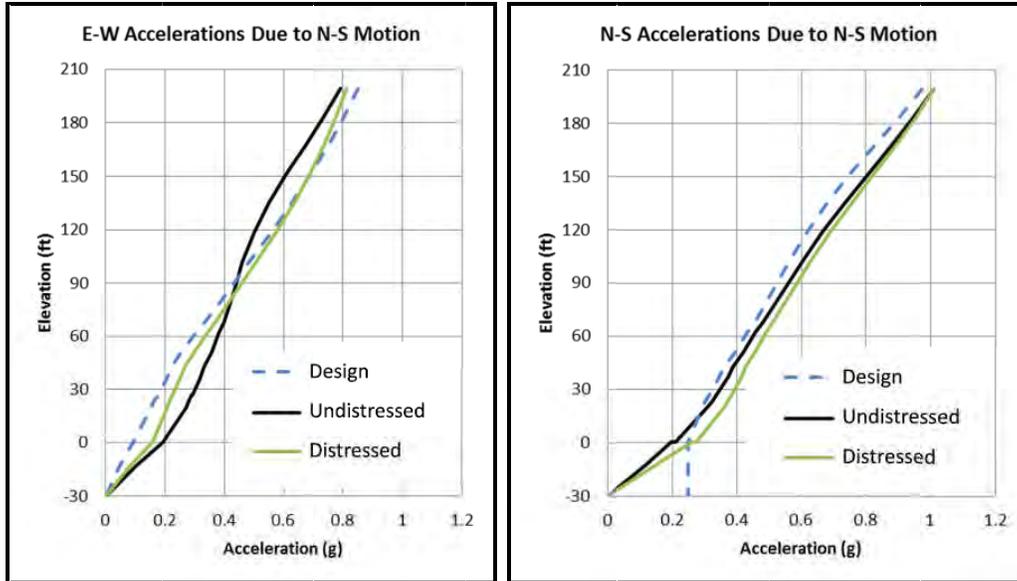
Figure 8. Variation of Maximum Acceleration with Elevation of the CEB

The stick models were used to calculate the overall dynamic behaviors of the CEB, and acceleration profiles for undistressed and distressed structures. Figure 8 shows typical overall orthogonal acceleration profiles due to a north-south input motion. This Figure shows responses for the original design calculations, and calculated responses for undistressed and distressed stick models. The acceleration profiles for both undistressed and distressed conditions closely follow the original design profiles. This comparison demonstrates that the models developed in this project closely backfit the original design, and ASR impacted mechanical properties of the concrete do not significantly impact the overall dynamic behavior of the CEB.

Natural frequencies and maximum accelerations of backfit, (undistressed) and ASR-distressed models were calculated. Maximum acceleration profiles of backfit models closely match the corresponding values reported in the original design. The overall responses of the CEB including maximum acceleration and in-structural response spectra, were not significantly impacted by ASR, since the ASR distressed areas are localized.

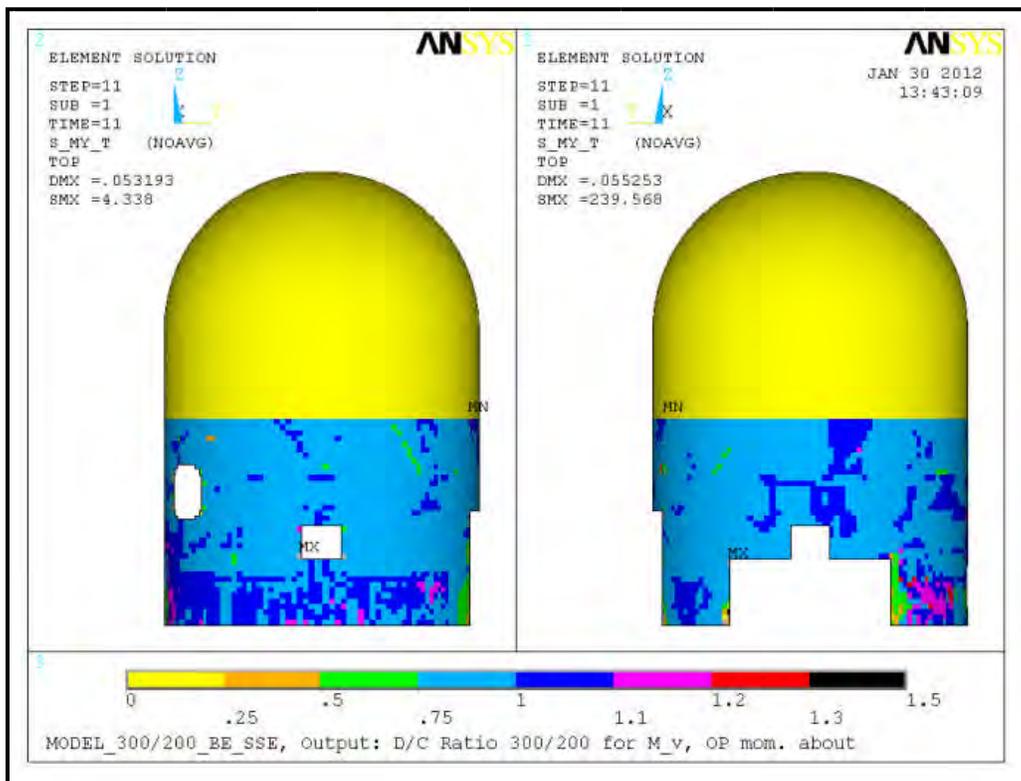
Figure 9. Reduction in Flexural Stress as Ratio of ASR distressed to undistressed Models

Figure 9 shows a typical impact of ASR on structural response for the ratio of the bending moments about the horizontal axis. The bending moment increases locally due to a reduction in the concrete mechanical properties where ASR impact is more significant. In general, non-seismic and seismic loads are partially redistributed to the undistressed concrete zones, based on the relative stiffness of undistressed concrete zones compared to distressed concrete zones. Therefore areas with no damage or minor damage will be more highly loaded than predicted in the original design; however, our calculations demonstrated that the original design had sufficient margin to resist the additional local demands due to load redistribution from distressed to undistressed areas of the structure.

The ASR distress in concrete did not significantly impact the overall forces/moments in the wall; however, the less-distressed areas attract more force since they become relatively stiffer the localized area impacted by ASR. Structural capacities for both undistressed and ASR distressed cases have been calculated in accordance with the requirements of ACI 318-71 based on original design parameters. Even with redistributed forces, 99% of the finite elements describing the CEB structure have demand/capacity ratios less than 0.50 for all load combinations, and the remainder of the elements had sufficient reserve capacity to resist the added demands load redistribution due to ASR impact.
