## CHERNOBYL: BRIEF HISTORY OF THE WORST NUCLEAR DISASTER

**Andre Salloum<sup>1</sup>, Orhan Gurbuz<sup>2</sup>, Sergey Deriuga<sup>3</sup>  
Mathieu Scherer<sup>4</sup>, James T. Cameron<sup>5</sup> and Farhang Ostadan<sup>6</sup>**

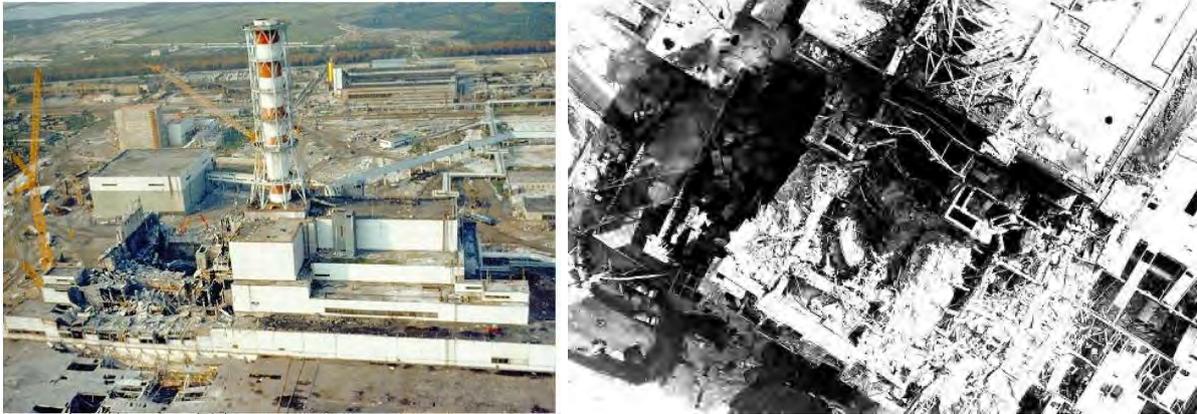
Figure 3 – ChNPP Unit 4 Accident on 26 April 1986

On 26 April 1986, at 1:23:49 am by Moscow time the Accident occurred at Chernobyl NPP Power Unit 4 (Figure 3). The consequences of the accident were the severest in the entire history of nuclear power industry. This Accident completely destroyed the reactor core and damaged the majority of the bearing structures of the power unit core. Chernobyl Unit 4 stopped existing as a power unit. The accident generated 190 tons of radioactive dust in 10 days, with radiation levels 90 times higher than Hiroshima (20 Sv/h at proximity of the Unit 4).
